## Kennebec Barrier Survey 2010

Grantee: Kennebec Valley Soil & Water Conservation District

Revised May 7, 2011

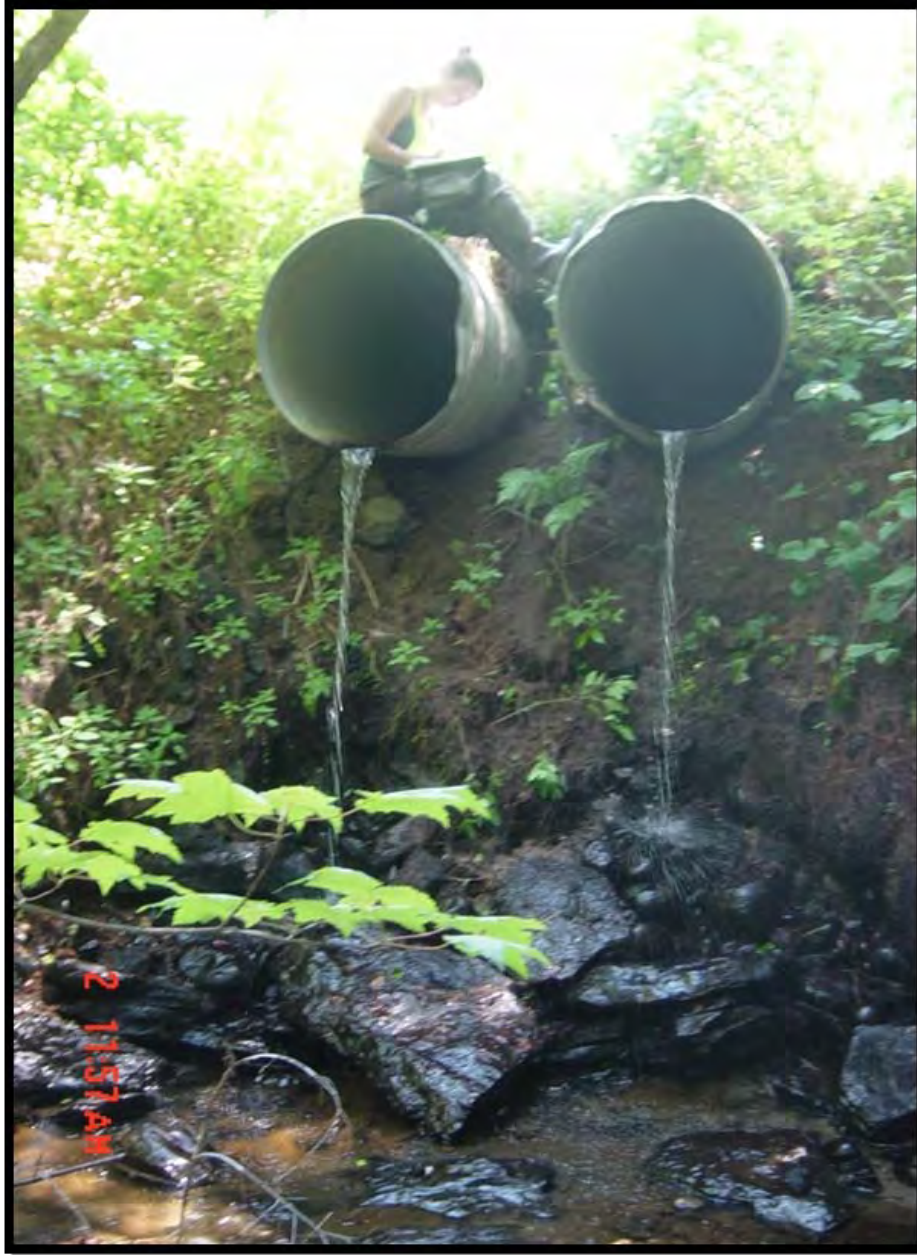
**Cover Photo:** The photo shows a “perched” culvert, defined as a culvert whose inlet or outlet is elevated above stream grade. In the lower Kennebec River watershed, perched culverts are the primary reason road-stream crossings block or impair fish passage. Courtesy Charlie Baeder, 2010.

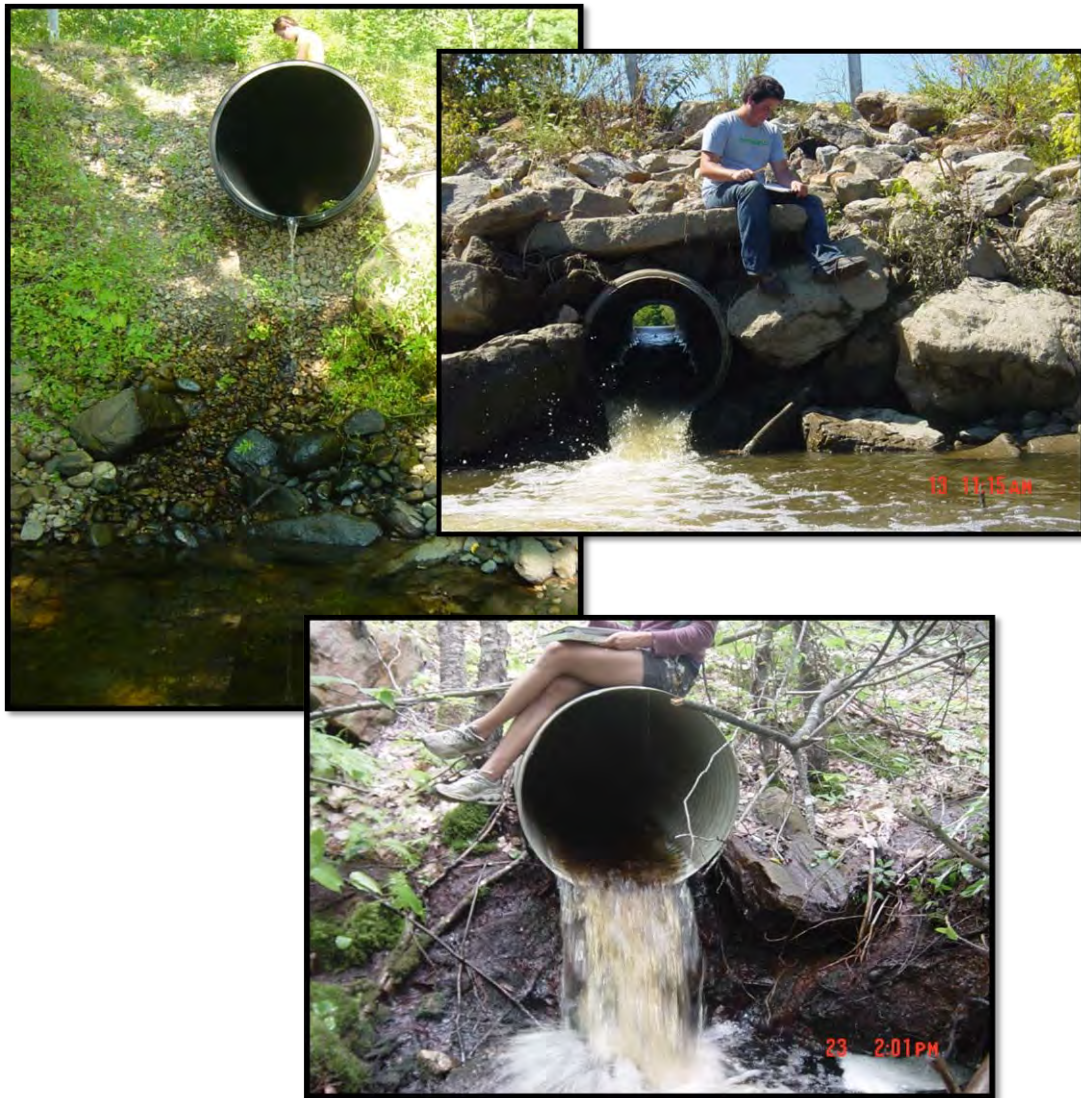
Perched culverts are defined as culverts whose inlet or outlet is elevated above stream grade, thus preventing or impairing fish passage. Perched culverts are typically referred to as “hanging” culverts by public works officials. The following pictures illustrate perched culverts.

Perch height, the distance from the bottom of the pipe to the water level of the stream, was also measured. For outlet perched culverts where perch height was measured ( $n=117$ ), the median perch height was 0.18 meters and the mean perch height was 0.35 meters. All outlet perched culverts are considered “severe” barriers, but the severity of the perch and the evaluation of perch height under different flow conditions is worthy of additional consideration on at least a site basis when considering restoration projects.

For the reasons noted above – perching, blockage, velocity barriers, and no substrate – undersized culverts have been targeted by fisheries biologists for replacement with fish friendly culverts. Culvert sizing recommendations made by biologists have supported a 1.2x bankfull width standard for the last decade, meaning that a culvert's diameter should be 1.2x (120%) larger than the bankfull width of the stream it will pass. This sizing standard, when properly implemented, improves fish and aquatic organism passage and habitat.

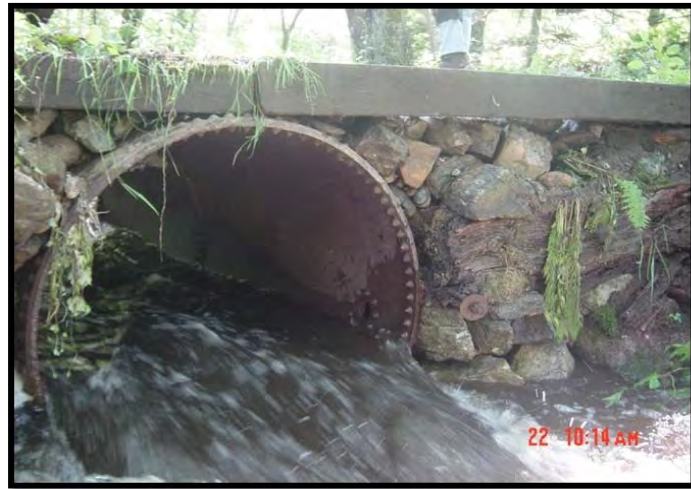
Sometimes it is done to block invasive fish, e.g., Northern pike, from entering an upstream watershed (rare). Sometimes they are installed with an inlet or outlet elevated above stream grade because of ledge (common). More often culverts which are now perched were originally installed at stream grade but were undersized for the volume of water they were required to pass. When culverts are undersized water accelerates and causes a “hose” effect which erodes downstream substrate in the stream channel resulting in an elevated “perch”. This hose effect is illustrated in the photo.

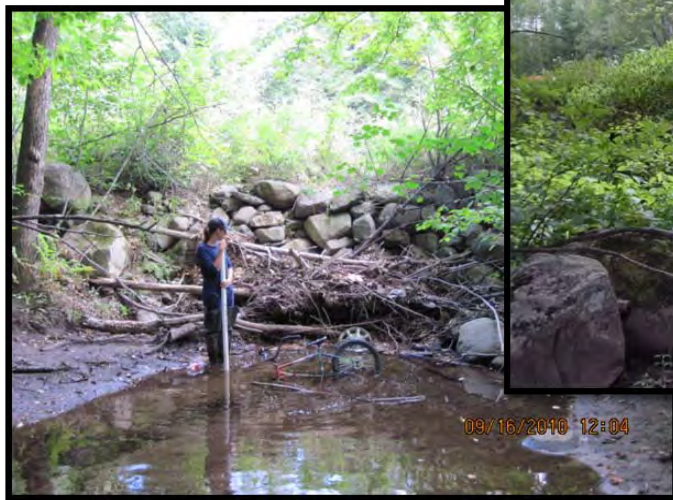
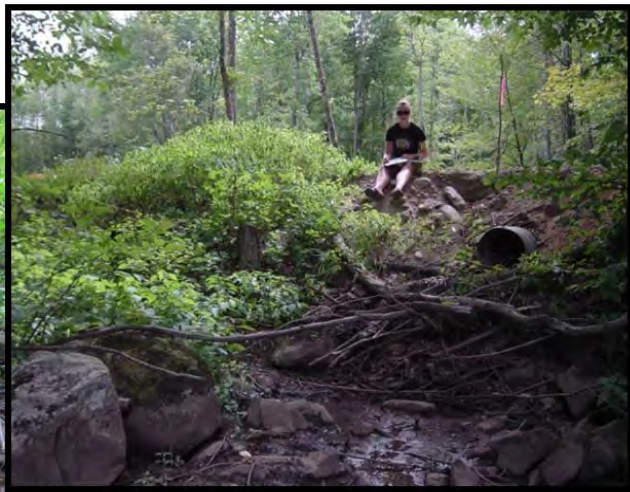
Blockages are significant fish passage barriers and were present in 9.82% of all culverts (n=33). In addition to 21 “severe” barriers – the “severe” definition is  $\geq 50\%$  blocked – another 12 culverts were 25% blocked. Nine of the severely blocked culverts were also outlet perched culverts. Both conditions are caused or made worse by undersized culverts. Representative photos illustrate the problem.

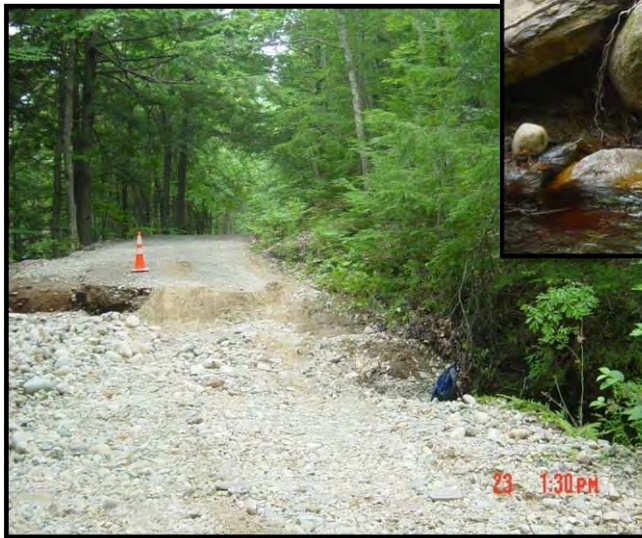
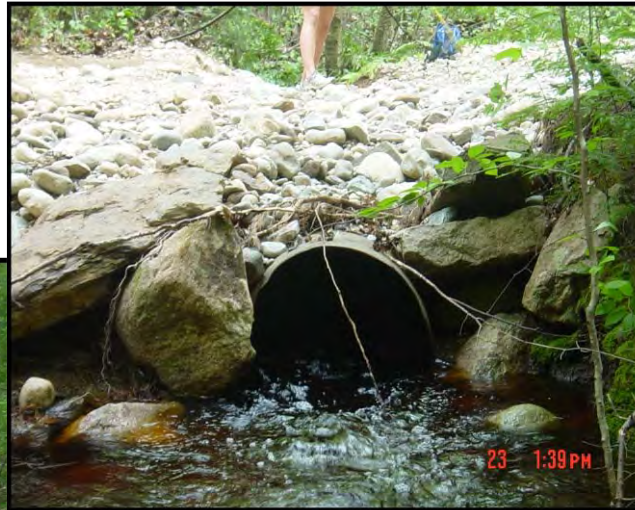
One of our survey crews observed this firsthand in the lower Kennebec watershed on Meadowbrook Road in Phippsburg following a storm in July 2010 that washed out the road. These photographs show the road after initial repairs were started and what appears to be the re-installation of an undersized culvert. Road failures were observed on a larger scale in Downeast Maine following a December 2010 storm that blew out several roads in that region. Culverts in that same area that had been replaced in the last few years by

Project SHARE with culverts sized at 1.2x bankfull width in order to restore fish passage weathered the storm without incident. In addition to impairing fish passage, undersized culverts are clearly a road infrastructure, public safety, and FEMA cost issue.
