## Habitat Restoration Inventory Summary Report for the Royal River, Spruce Creek, and Lower Kennebec River Estuary

**HABITAT RESTORATION INVENTORY  
SUMMARY REPORT  
FOR THE  
ROYAL RIVER, SPRUCE CREEK, AND LOWER KENNEBEC  
RIVER ESTUARY  
VOLUME I**

**DECEMBER 2005**

**Prepared by: Northern Ecological Associates, Inc.  
451 Presumpscot Street  
Portland, Maine 04103**

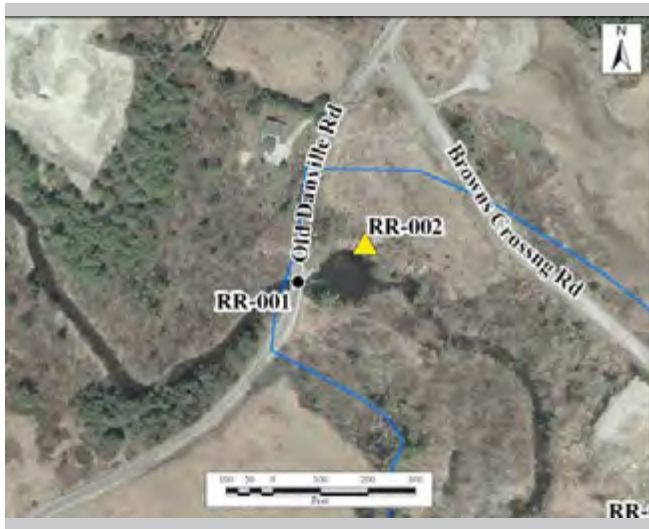
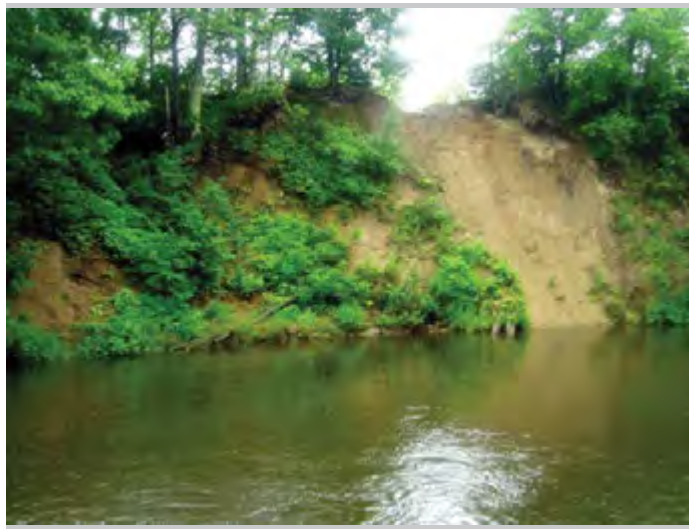
Very steep, actively eroding bank on opposite shore from RR-001. Site is ~30-feet tall and 50 to 75-feet wide, and consists of silt and sand, with exceptionally loose material across the lower 20-foot swath. Trees on the adjacent bank are severely undercut. Bank damage does not appear to be due to river flood stage. Observe substantial downstream deposition of sand

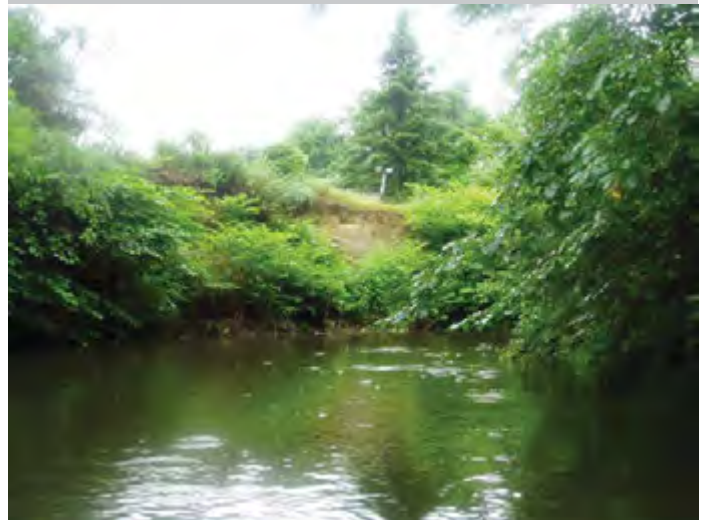
Japanese knotweed stand, approximately 75 x 10 feet.

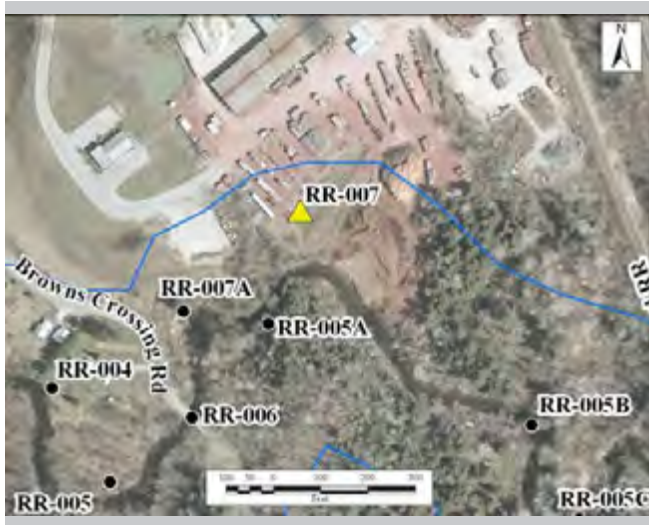
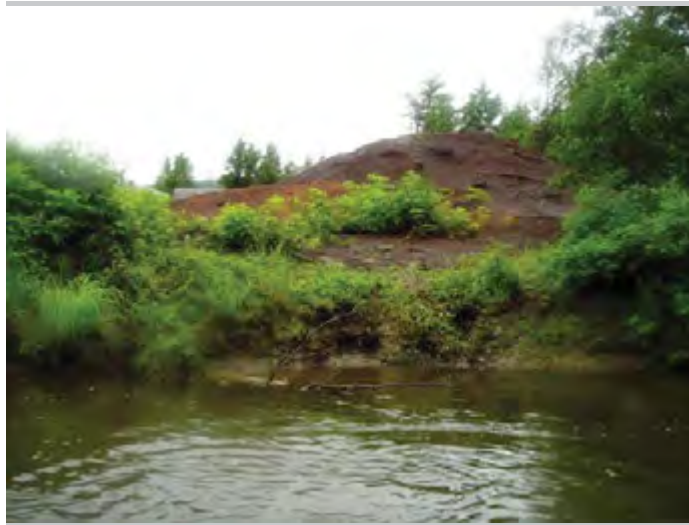
Morin Brick Company property consists of a mix of stable and eroded bank areas. Stable banks consist of placed stone and/or discarded brick. Unstable areas generally have denuded vegetation, loose soil and erosion, undercut banks, sediment loading in water, and turbid water inputs. Native vegetation impaired in most areas.

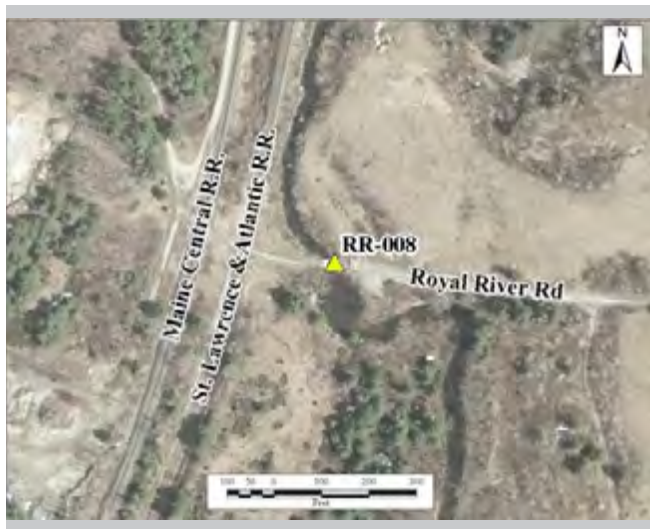
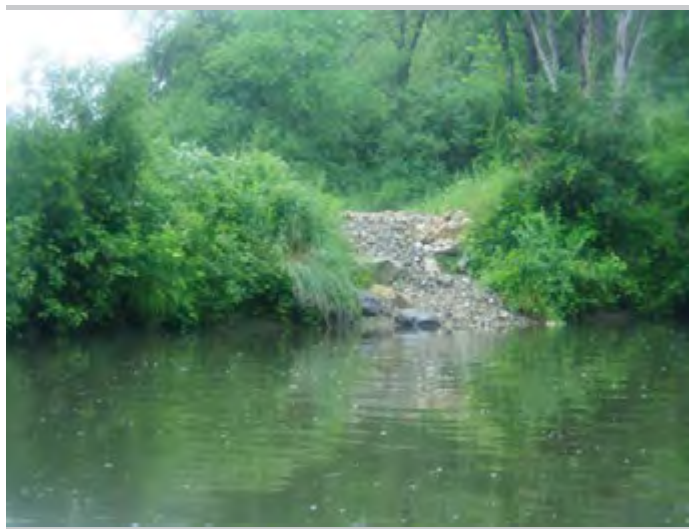
Bridge road crossing with associated rock support structure. Orientation of bridge has redirected the stream flow into a unnatural direction, thus causing a localized constriction and downstream erosion bank area. The bridge itself is unused and in poor condition.

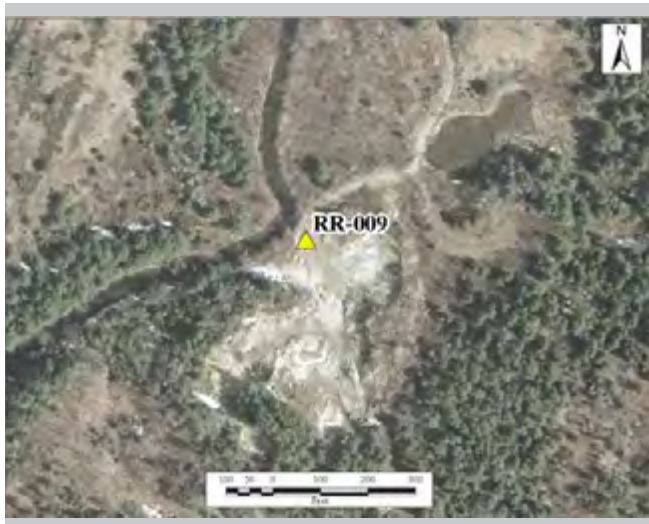
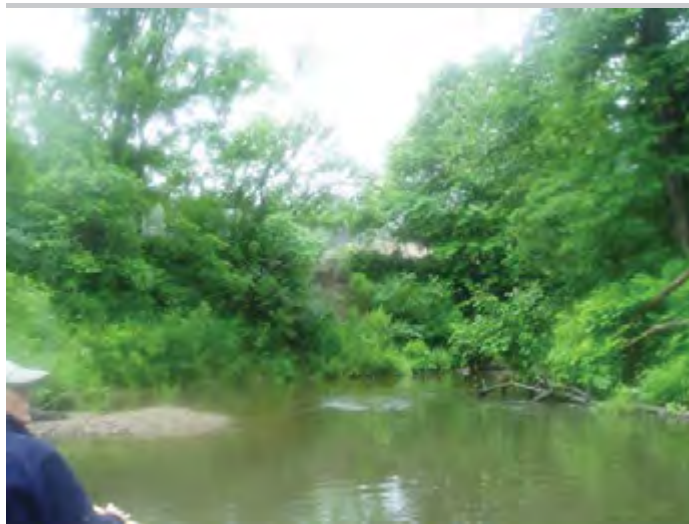
Active gravel pit adjacent to river. Narrow buffer vegetated to top of slope, then gravel pit operations. Steep slope (approx. 45-degree), and 25-feet high. Some minor erosion noted on outside bend in channel, which may be partially due to natural causes.

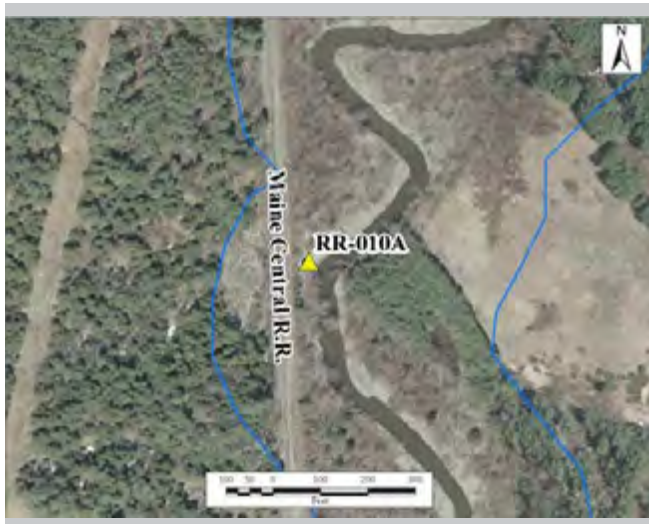
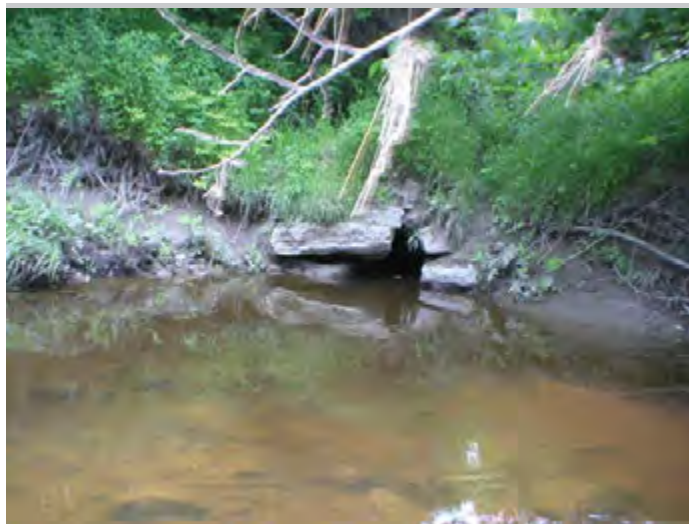
Rock culvert at railroad tracks has minor erosion noted around top and sides of culvert. Railroad bed may eventually need stabilization. Buffer is high quality but narrow (60 feet); maintained within 20 feet of railroad line.

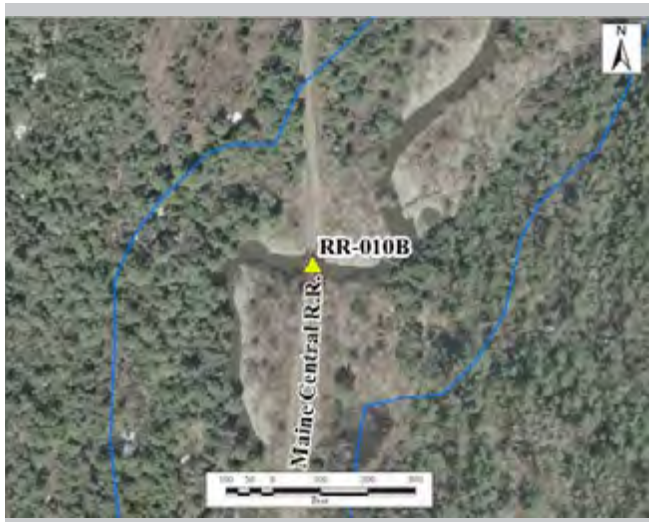
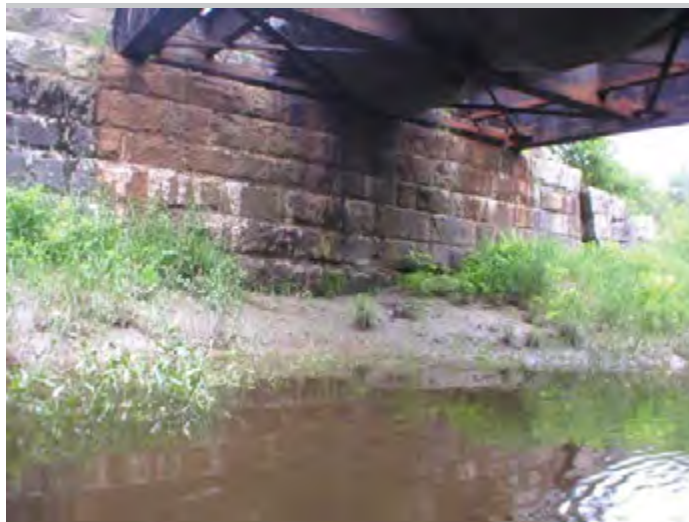
Railroad bridge crossing. Fabric liner under railroad tracks catch debris from railroad. Minor erosion, lack of vegetation under bridge. Bridge foundations have some minor effect on flow. Maintained buffer along railroad ROW.

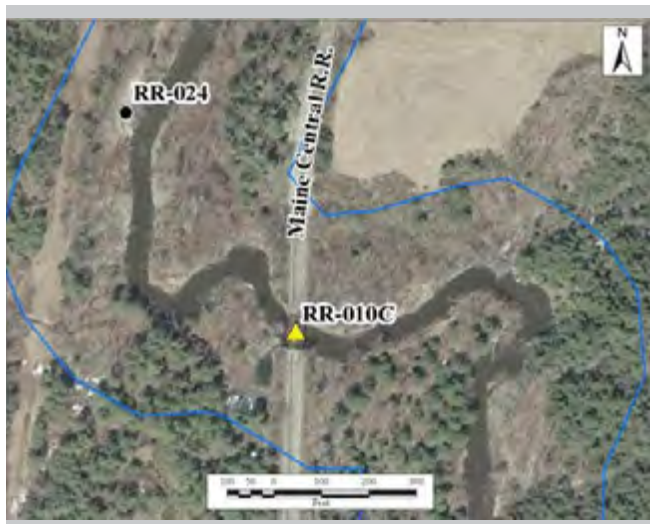
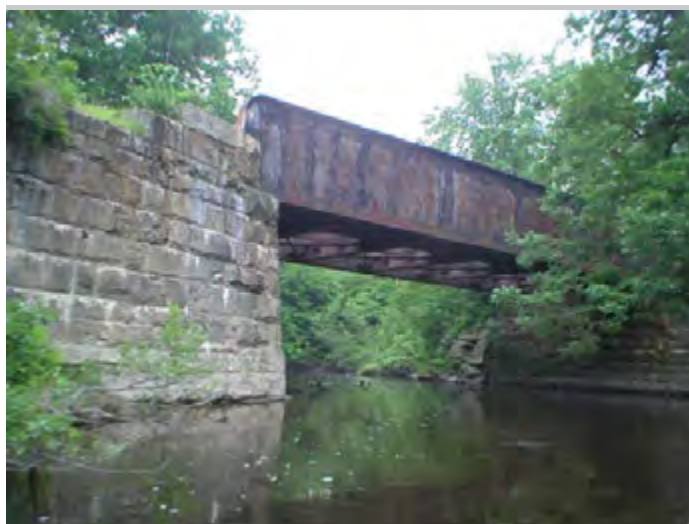
Railroad bridge crossing. Some sediment accumulating under bridge; foundation is constricting flow slightly. Banks held in place with stone wall. Otherwise, banks well vegetated and stable.

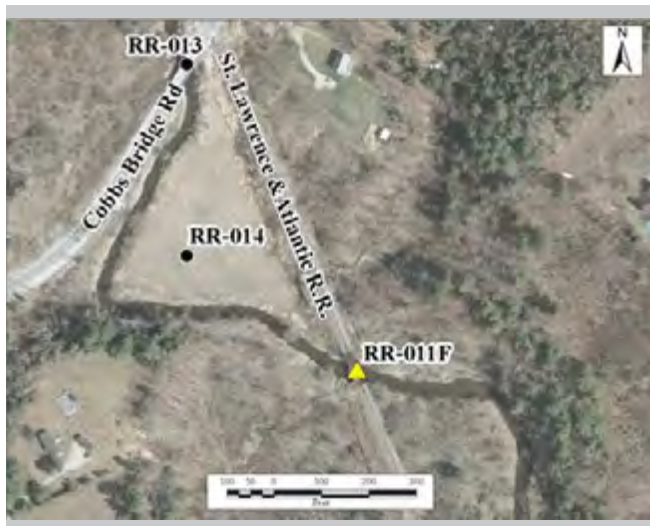
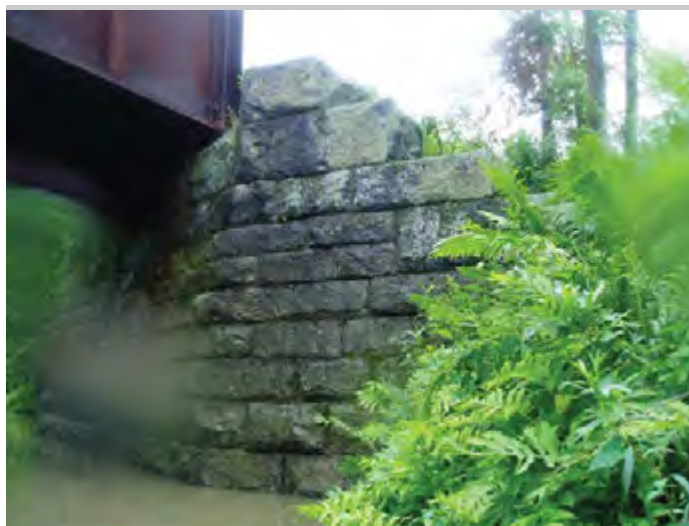
Railroad bridge crossing. ROW maintained through cutting back of vegetation. Sediment accumulation under bridge. Banks stable, placed, cut rock wall foundation.

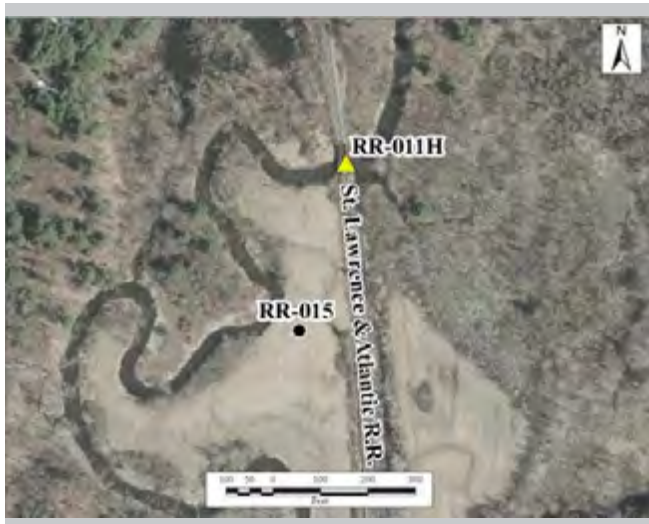
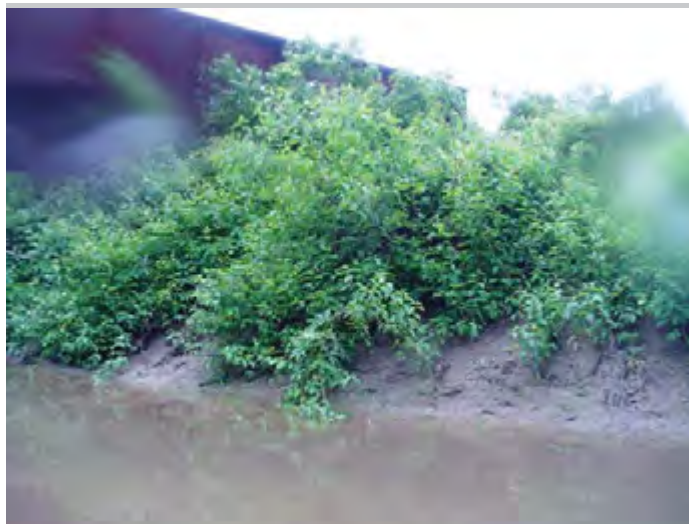
Railroad bridge crossing. ROW maintained through cutting back of vegetation. Banks stable, not eroding, with placed, cut rock foundation. Sediment deposition under bridge. Slight constriction of waterflow.

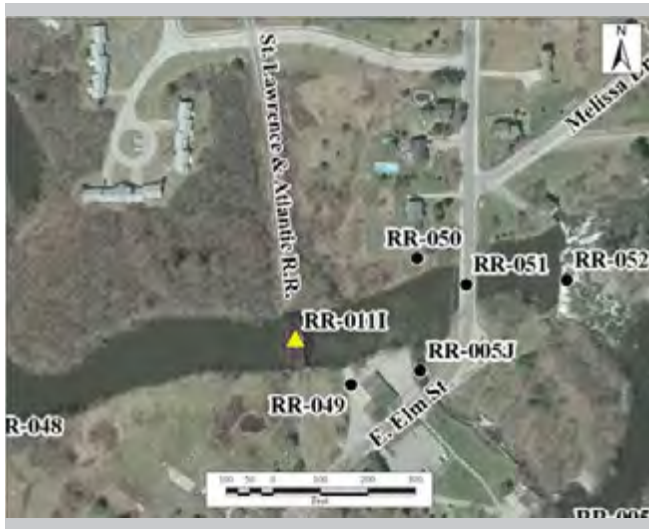
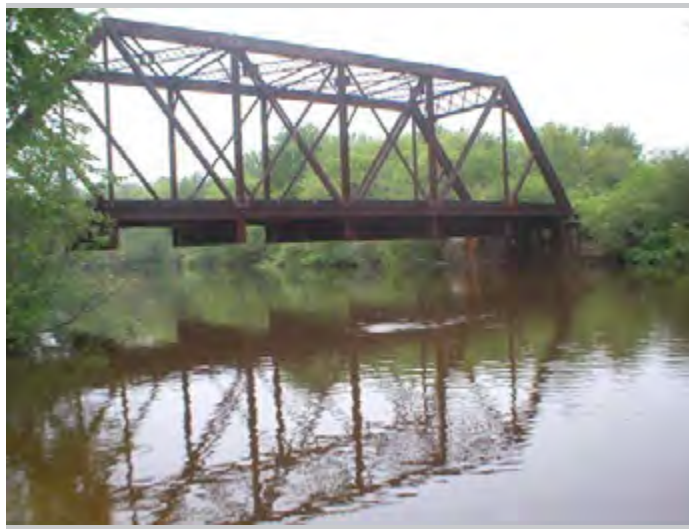
Railroad bridge crossing. ROW maintained through cutting back of vegetation. Placed, cut rock foundation.

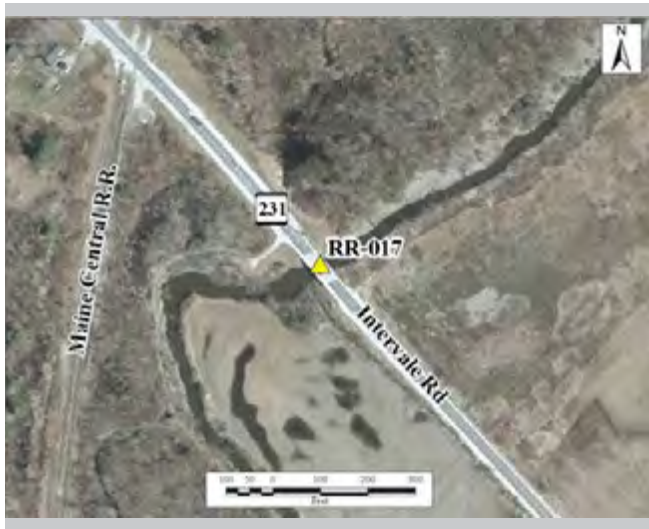
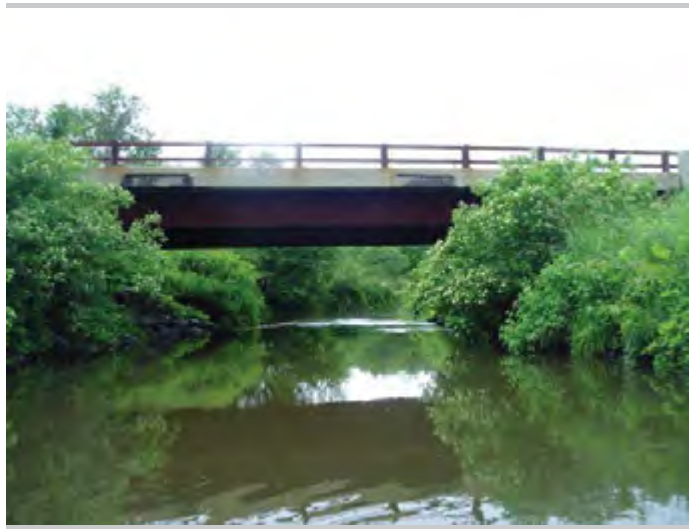
Highway 231/Intervale Rd crossing. Banks are generally stable and vegetated. Area under bridge is also stable with rip-rap on banks. Bridge causes a slight localized constriction and increased stream flow. Japanese-knotweed present at the top-of-bank adjacent to the road.

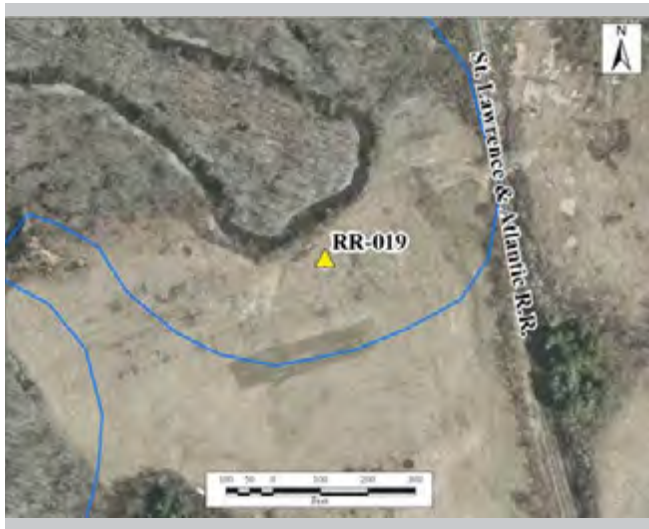
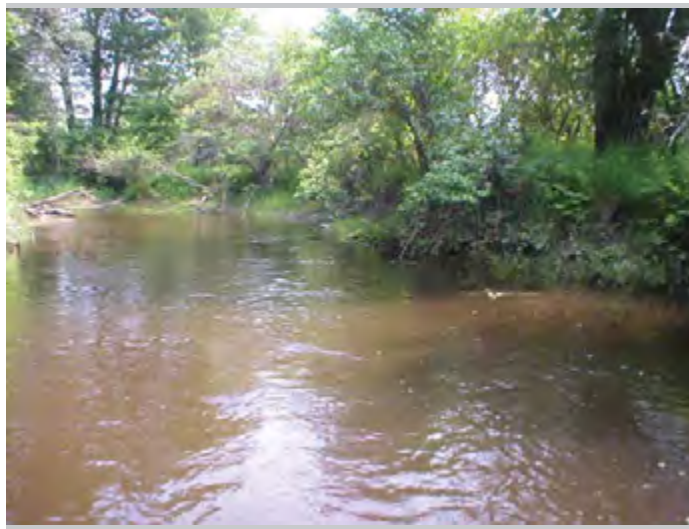
Inadequate buffer. Steep banks (approx. 50 to 75% slopes) have marginal vegetation with few trees, thus leaving exposed ground and slumping areas.

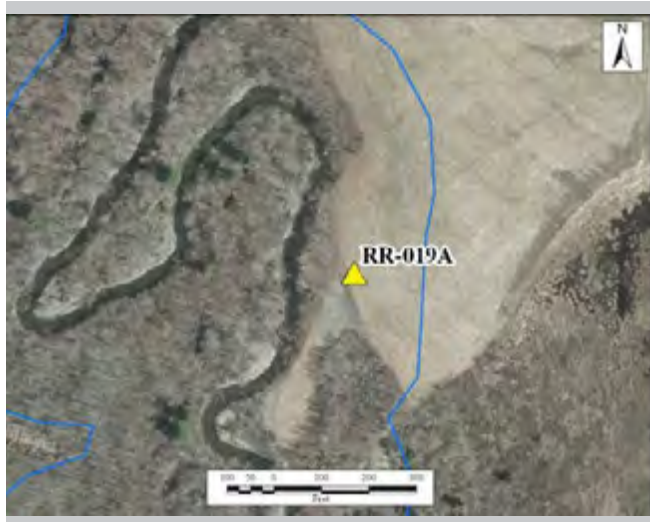
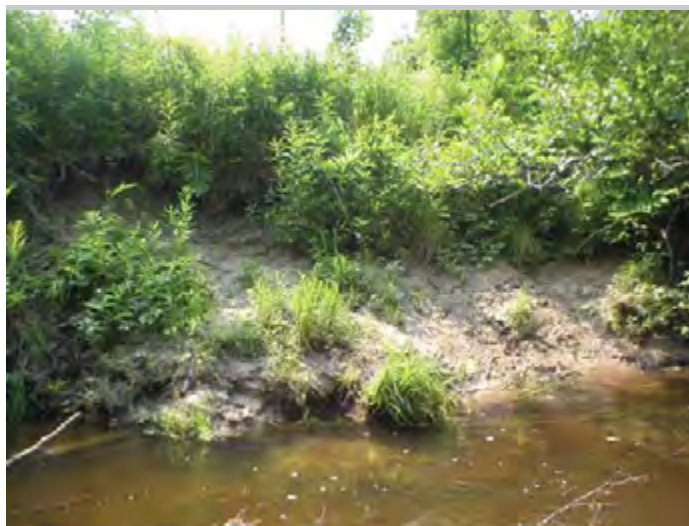
Minor erosion of shoreline. Some sediment loading has occurred as a result. Area has an inadequate buffer mostly of dense herbs.

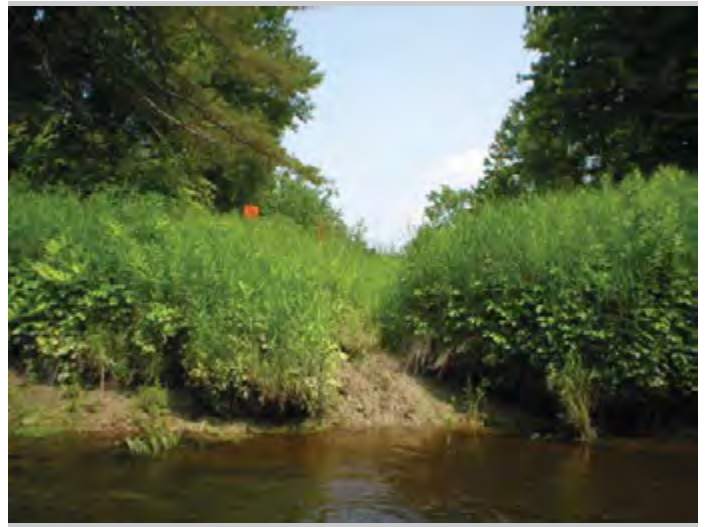
Pipeline right-of-way. Mostly dense vegetation cover of herbs only. Some minor exposed ground and erosion near water's edge, possibly due to animal trails. Banks approximately 5-feet high with slopes of about 25 to 50%.

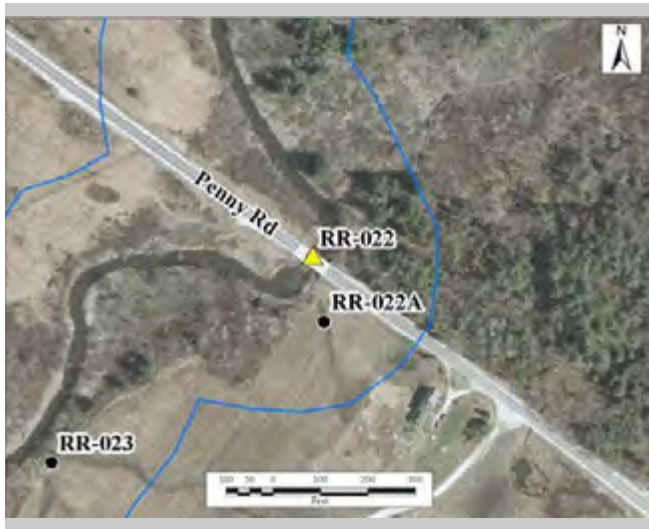
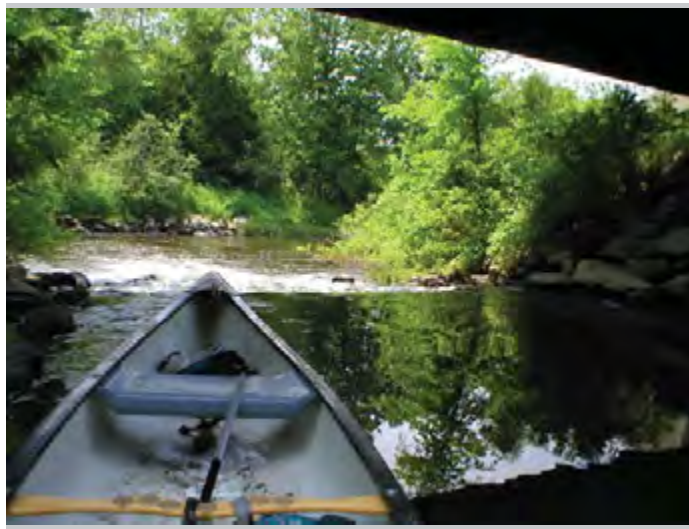
Penny Road crossing. Area under bridge stabilized with rip-rap, causing minor constriction of flow. Banks stable, not eroding, well vegetated with herbs, shrubs. Some loose dirt beneath bridge.

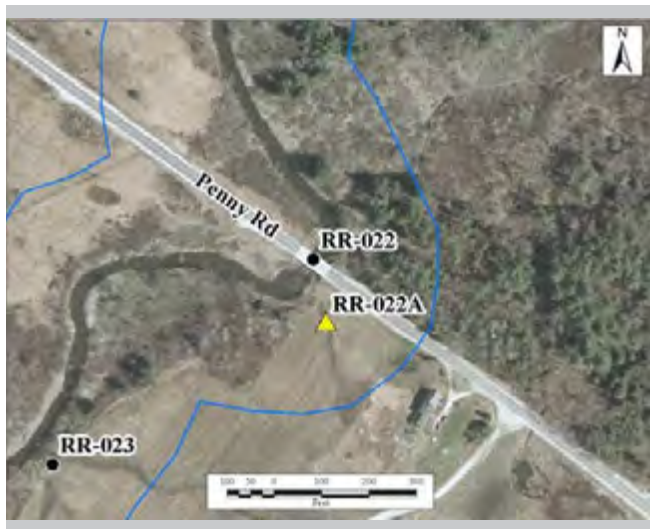
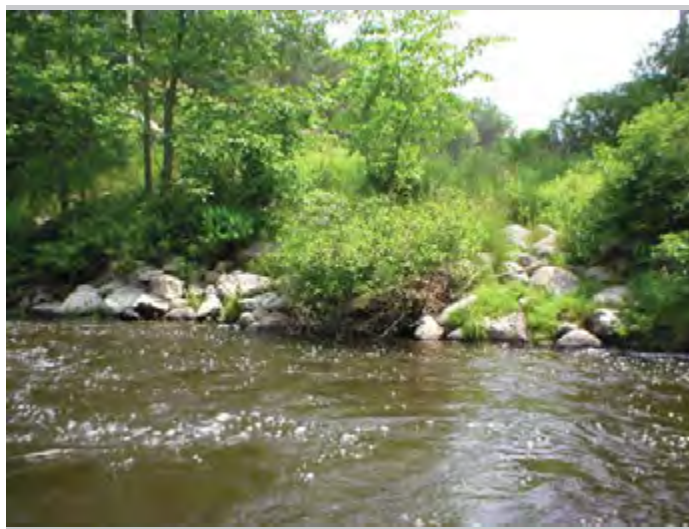
Inadequate buffer. Stable bank but mostly herb and shrubs. Rip-rap on shoreline impeding some vegetation growth.

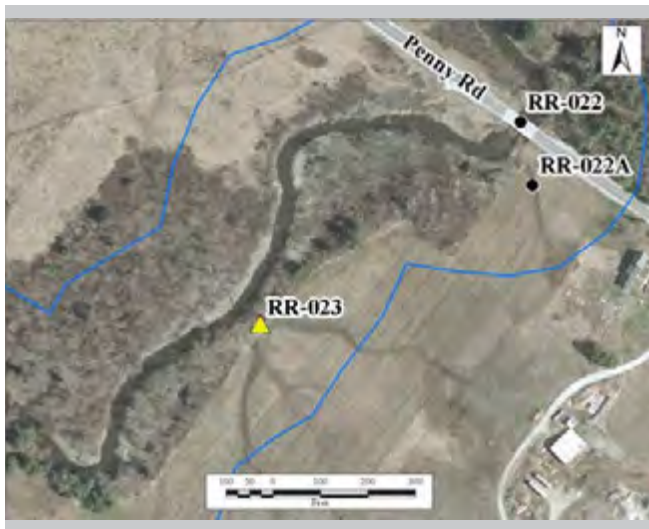
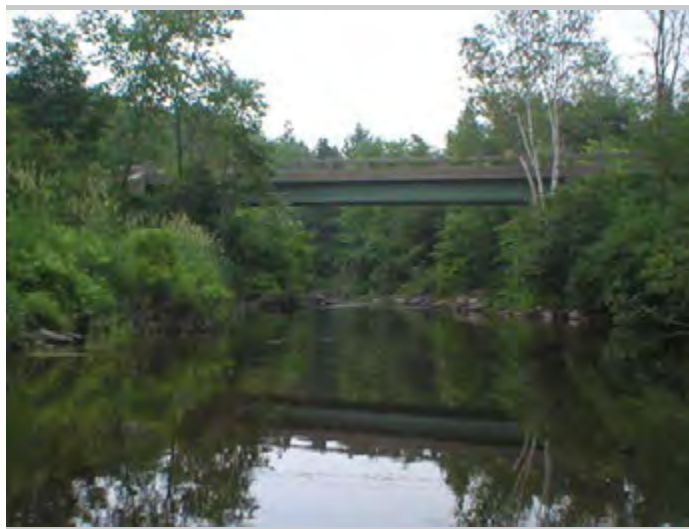
Depot Road crossing. Bridge foundation consists of cement and placed, cut stone. Erosion source - loose sand/dirt at top-of-slope under bridge and nearby. Trails causing minor potential erosion problem.

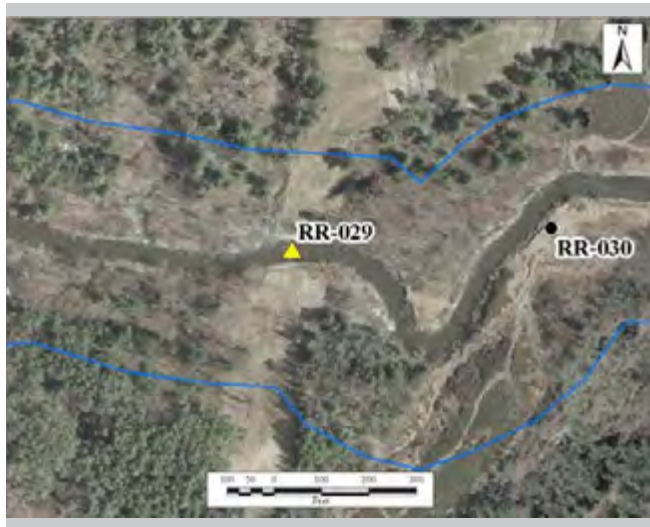
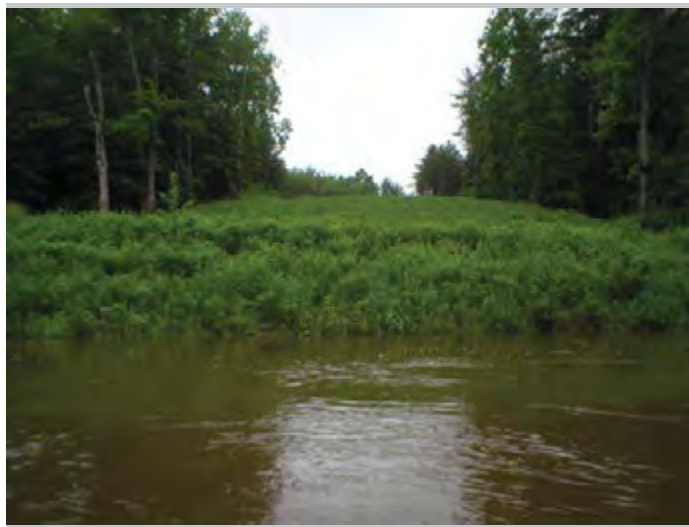
Pipeline right-of-way, approximately 100-feet wide and maintained. Only herbaceous vegetation, no shrubs or trees. Some minor bank erosion noted.

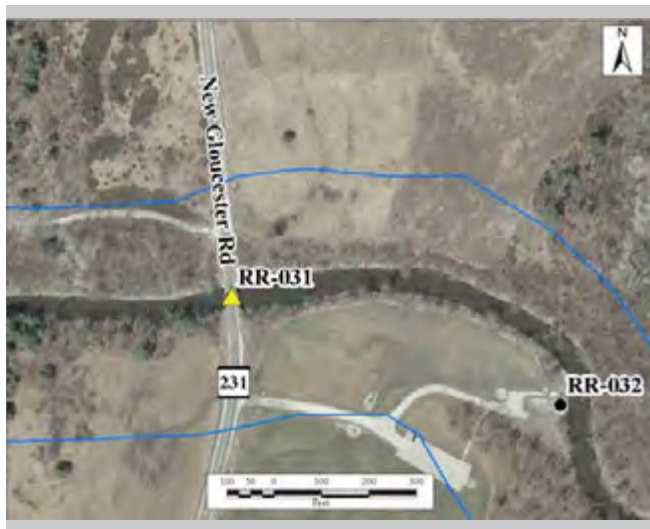
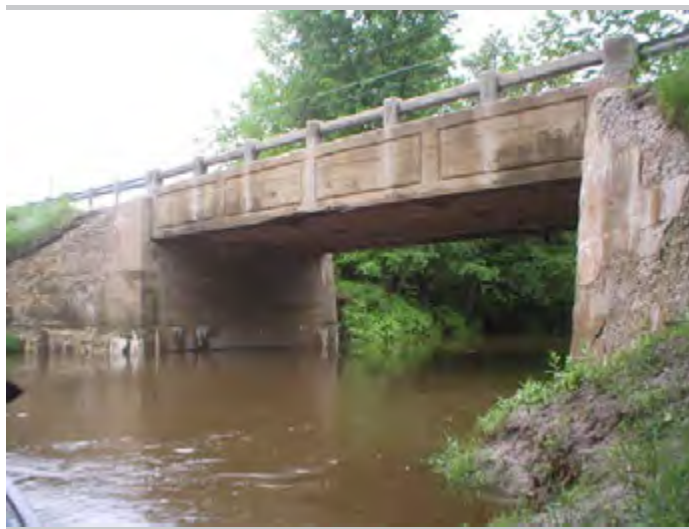
Hardened road crossing/bridge at New Gloucester Road and Route 231. Concrete foundations have replaced/hardened shoreline. Inadequate buffer on north side, mostly herbs and evidence of erosion in bare areas.

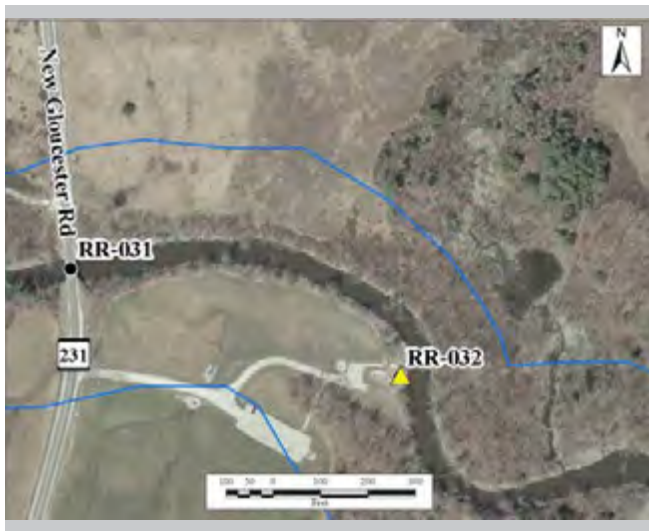
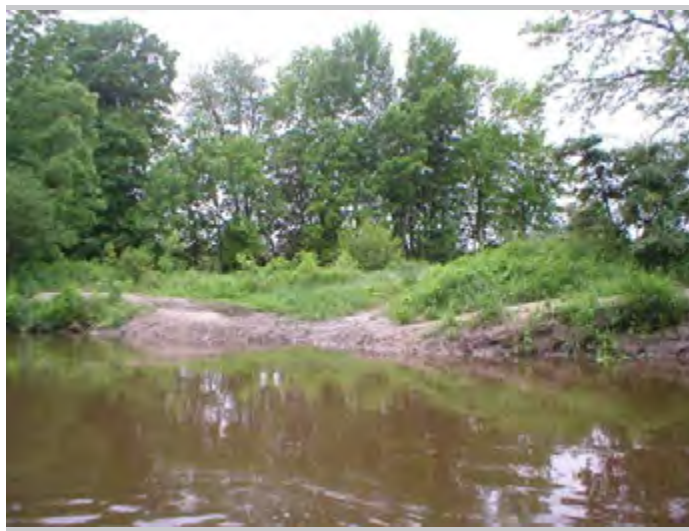
Public park, boat launch. Inadequate buffer of mostly herbaceous with bare areas used as a boat launch within 25 ft of water. Narrow tree line and open mowed areas beyond 25 feet. Storm water wetland detention areas nearby have rip-rap and culverts. Sediment loading in basin and throughout area (likely from an upstream source).

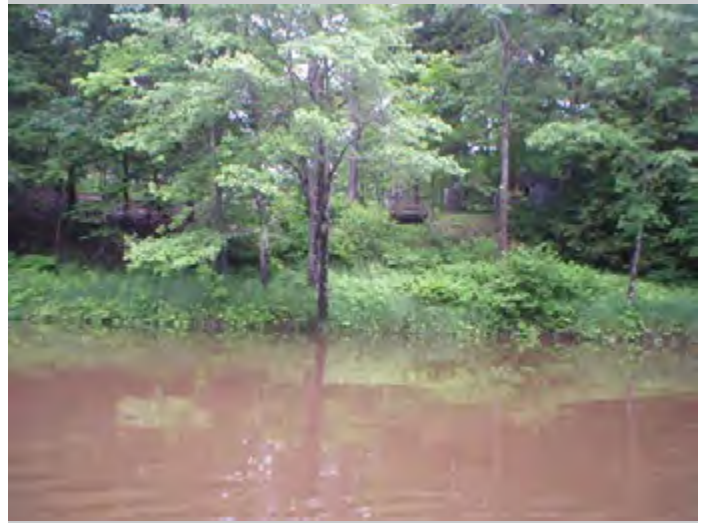
Viewing deck over looking Royal River. Nice buffer of herbs, trees, some shrubs.

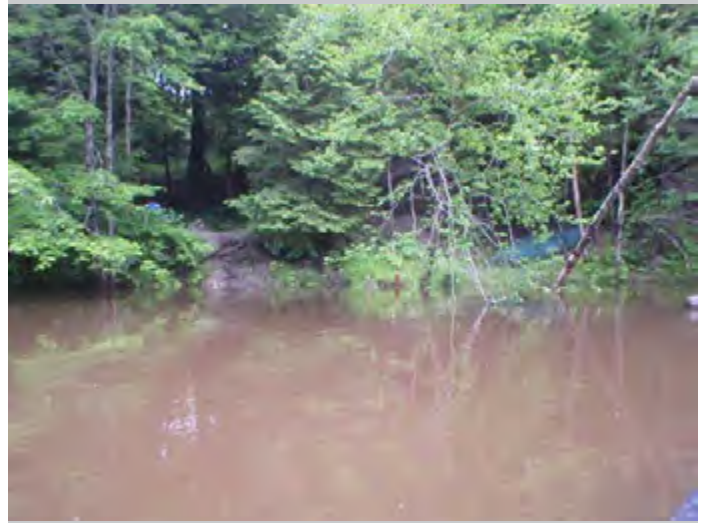
Campsite and canoe access point. Bank erosion evident next to fire pit, some bare ground. Chairs and canoe impeding on plant growth.

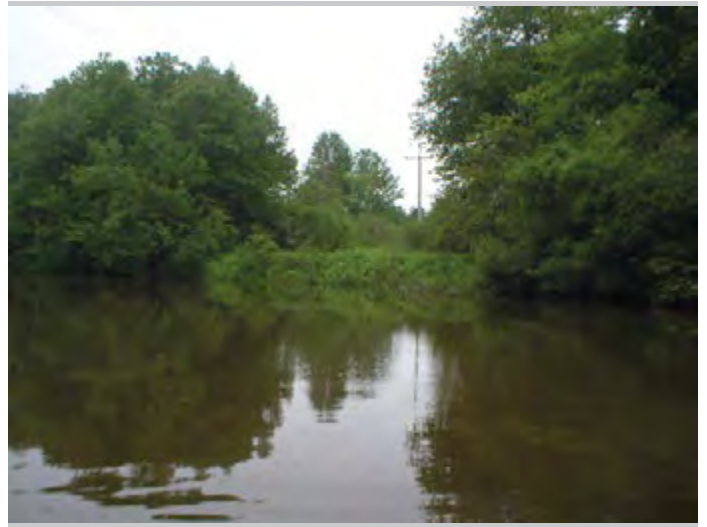
Powerline right-of-way. Maintained with herb and shrub cover. Few shrubs on west bank; some bare ground with minor erosion potential.

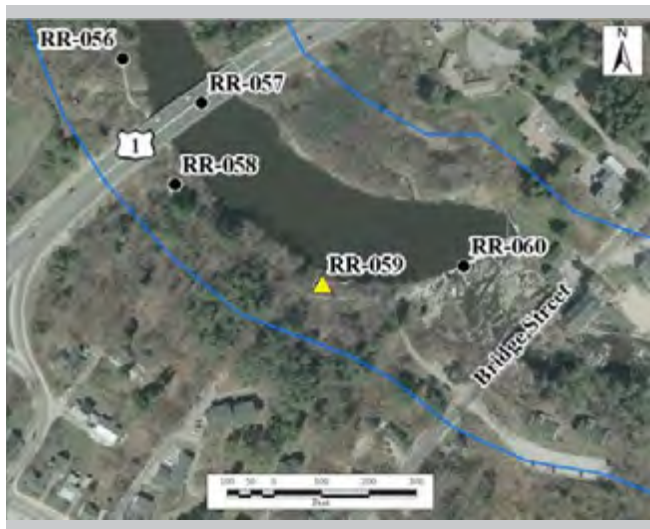
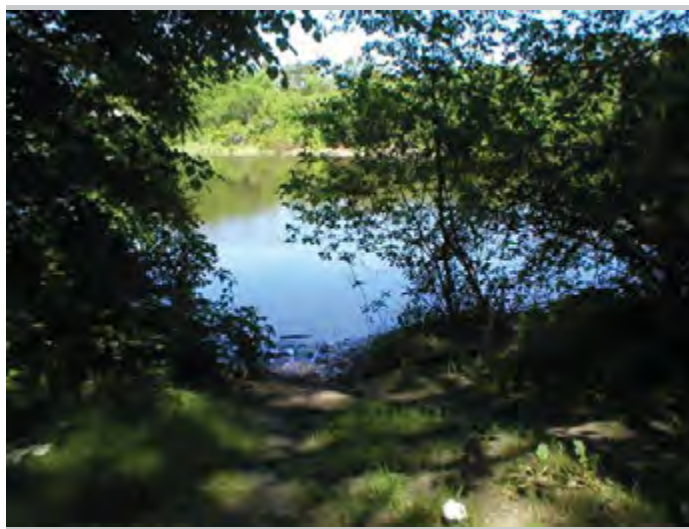
Access point to river (15 x 6 feet wide). Eroding banks with bare ground. Loose silty soil. Sparse herb cover on path.

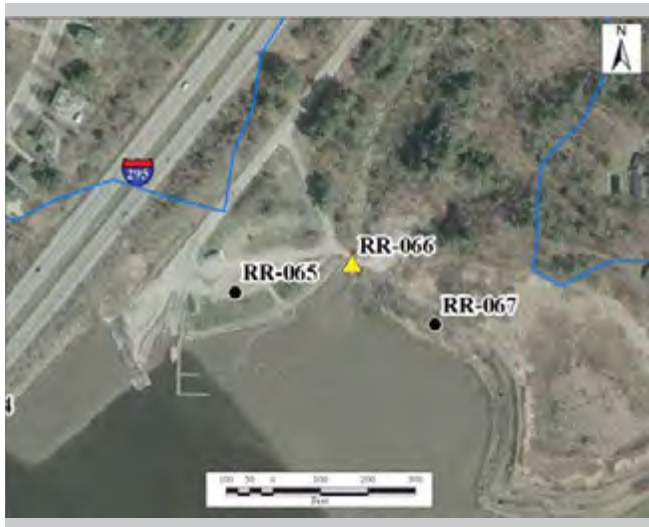
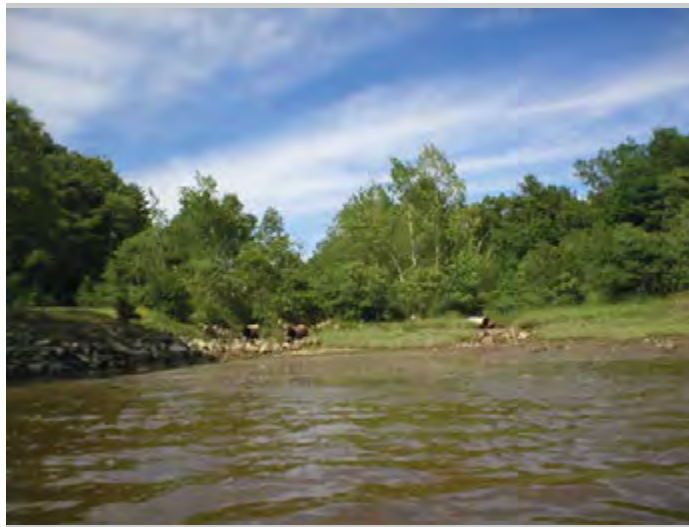
Three culverts that drain under gravel access road. Culverts of corugated metal all have rusted at the bottom. Slight erosion issue. Salt marsh in front of culverts is gone. Drain over cobble/gravel to water.

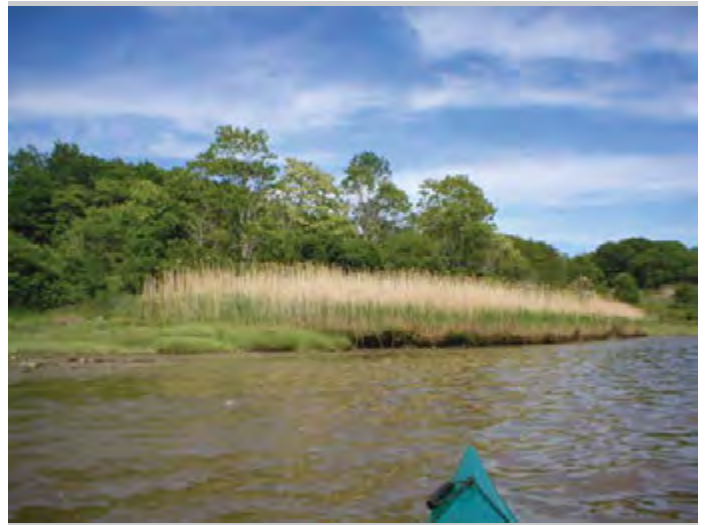
Phragmites stand, approximately 100 x 40 feet.

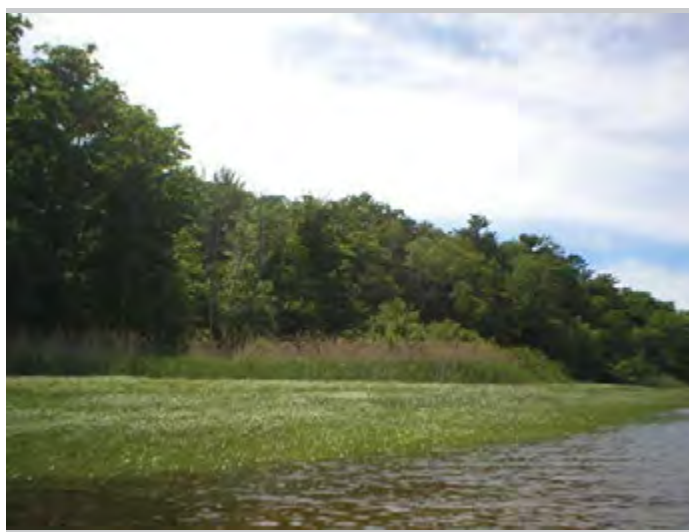
Two Phragmites stands in close proximity, approximately 150 x 30 feet and 60 x 12 feet.

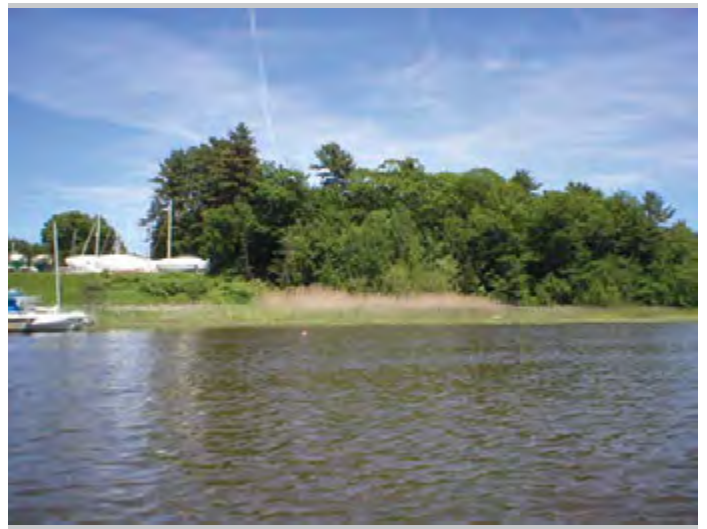
Phragmites stand, approximately 100 x 40 feet. Located adjacent to Royal River Boatyard Marina (RR-070).

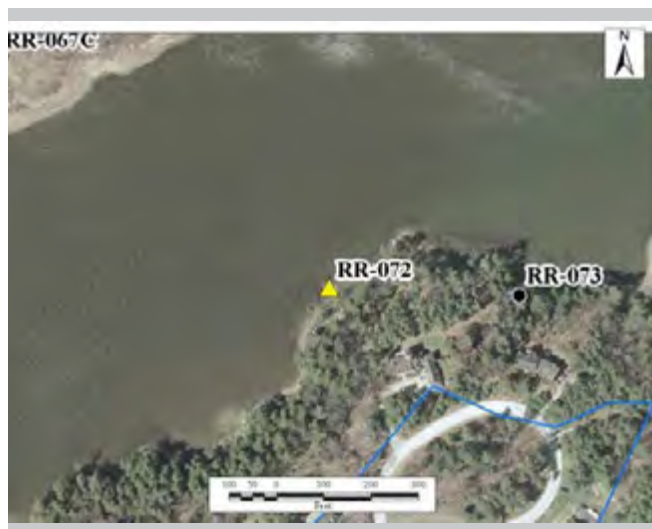
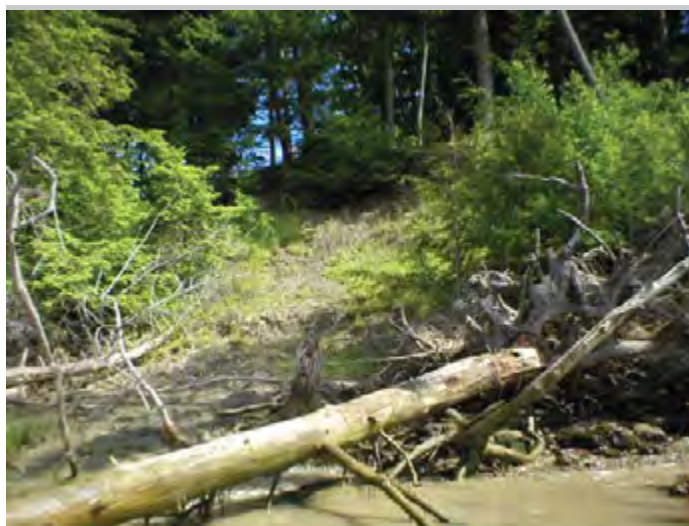
Bank erosion. Turbid water due to erosion of loose sediment.
