Libby Brook Watershed Survey Final Report

LIBBY BROOK WATERSHED SURVEY FINAL REPORT

Prepared by:
John MacKinnon, P.E.
Friends of the Royal River
January 2002

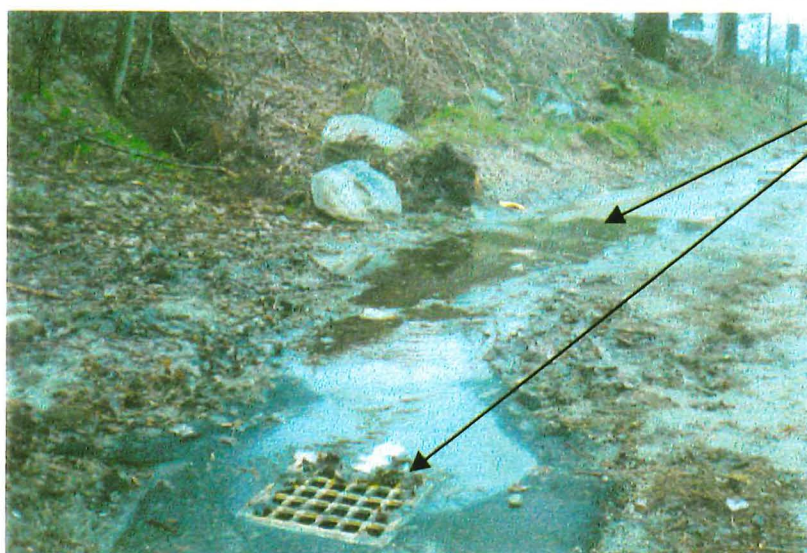
Problem:

- Winter sand and eroded road shoulder material is washed into storm drain inlet located directly over a stream
- Polluted runoff from an upstream parking lot also flows into the storm drain inlet

Possible Solutions:

- Excavate a ditch at toe of embankment and construct a sediment trap upstream of the storm drain inlet
- Stack rock-filled mesh bags around the storm drain inlet

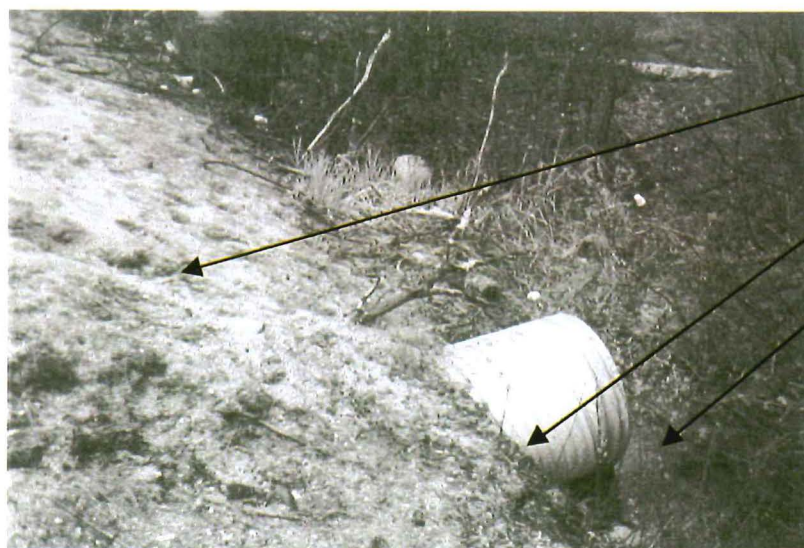
Problem:

- Bare soil on road embankment eroding into stream
- Unstable soil around culvert outlet
- Stream channel filling with sediment reduces channel capacity and harms aquatic habitat

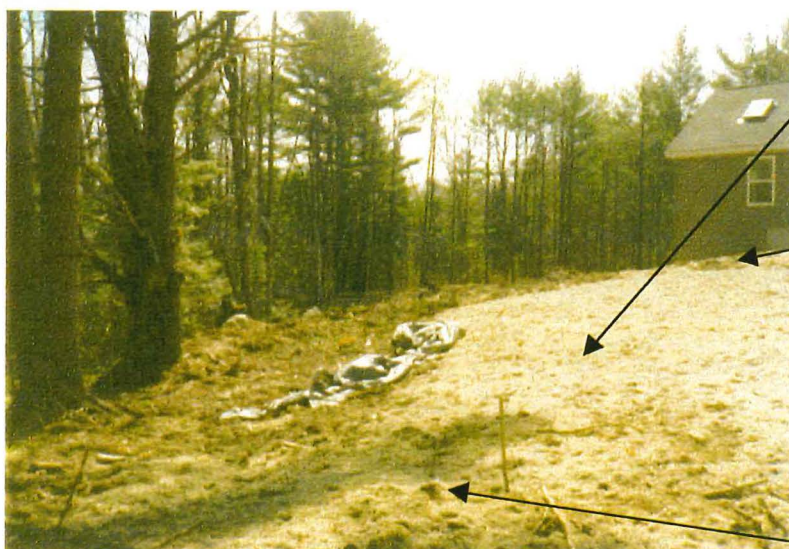
Problem:

- Soil is bare and prone to erosion
- No established erosion and sediment controls other than debris berms
- Roof runoff discharges onto bare soil

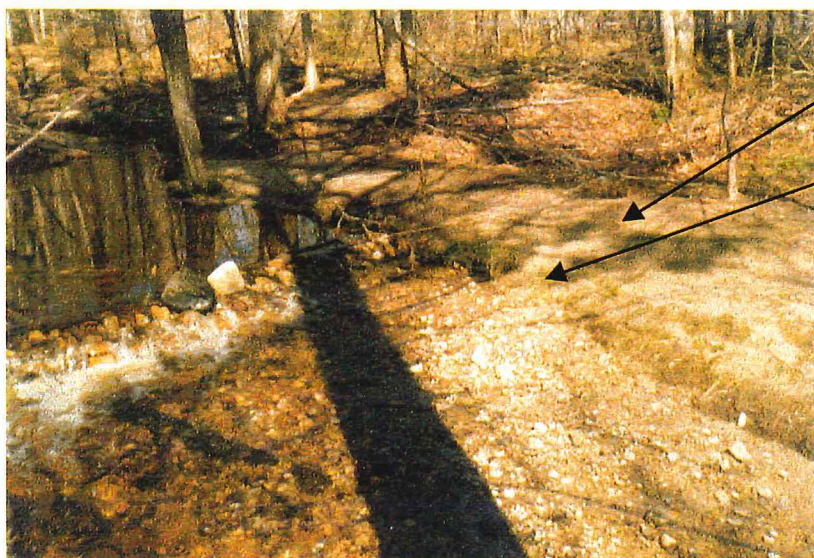
Problem:

- Foot traffic has trampled vegetation on the streambank, leaving the soil bare
- Bare soil is eroding into the stream
- Streambank erosion will accelerate during high flows because there is no vegetation holding the soil in place

Resolving streambank erosion problems caused by foot traffic would obviously require cooperation from the people that use the stream. They would have to agree to using a foot path set back from the streambank and only approach the stream where the banks are reinforced by existing rock or imported rock. Once it is determined that the eroding streambank is no longer subjected to foot traffic, the revegetation process can be accelerated using cuttings of dormant water-loving plants. The cuttings would take root and the resultant trees would rapidly spread along the streambank. Care should be taken to ensure that the cuttings are from trees that are able to thrive in that particular environment.
