Wallace Shore Road in Harpswell, Tidal Restriction Restoration 2015 Monitoring Report, Year 1 of 5, Post-Construction

Tidal Restriction Restoration at Wallace Shore Road

2015 Monitoring Report: Year 1 of 5, Post-Construction

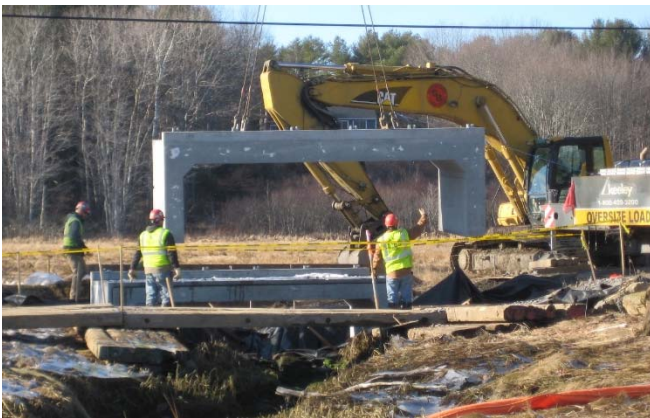
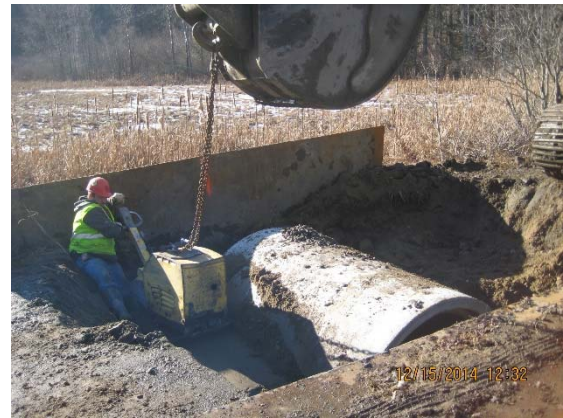
Figure 1. Installation of open bottom concrete box culvert at the lower site (9079, left) and embedded concrete round pipe at the upper site (9078, right).

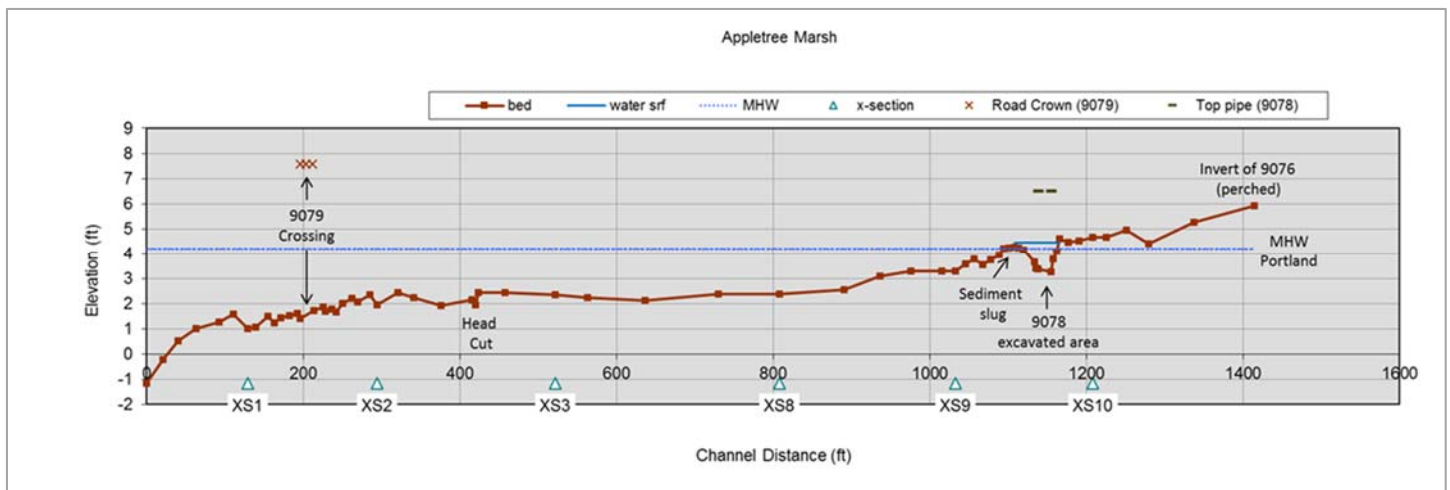
Figure 18. Post-project longitudinal profile of the tidal creek (2015). Mecklenburg 2006.

The channel bottom at 9079 is consistent with the channel grade upstream and downstream, and the accumulated sediment upstream is no longer evident. A series of shallow pools remains immediately downstream of 9079, and has formed immediately upstream in response to gradual movement of sediment. A small head cut was observed a little more than 400' upstream from the bay, with the channel bottom relatively flat until getting shallower between Station 8 and 9. The channel bottom at 800' (Fig. 18) has dropped by approximately 1' from the 2012 survey (50', Fig. 17). Further upstream, the channel becomes extremely shallow approaching 9078, where the slug of coarse-grained sediments (evident in both Fig. 17 and 18) sits on the marsh surface, resulting in a very shallow braided channel below the outlet of 9078. The sand is believed to have been deposited in this location during a culvert blow-out prior to any discussions about a restoration project. Local residents described a portion of the road bed washing onto the downstream marsh along with the culvert. Immediately upstream of the slug, and immediately downstream of the culvert outlet, is the area excavated during culvert installation. Here, water is pooled behind this grade control through the culvert into the excavated area upstream, above which a defined channel is no longer visible. This issue is discussed further in Section 4.2.

As noted in Section 3.4, and described further in Section 3.10 (and illustrated in the 2015 longitudinal profile in Fig. 18), over the course of several monitoring visits, CBEP observed that surface water is pooling in the excavated channel outlet of crossing 9078 due to a lack of channel development/scour. Water flowing into the excavated area from upstream (north side of culvert) is impounded at the edge of the area excavated during installation, and backs up through the pipe into the excavated area upstream of the inlet, creating a standing pool of water that discharges in a braided network of channels before it reaches the downstream channel. Closer examination revealed that a sediment slug from a historic culvert failure is controlling the grade just downstream of the 9078 outlet. This may be maintaining water levels that allow for persistence of glycophytic species and slow the process of conversion to brackish and halophytic communities at Station 10. The issue is most obvious during low flow conditions that co-occur with a neap tide phase when the flow out of this pool becomes a trickle (Fig. 22). Shallow exploratory probing of the channel suggests that coarse-grained sediments are present on the marsh surface along the edge of the excavated area, and are not mobilizing, presumably due to a lack of velocity/volume combined with volume of sediments present. As previously mentioned, anecdotes from abutters confirm that several years ago (preceding the project), the culvert blew out at this location, washing road fill onto the downstream marsh. The pool, and the sediment slug, may be contributing to the presence of cattails immediately downstream (Fig. 22).

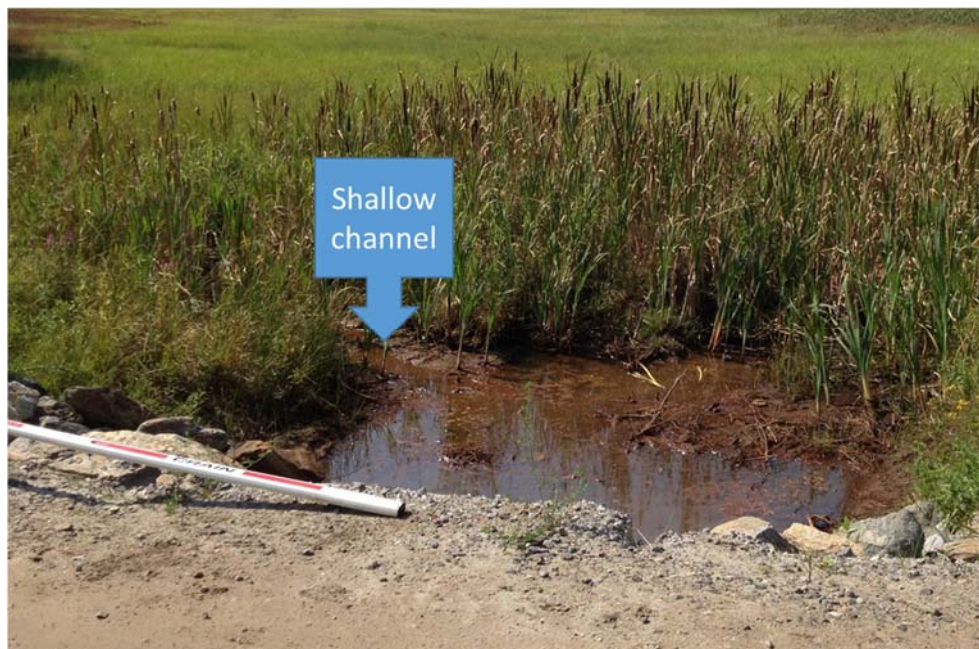
Figure 22. Pooled water at the outlet of crossing 9078 (2015).

None.	Over the course of several visits, CBEP observed that water is now pooling in the excavated channel outlet of crossing 9078 due to a lack of channel development/scour. Probing suggests that coarse grained sediments are present on the marsh surface and are not mobilizing due to a lack of velocity/volume. Anecdotes from abutters confirms that several years ago the culvert blew out at this location, washing road fill onto the downstream marsh.	No action was taken during the monitoring period. See Section 4.2, Recommendations for Adaptive Management.

2. Remove sediments from the channel. Use hand tools (shovel, hoe) to carefully hand dig coarse-grained sand out of the narrow channel without damaging adjacent vegetation, and transport sediments offsite using a few five gallon buckets. Prior to implementation, additional sediment probes in the channel could be used to determine the extent and depth of coarse grained road fill in the channel. A simple plan could be drawn up in advance to determine channel elevations and width, based on the 2015 longitudinal profile, and survey equipment would be used to check elevations during field implementation. Implementation could be conducted in the summer of 2016. No cost is anticipated with this approach, which could be completed by two people in a couple hours. This is the preferred approach and is recommended out of the three options presented, provided that no additional permitting and approvals is required.

3. Remove sediments from the marsh and channel. Another approach would be to bring heavy equipment back to the site to excavate sediments from both the marsh surface and the channel. The purpose would be to not only improve flow out of the excavated area, and relieve the impoundment, but also to lower marsh surface elevations. A detailed topographic survey downstream of the 9078 outlet may be warranted, as well as a more expansive survey of sediments, to determine the extent and depth of coarse grain sediments downstream of 9078. Simple drawings may be warranted to guide excavation of sediments working with large equipment (presumably, a back hoe or excavator and a dump truck). This option is least preferred. Although this approach could realize additional benefits by removing fill from the marsh surface, use of an heavy equipment brings an inherent risk of doing more harm than good (damage to vegetation, digging out a larger or deeper channel than is suitable, etc.). For this reason, the approach is not recommended. Work could be conducted in late summer/early fall 2016 if funding was obtained, and permits were secured if necessary, but these are unknown considerations at this time.

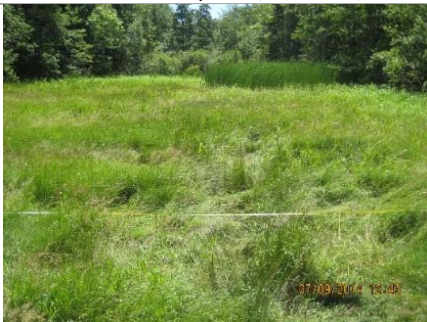
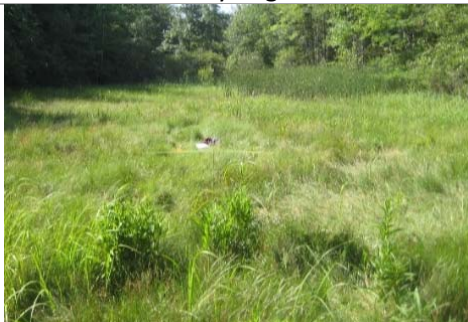
Station 7 (L – 7/9/2014; R – 7/28/2015); view to S. Channel obscured by vegetation.

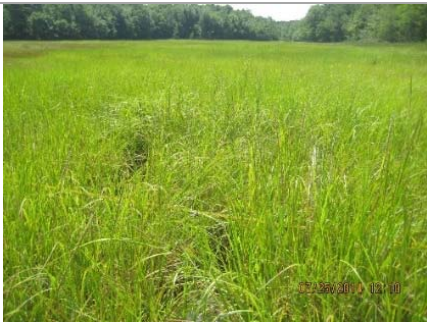
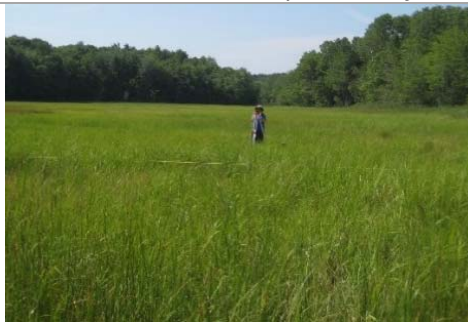
Station 9 (L – 7/25/2014; R – 7/30/2015); view to S toward St. 8. Channel obscured by <i>S. alterniflora</i> .
