Designed to Fail: Why Most Commonly Used Designs Will Fail and How to Fix Them

Richard C. Cote
Comprehensive Environmental Inc.

Presented at the Cold Climate Conference

Portland, Maine, November 5, 2003

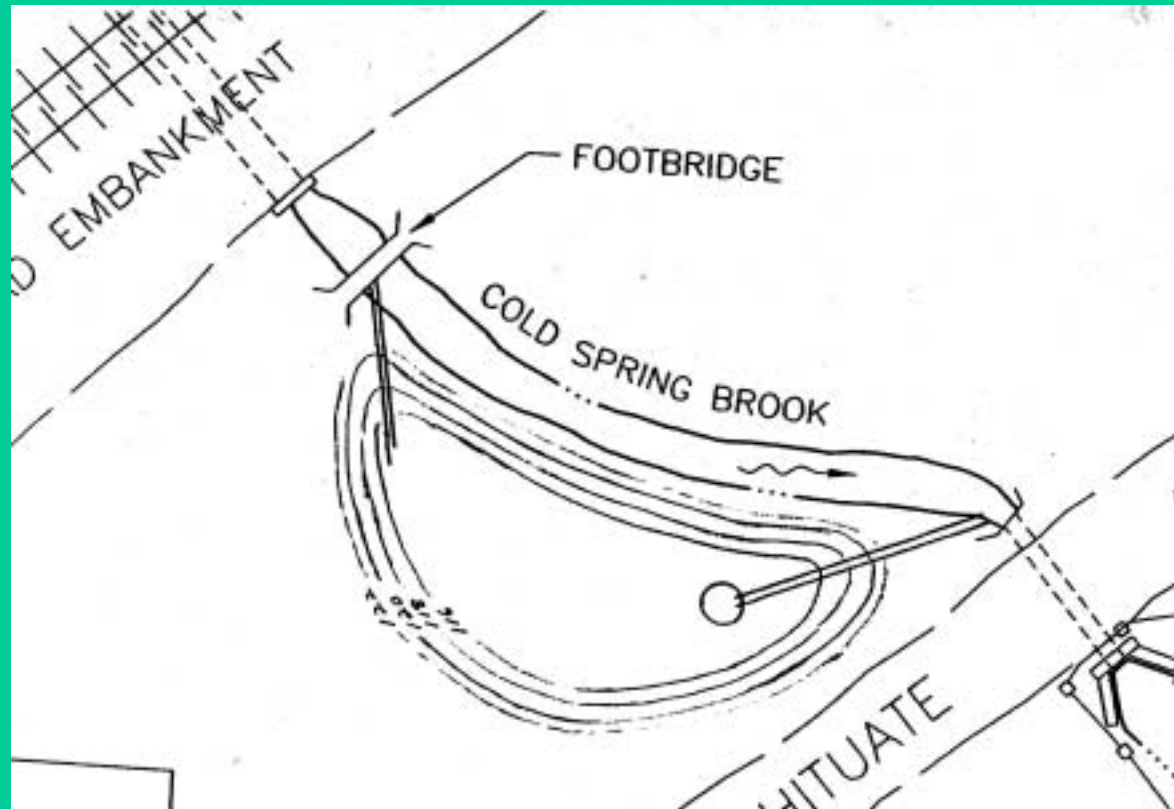
Original Design

- Total sediment load/yr = 8,950 cf
- Forebay capacity 3,200 cf
- Inflow = 21 cfs
- Inflow of 11 cfs = Scour velocity of 2.5 fps

- Recommendations:
 - Large drainage areas need a treatment train, not a single BMP
 - Offline treatment may keep size and cost down, and effectiveness up

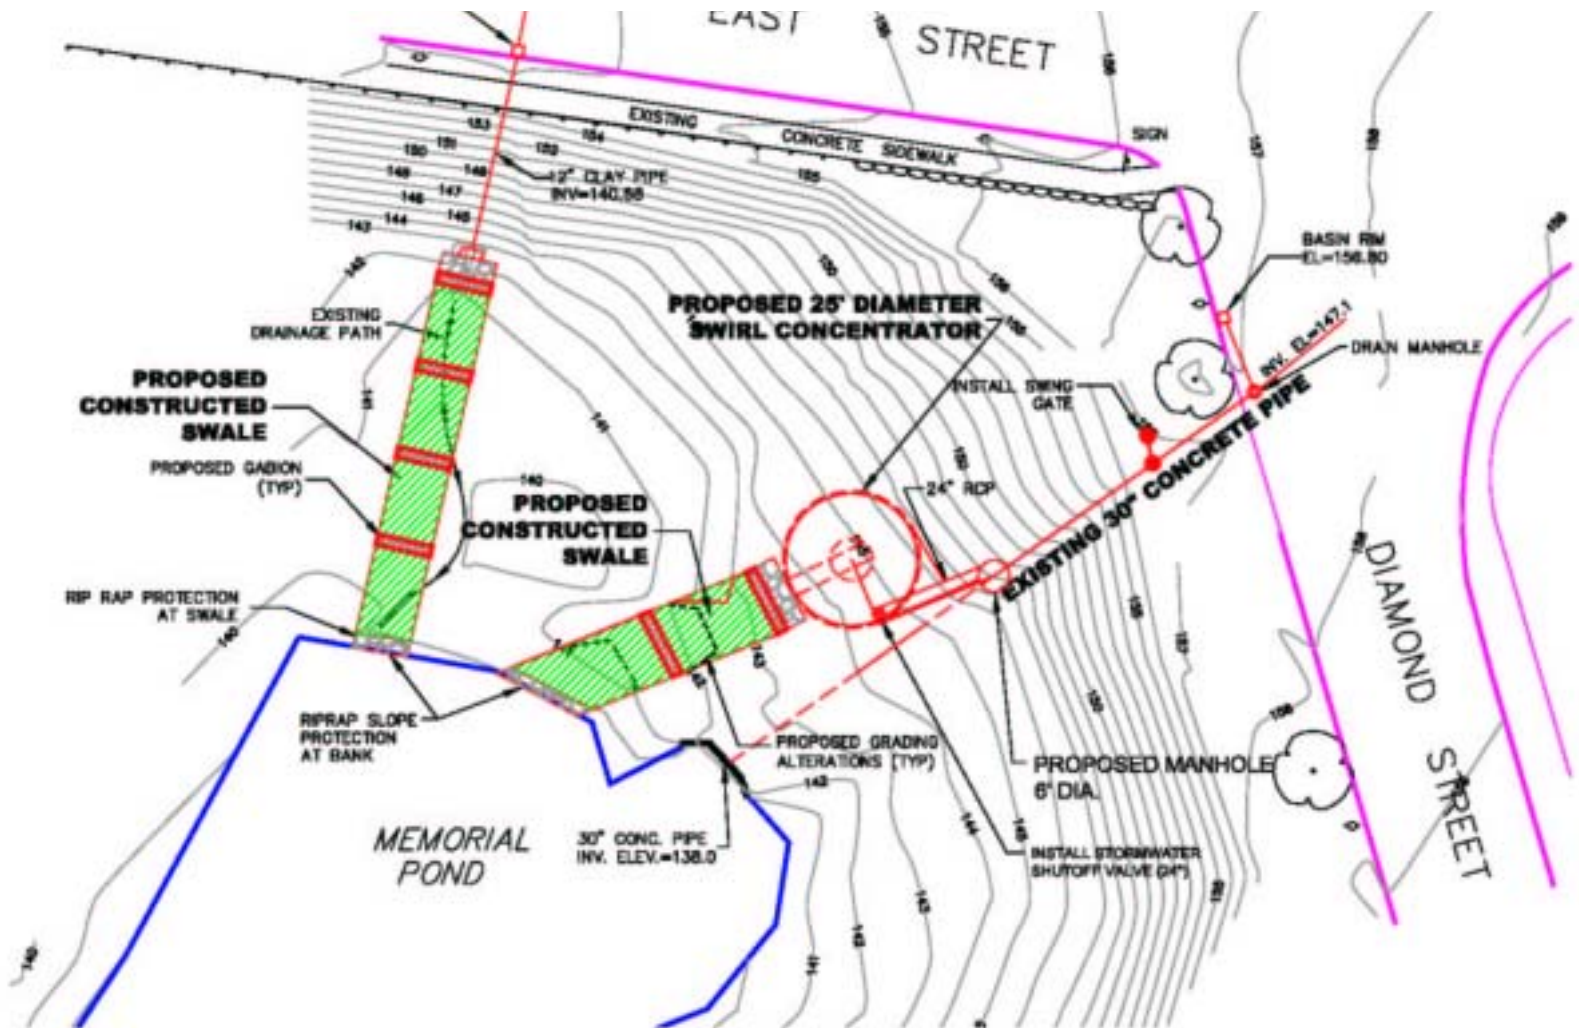
Treatment train that includes offline diversion for a large, high velocity drainage area

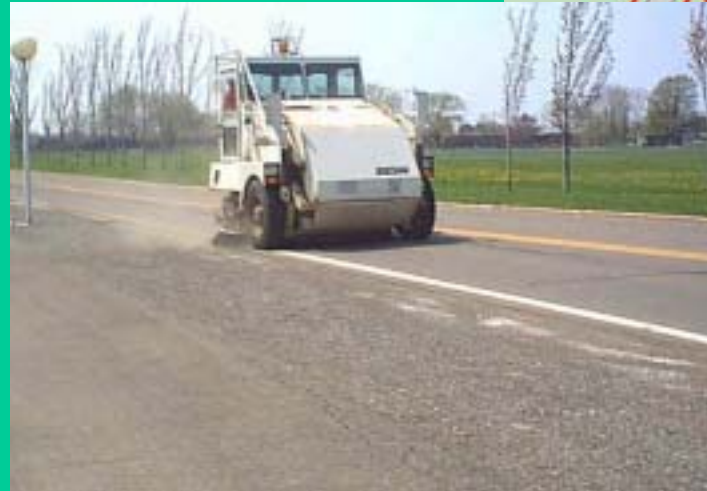
- Problem: estimates of loadings sometimes use unrealistic assumptions.

Example: one design assumed that the parking lot would be swept weekly.

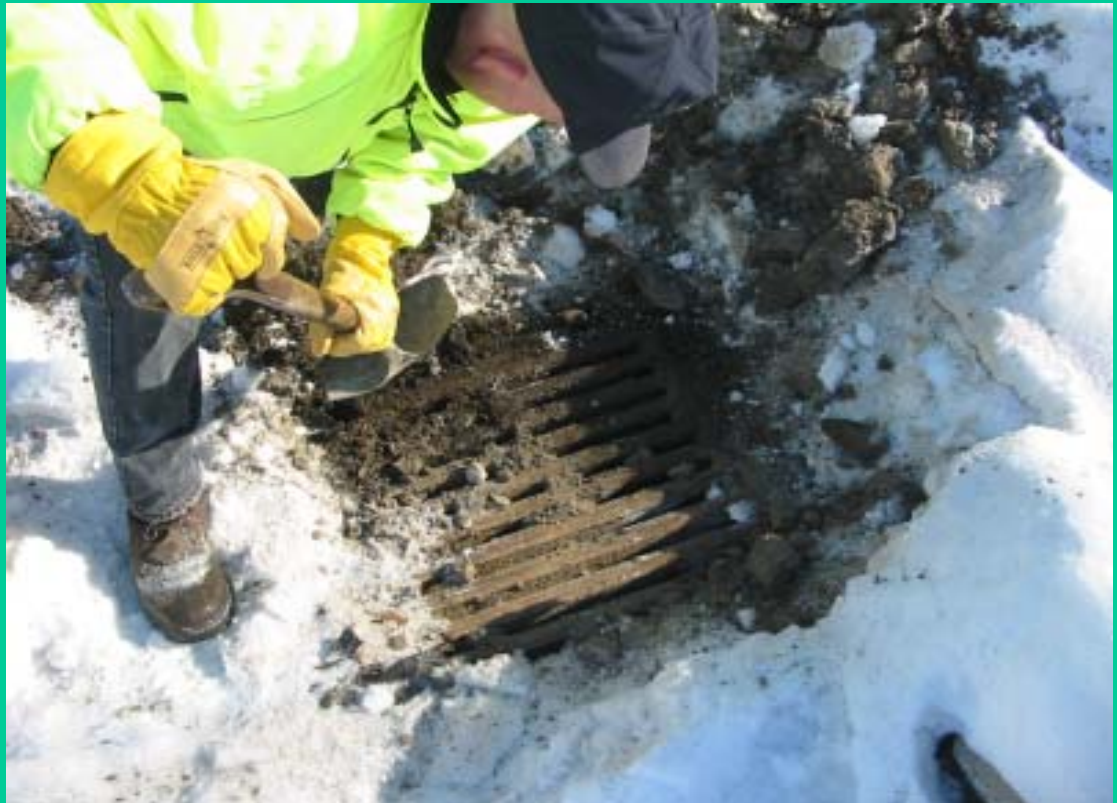
No. 7: Cleanouts

Inaccessible or Non-Existent

- Problem: no way to maintain the BMP due to long reach; steep slope or other reason for inaccessibility to the equipment used by the community or site owner

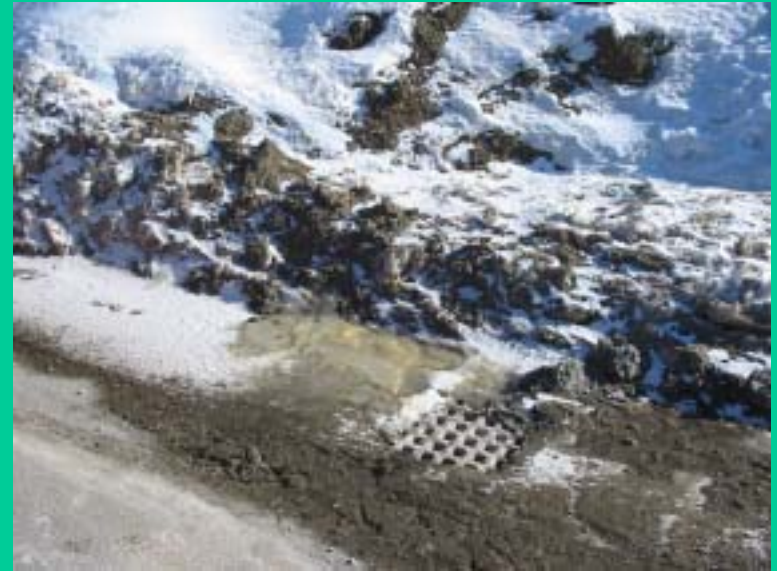
Above site was designed assuming that the post condition would be “good” condition grass cover >75%

- Problem: Most BMPs designed today make optimistic assumptions:
 - Overall site use is optimal, for example, “good” or “excellent” forest; no compaction of playground soils
 - No eventual decline in performance over time
 - Rapid exfiltration at all times
- Recommendation: BMPs need to be designed for worst case instead of the most optimistic assumptions available.

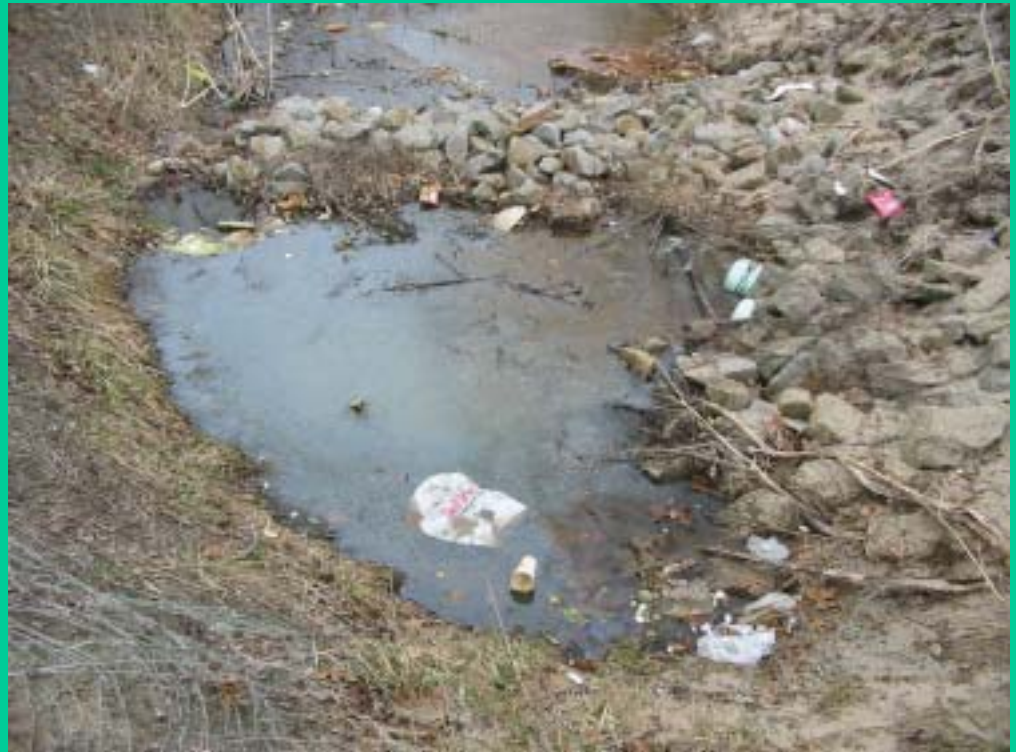
Sediment forebay in area of high groundwater near a landfill. Discharge is below surface of groundwater which appears to contain leachate.

- Recommendations:
 - Borings needed before final design
 - Most BMPs should drain within 48 hours to avoid mosquito breeding
 - Need 3 foot separation from seasonal high groundwater

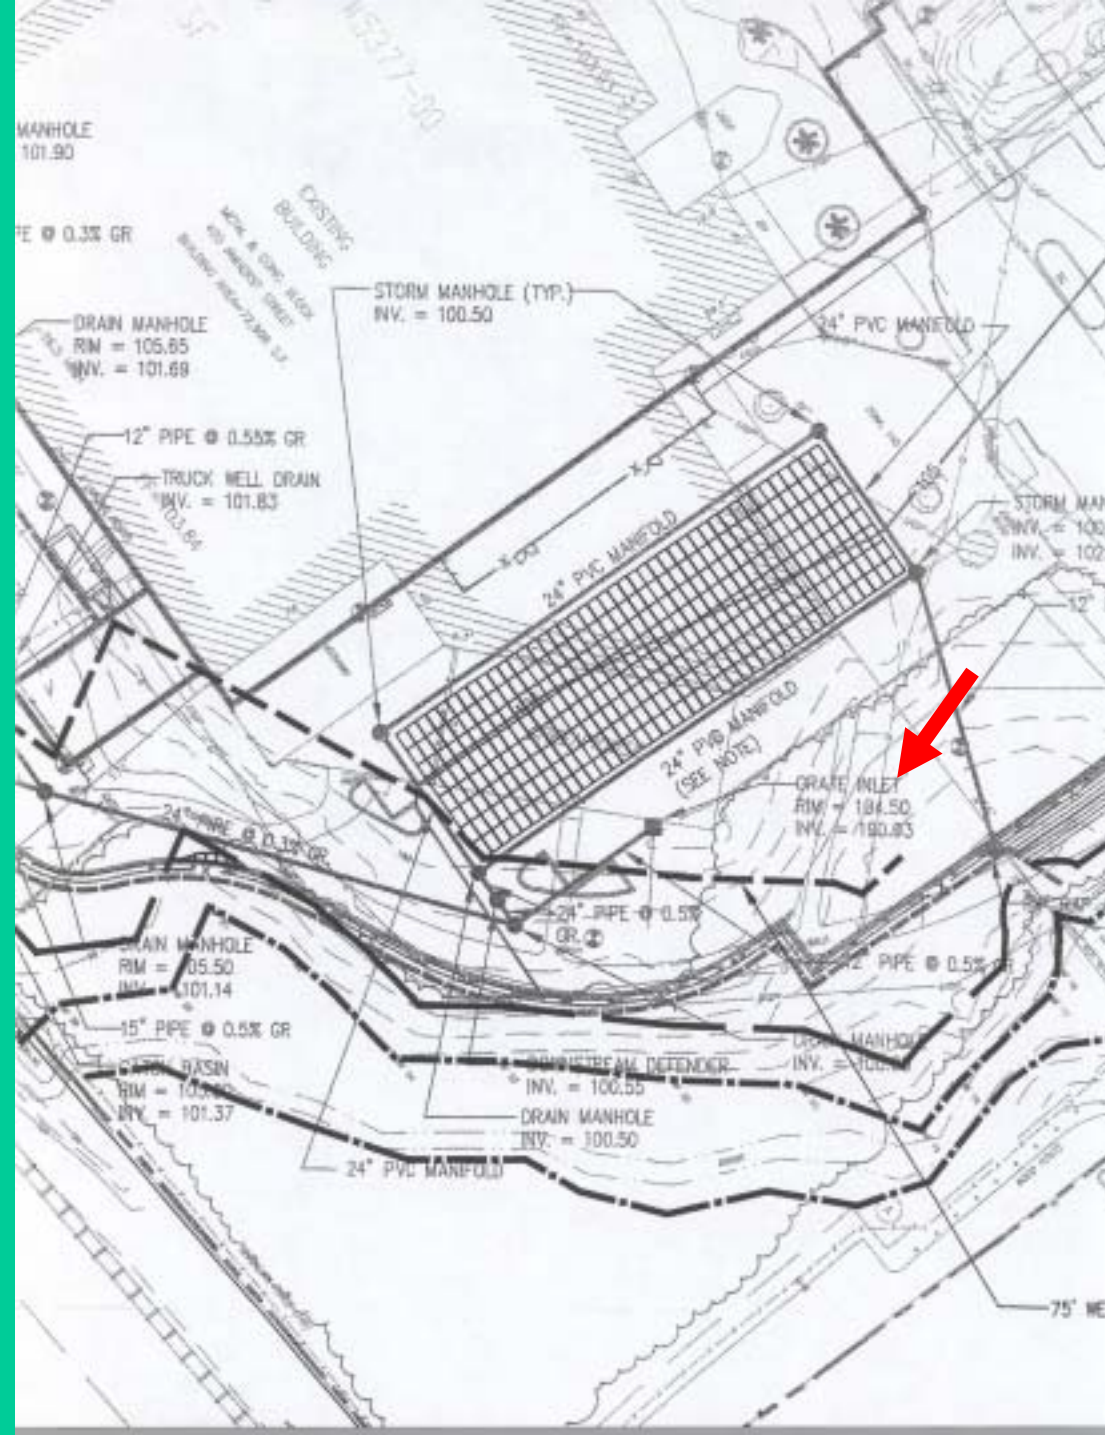
Infiltration galleries proposed but invert is at 100 and groundwater shown at 98-100 feet. A minimum of 3 feet to seasonal high groundwater is needed.

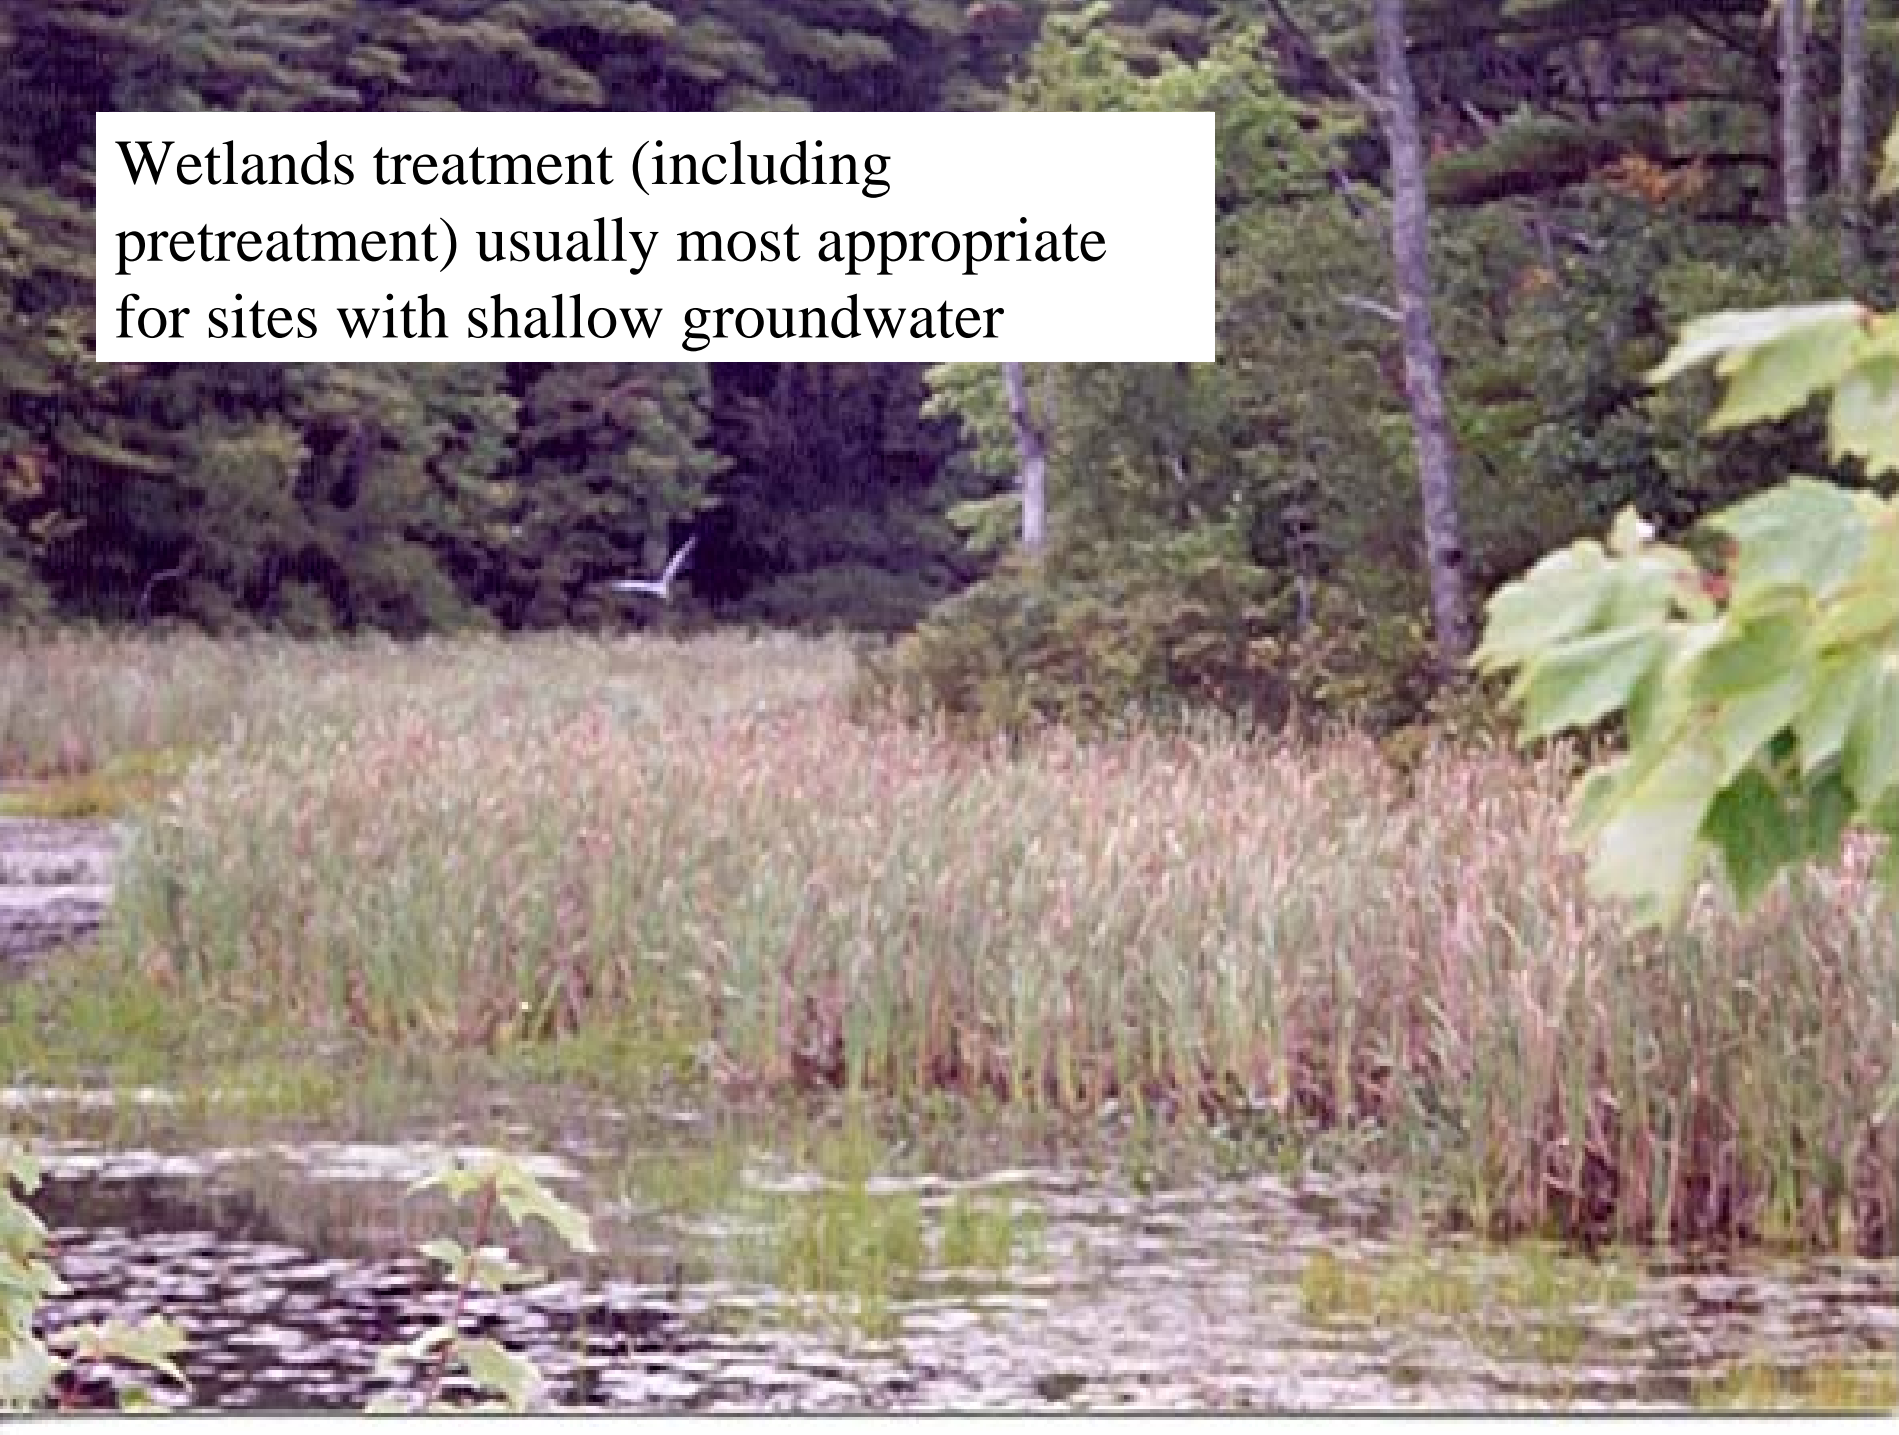
Wetlands treatment (including pretreatment) usually most appropriate for sites with shallow groundwater
