## Recommendations for Future Restoration and Management Efforts for Mill Brook, Westbrook, Maine: Appendix C. Preliminary Culvert Photos

Casco Bay Estuary Partnership

**Preliminary Culvert Photos  
2003 & 2007**

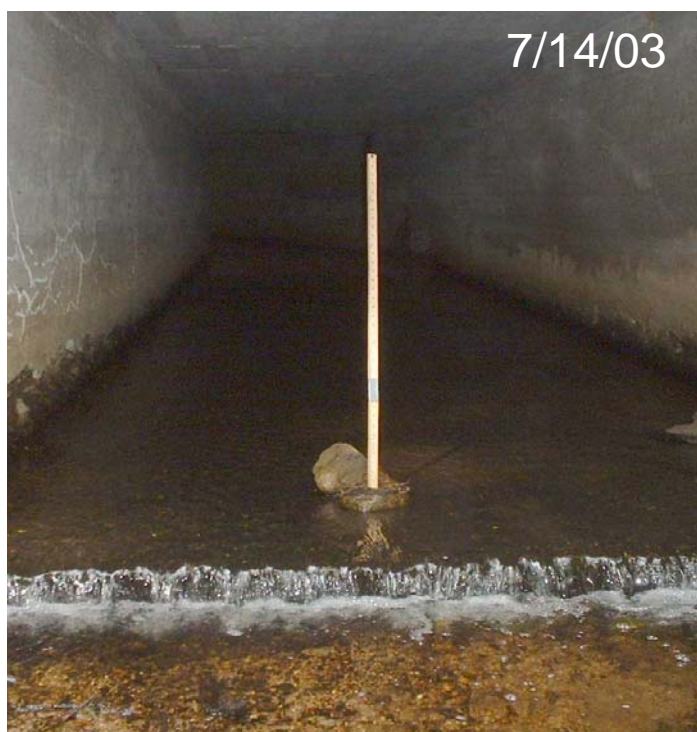
## Rte 302

Shallow water (at certain times of year) and flat, concrete bottom.

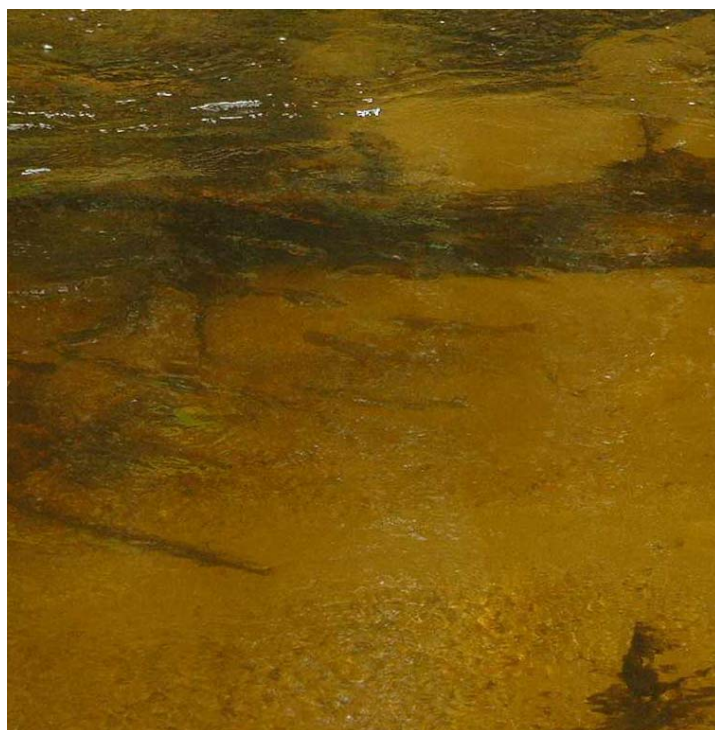
Alewives below a debris jam near Rte 302 -- 5/31/03

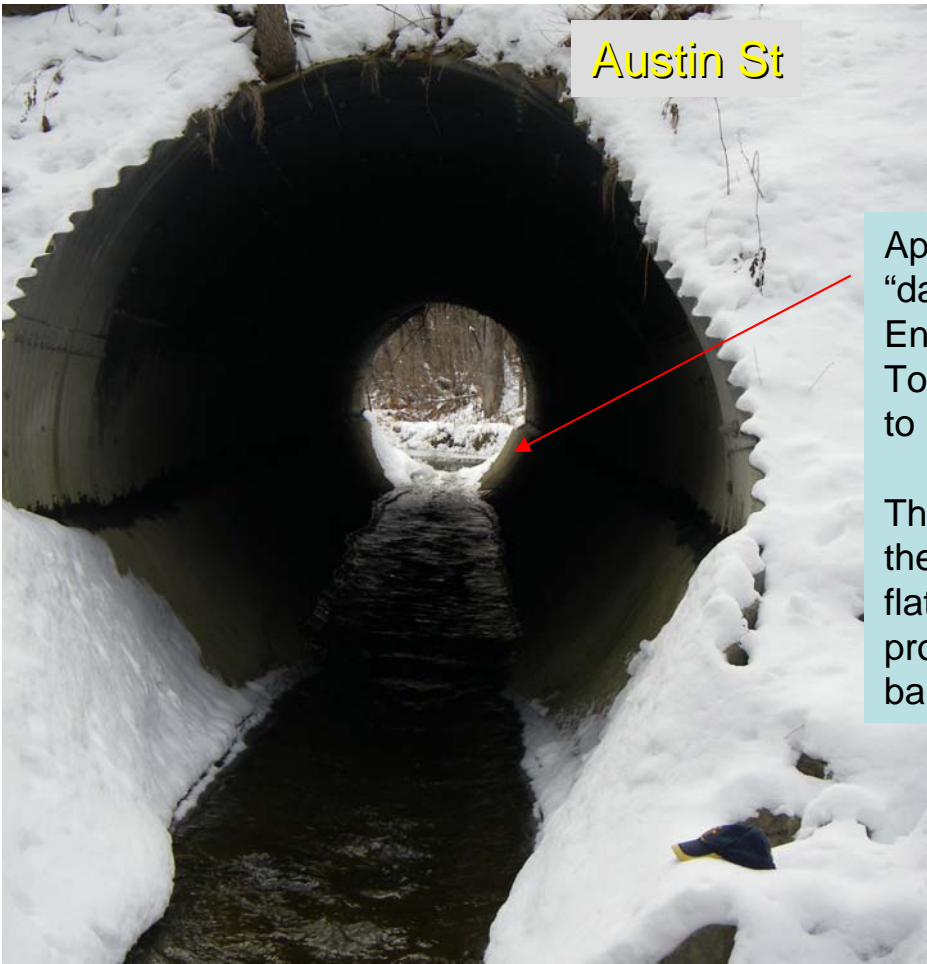
Austin St

Apparent, engineered log "dam" placed at upstream End of right culvert. Appears To be there to encourage fish to use other culvert.

This is a good idea. Still, the left culvert bottom is flat concrete and may still prove to be somewhat of a fish barrier.

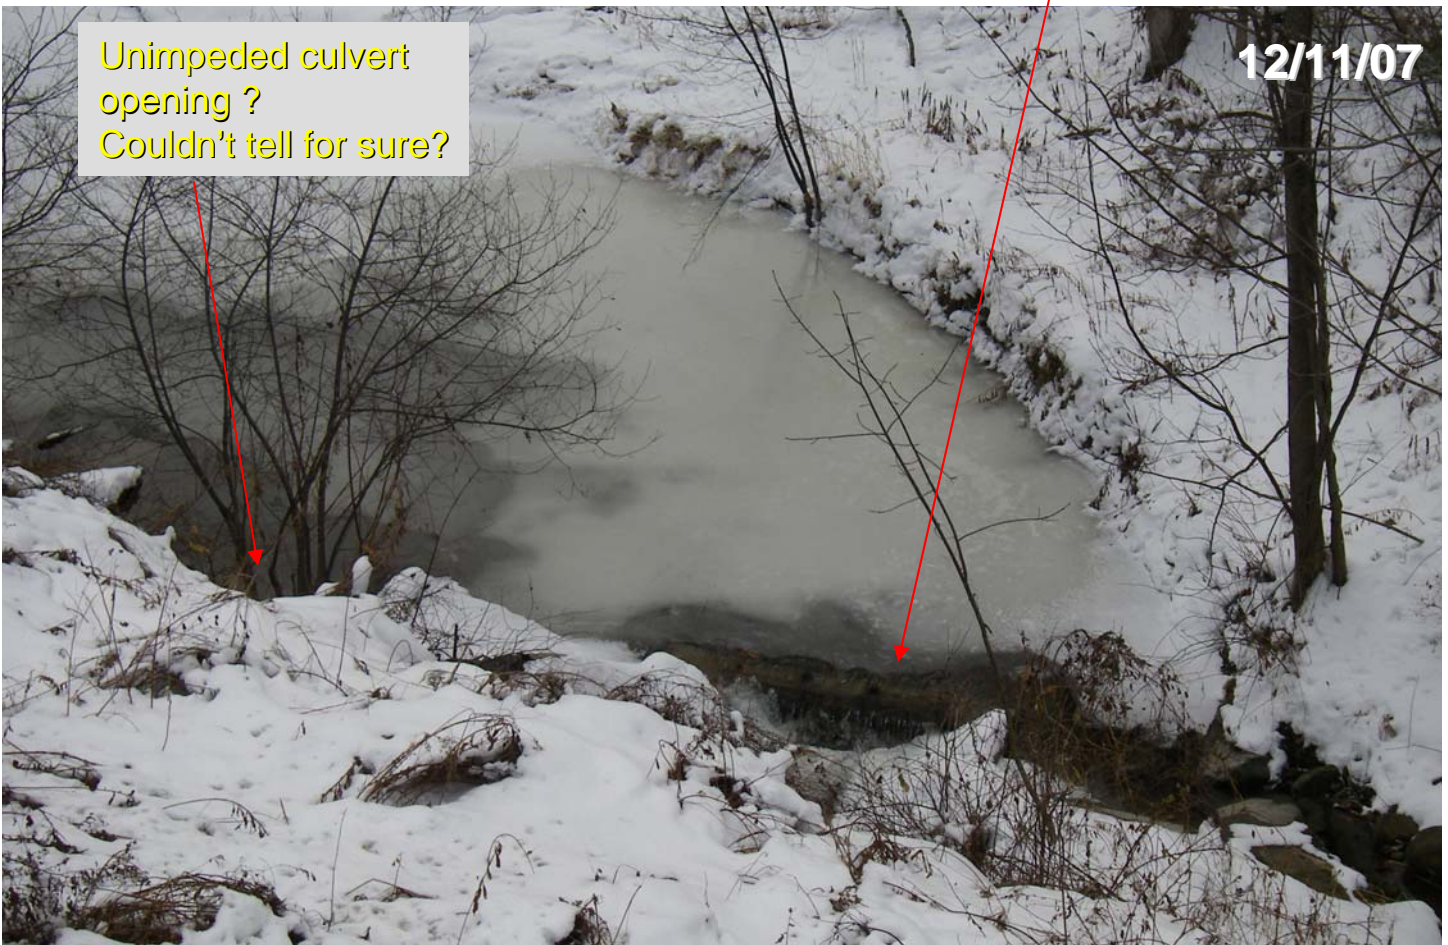
Unimpeded culvert opening ?  
Couldn't tell for sure?

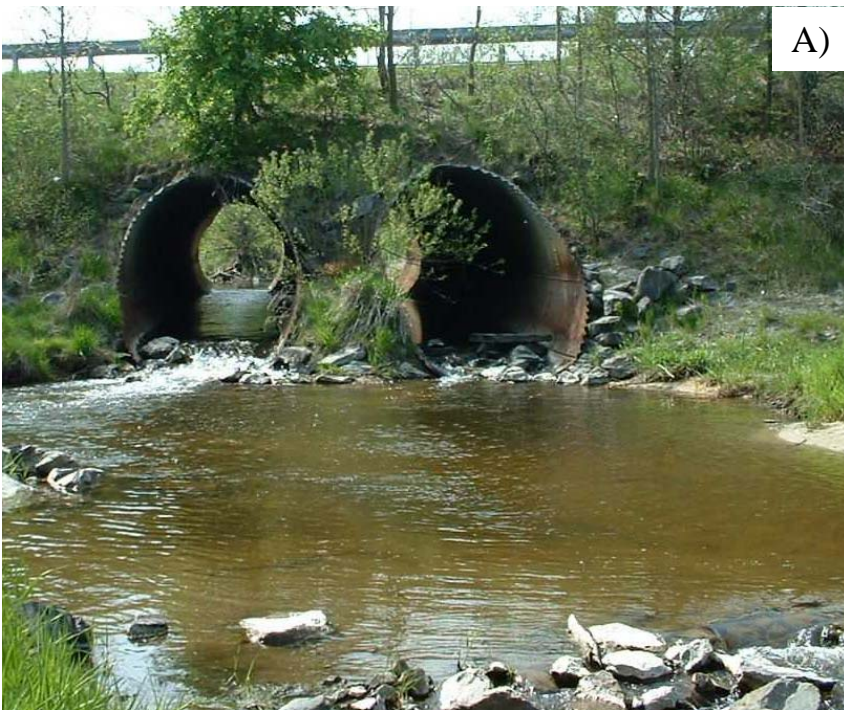
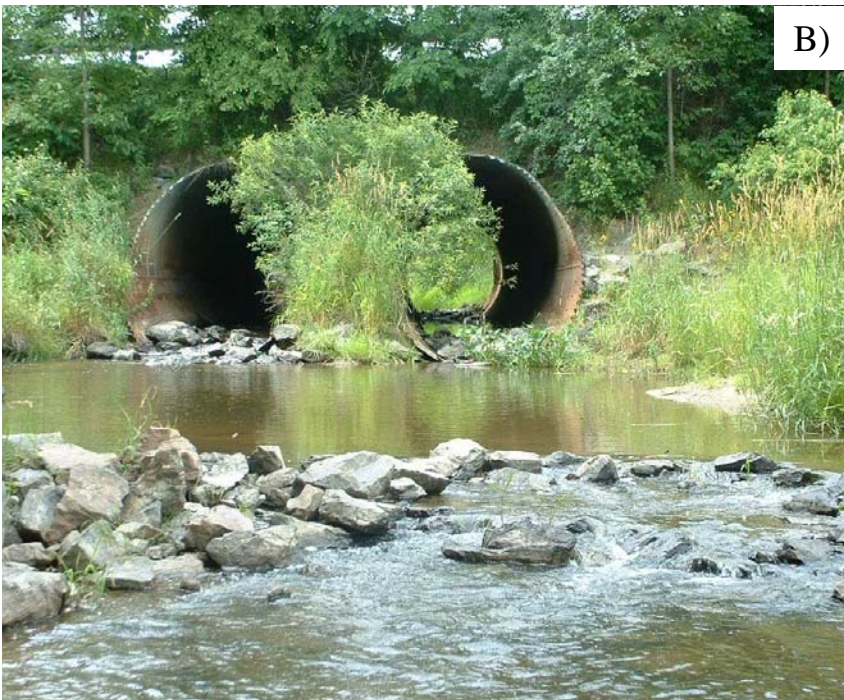
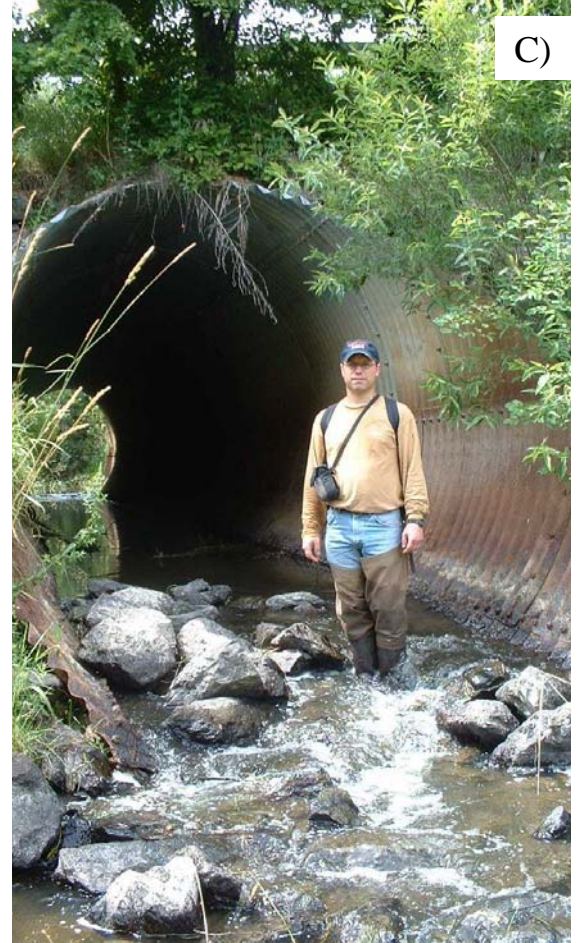
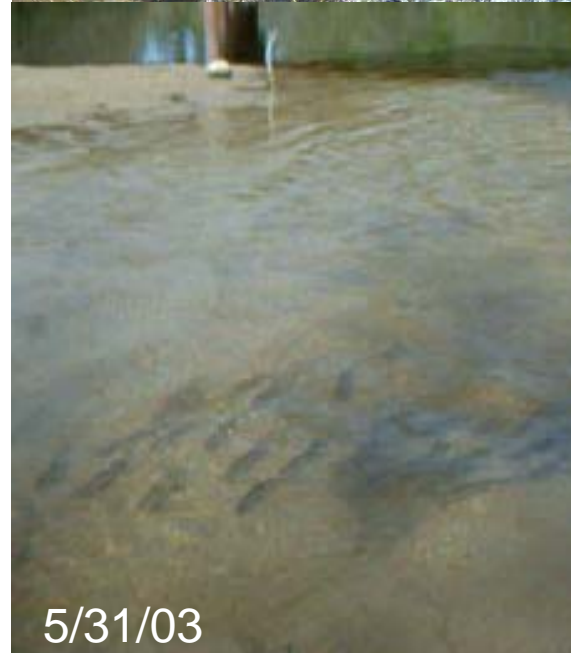
## E. Bridge St.

Photographs of the culverts underneath Bridge Street: A) taken on May 20, 2003; and B-C) taken on July 14, 2003.
