Recommendations for Future Restoration and Management Efforts for Mill Brook, Westbrook, Maine: Appendix E. Mill Brook Stream Habitat Walk

Mill Brook

Stream Habitat Walk

Cumberland County, Maine
May 31, 2003

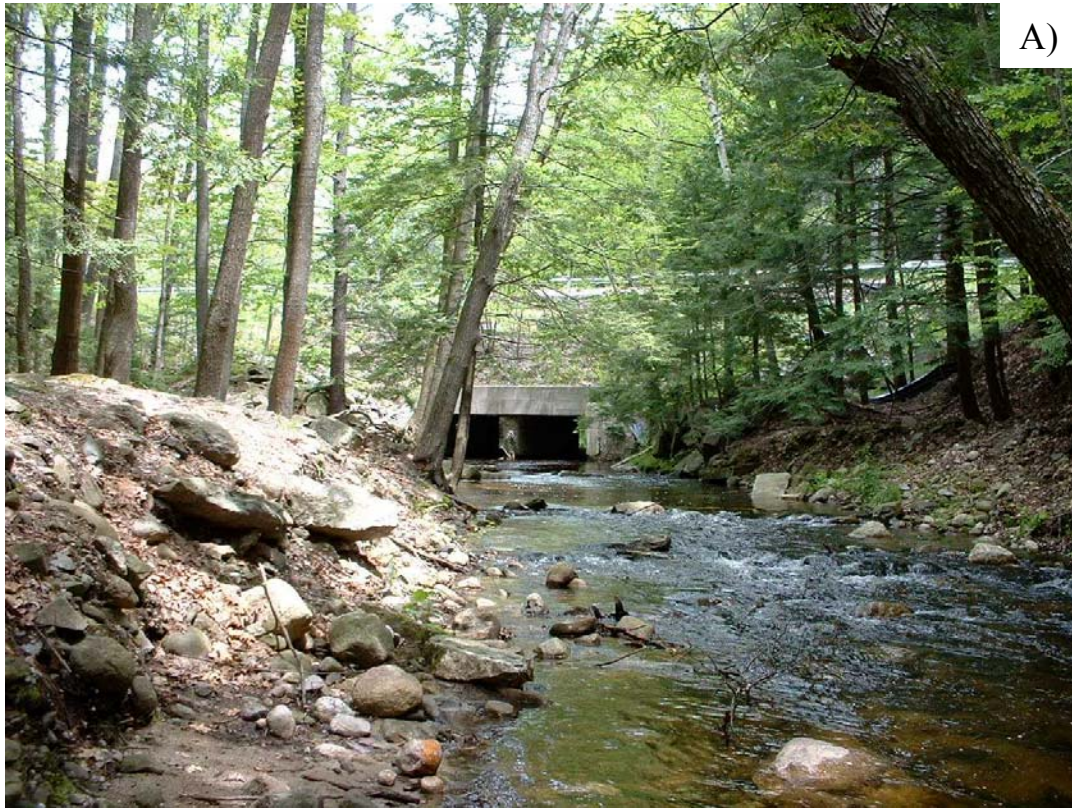
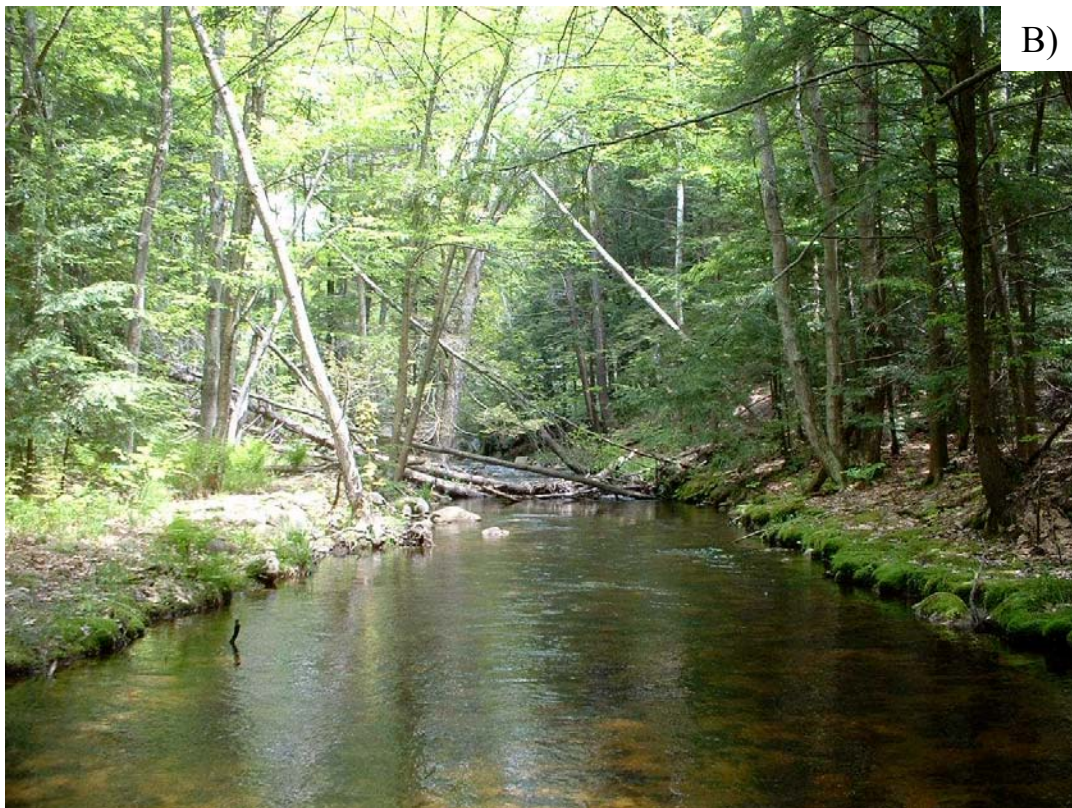
Site 1 photographs: A) the Route 302 bridge over Mill Brook and a riffle; and B) a run plus a woody debris dam.

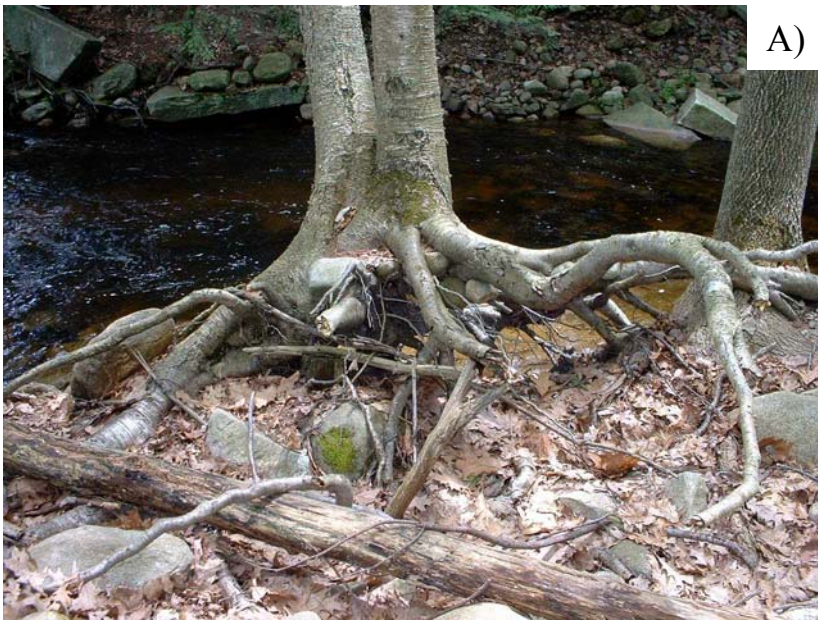
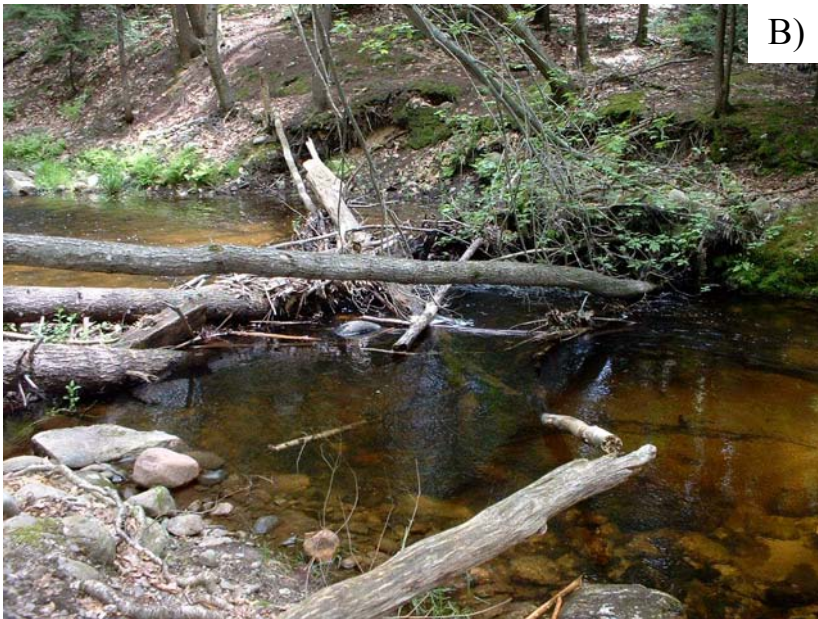
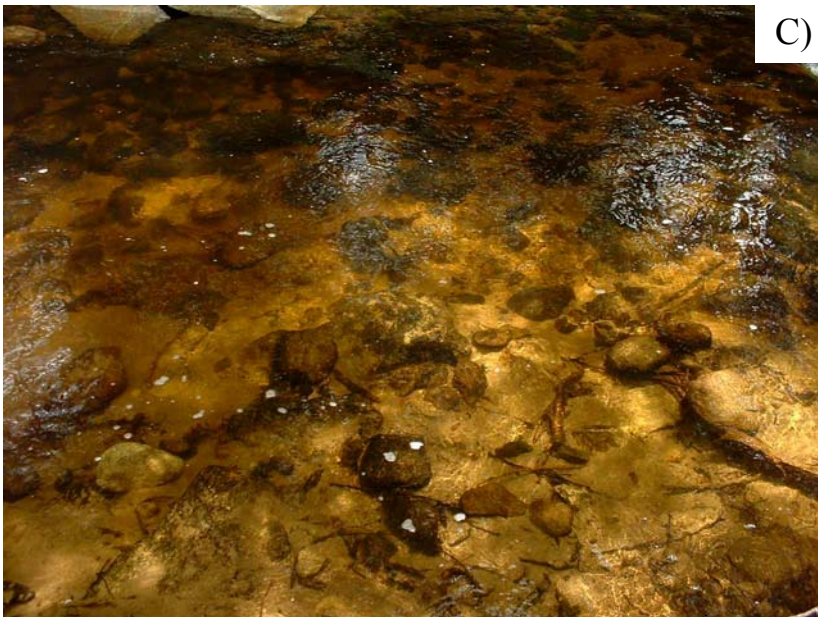
Site 1 photographs: A) scoured tree roots downstream of the Route 302 bridge/culvert; B) a woody debris dam and pool; C) a representative photograph of substrate in a run; D) trash on the streambank; E) alewives; and F) water level in the culvert (approx. 1 inch) (photo F taken on 7/14/03).

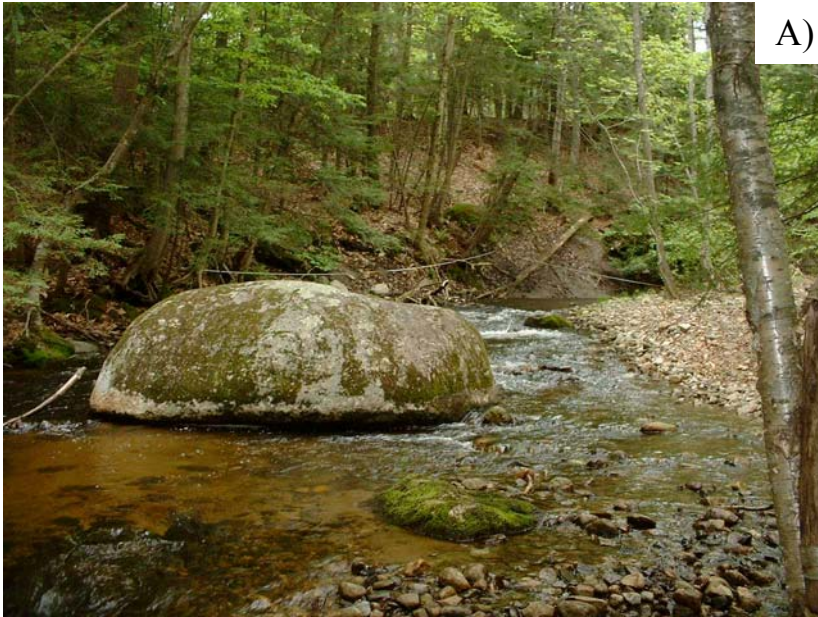
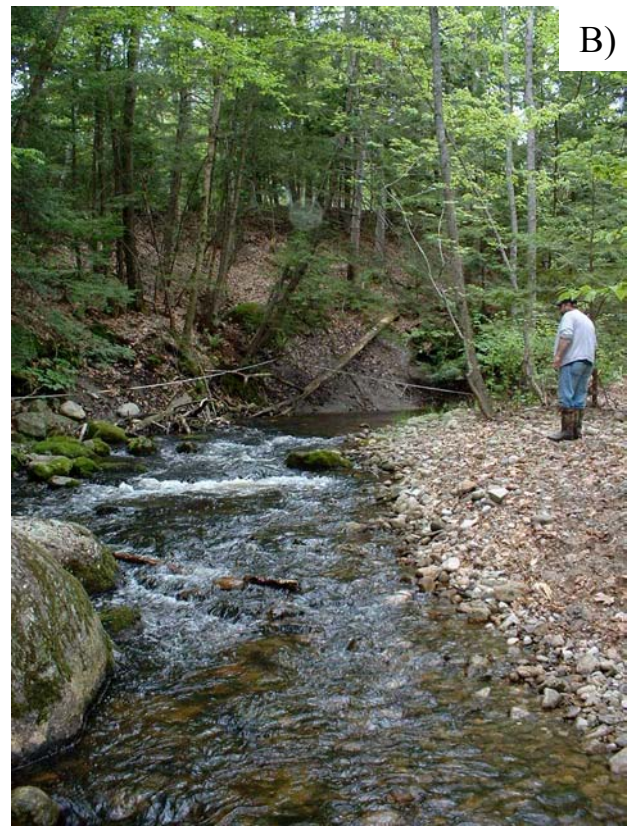
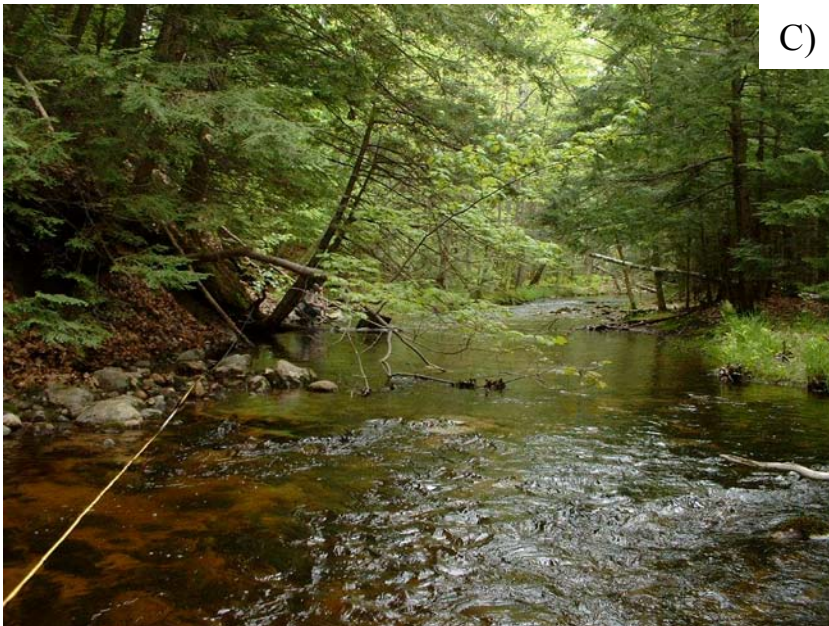
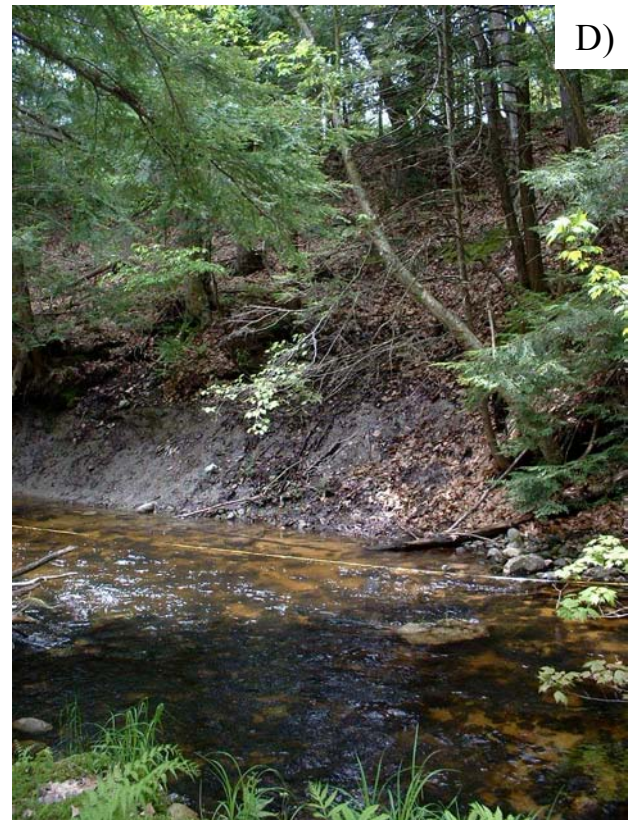
Site 2 photographs: A) a riffle, boulder, and pool sequence; B) a riffle; C) run habitat; and D) groundwater seepage out of a bank along with some apparent scour and/or bank sloughing.

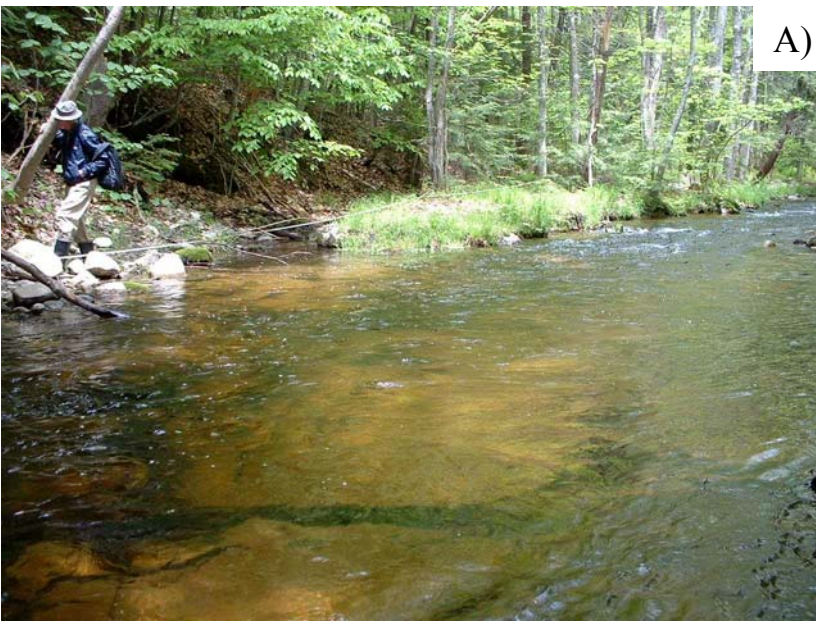
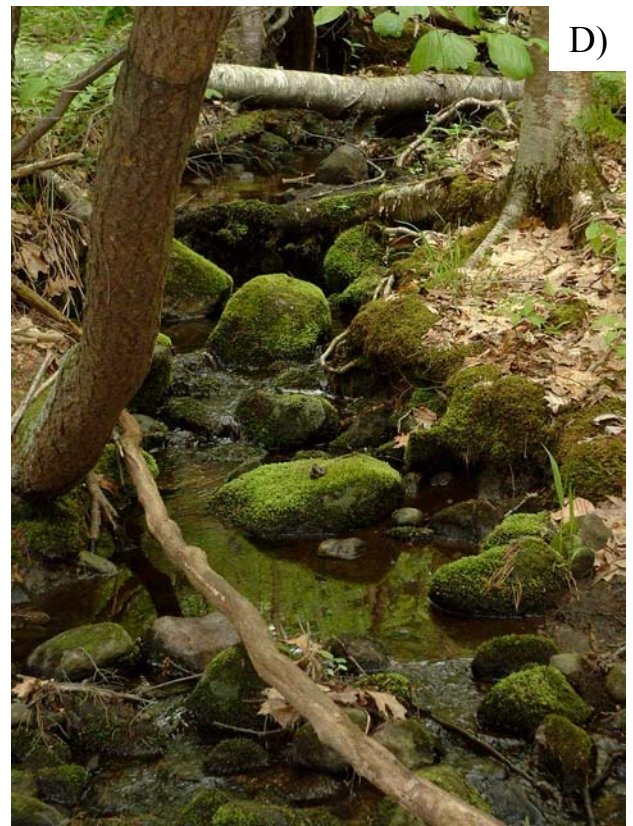
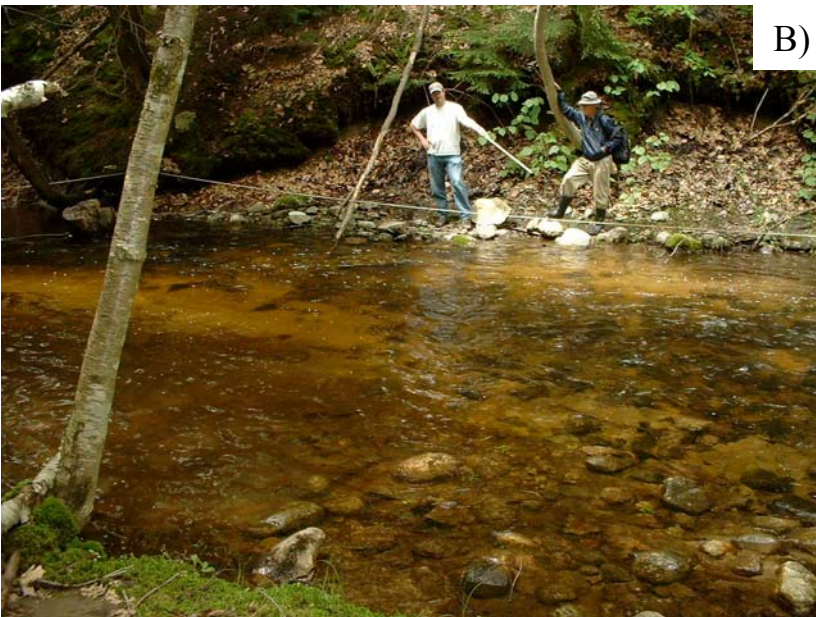
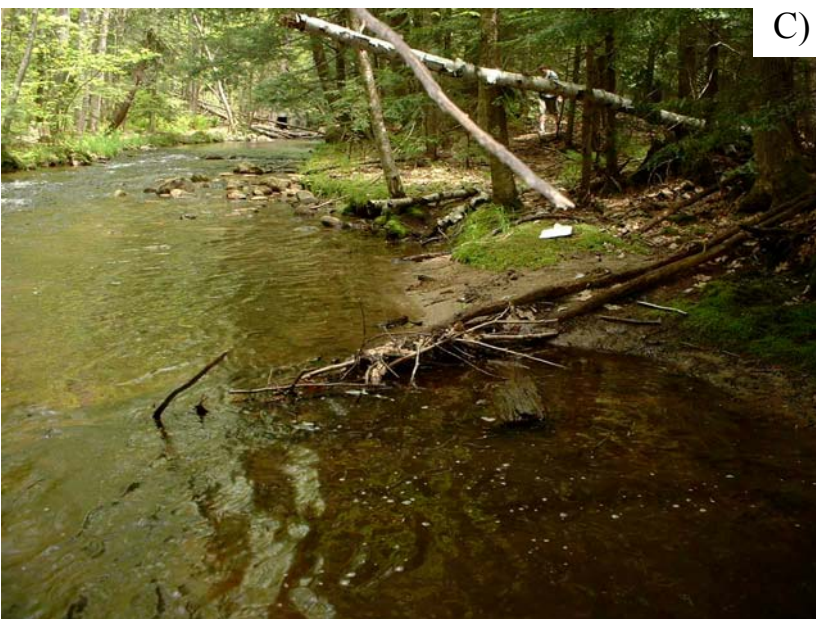
Site 2 photographs: A-B) signs of sediment inputs via a tributary containing some road runoff; C) sediment accumulation on the bank of Mill Creek opposite from the tributary input; D) a close-up photo of the tributary (notice the frog on the rock in the middle); and E) some “J-shaped” tree trunks on a nearby, steep bank, indicating relatively slow hillside erosion rates in the local area.

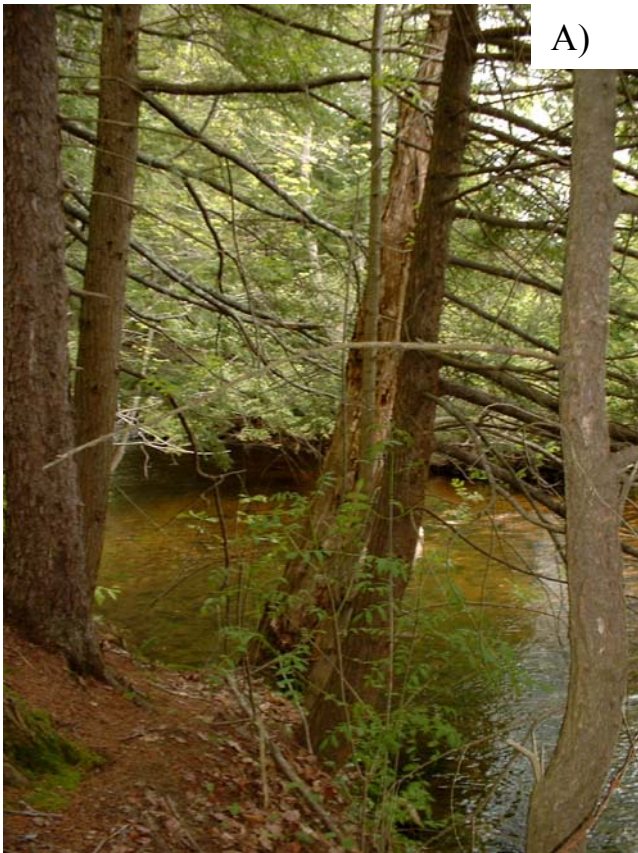
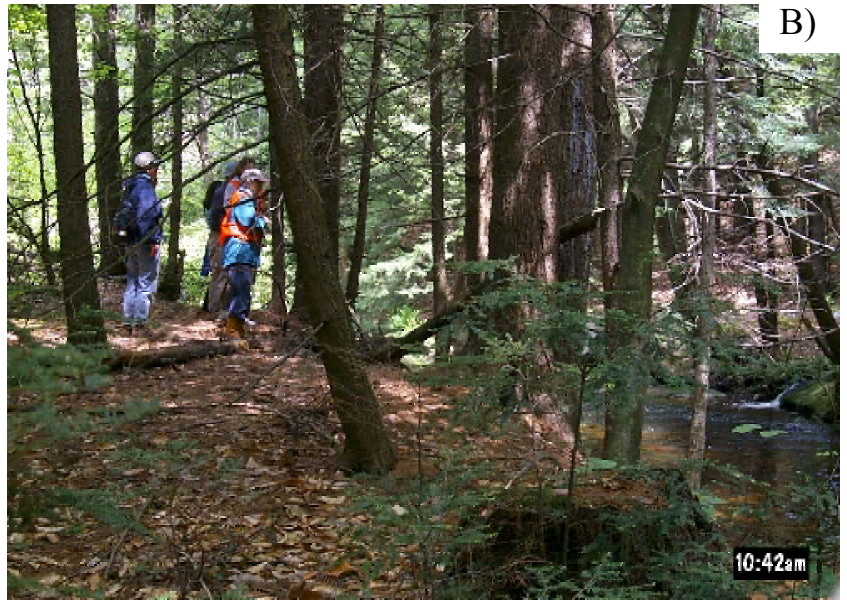
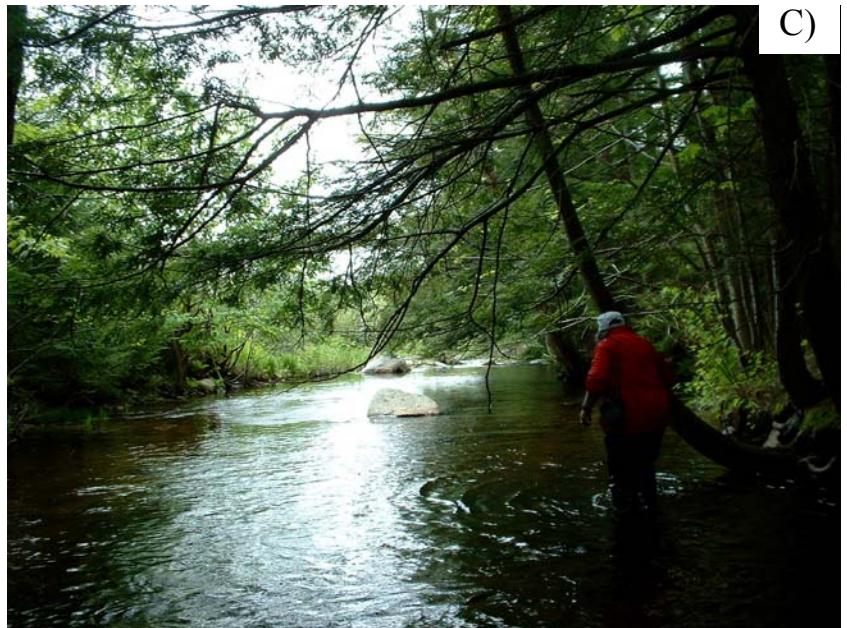
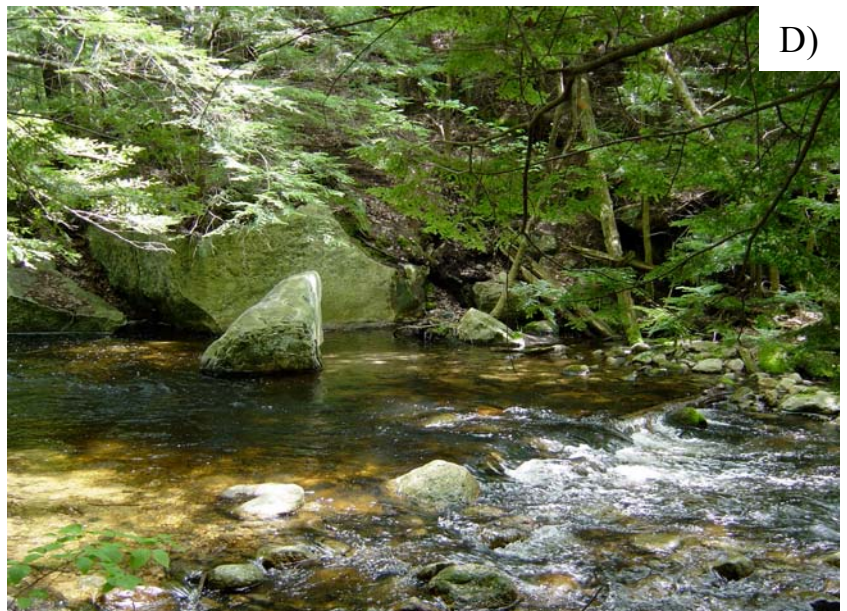
Site 3 photographs: A-B) view of stream through forested banks (note the J-shaped trees - they suggest that bank erosion rates may be relatively slow in the local area; C) a shaded pool.; and D) a riffle.

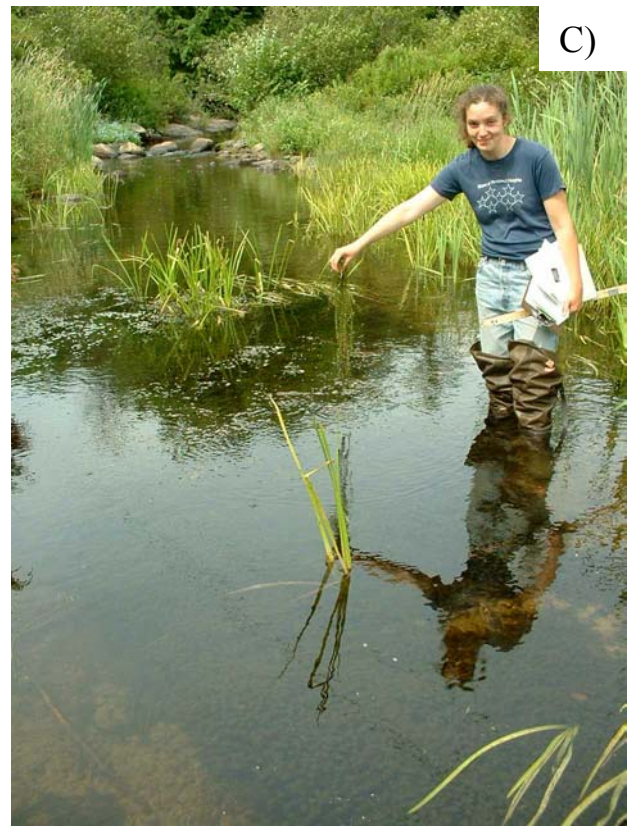
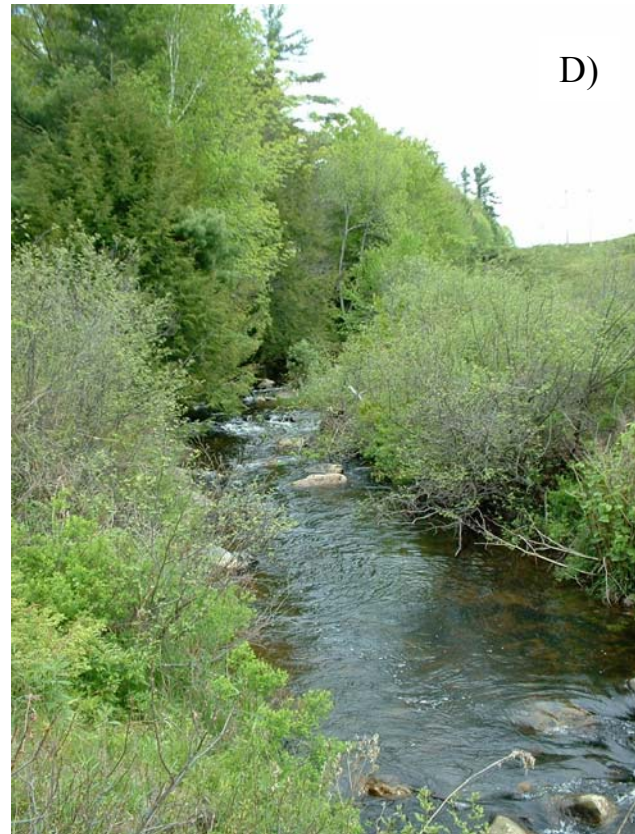
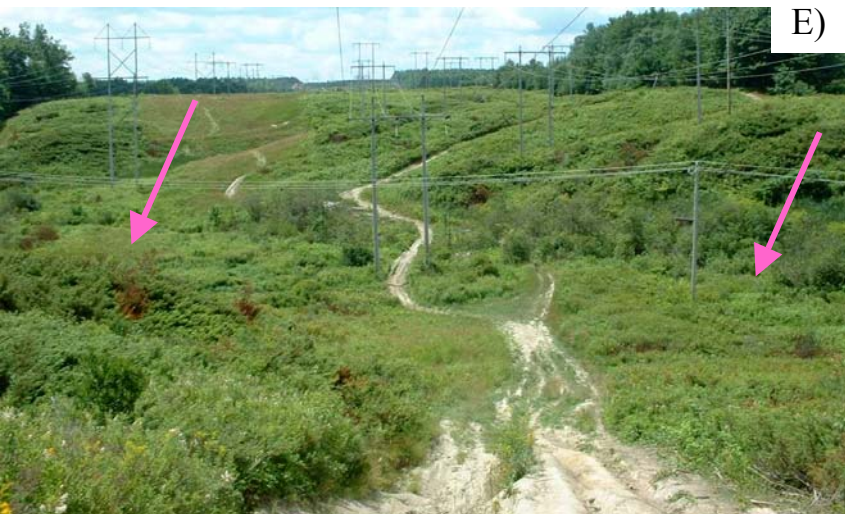
Site 4 photographs: A) recent riparian cutting along brook in powerline area; B) typical vegetation included bushes less than 10' in height such as young alders; C) *Elodea* sp. (American waterweed) found on July 14th (*Elodea* is an aquatic plant that is native to Maine, unlike Eurasian and variable water milfoil, both of which are exotic/invasive plants); D) Mill Brook in the powerline area, where shade is sparse; and E) looking downhill at the powerline area (the arrows point to where the brook is located; the stream is flowing right to left) (this photo was taken on 7/25/03).

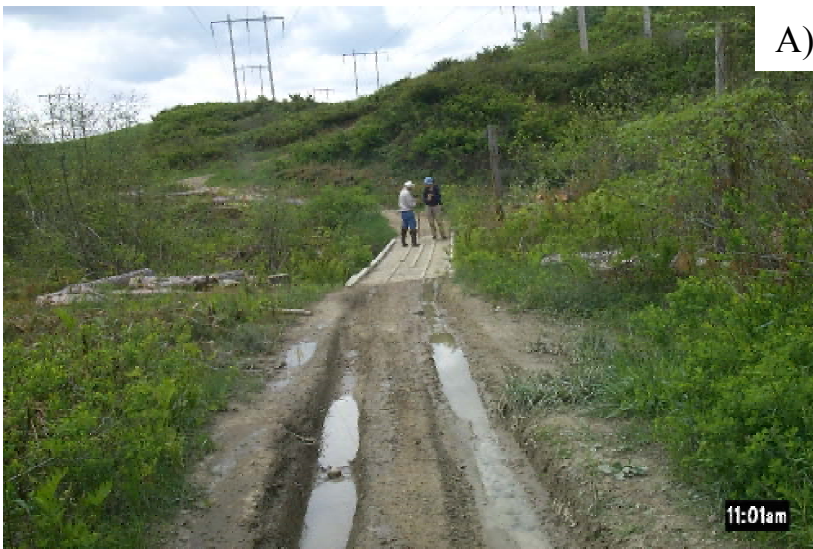
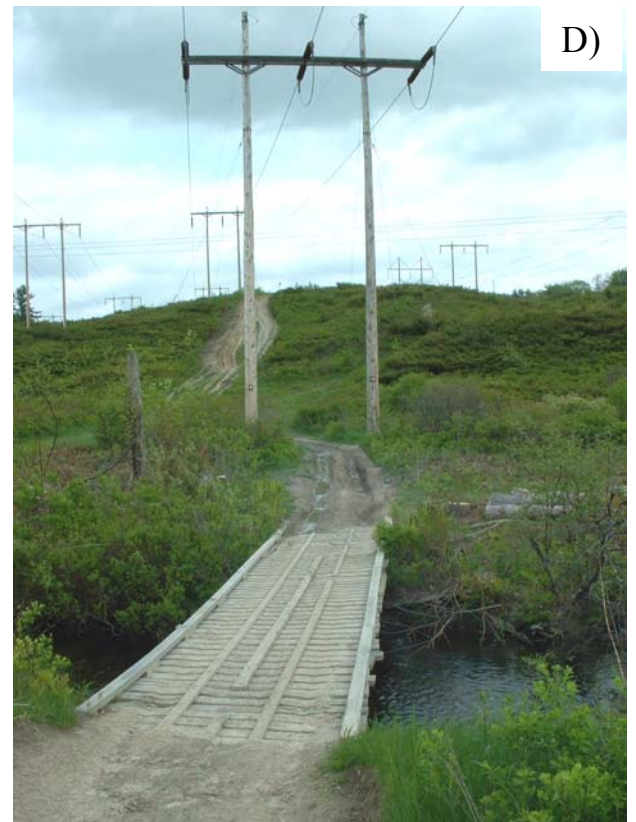
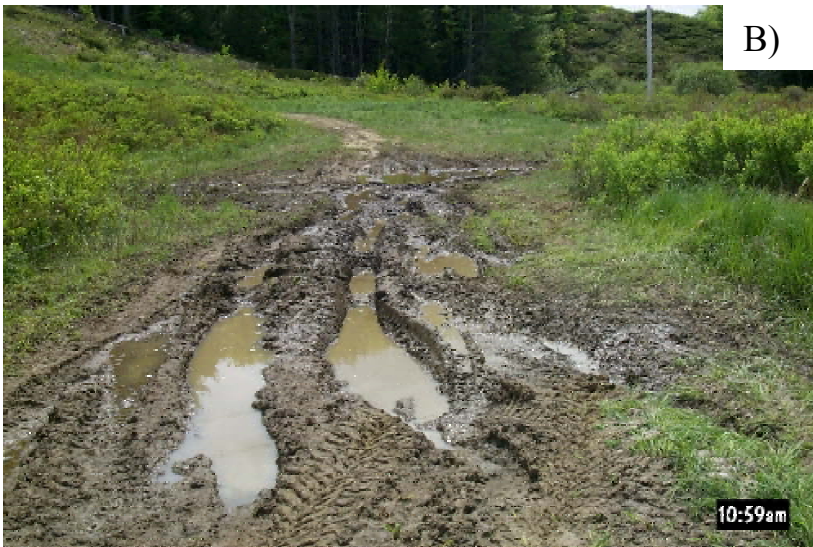
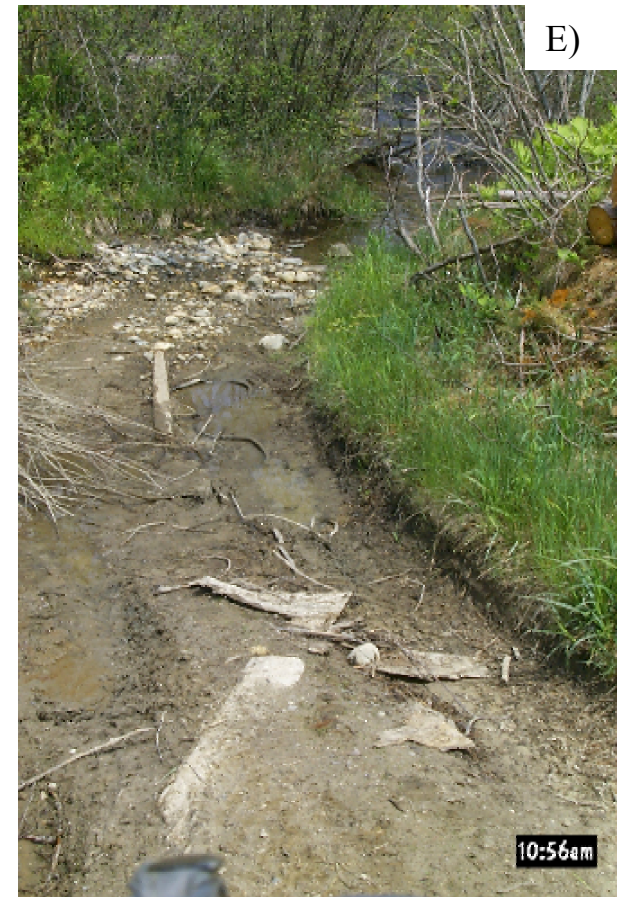
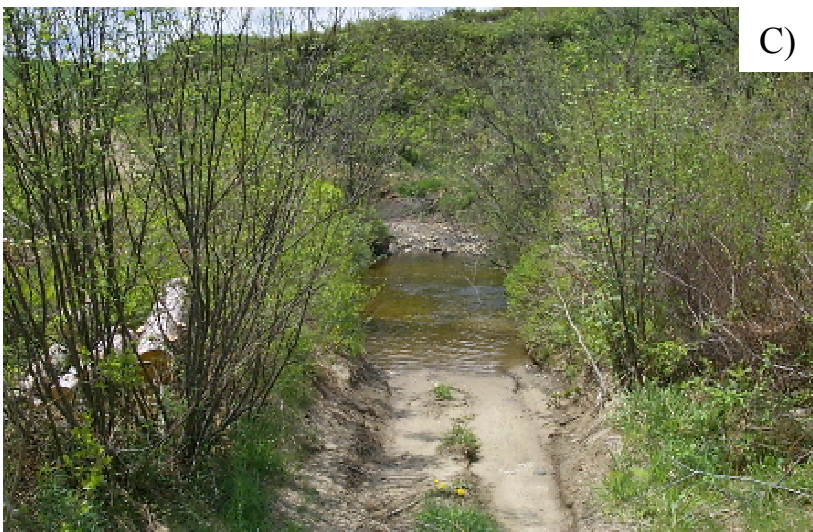
Site 4 photographs of ATV impacts: A & D) ATV bridge over Mill Brook; B) tire ruts alongside the brook; C) ATV crossing through the stream adjacent to the bridge; and E) trail leading to stream.

Site 4) This area has been heavily disturbed by powerline-area clearing and associated ATV trail use. There is a high potential for erosion and sedimentation, as well as stream shading/temperature, problems here.

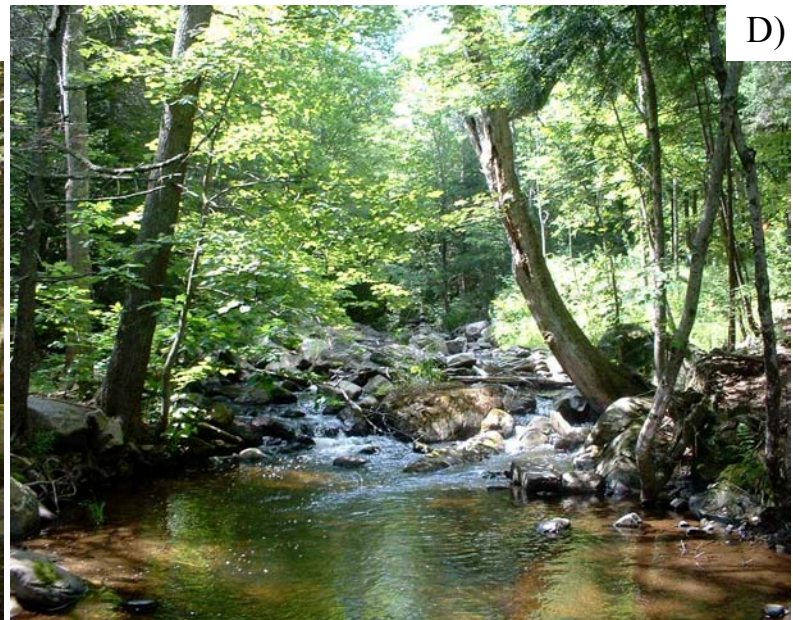
Site 4-B* photographs: A-B) Mill Brook and streamside areas in the vicinity of a gravel mining operation (note the berm wall on one side of the stream - it currently is serving as a barrier between a stormwater detention pond and the stream) and C-D) pools, riffles, and streamside forest. *These photos were taken on July 25, 2003, on a reconnaissance walk of this area, which is located downstream of Site 4 (see the map on page 2).

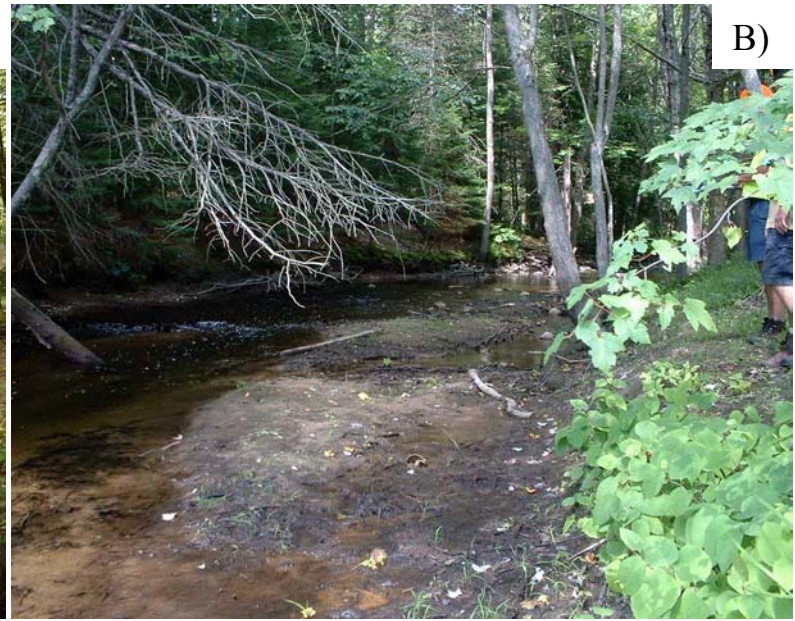
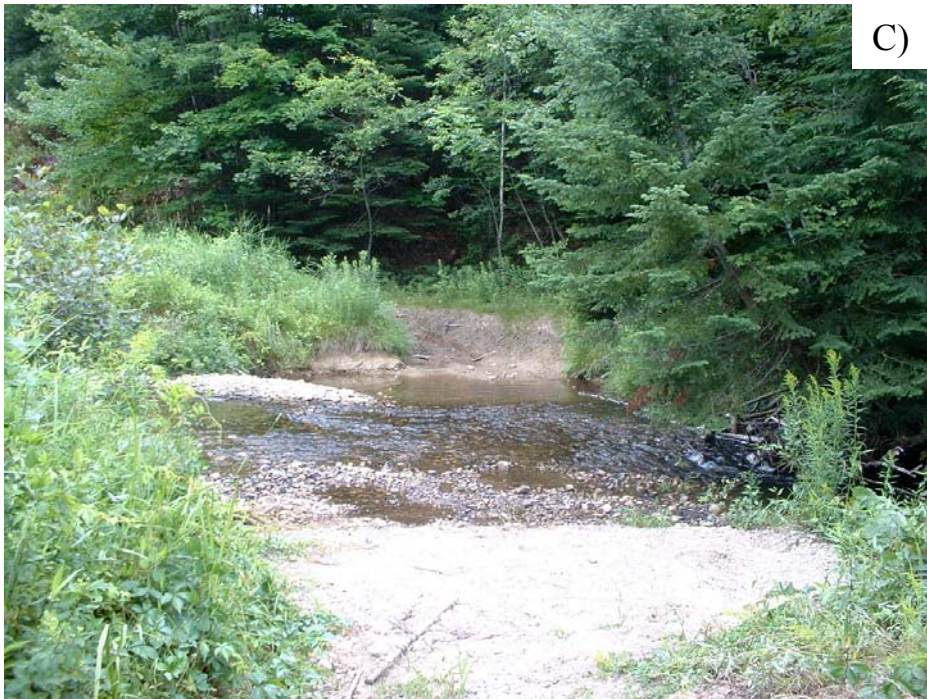
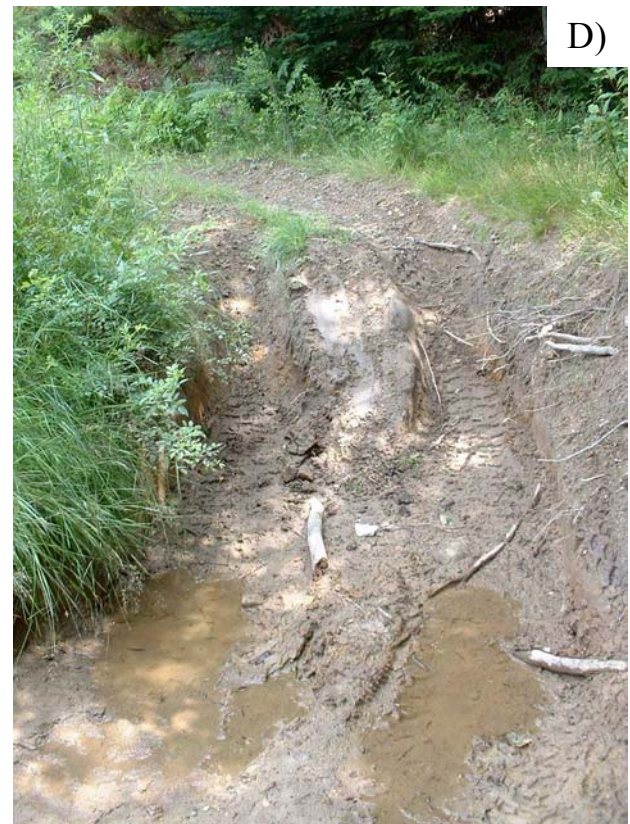
Site 4-B* photographs: A-B) signs of aggradation (that is, sediment accumulation or bar formation) in the middle of Mill Brook's channel and C-D) local ATV trail impacts. *These photos were taken on July 25, 2003, on a reconnaissance walk of this area.

Site 4-B) This site only was only subjected to a reconnaissance walk. However, this rapid survey discovered that sedimentation appears to be a problem, which is likely due to ATV trail use, upstream sources of erosion, as well as possibly a nearby gravel pit (although sediment settling basins are present here).

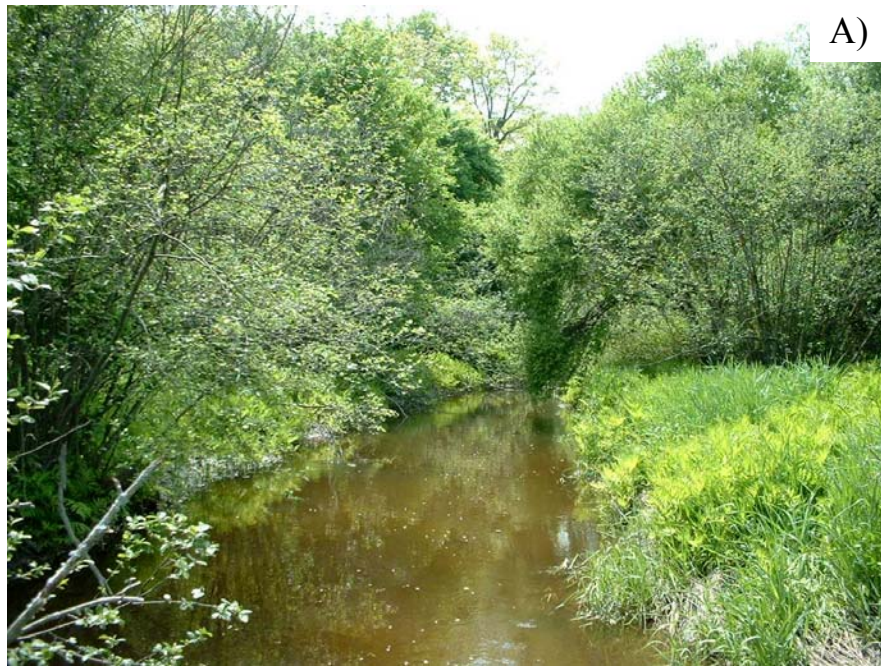
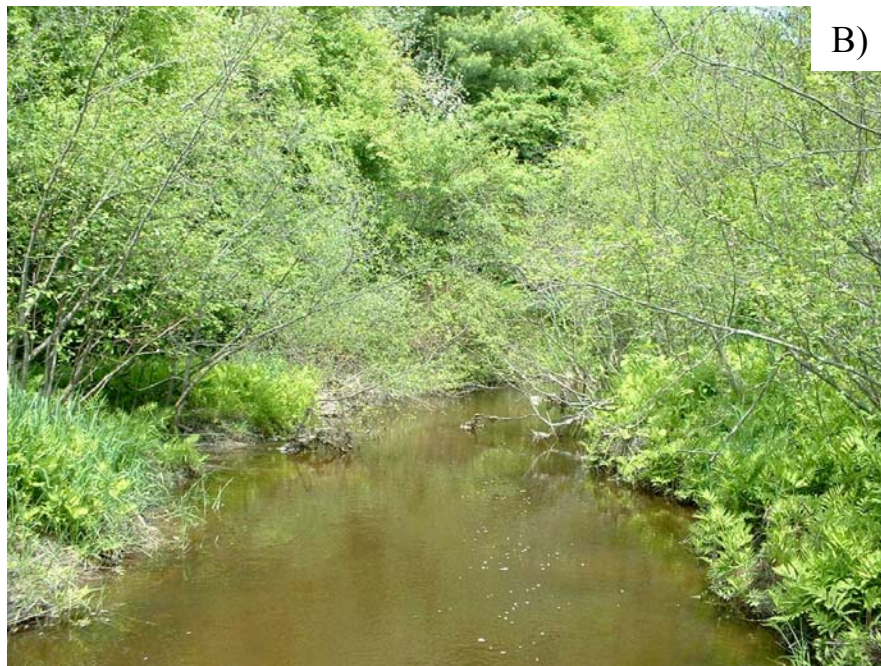
Site 5 photographs: A-B) Looking upstream and downstream from the ATV bridge shown in photo C; C) ATV bridge; and D) a small debris dam perhaps created by beaver.

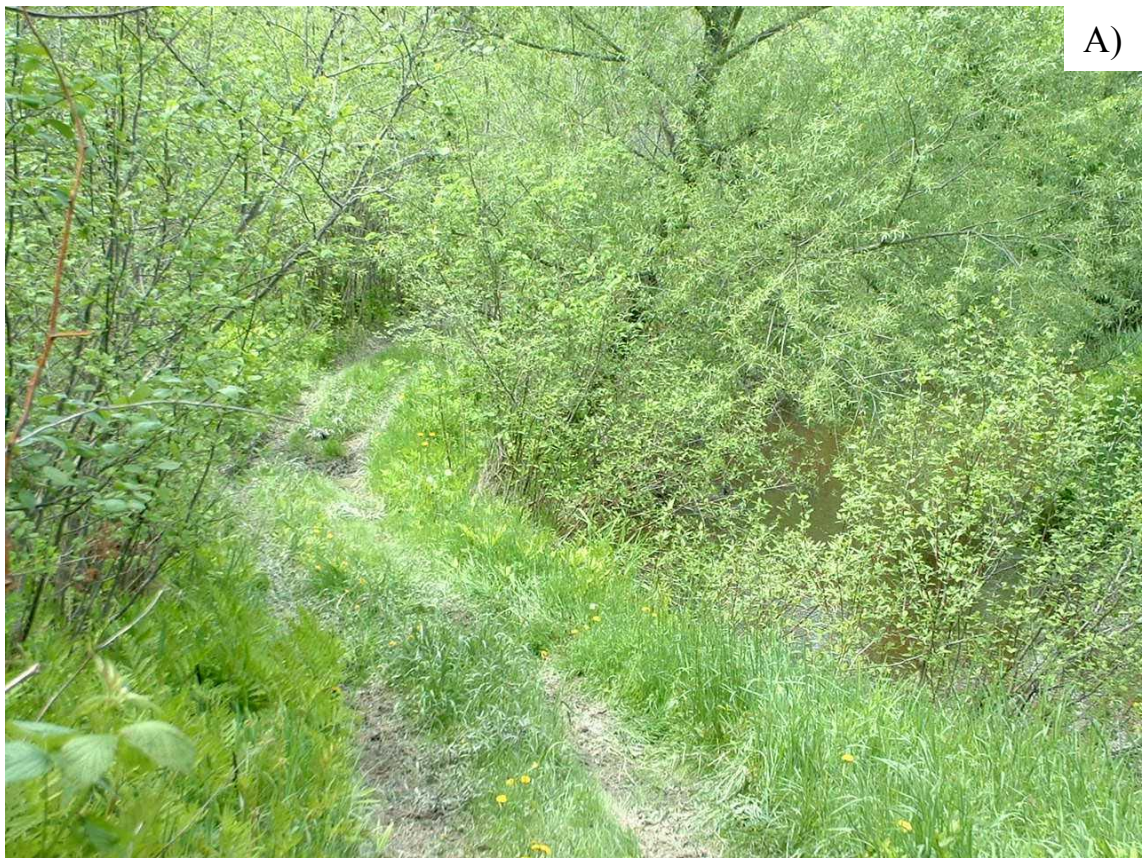
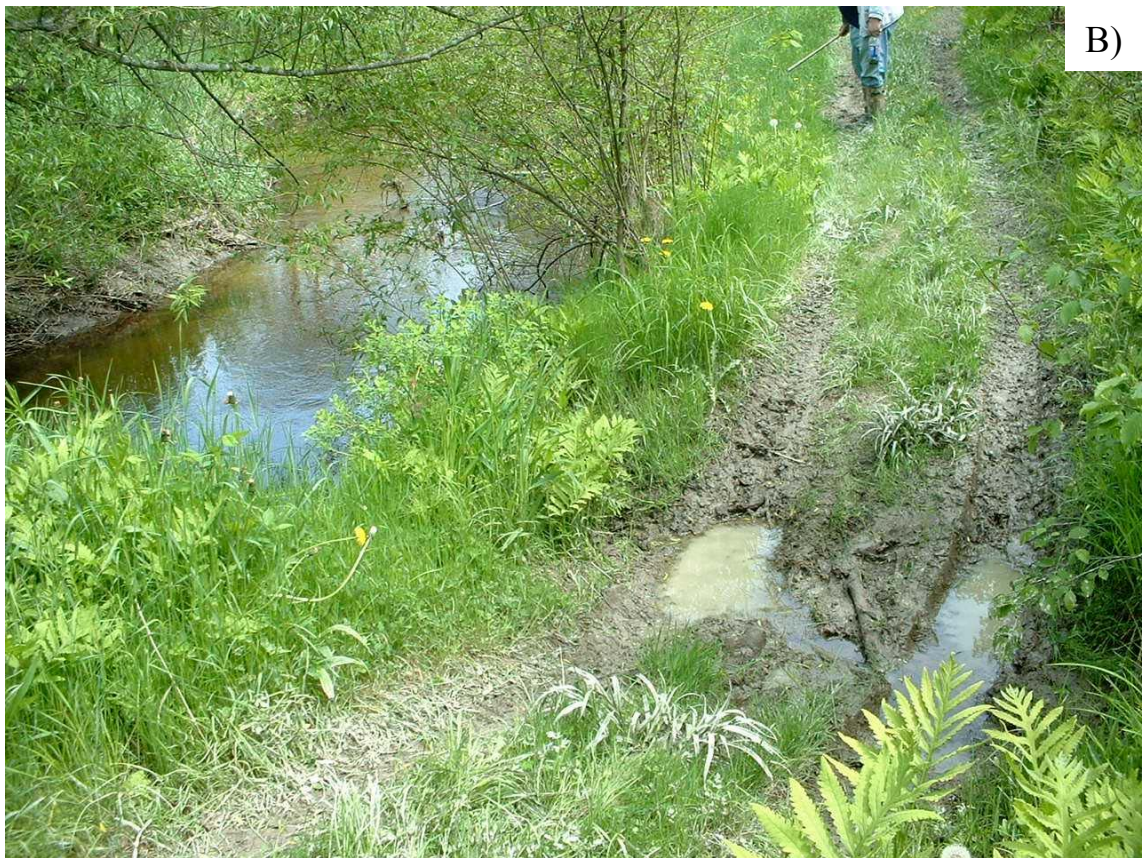
Photographs collected near and between Sites 5 & 6: A-B) muddy ATV trails located a few feet away from Mill Brook. Note that the brook is fairly hidden behind some trees and shrubs on the right side of photo A.

Sites 5 & 6) Major concerns: Sediment pollution from badly eroding ATV trails, thermal stress from a general lack of many mature, tall trees in the riparian zone, and potential sewer line leaks.

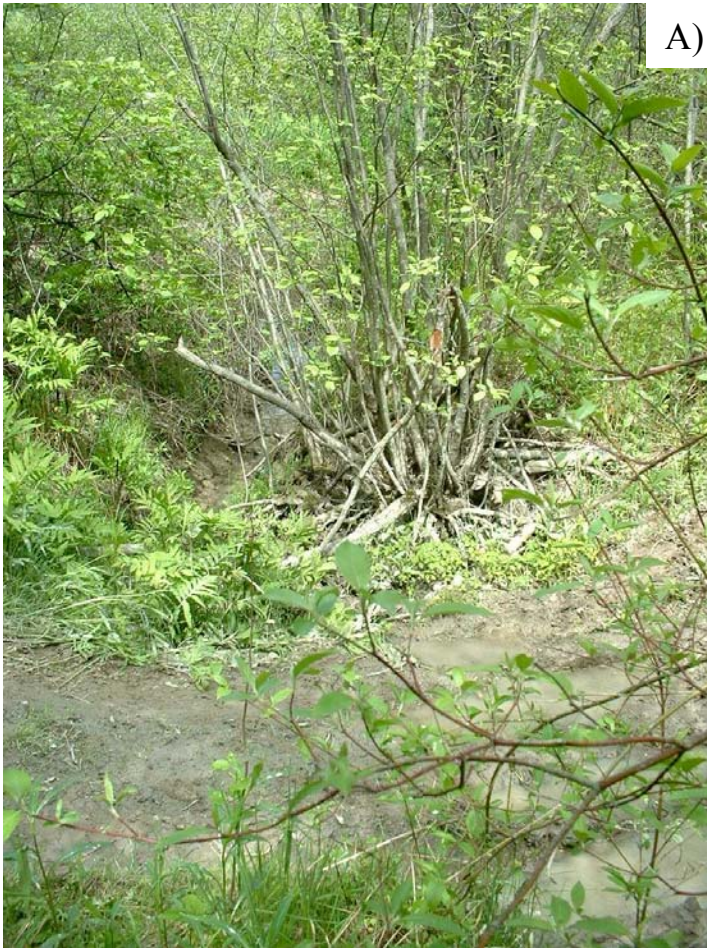
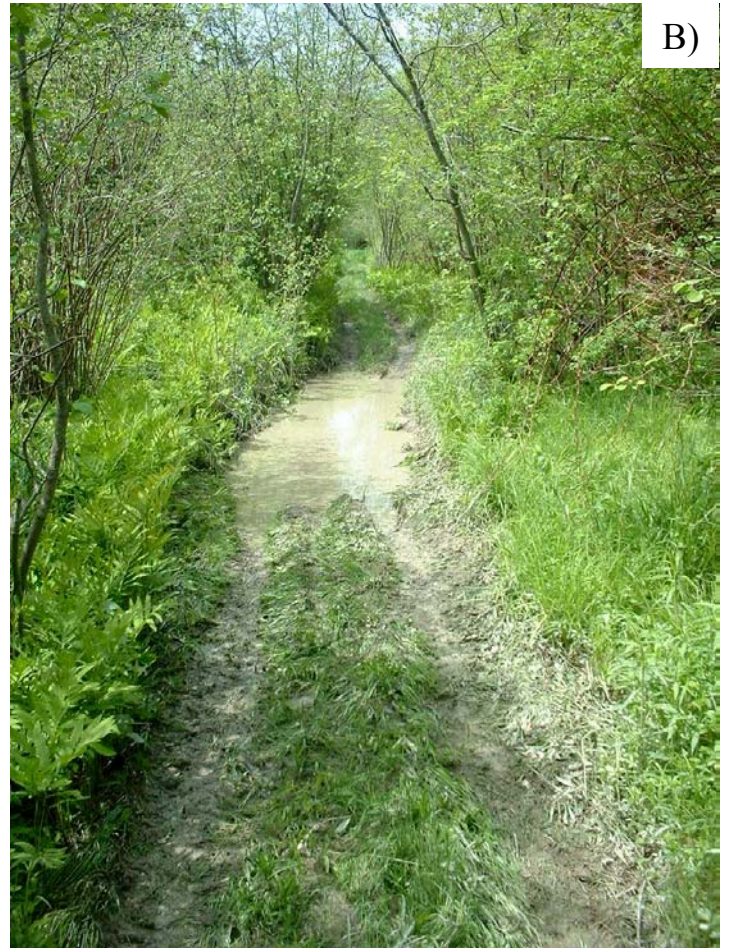
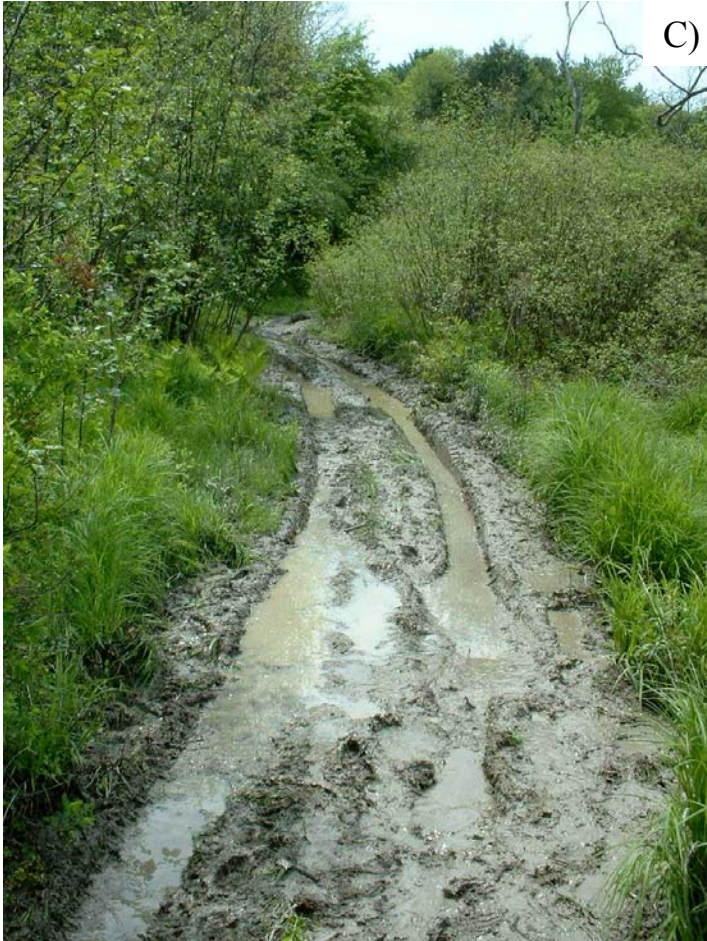
Photographs collected near and between Sites 5 & 6: A-C) muddy ATV trails located a few feet away from Mill Brook. The brook is fairly hidden behind some trees and shrubs in the upper-central location of photo A. Also note the drainage off of the ATV trail into the brook in this photo.

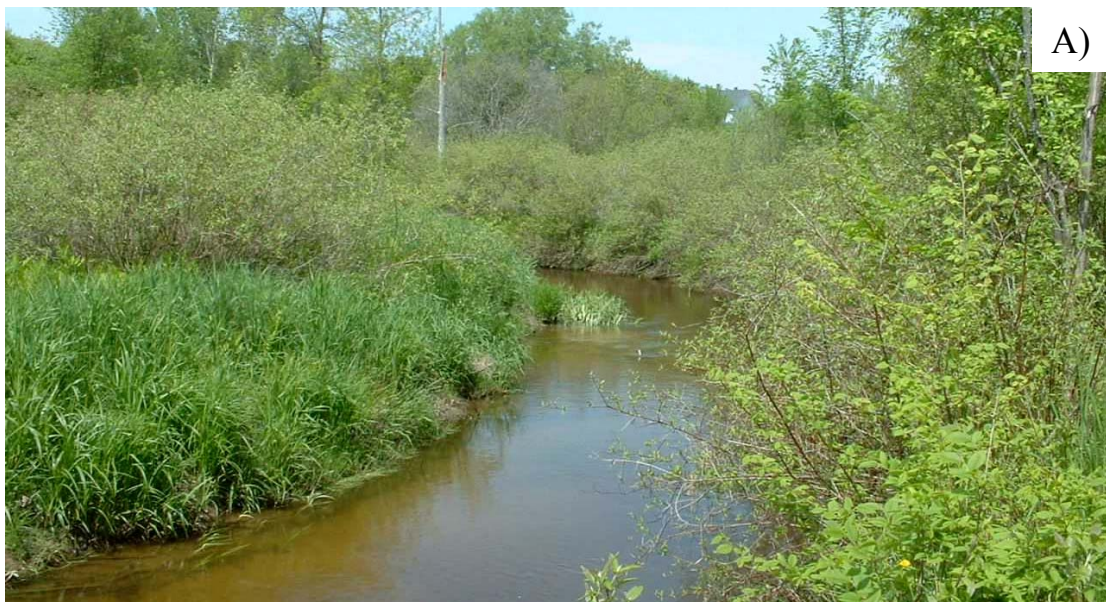
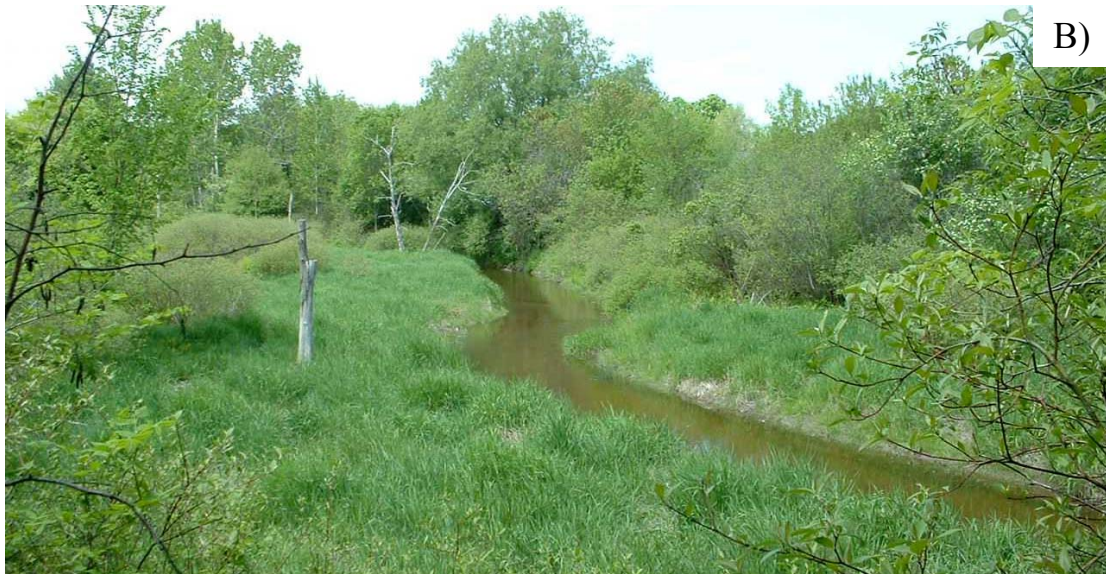
Site 6 photographs: A-C) meandering, low gradient, silty-sandy-bottomed stream; and D) a manhole above a sewer line and an ATV trail near Mill Brook. Photo C was taken on 5/20/03 and it is situated just upstream of Bridge Street.
