Recommendations for Future Restoration and Management Efforts for Mill Brook, Westbrook, Maine: Appendix E. Mill Brook Stream Habitat Walk

Mill Brook

Stream Habitat Walk

Cumberland County, Maine
May 31, 2003

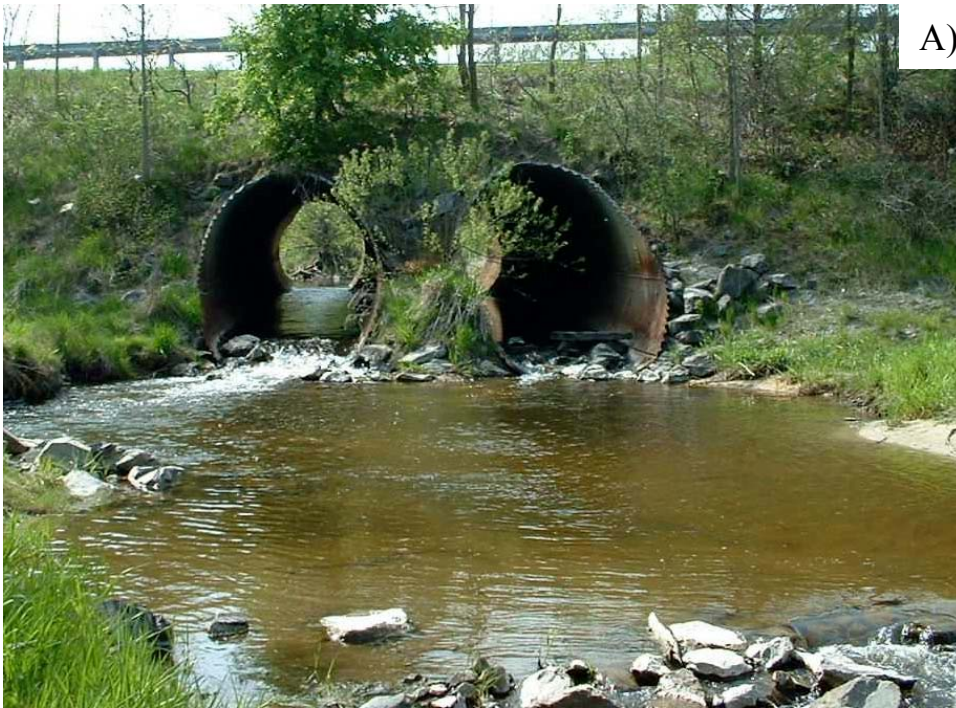
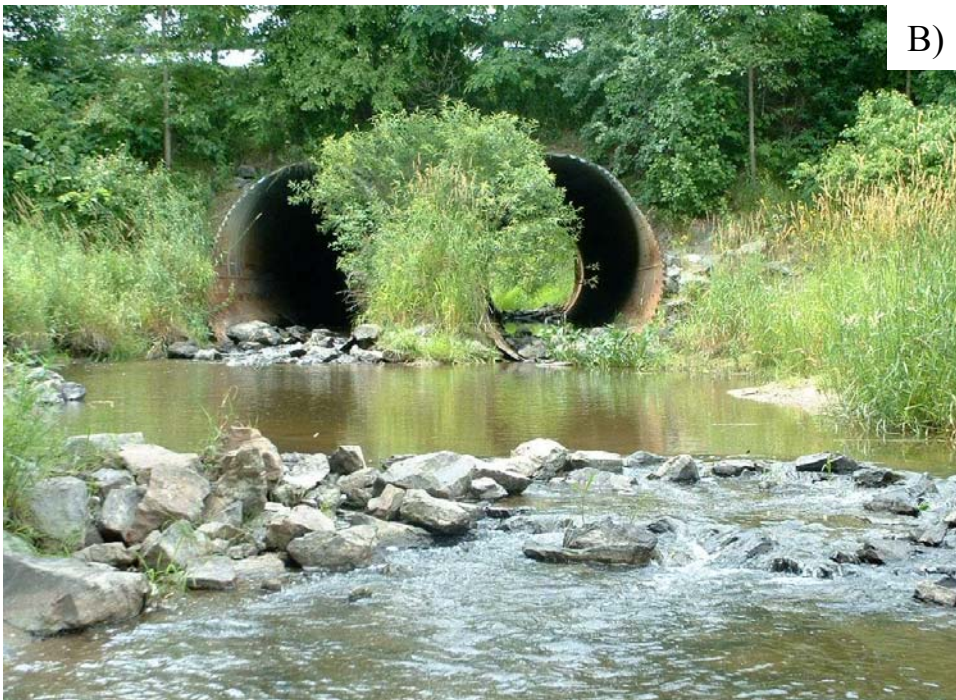
Photographs of the culverts underneath Bridge Street: A) taken on May 20, 2003; and B-C) taken on July 14, 2003.

- > Investigate potential fish passage issues at all the culverts on the stream.
- > Conduct more stream walks on sites not included in this survey, including small tributaries to Mill Brook which might provide cold water to certain areas of the brook that can provide cold-water refugia to fish such as salmonids during warm periods of the year.

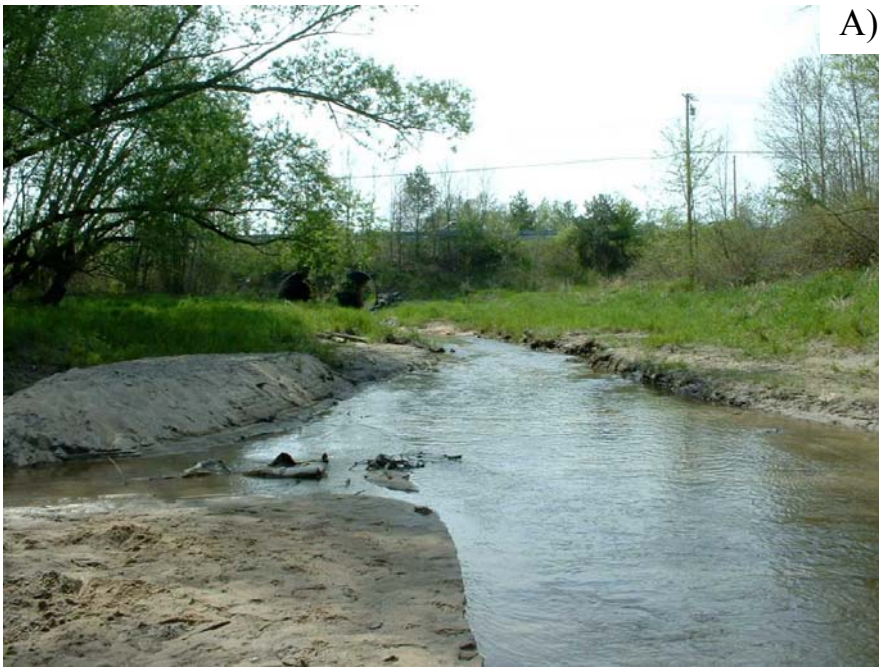
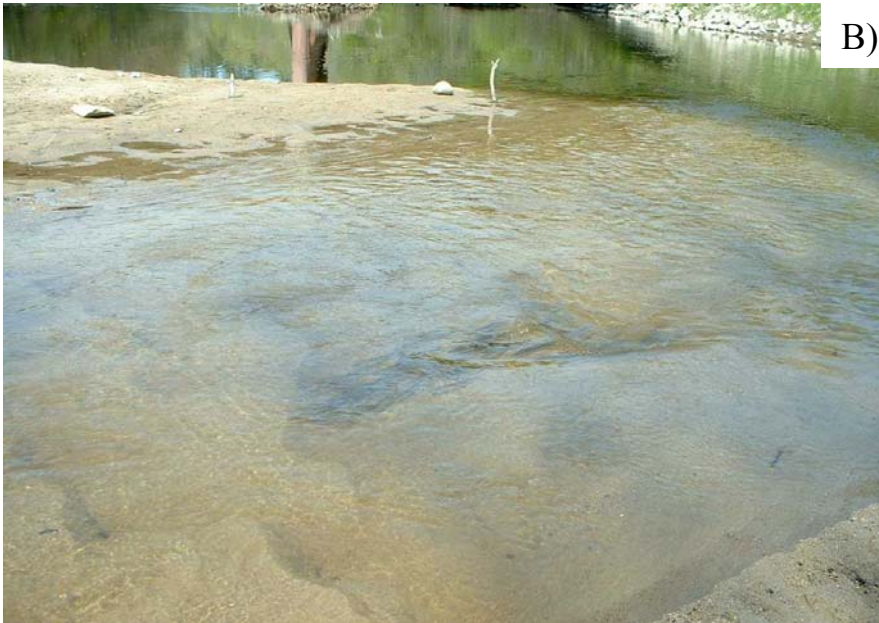
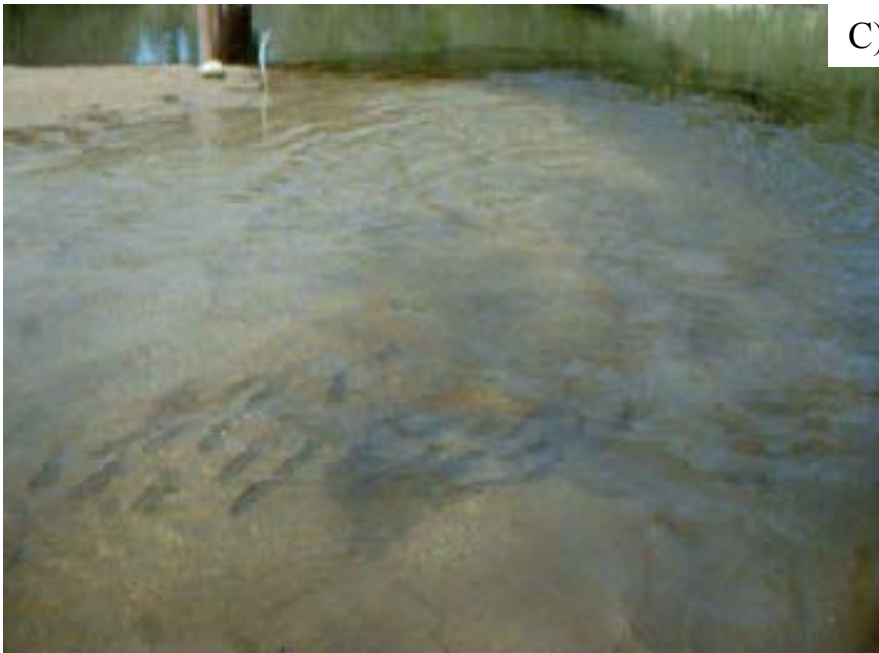
Photographs taken near where Mill Brook drains into the Presumpscot River: A) sandy banks; and B-C) alewives entering Mill Brook.

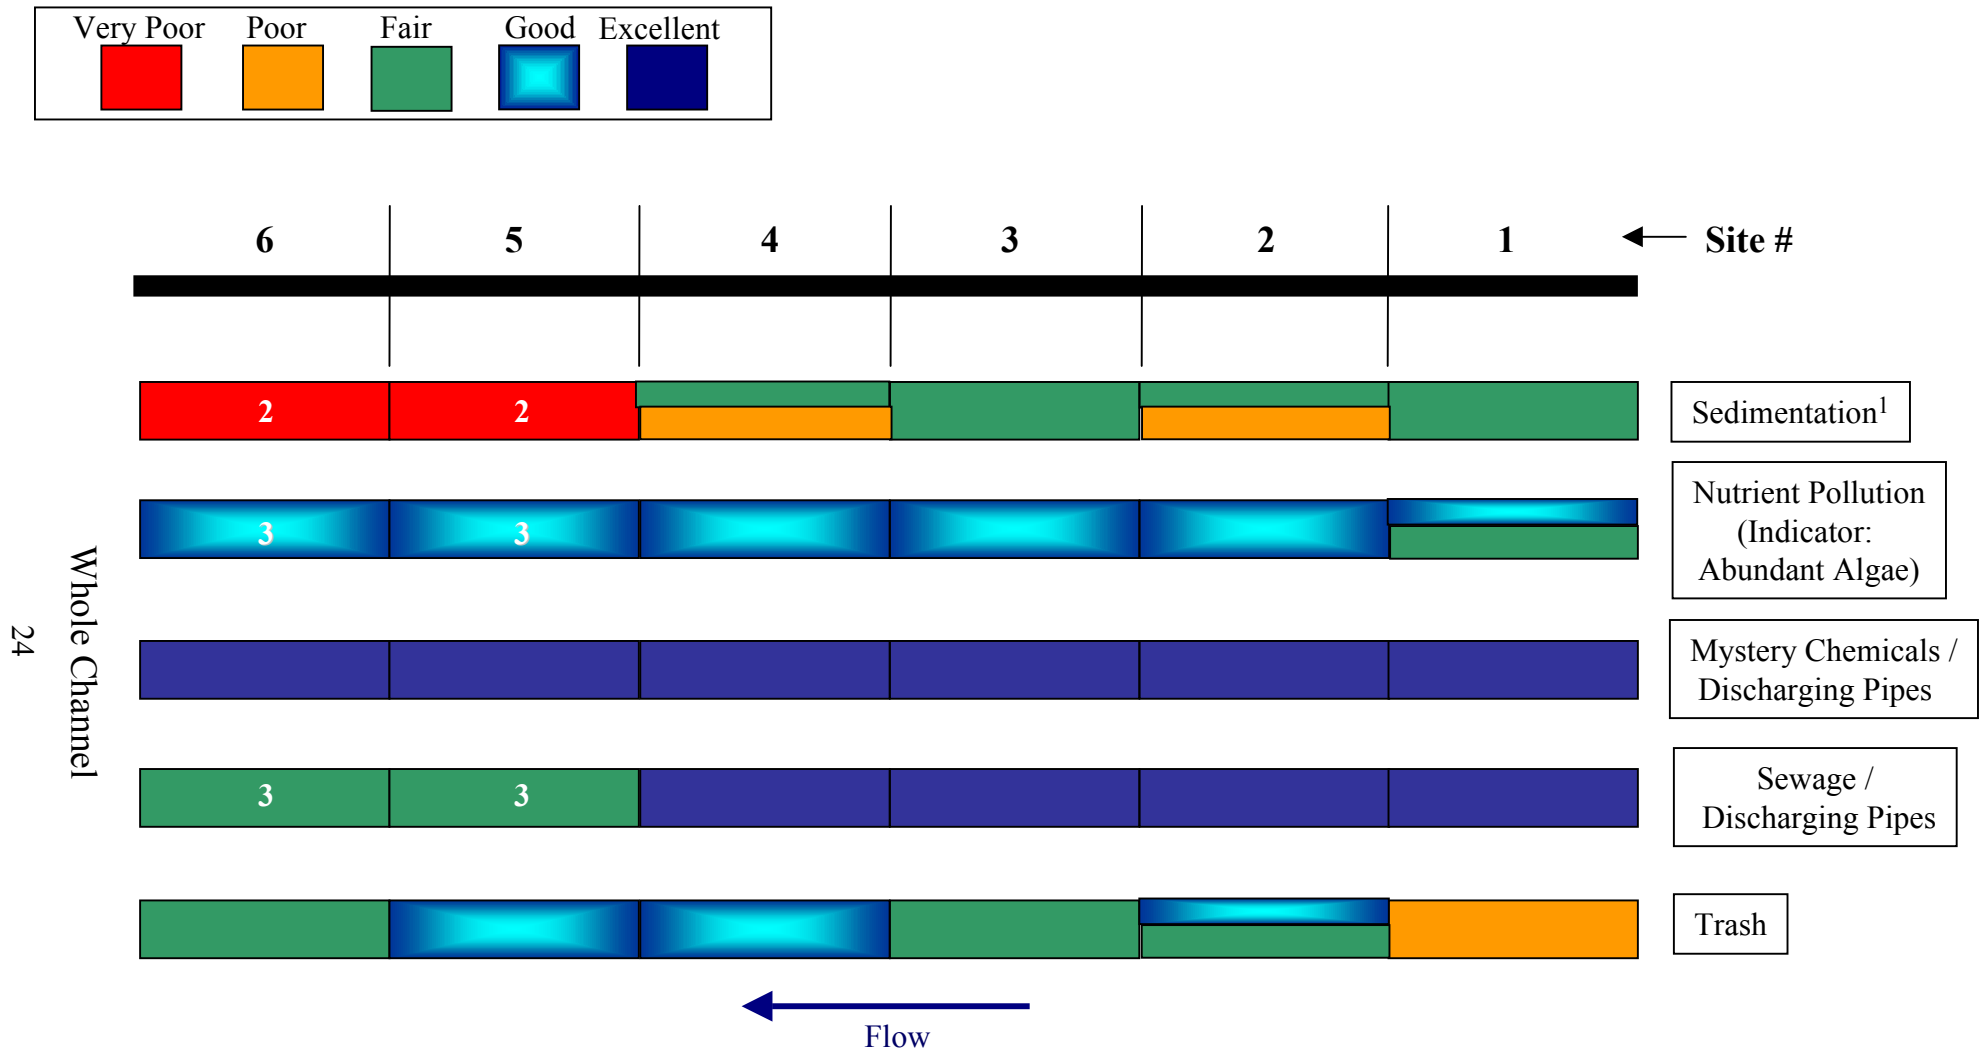
Figure 3. Evidence of Pollution or Other Impacts.

¹ Embeddedness is high in many places, although the fact that the local surficial has a lot of sands and clays in it may be a large influence.

² The substrate at these sites was almost entirely sands and silts. This may be due to natural factors such as local surficial geology, gentle slope, beaver activity in addition to erosion from ATV trails and poorly vegetated areas.

³ A sewer line was close to the stream in these areas, which possibly could contribute nutrients, bacteria, and viruses if leaks were to occur.
