Long Reach Lane at Long Marsh, Harpswell, 2015 Post-Project Monitoring Report, Year 1 of 5

2015 Post-Construction Monitoring Report: Long Reach Lane at Long Marsh, Harpswell

Year 1 of 5

Compensation for the Martin's Point Bridge Project, Falmouth-Portland
(PIN 16731.00)

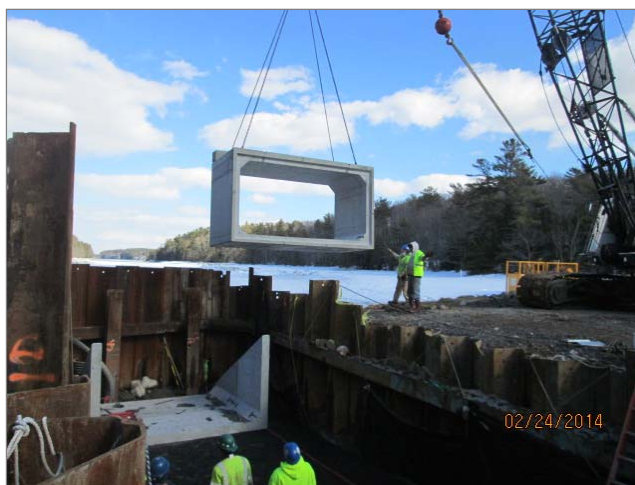
In 2012, the Maine Department of Transportation (MaineDOT) proposed a mitigation project at Long Reach Lane in Harpswell (Figure 1) to compensate for the functional impacts to marine wetlands associated with the construction of the Martin's Point Bridge between Falmouth and Portland. The mitigation project took place in January and February 2014, and resulted in the successful replacement of a 36" (7.1 ft² flow area) round concrete pipe beneath Long Reach Lane with a larger 6' x 12' concrete box culvert (72 ft² flow area) in February 2014 (photo MaineDOT, below).

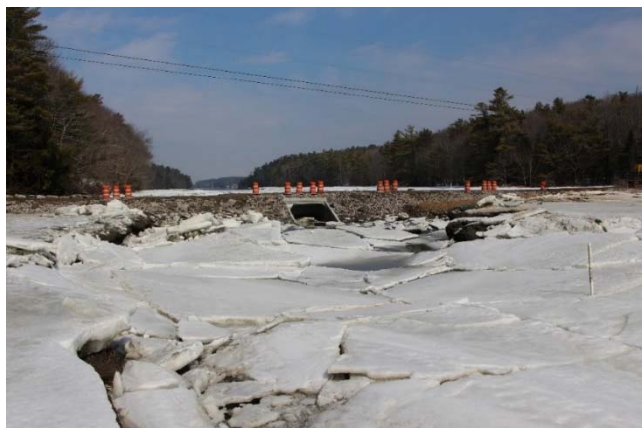
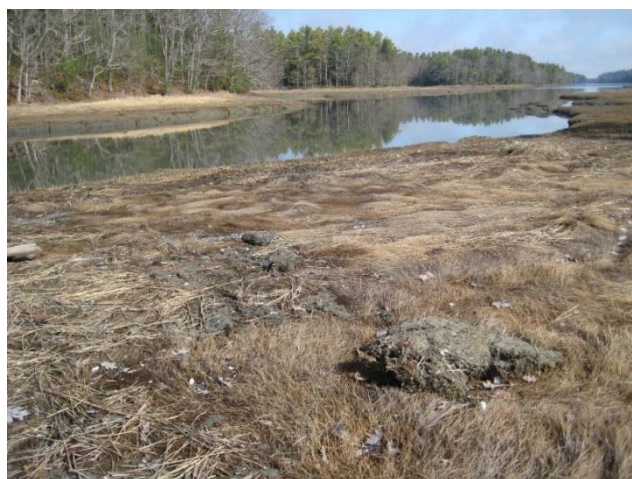
Replacement of the culvert at Long Reach Lane took place over several weeks during the winter of 2013-2014 and concluded in February. A thick layer of ice covered much of the flats, tidal creek, and adjacent marsh surface over the winter. As ice thawed, the new increase in tidal exchange resulted in large blocks of ice moving between the creek and high marsh surface, depositing wrack, sediments, and chunks of peat on the high marsh. At a small scale, vegetation communities, marsh surface elevation, and channel morphology appear to have been altered by ice scour and resulting sediment deposition, following decades of impoundment. Ice movement affected the location of markers and wells at some Stations, but only one marker, denoting the vegetation transect at Station 1, was lost.

The new culvert increased ice movement within the Project Area (CBEP, March 2014).

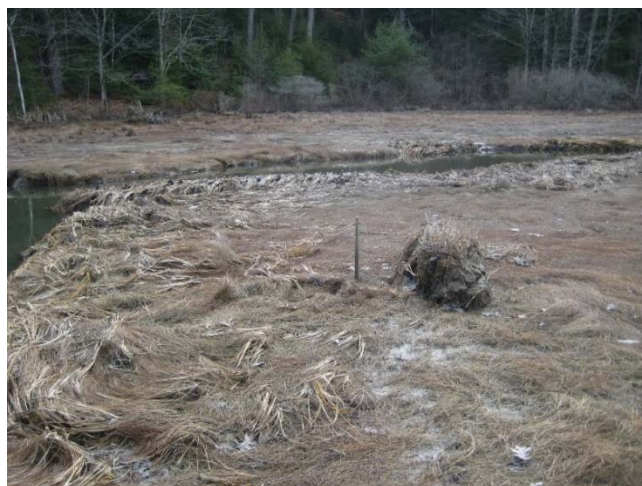
Peat and sediment on the high marsh surface resulting from ice scour, at Station 1 (top), and Station 6 (bottom; CBEP,

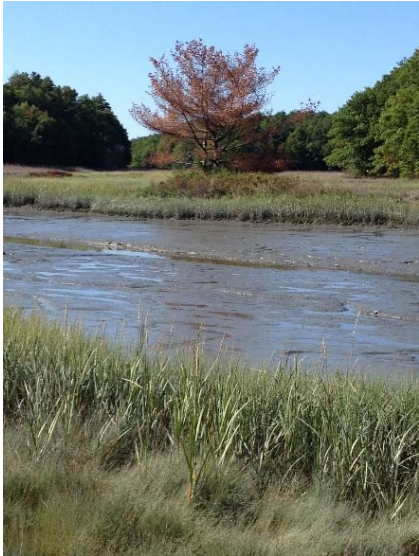
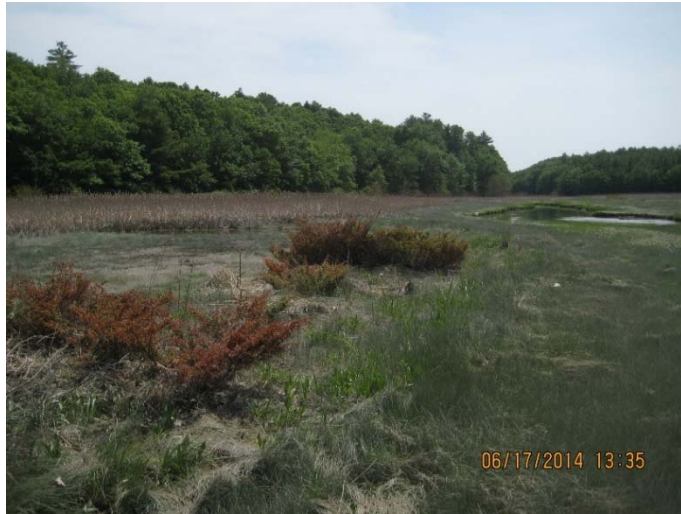
The effect of increased tidal inundation and salt delivery into soils was quickly evident where low lying vegetation was visibly stressed or dead by mid- to late spring 2014 (top right, junipers along a berm at Station 3; top left, white pine on a berm at Station 2; below, Typha and Spirea mortality near Station 4).

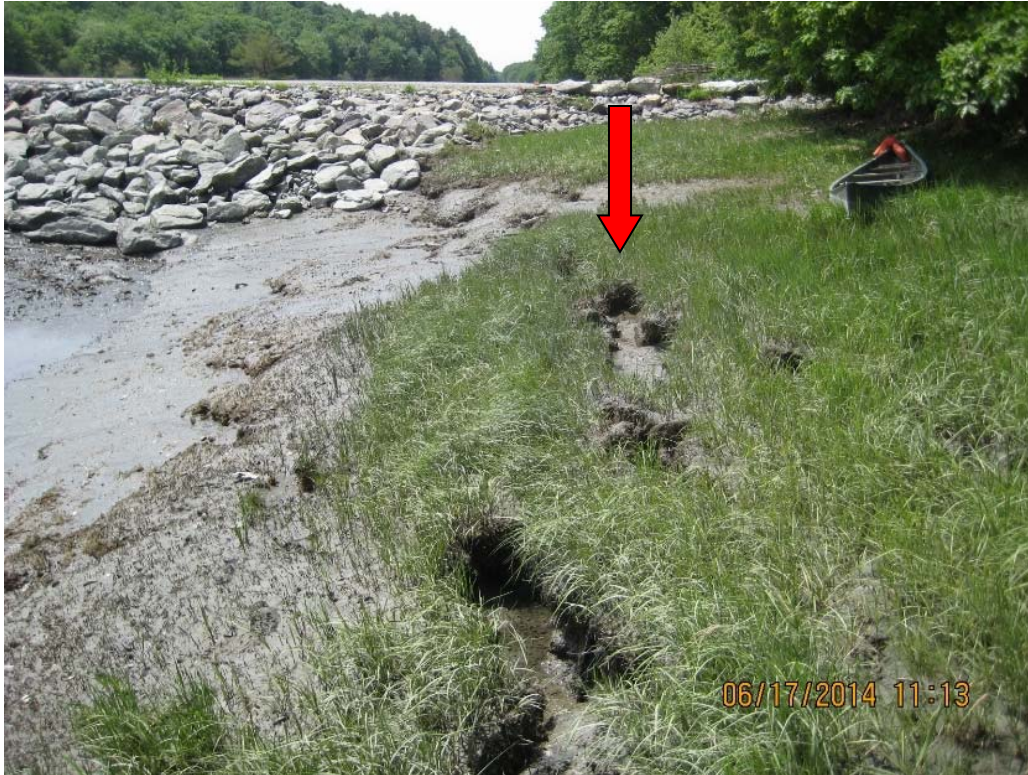
Headcut in the creek channel upstream of Long Reach Lane (CBEP, 4/24/14).

- (1) Modify accumulated coarse sediment deposits in the scour pool immediately upstream of the new culvert inlet. These deposits are presumed to be slugs from erosion associated with the 36" concrete pipe that was in place prior to the mitigation project. The location and elevation of the deposits results in a series of pools and ripples in the scour pool at low water, and could be moved by hand rake to match the slope from the culvert to the upstream channel bottom. Although these pools and ripples are not likely to be problematic for nekton using the marsh, the uneven channel bottom is likely affecting both the way that sediment transport is occurring out of the marsh, and could also affect the location, extent, and rate of erosion in the scour pool and the adjacent banks.

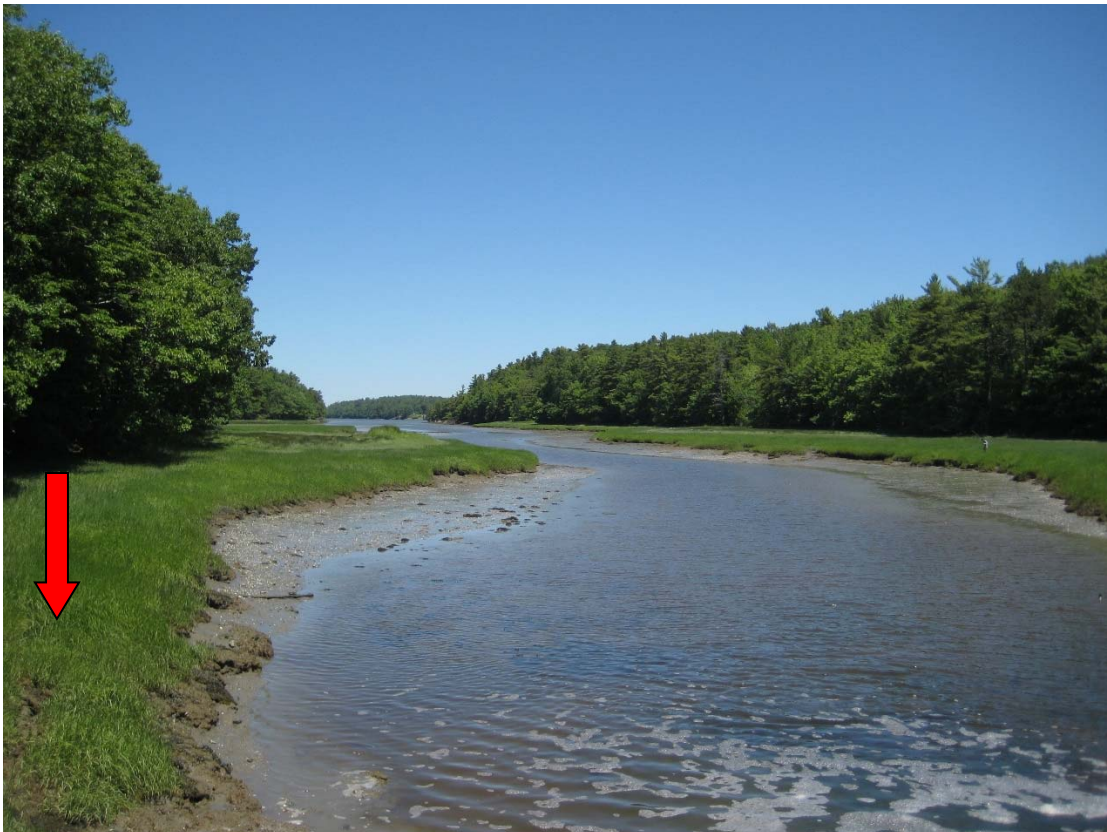
Rills along the west channel edge downstream of Long Reach Lane in 2014 (view to south, top), and 2012 (view to north, bottom), which were picked up in channel cross section surveys (photos CBEP).

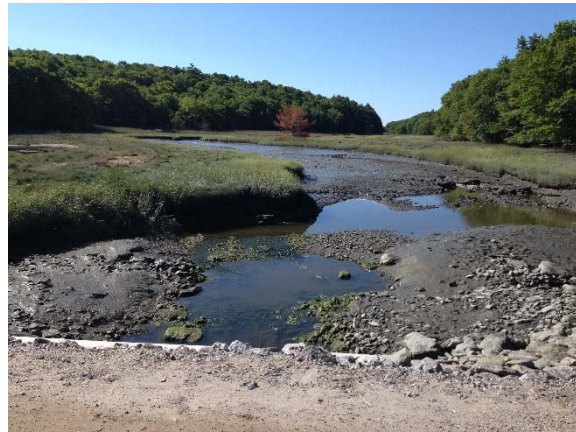
- (2) Explore local support for removing large rocks from a remnant ford (Figure 42) from the stream channel near Station 8. Hydrology in the southern Project Area is affected by this historic ford that crosses the marsh at a narrow point between Station 8 and Station 9. This ford, which is approximately 20 feet wide, impounds water upstream and
