Merepoint Boat Launch Facility Eelgrass Mitigation Measures: 2013 Monitoring Report

**Merepoint Boat Launch Facility Eelgrass Mitigation Measures:
2013 Monitoring Report**

MER Assessment Corporation

12 December 2013

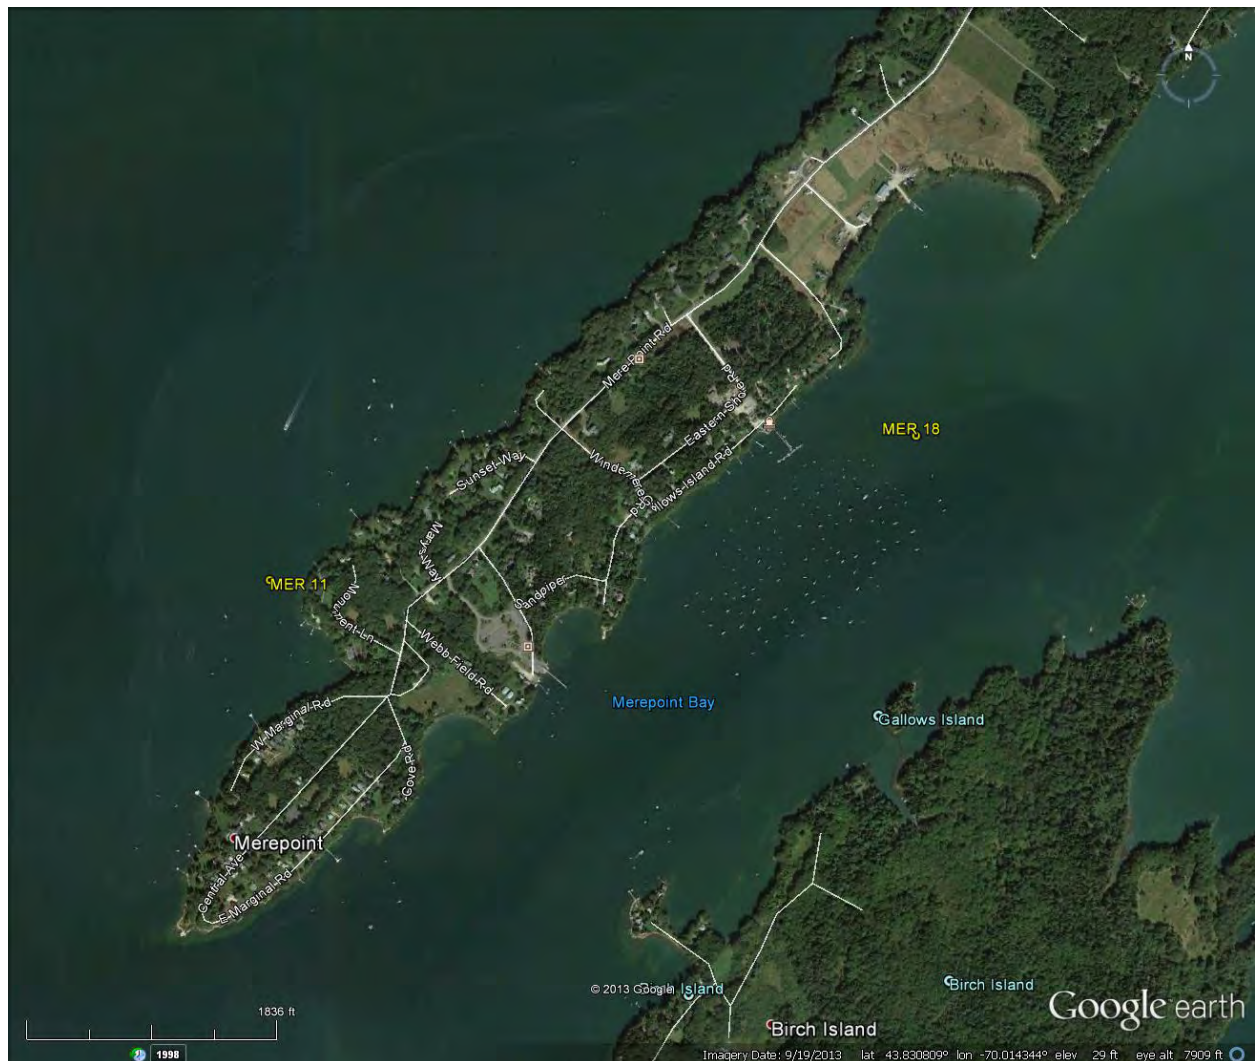
Figure 3 Location of the two (2) moorings selected for monitoring in 2013 (*Google Earth image*)

Mooring scar measurements were made on August 12, 2013 around the two (2) moorings selected for the 2013 monitoring effort. Both MER 11 and MER 18 moorings in Maquoit Bay and Merepoint Bay, respectively, are embedment helix mooring replacements for traditional mushroom/ block-chain moorings. The locations of the two moorings are shown in Figure 3.

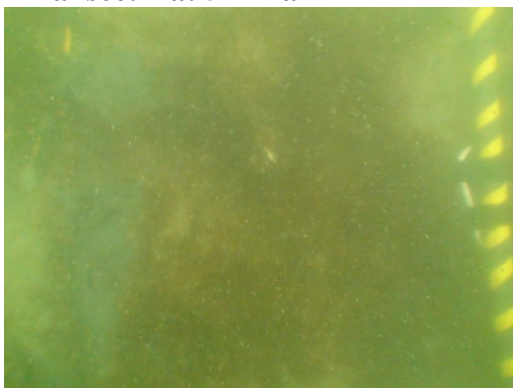
Transect 1 at 5m mark

The 2012 video survey showed a continuation of the thinning and general decline of the eelgrass within the meadow that appears to have begun in 2011; however, in 2013 as the photos below show, no eelgrass was found along the two transects and the bottom was generally covered with a brown epilithic diatom mat.

Still images taken with the Sony HDR-HC9 high definition digital camera of Transect 1 at 30m intervals are shown below; these locations correspond to the locations where sediment chemistry and eelgrass (below-ground) sampling was done, the sampling frame appearing in some photos.

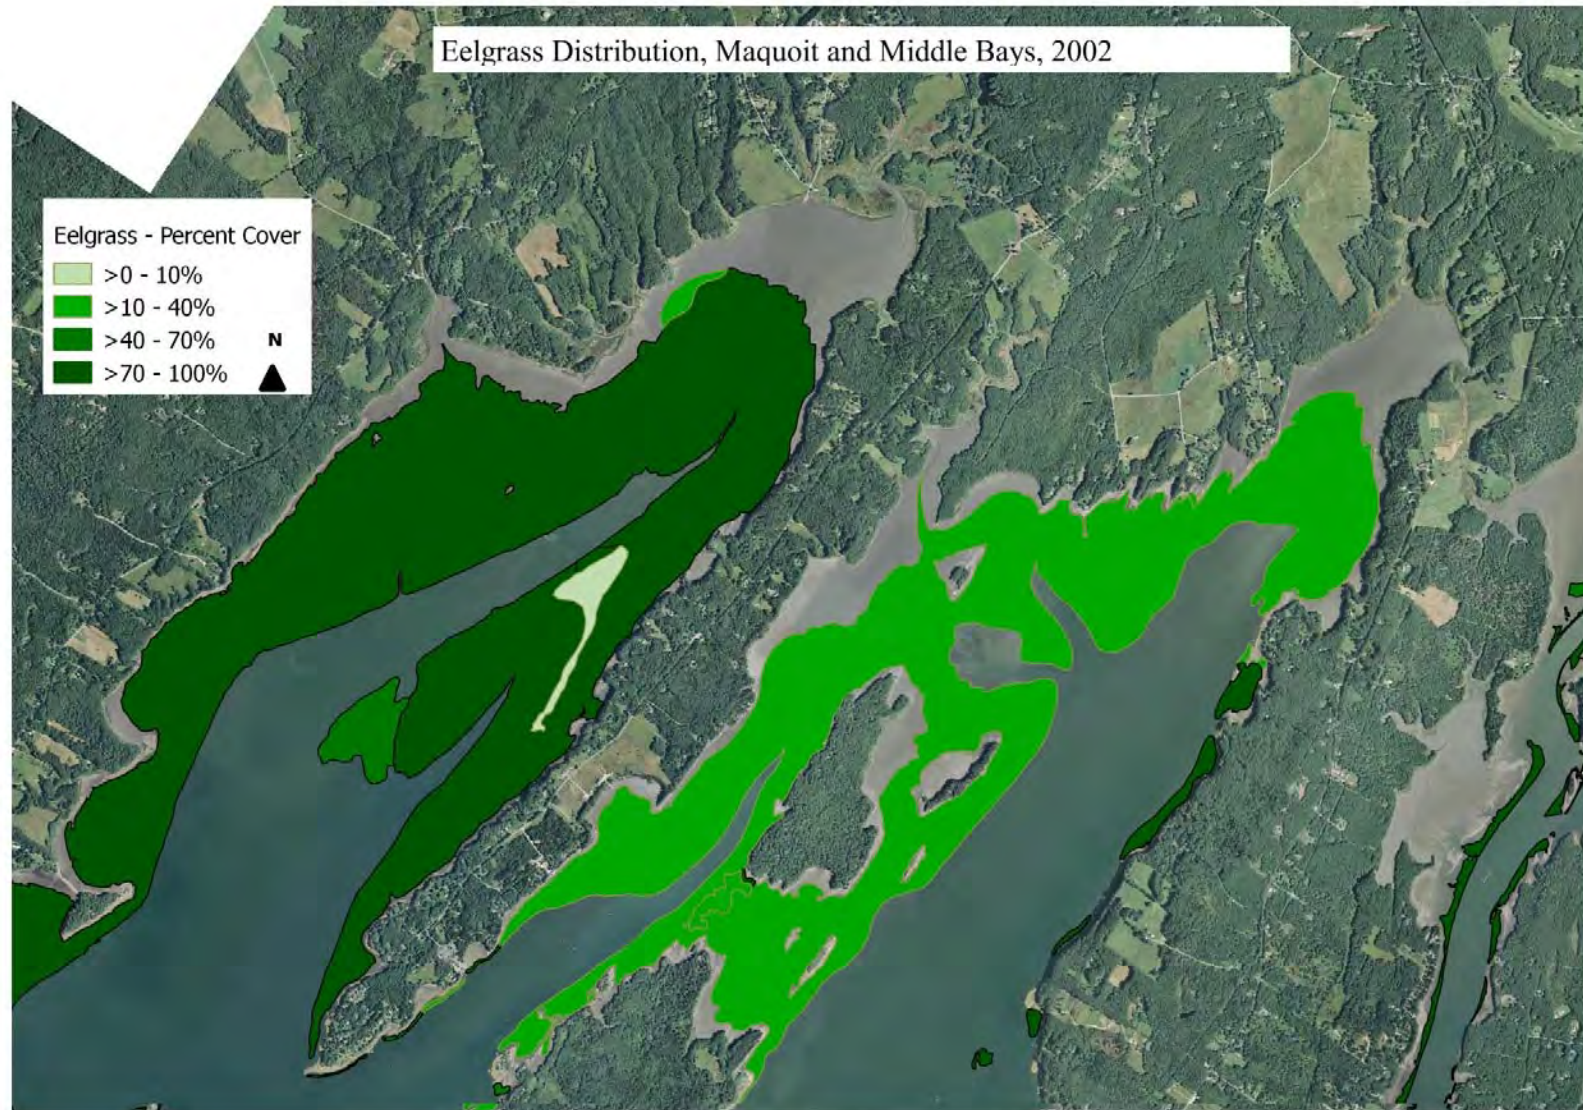
Figure 9. 2013 Sewall aerial photo Maquoit Bay and Middle Bay area in 2013 showing photo-interpreted eelgrass distribution in 2002 per Seth Barker (formerly with Maine DMR).

The video monitoring at the mooring scars and vicinity of Simpson Point revealed a near catastrophic loss of eelgrass in Maquoit and Merepoint Bay. These observations were confirmed by aerial photography conducted by Sewall as part of a collaborative effort by the Maine DEP and DMR and Casco Bay Estuary Partnership (CBEP) with photo-interpretation of eelgrass distribution done by Seth Barker, formerly with the Maine DMR.

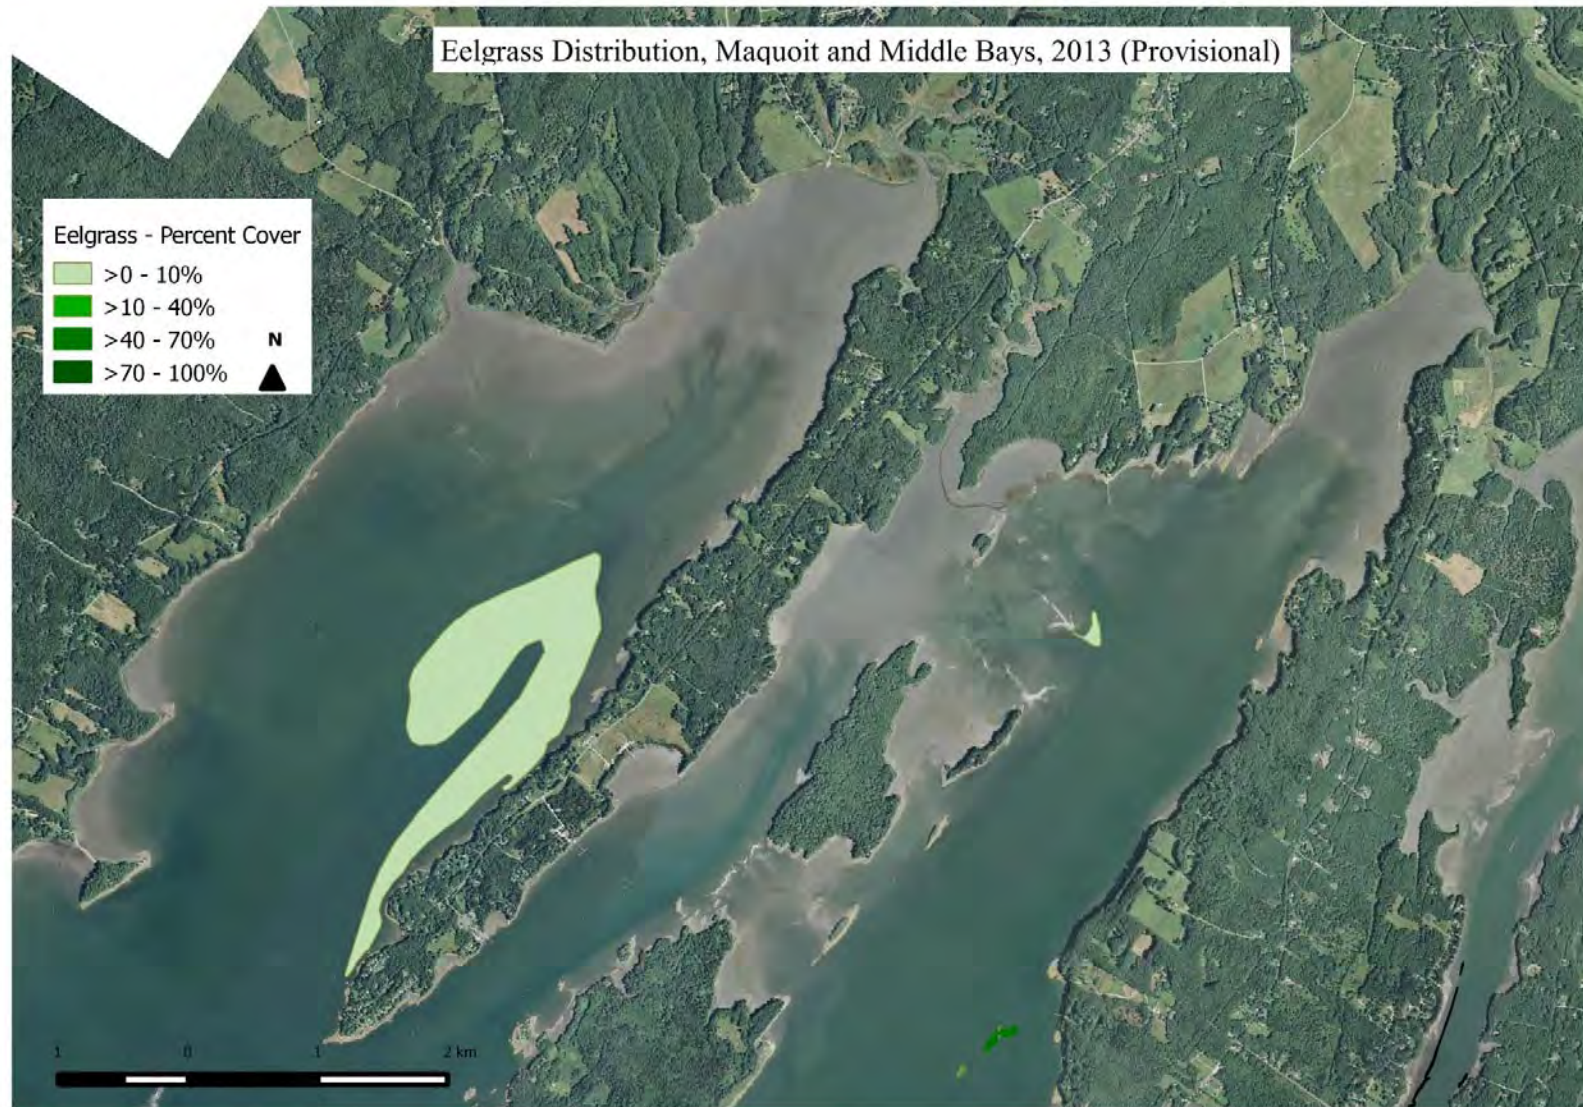
Figure 10. 2013 Sewall aerial photo Maquoit Bay and Middle Bay area in 2013 showing photo-interpreted eelgrass distribution in 2002 per Seth Barker (formerly with Maine DMR).

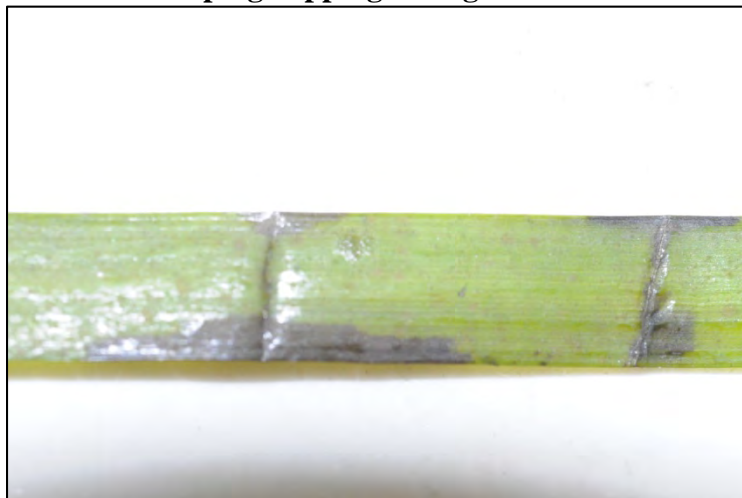
Additionally, populations of the blue mussel, *Mytilus edulis*, in Casco Bay have been declining over the past several years (personal observation; pers. comm. Andre Cocquyt); soft-shell clams, *Mya arenaria*, also appear to be in decline with few sub-legal clams being reported in shellfish surveys conducted in Casco Bay (MER survey of Yarmouth clam flats, 2013; pers. comm., Dan Devereaux, Brunswick Marine Warden). The decline in shellfish has been attributed to an explosion in the population of green crabs, *Carcinus maenas*, that appear to be devastating small clams. The green crab has also been suggested as the cause of eelgrass loss. Eelgrass is not part of the green crabs' diet (Ropes, 1968); however, recent work in Casco Bay comparing eelgrass survival between enclosure-protected transplanted eelgrass and non-protected transplanted eelgrass points to green crabs as a primary cause of loss of eelgrass in Maquoit Bay (pers. comm., Hilary Neckles, USGS). Evidence of such clipping seems to be apparent on eelgrass blades taken from sample in Maquoit Bay (see Figure 11).

Figure 11 Suspected evidence of green crab crimping/clipping of eelgrass blade

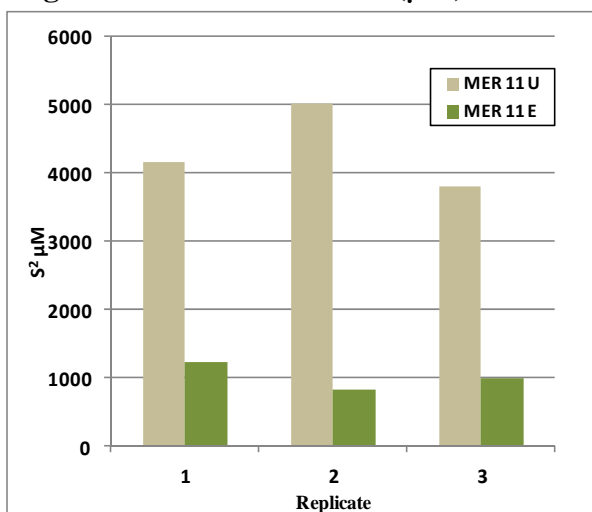
Figure 12 MER 11 sulfides (μ M)

It has been suggested that the lack of recovery of eelgrass within the mooring scars might be the results of unsuitable sediment conditions, specifically elevated sulfide and total organic carbon resulting from accumulation and decomposition of organic matter within the depression created by the sweeping chain. Goodman (1995) classified pore water sulfide concentrations in excess of 600 μ M as toxic to eelgrass, based on EC50 laboratory experiments for eelgrass photosynthesis. As Figures 12 and 13 show, sulfide concentration within the “unvegetated” (‘U’) scar area (tan bars), particularly at MER 11, are significantly higher than in the surrounding “vegetated” area (green bars). The sulfide concentration levels are significantly higher than the 600 μ M. These levels are clearly toxic to eelgrass and likely the reason for the lack of recovery of the scars, at least those areas toward the center of the scars.

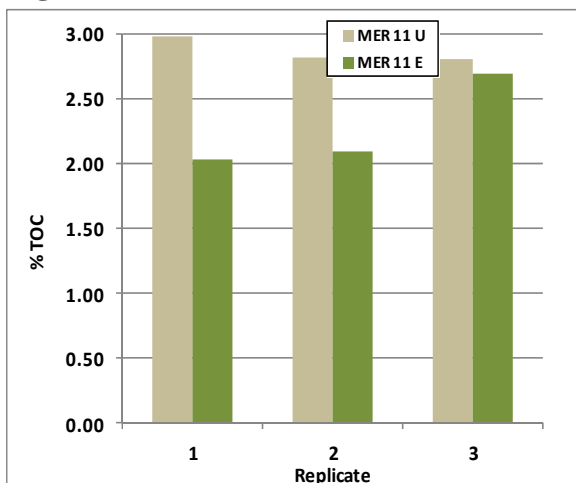
Figure 14 MER 11 TOC (%)

Total organic carbon is consistently higher within the scar area compared to the vegetated areas, but the difference is small compared to the sulfide results (Figures 14 and 15). These results are generally similar and only slightly higher than results obtained from soft bottom reference sites elsewhere along the Maine coast.

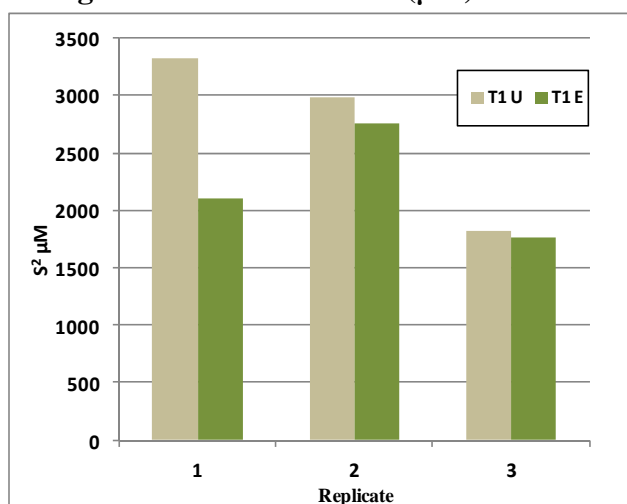
Figure 16. SP T1 sulfides (μ M)

No eelgrass was found at Simpson Point and there is, therefore, no difference between the “unvegetated” and “vegetated” samples other than the “unvegetated ‘U’ ” samples were collected over the first 60 meters of the transect and consequently in shallower water (approx 1.5 feet depth at low water) compared to the “vegetated ‘E’ ” collected over the second 60 meters of transect in deeper (approx. 3.5 feet depth at low water). The Simpson Point sulfide concentrations are generally lower than those found in the mooring scar areas; however all are still well above the toxic level of 600 μ M, indeed all being above 1,000 μ M (Figures 16 and 17).

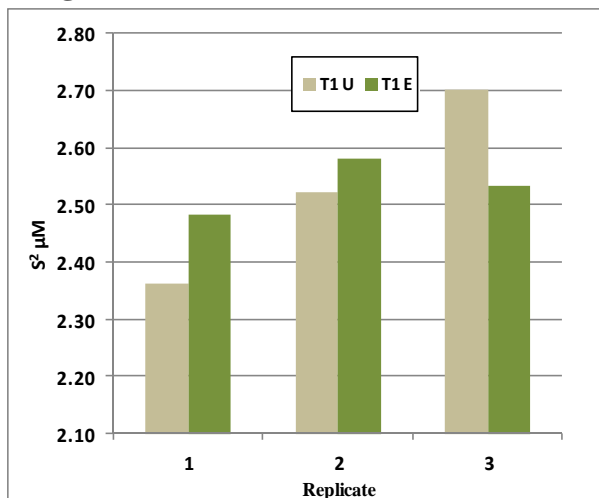
Figure 18. SP T1 TOC (%)

The Simpson Point total organic carbon results are similar to results obtained from soft bottom reference sites elsewhere along the Maine coast, that is, within the 2.00% to 2.50% range (Figures 18 and 19).

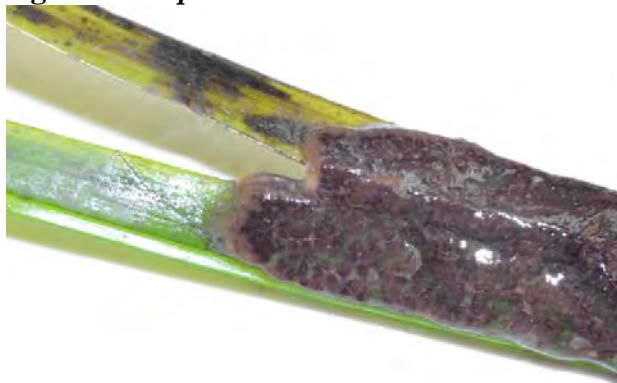
Figure 20. *Diplosoma listerianum*

Given the small amount of eelgrass observed during the 2013 survey, tunicate coverage estimates are limited to the vegetated area surrounding mooring MER 11 in Maquoit Bay where coverage was estimated by the diver at 0%-10%; two species, *Botrylloides violaceus* and *Diplosoma listerianum* (identification by Mary Carman, WHOI), both invasive species, are present (see Figures 20 and 21). Additionally, little evidence of wasting disease was seen at the Maquoit Bay site where incidence was estimated a 0%-10%.

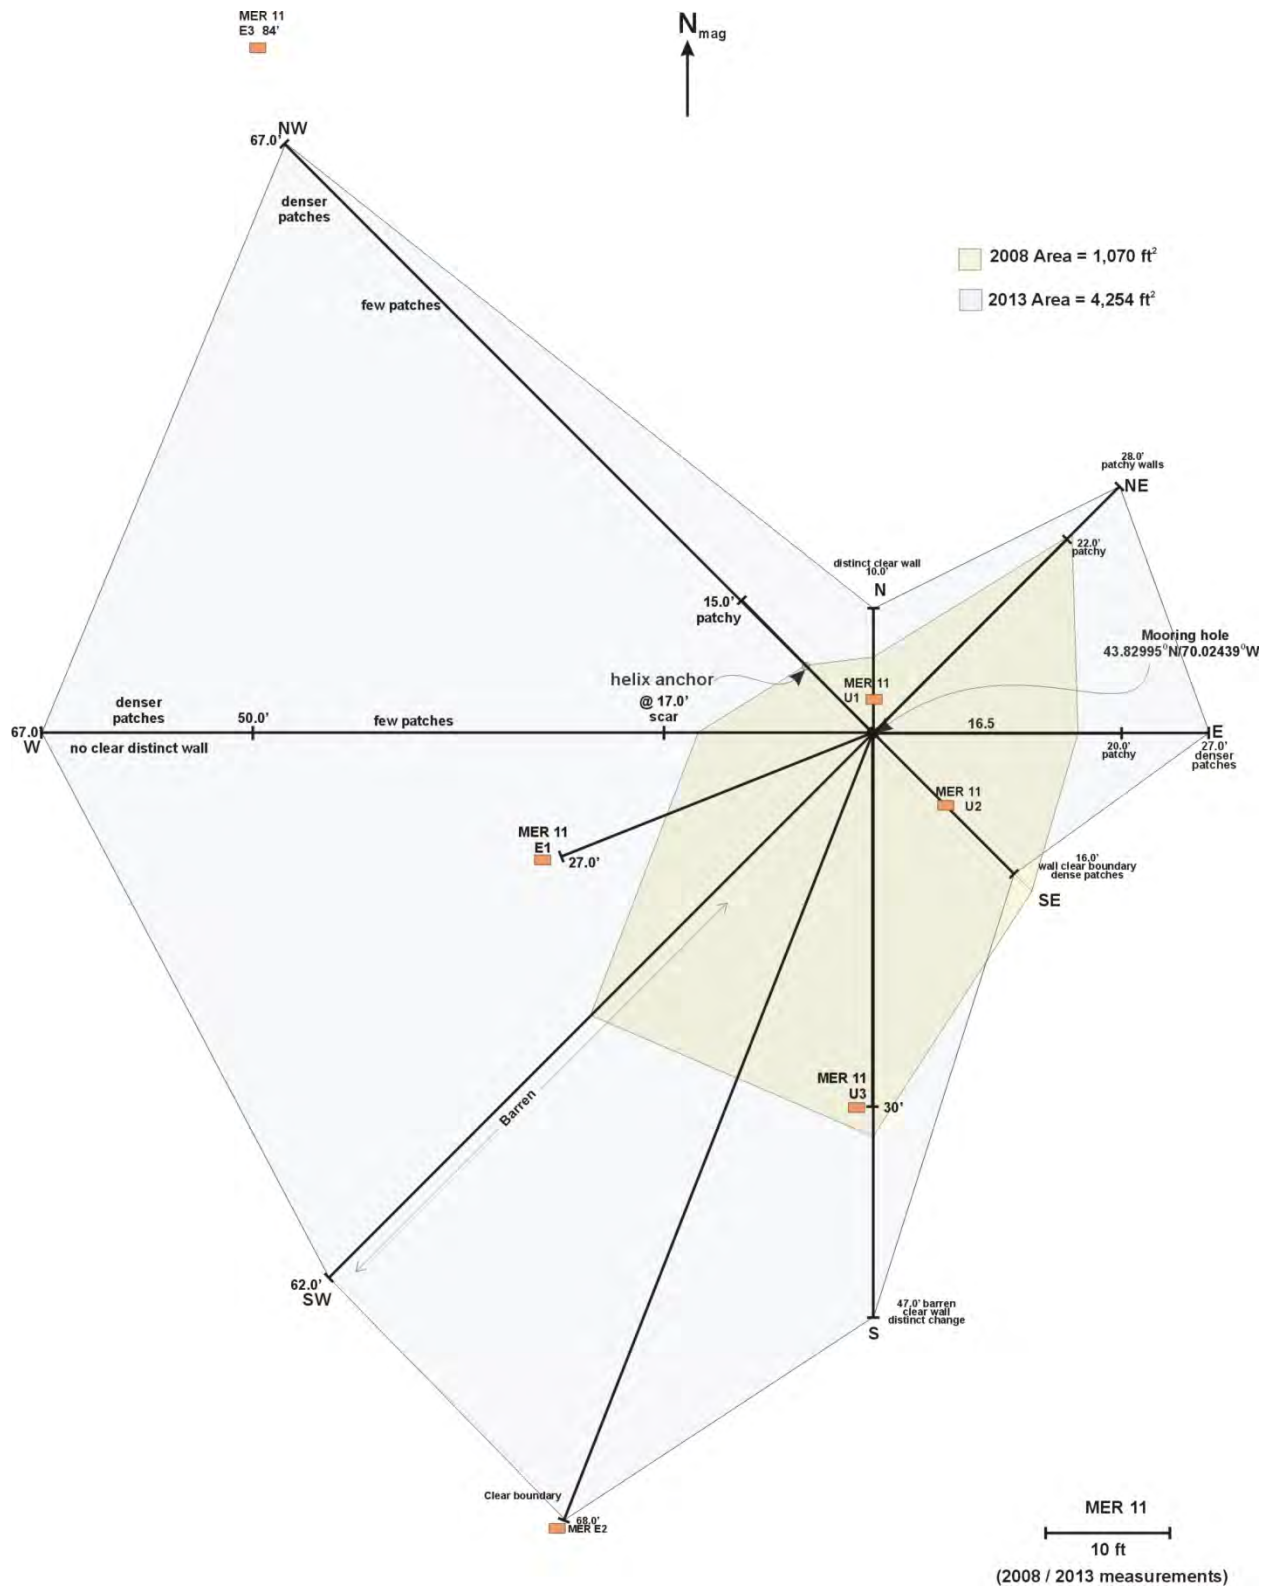
**Graphic representations showing 2008 and 2013 mooring scars area based
on eight *in situ* radii measurements**

These results clearly show that, following some moderate recovery of these two scars between 2008 and 2011, the trend towards increased scar area that began in 2012, presumably due to a general decline in eelgrass within the region, continued through 2013 to the extent that no eelgrass was observed in the vicinity of MER 18 indicating a complete loss of eelgrass within the area.
