## Crooked River Watershed Survey

# CROOKED RIVER

## WATERSHED SURVEY

Cumberland County Soil & Water Conservation District

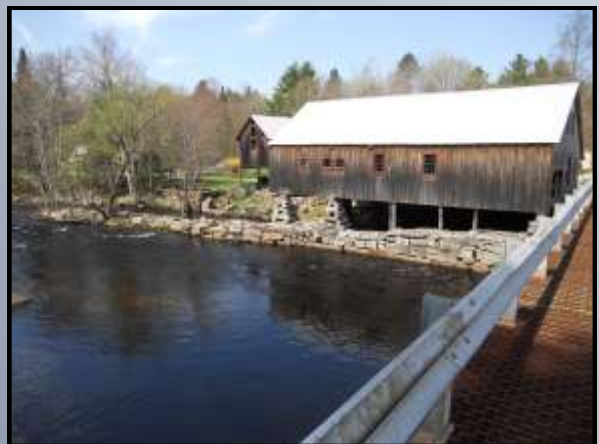
**Scribner's Mill** in Harrison, Maine was in operation in 1847 through 1962 and the dam furnished water power to run the sawmill. In 1972, the dam at Scribner's Mill was removed. Three years later the site was acquired by Scribner's Mill Preservation, Inc. Their goal has been to restore the mill as an educational exhibition of the water powered industrial technology that pre-dates fossil fuels. An application to MDEP to rebuild the dam was filed in 2002. In 2007, a revised application was filed. It called for reconstruction of the dam with a rock ramp fishway, and an 11 acre impoundment extending upstream for a mile. The application was denied, but a revised plan and application have been submitted and is currently under review. After the removal of Scribner's Dam, a fishway was installed at the next upstream barrier at **Bolster's Mill** dam in 1974. In 1987-1988 Bolster's Mill dam was partially removed, and fish passage were improved.

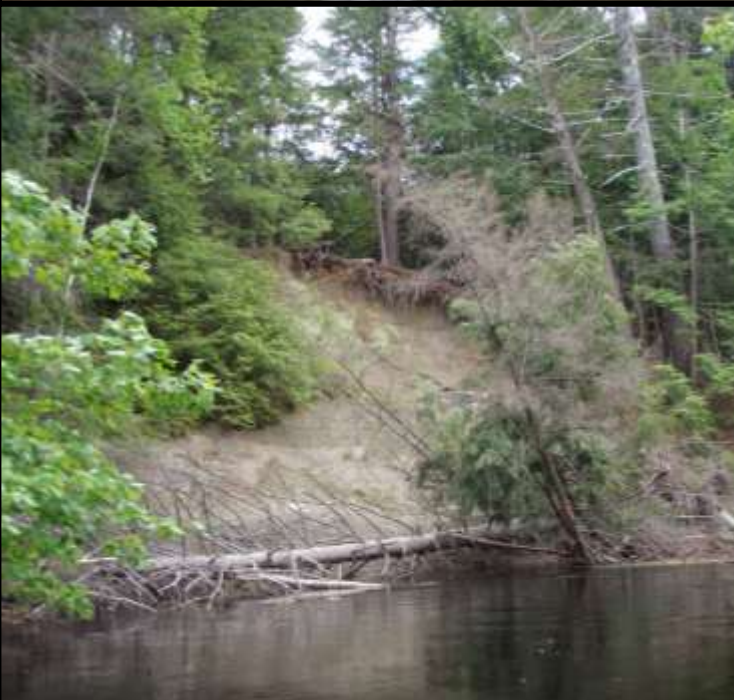
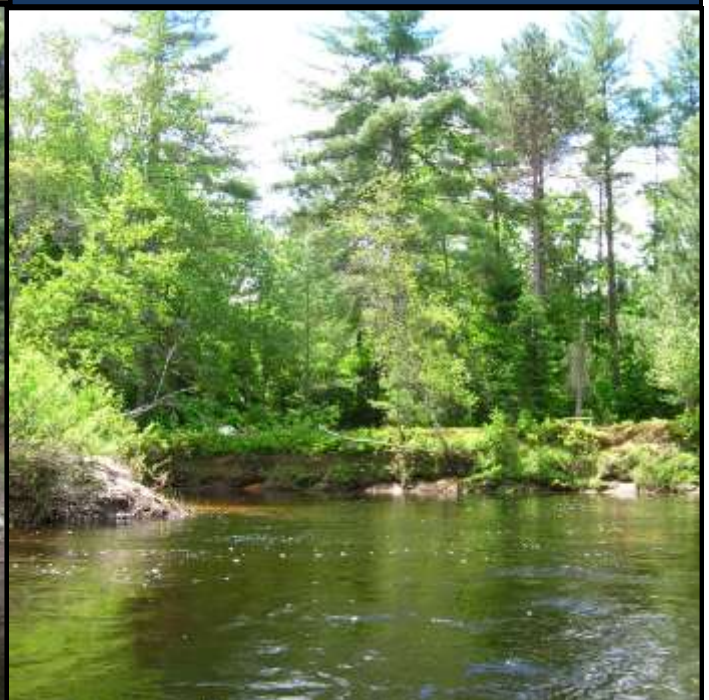
- ◆ **Blow downs**— naturally occurring and sometimes a result of high wind/rain events. If debris is large enough and numerous, it can create obstructions for water flow, and for fish and wildlife.
- ◆ **Land clearing**—Likely for buildable lots and photo below indicates most vegetation removed up to river's edge.
- ◆ **Bank failure/slump**—sometimes naturally occurring, while others are human induced due to land use activity.

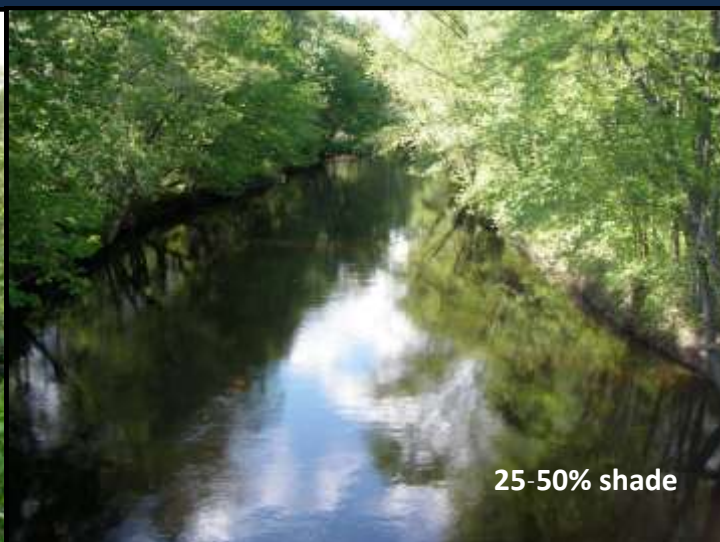
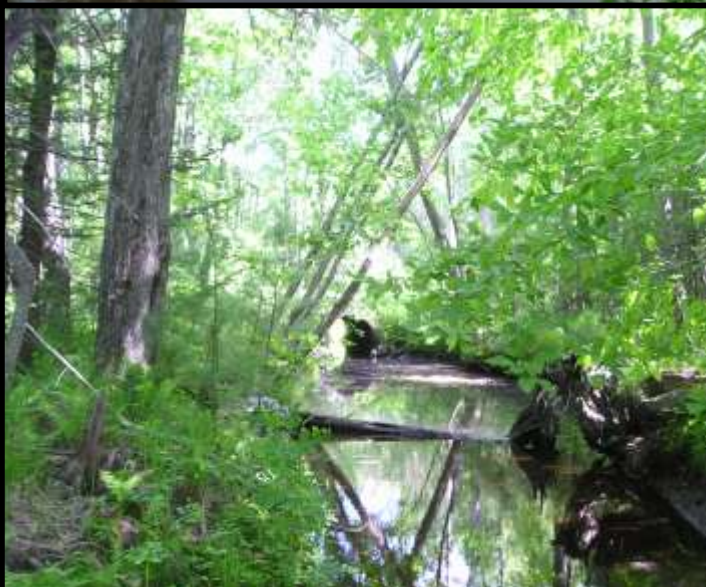
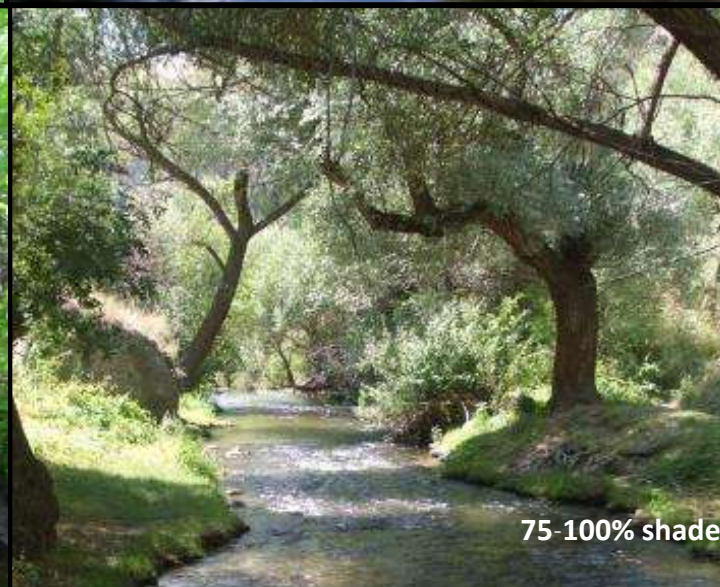
Trees not only provide shade but nutrients and organic material for small organisms to eat. Trees also stabilize the soil along the banks and provide wildlife habitat. Shade trees also help keep water temperatures cooler and protect water quality by acting as natural filters. The photos on this page are examples of shade cover. For a river or stream to be fully shaded it would also need to be very narrow as the two bottom photos show. For more detailed data see Appendix D.
