## **Preliminary Summary of Existing Biological Monitoring Data from Capisic Brook in Portland, ME**

Susanne Meidel Meidel  
*Partnership for Environmental Technology Education*

Leon Tsomides  
*Maine Department of Environmental Protection*

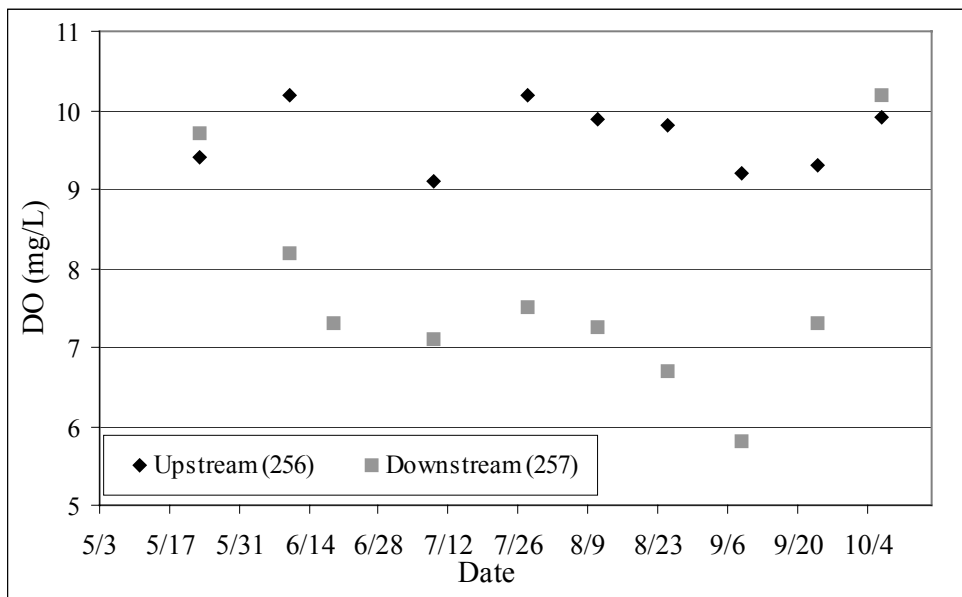
Fig. 3. Instantaneous dissolved oxygen in Capisic Brook

The concentrations of instantaneous dissolved oxygen (DO) at the upstream station on Capisic Brook were usually high, with a minimum of 9.1 mg/L in early July, and a maximum of 10.2 mg/L in early June and late July (black diamonds in Fig. 3). At the downstream station, DO concentrations were quite variable with a minimum of 5.8 mg/L in early September, and a maximum of at 10.2 mg/L in early October (gray squares in Fig. 3).

The dissolved oxygen concentrations in Capisic Brook at the upstream station always were at a level that favors healthy macroinvertebrate communities. This positive finding is likely attributable to two main factors: 1) the cool temperatures existing in this stretch of the stream (see below) allow the water to hold a high concentration of dissolved oxygen; and 2) the absence of algae means that oxygen levels are not depleted due to algal respiration and decomposition.

The dissolved oxygen concentrations in Capisic Brook at the downstream station were always above the Class C numeric criterion for summer DO levels (5 mg/L), and mostly above 7 mg/L, which is generally considered a healthy level for most macroinvertebrates.

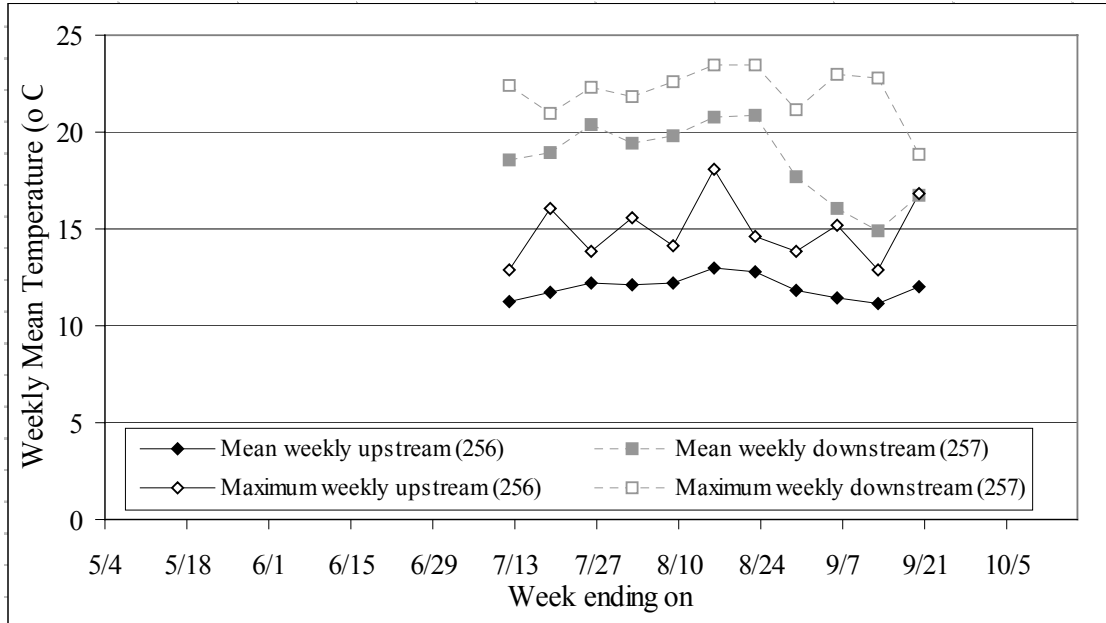
Fig. 7. Continuous temperature in Capisic Brook

The temperature record at the upstream station (black diamonds and solid lines in Fig. 7) showed a relatively constant mean weekly temperature between 11 and 13° C throughout the recording period, but a highly variable maximum weekly temperature between 13 and 18° C during that same period. Further data analysis showed that in all

cases the high temperatures indicated by the maximum temperature records never lasted for more than 1.5 h with temperatures before and afterwards being lower by at least 2° C. At the downstream station (gray squares and dashed lines in Fig. 7), the mean weekly temperature was between 18 and 21° C from early July to mid-August before dropping to between 15 and 18° C for the remainder of the recording period. The maximum weekly temperature at this station fluctuated between 21 and 24° C between early July and early September before dropping to 19° C in mid-September.

The cool temperature regime generally encountered at the upstream station in Capisic Brook is very favorable for healthy animal communities. Factors responsible for this temperature regime are likely the closeness to the headwaters (springs in Evergreen Cemetery), an intact riparian zone with many large trees providing good shading, and an absence of heated stormwater runoff. It is important to preserve these conditions to ensure the continued favorable temperature conditions in this stretch of Capisic Brook.

The relatively high mean and maximum temperatures recorded in midsummer at the downstream station in Capisic Brook were in, or close to, a range that is considered stressful for many fish and aquatic invertebrates. In late summer, the mean temperature dropped to a more favorable level although the maximum temperature still was above 20° C. Studies have shown that sensitive macroinvertebrates such as certain mayflies or stoneflies prefer temperatures below 17° C, while sensitive fish such as Brook Trout prefer temperatures below 20-22° C (see references in Varricchione 2002). Thus, as a prerequisite for restoring healthy biological communities, water temperatures at the downstream station in Capisic Brook must be lowered in summer.

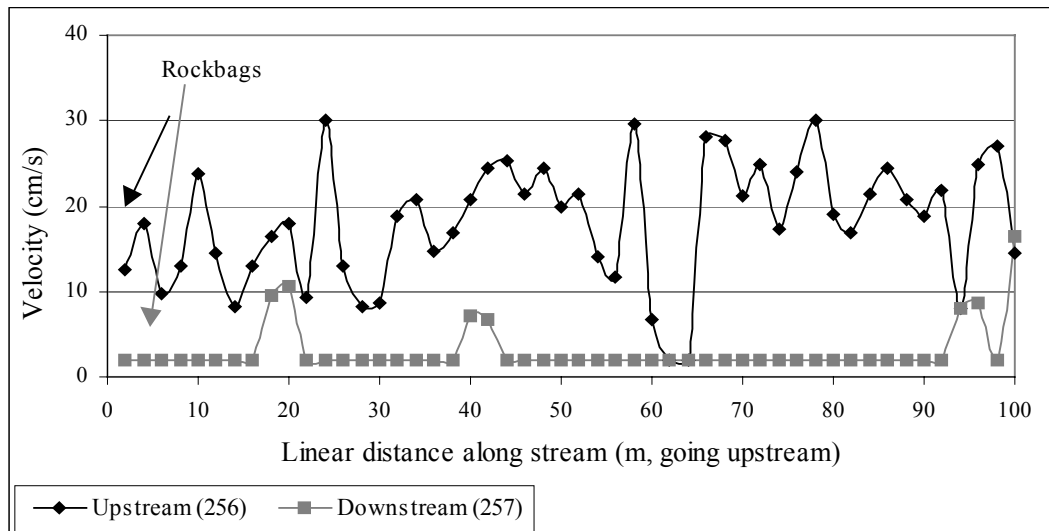
Fig. 8. Variability of flow velocity in Capisic Brook

1. The flow regime at the upstream station in Capisic Brook was highly variable, with velocities ranging from approximately 1 cm/s to 31 cm/s (Fig. 8). At the downstream station, very little flow was measured, with velocities ranging from non-detectable (graphed as ~1 cm/s) to ~11 cm/s (Fig. 8).

The variable flow regime found above the upstream station is another positive feature of this stretch of the stream as it provides aquatic organisms with a wide variety of environments to occupy, thus increasing the potential for a diverse biological community.

In contrast, the homogeneous flow regime found above the downstream station on Capisic Brook does not favor a diverse biological community because organisms requiring relatively swift flows, for example for feeding, will be absent in this environment. Furthermore, a slow flow regime promotes the accumulation of fine sediment on the stream bed which can smother organisms or make feeding structures such as the nets of some caddisflies ineffective. Finally, fast flowing areas in small streams are usually associated with miniature ‘waterfalls’ or riffles where the water tumbles over rocks, which contributes to a re-aeration of the water with dissolved oxygen. As shown above (Water quality monitoring, Continuous dissolved oxygen measurements), dissolved oxygen was identified as a likely factor impacting macroinvertebrate communities at the downstream station.

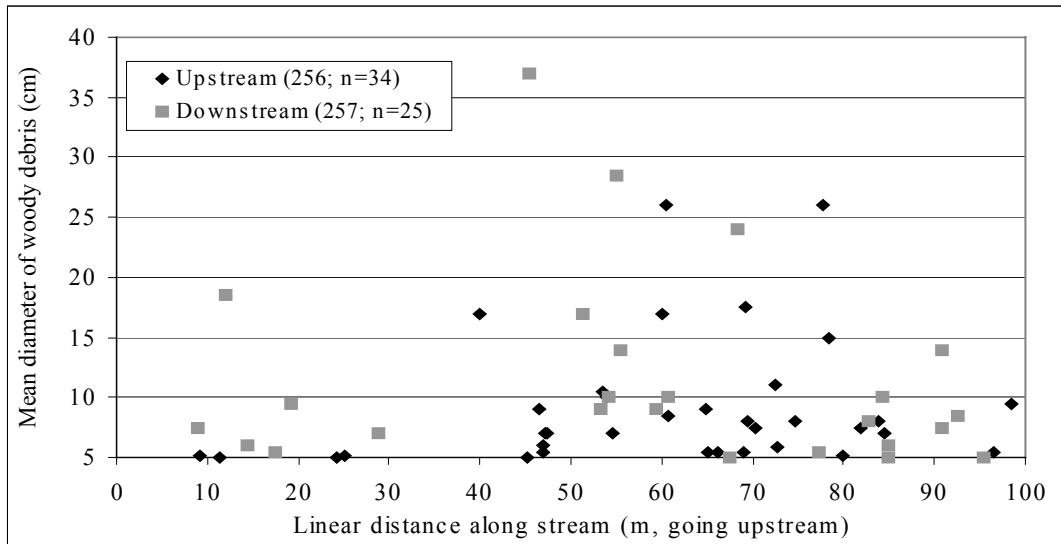
Fig. 9. Distribution of woody debris in Capisic Brook

- Woody debris in Capisic Brook above the upstream station was abundant (34 pieces) with a good size distribution (mean diameter of 5 to 38 cm; black diamonds in Fig. 9). Above the downstream station, fewer pieces were found (25) and the size distribution was more limited (5-29 cm; gray squares in Fig. 9).

The abundance and size distribution of woody debris in Capisic Brook reflects the availability of wood in the riparian zone, the area adjacent to the stream. In Evergreen Cemetery above the sampling location, the riparian zone consists of many trees. Trees also are present in the riparian zone above the Lucas Street bridge (starting at ~40 m in Fig. 9), causing a relatively favorable abundance and size distribution of woody debris in this stretch of the stream. Immediately above the downstream station (from 0 to ~35 m in Fig. 9), however, the riparian zone is essentially bare of trees or other woody plants, with cattails and grasses accounting for the large majority of vegetation. The absence of trees and hence woody debris significantly reduces the habitat quality for aquatic organisms in this stretch of Capisic Brook in terms of habitat diversity and food supply.
