Final Report of a Substrate Survey of the Mallison, Little Falls, and Saccarappa Impoundments, Presumpscot River, Maine

Northern Ecological Associates, Inc.

**FINAL REPORT OF A SUBSTRATE SURVEY OF THE MALLISON,
LITTLE FALLS, AND SACCARAPPA IMPOUNDMENTS,
PRESUMPCOT RIVER, MAINE**

FEBRUARY 2001

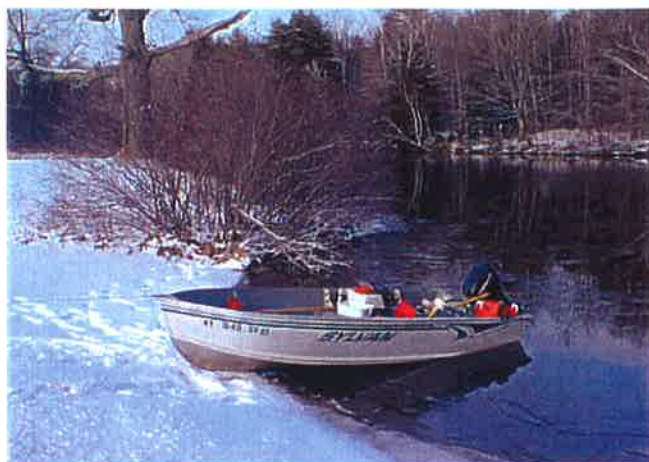
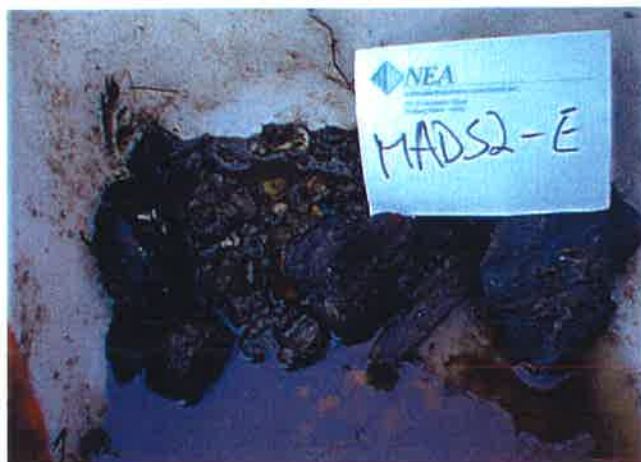
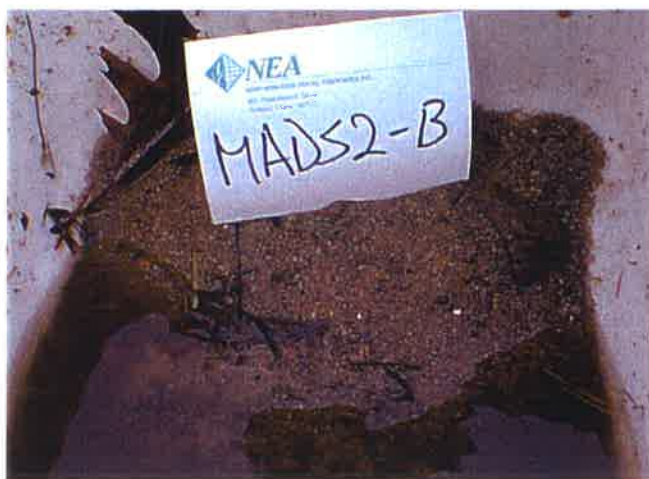
Sampling was conducted from a 15-foot aluminum boat using a 6 x 6 inch Wildco Ponar grab sampler (see photo on cover). The grab sampler was lowered over the side of the boat once the boat was in the correct position. The sampler is held open by a spring-released pin that falls out of a hole when the sampler contacts the bottom and allows the two jaws of the sampler to close as it is hauled back to the surface. It is designed to penetrate the bottom to a maximum depth of 2.75 inches, but the actual sampling depth achieved during this survey was limited in most cases to 1 – 2 inches. If a sample could not be collected the first time, repeated attempts were made until enough material was collected to allow an adequate characterization of sediment composition. This was not possible in all cases because of bedrock outcrops or the presence of large stones that could not easily be picked up in the sampler. Samples were rejected when material such as a stone or twig stuck in the jaws of the sampler and caused finer sediments to wash out of the sample. At a few stations, replicate samples were collected using a larger, heavier Ponar sampler that penetrated approximately two inches deeper into the sediment than the smaller one. Visual inspection of samples collected with the two samplers failed to reveal any significant differences between the two, so the smaller Ponar was used.

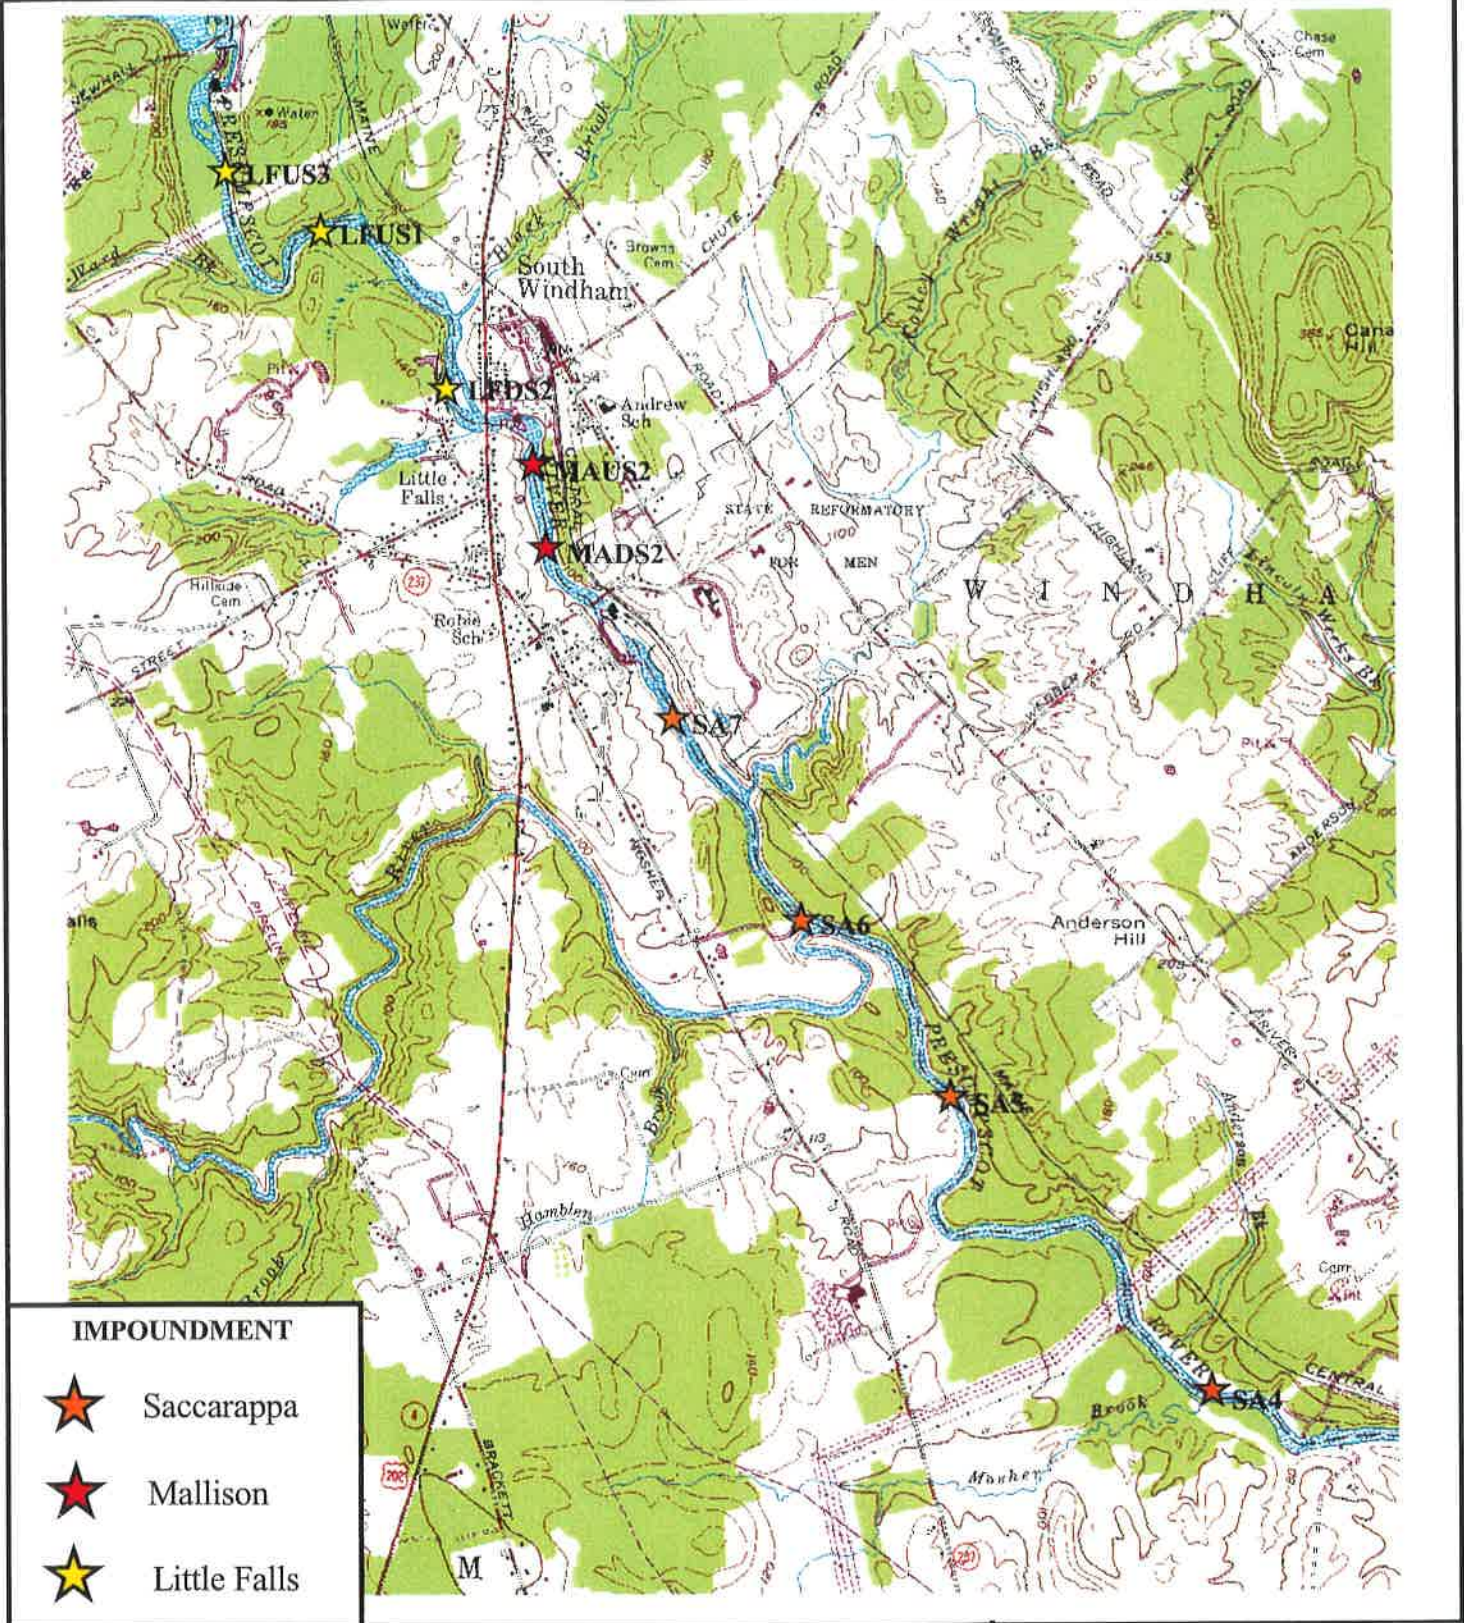
**Figure 1. Substrate Sampling
Locations
December 2000**

The three impoundments identified for this survey were the Saccarappa, Mallison, and Little Falls impoundments (Figure 1). The lower of these, the Saccarappa impoundment, is 5 miles long. It begins at the Saccarappa Dam in Westbrook, Maine, and ends approximately 750 ft below the Mallison Dam in South Windham, Maine. Proceeding up-river, the next impoundment that was surveyed is the Mallison impoundment, which is formed by the Mallison Dam and extends upstream to the Little Falls Dam. This impoundment is very short, measuring only half a mile in length. The third impoundment is 1.7 miles long and is located upstream of Little Falls Dam, between this dam and the Gambo Dam.

Substrate samples were collected for this study at discrete locations along four transects in the Saccarappa impoundment, two transects in the Mallison impoundment, and three transects in the Little Falls impoundment in late December 2000 (Figure 1). Three more transects in the lower part of the Saccarappa impoundment could not be surveyed due to ice formation, but will be surveyed in the spring of 2001. Transects were located at more or less equal distances in each impoundment in order to obtain a representative characterization of substrate in each impoundment. Transects were located based on the following rationale: for Mallison and Little Falls, all five transects were located at sites that were surveyed by in 1997, although the NEA sampling along these transects extended across the full width of the river. Due to the greater length of the Saccarappa impoundment, additional transect sites were chosen in that impoundment to provide results that would be representative of the entire impoundment. Along each of the chosen transects, 5 discrete samples were collected, spaced at equal distances from one bank of the river to the other, starting with sample A on the left bank (looking upstream) and proceeding across the river to sample E on the right bank.

Five samples were collected on December 21, 2000, at each of four transects in the middle and upper end of this impoundment (Figure 1). One transect (SA4) was located in the middle of the impoundment, just north of Rousseau Road and south of where power lines cross the river; a second (SA5) was located approximately 0.6 miles south of the confluence of Little River; a third (SA6) just upstream of the mouth of the Little River; and, a fourth (SA7) 1,000 feet downstream of the lower end of the raceway below the Mallison Dam. The extreme upstream transect was in the same location as the IA/DES transect SAUS2.
