Libby Brook Implementation Plan

Cumberland County Soil & Water Conservation District

Casco Bay Estuary Project

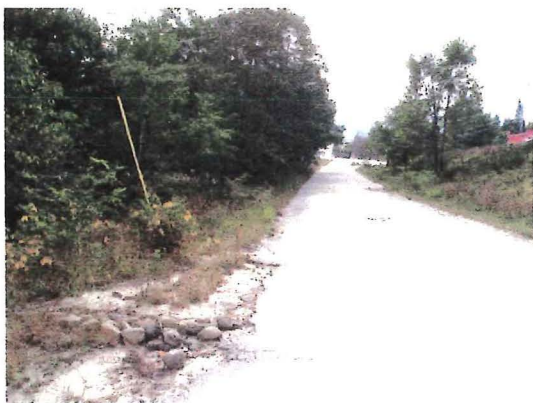
Private Roads

Problem: Entrance to this road is paved but lack of drainage ditching has eroded shoulders, ditch capability has been exceeded and pavement has begun to crumble.

Solution: Install/redefine ditches on both sides of 600' stretch of entrance to private gravel road and construct turnouts.

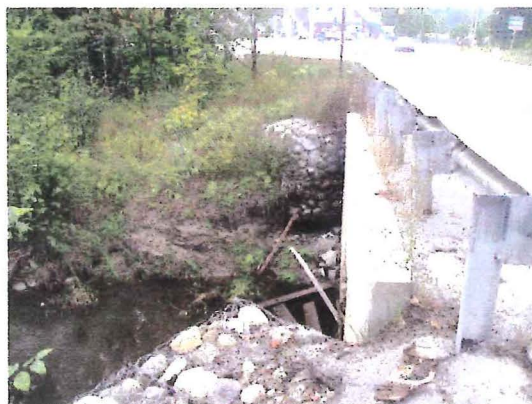
Stream Crossings

Problem: Moderate shoulder erosion, gabion baskets being undermined with direct flow to Mill Brook.

Solution: Build up road, install ditching, turnouts and replace undersized culvert.

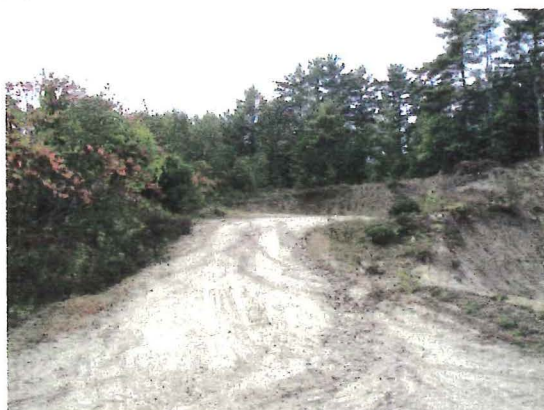
Gravel Pit Road

Problem: Moderate to severe surface erosion on gravel pit road with direct flow to Libby Brook tributary.

Solution: Establish erosion controls and enhance vegetated buffer.

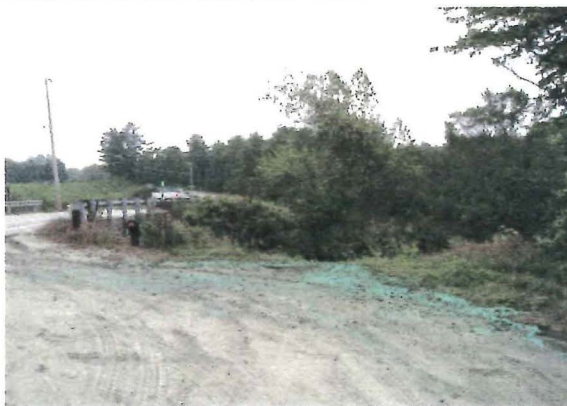
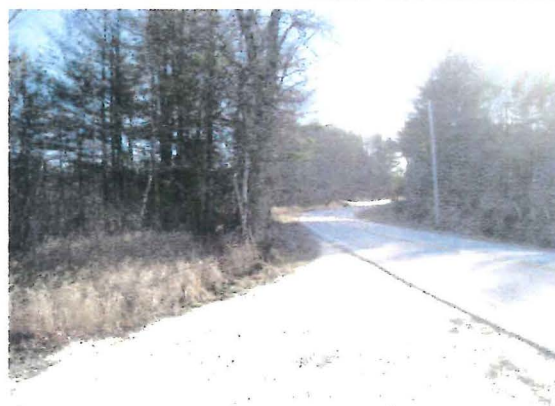
Unstable turnaround/Town Roads

Problem: Unstable turnaround with moderate surface erosion, unstable culvert inlet & outlet; hydroseed washing into Libby Brook. Lack of ditching and winter sand is making its way to brook.

Solution: Armor culvert inlet and outlet, construct earthen berm around edge of turnaround, seed and mulch, remove winter sand. Install ditching, turnouts and remove winter sand.
