**Fisheries & Aquatic Habitat Restoration Feasibility Study, Royal River Restoration Project Yarmouth, Maine**

# FISHERIES & AQUATIC HABITAT RESTORATION FEASIBILITY STUDY

## ROYAL RIVER RESTORATION PROJECT YARMOUTH, MAINE

**Stantec Consulting Services Inc.**  
30 Park Drive  
Topsham, Maine 04086

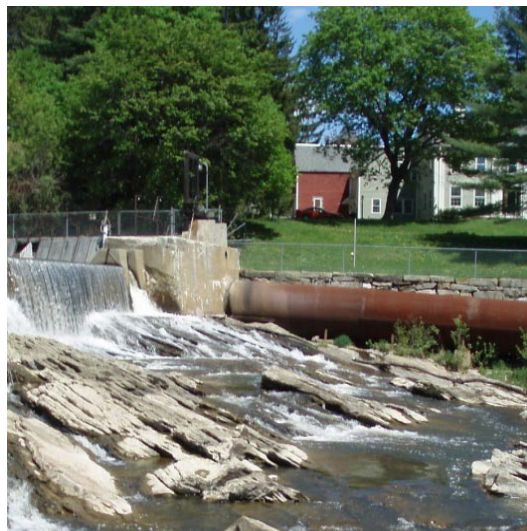
*Bridge Street Dam Head Gate Structure and Sparhawk Mill Penstock*

The use of the use of the penstock during periods of moderate to low flows (i.e., flows less than 100 cfs), such as those commonly encountered during the warmer months of the year, shifts water that would otherwise spill over the Bridge Street Dam to be largely diverted around the reach of river immediately downstream from the dam (utilizing a penstock diversion maximum diversion capacity of 90 cfs). Water remaining in the channel during such periods is largely passed through the fishway, with minor leakage occurring along the face of the dam. The impact of rapidly wetting and drying this reach of river has a detrimental effect on the fish community, as fish trapped in isolated pools as the water recedes face asphyxiation and/or predation as the isolated pools warm and shrink with evaporative water losses.
