Long Reach Lane at Long Marsh, Harpswell, 2015 Post-Project Monitoring Report; Year 2 of 5

2015 Post-Project Monitoring Report:
Long Reach Lane at Long Marsh, Harpswell
Year 2 of 5

Compensation for the Martin's Point Bridge Project, Falmouth-Portland
(PIN 16731.00)

March 2016

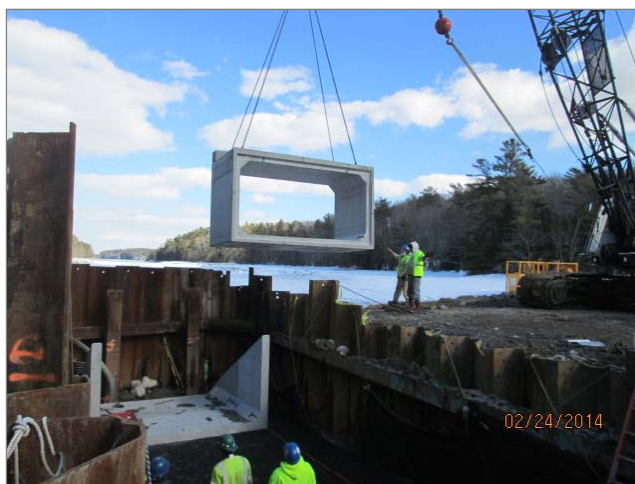
In 2012, the Maine Department of Transportation (MDOT) proposed a mitigation project at Long Reach Lane in Harpswell (Figure 1) to compensate for the functional impacts to marine wetlands associated with the construction of the Martin's Point Bridge between Falmouth and Portland. The mitigation project took place in January and February 2014, and resulted in the successful replacement of a 36" (7.1 ft² flow area) round concrete pipe beneath Long Reach Lane with a larger 6' x 12' concrete box culvert (72 ft² flow area) in February 2014 (photo MDOT, below).

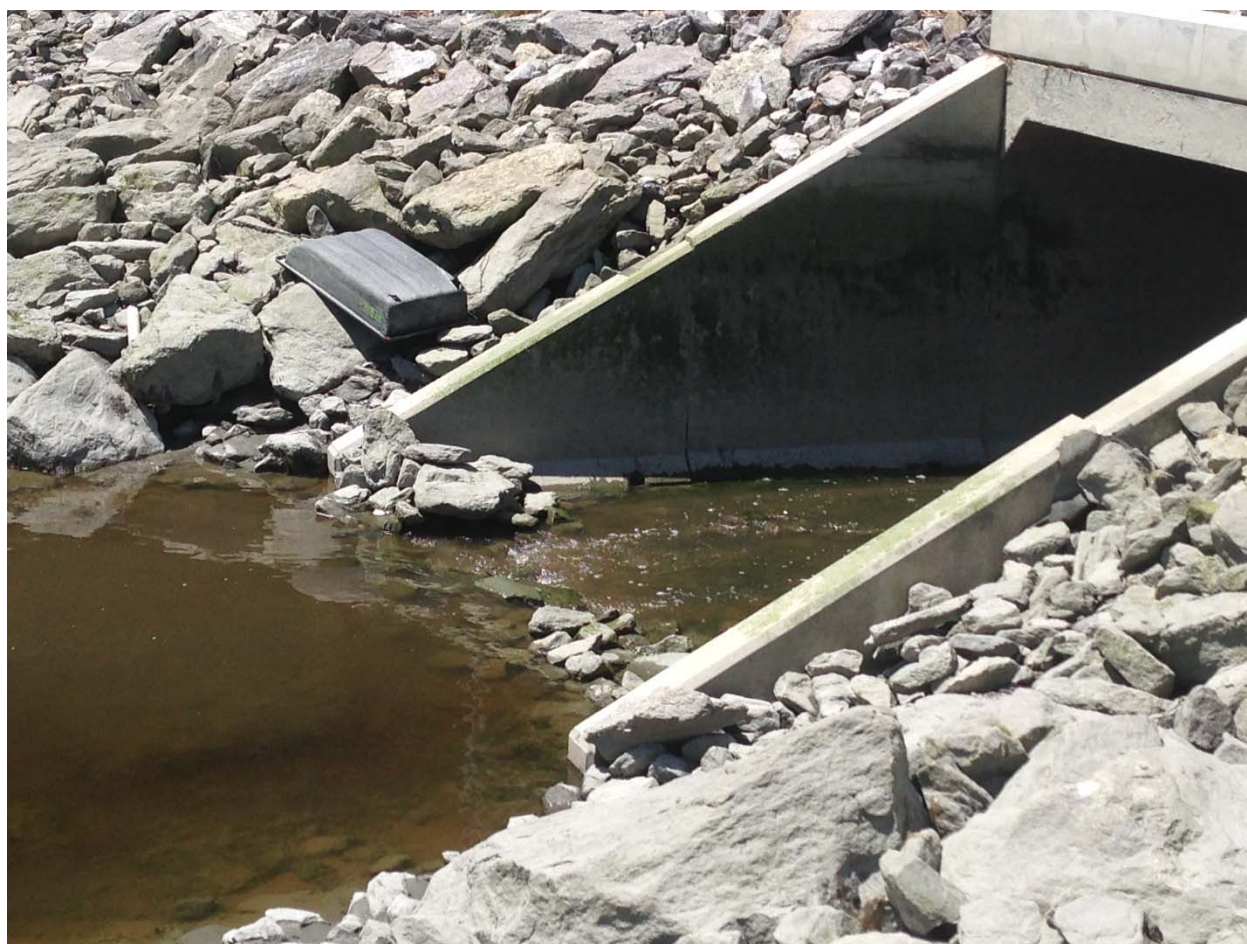
During cross section surveys on 6/25/15, CBEP staff observed a narrow band of rocks placed in a line across the culvert inlet, presumably in an effort to raise water levels upstream (photo, below). The rocks appeared to have been moved from the adjacent armored road bank and a black sled, standard equipment for shellfish harvesters, was observed next to the inlet. CBEP staff hand-removed the rocks from the culvert and placed them back on the road bank.

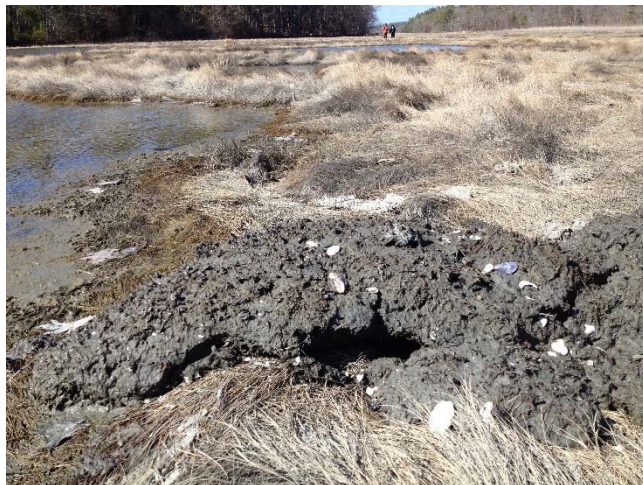
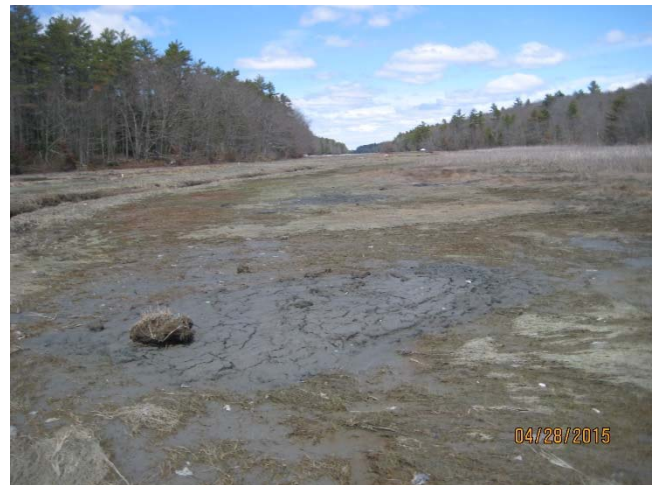
Peat, sediment and shell deposited on the marsh surface resulting from ice scour, at Station 2 (left, 5/1/2015), and Station 4 (right, 4/28/2015).

The winter of 2014–15, and associated ice formation and movement, resulted in extensive sediment deposits on the marsh surface. To document the extent of sediment deposits, CBEP hired a consultant to obtain aerial video footage of the project using a drone on 5/1/15, just as vegetation was starting to emerge. Ice movement affected the location of markers and wells at some Stations. (Video footage is available upon request).

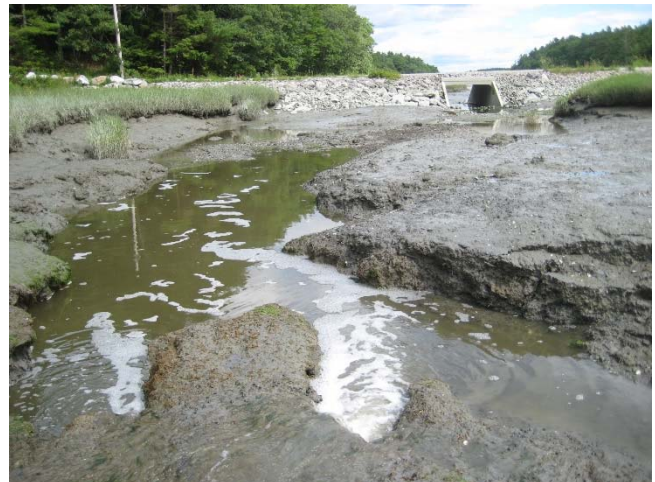
The upstream head cut moved toward the center of the channel, possibly toward the location of the original channel (CBEP; 7/23/15).

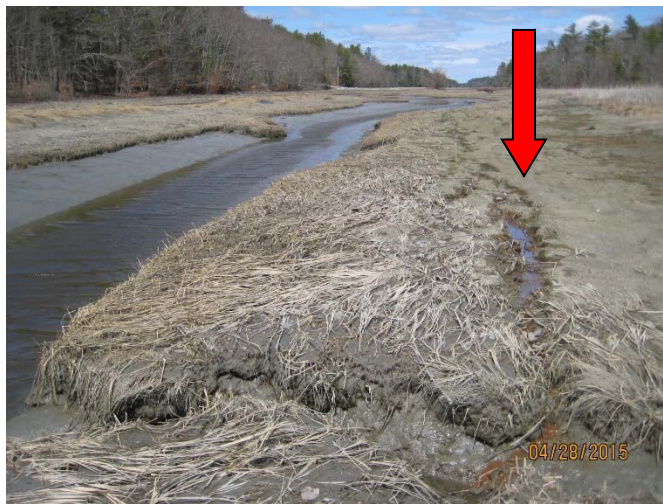
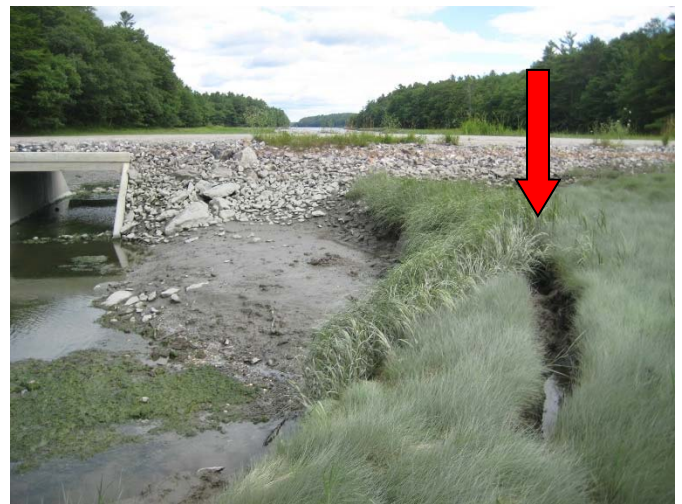
Channel response to increased tidal exchange was not always captured in surveys. A new and expanding rill along the east side of the channel at Station 4 (left, view N) could indicate future dimensions under the new hydrologic regime. Similarly, at the culvert inlet (right, view N), large chunks of peat continue to slump off, collapsing into the creek channel, following culvert replacement.

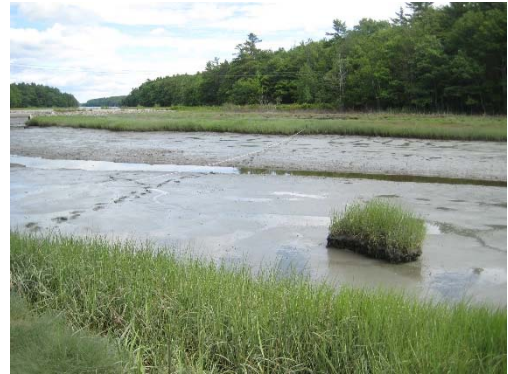
Station 2 cross section. Most of the channel remains mudflat, with a narrow thalweg in the center. Peat from winter ice movement in foreground.

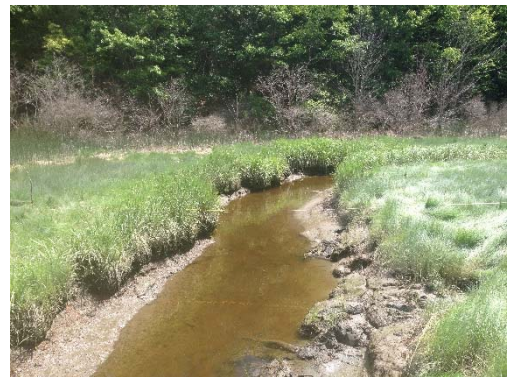
Station 8 cross section. Remnant peat exposed on west bank (r).

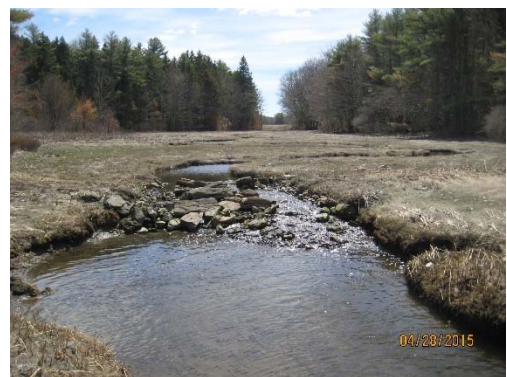
Scour downstream of the old road bed between Stations 8 and 9.
