Thomas Bay Salt Marsh Restoration

Casco Bay Estuary Partnership

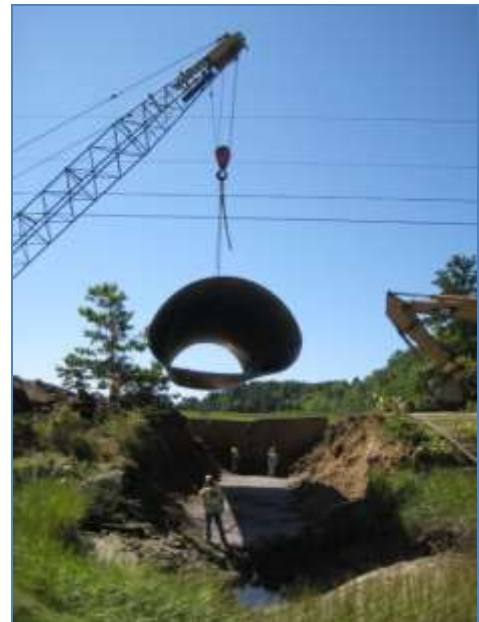
The Adams Road culvert at Thomas Bay Marsh was replaced in August 2011.

Restoration Partnership to replace the culvert with a larger volume pipe arch culvert. After close to a year spent on designs and permitting, the culvert was replaced on August 17, 2011.
