## Pleasant River Watershed Management Plan

## WATERSHED MANAGEMENT PLAN

Cumberland County Soil & Water Conservation District

Prepared by Heather True  
June 2011

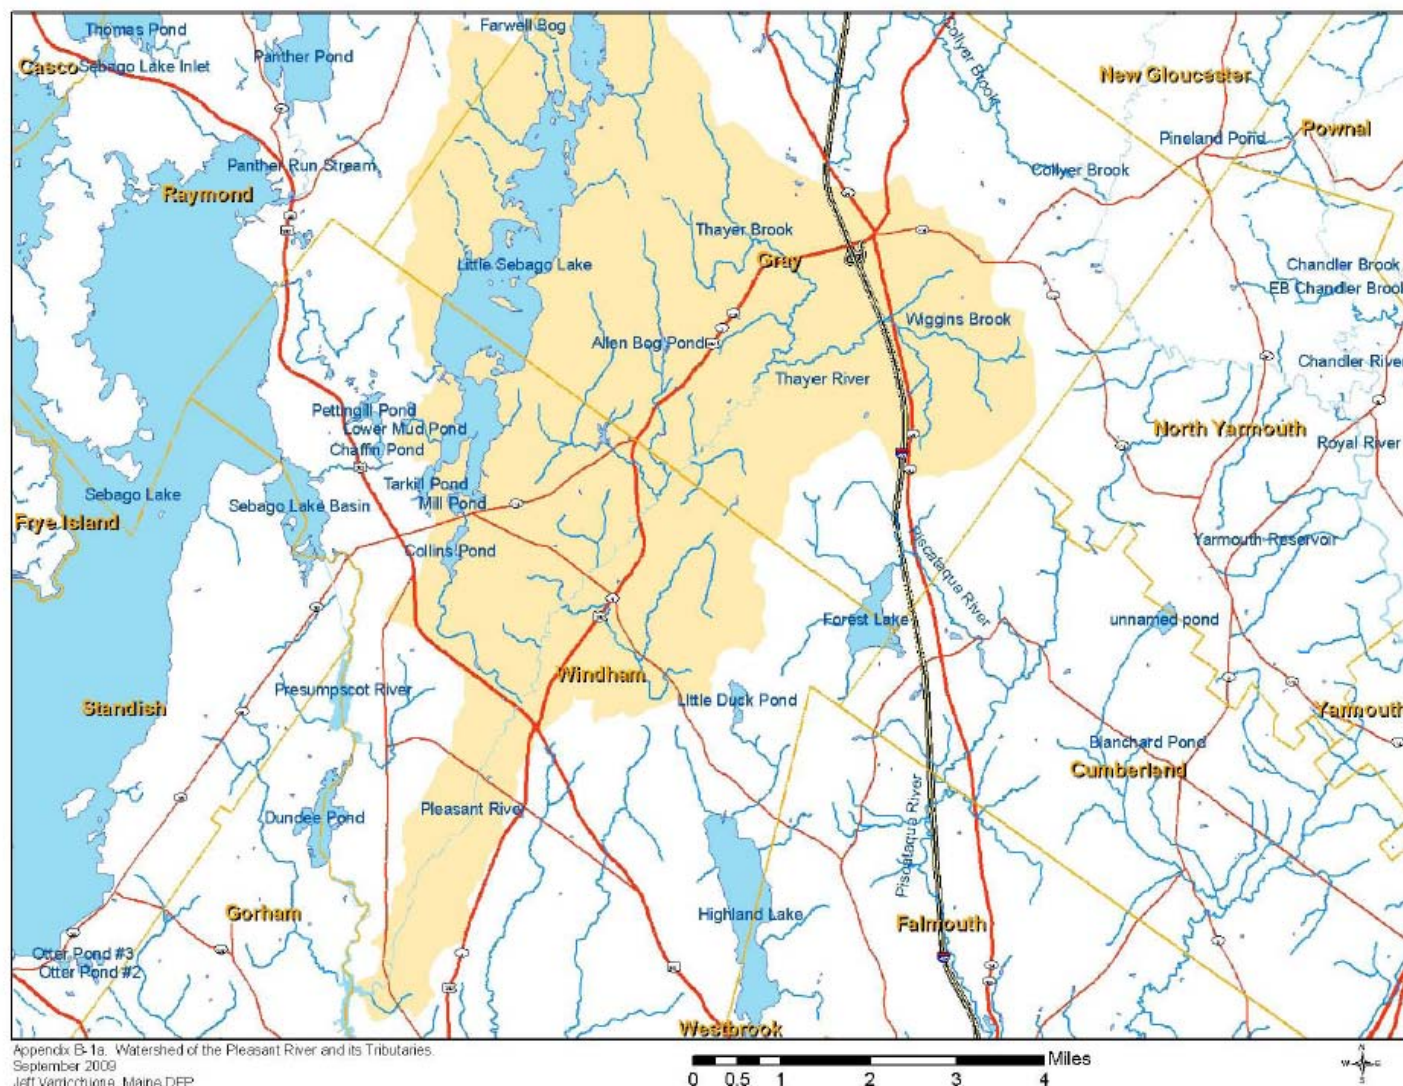
The map above highlights the Pleasant River Watershed including the sub-watersheds of Little Sebago Lake and Collins Pond which drain into Pleasant River via Ditch Brook. Map from Pleasant River and Tributaries Reconnaissance Study, Maine DEP 2009.

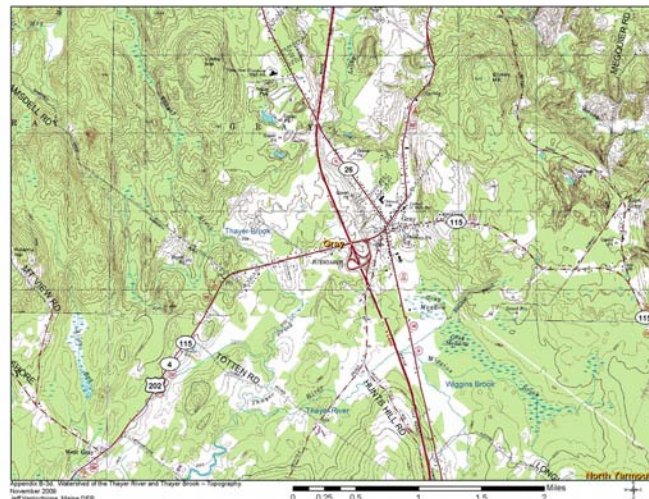
Above map is a topographic map of the headwaters of Pleasant River near downtown Gray. Map from Pleasant River and Tributaries Reconnaissance Study, Maine DEP 2009. (See Appendix A: Topography Maps for larger map).

The topography of the Pleasant River and its tributaries has a fairly low gradient. Exceptions include certain stretches of Thayer Brook, which alternate through areas comprised primarily of glacial till (a glacial deposit from the bottom or insides of a glacier consisting of poorly sorted mixture gravel, sand, silt and clay), areas of flat wetlands, and areas of cascades flowing over exposed ledge / bedrock at a few locations along Pleasant River. The topography of the land adjacent to the Pleasant River and its tributaries appears to have moderately steep slopes with the stream banks becoming steeper in areas along the main branch of the Pleasant River prior to flowing into Presumpscot River. (see Appendix A: Topography Maps, p. 24-26)

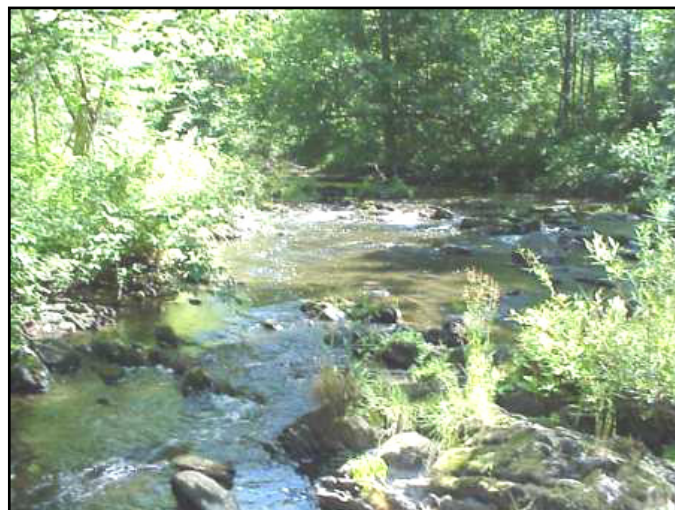
Site of Maine DEP macroinvertebrate sampling location, upstream of Pope Road crossing (Photo Credit: Maine DEP)

In addition to PRW's water quality monitoring program, MEDEP also conducts biomonitoring along the Pleasant River and Baker Brook. Biomonitoring consists of sampling the number and diversity of aquatic organisms to assess the condition of the ecosystem. MEDEP conducts biomonitoring approximately

every five years, and samples taken since 1991 have shown the Pleasant River and Baker Brook to be in attainment of Class B standards for macroinvertebrates. MEDEP also monitors sites along the Pleasant River and Baker Brook for algae. There are no official state algal density standards.

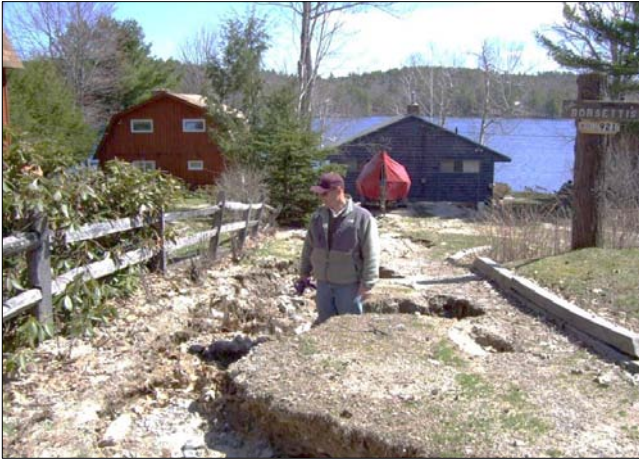
*Sediment from erosion sites such as this one on Little Sebago Lake in Windham is the biggest source of pollution to surface waters in Maine.*

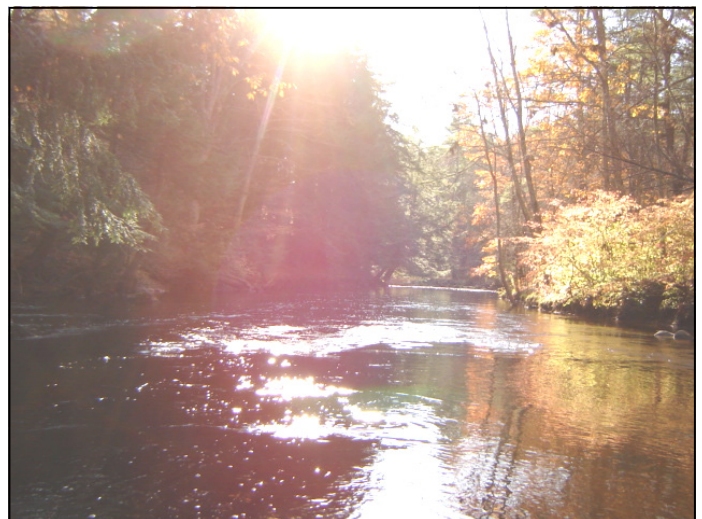
*Vegetated buffers along stream banks provide a number of benefits including stream shading, habitat, stormwater filtering, and bank erosion protection.*

Vegetated areas next to water resources help to protect water quality by filtering sediment and pollutants before they reach the river. These vegetated buffers have intertwined root systems that also protect shorelines from erosion and provide valuable wildlife habitat. The loss of vegetated strips of land along the river can degrade water quality by allowing unfiltered pollutants to flow directly into a waterbody, causing shorelines to erode due to the lack of root systems, and an increasing the amount and velocity of stormwater flow. Loss of vegetative cover and the lack of shade it produces can also increase water temperature reducing the population of fish and bottom-dwelling insects that need cold water to thrive and increasing nuisance and invasive aquatic plants and algae.

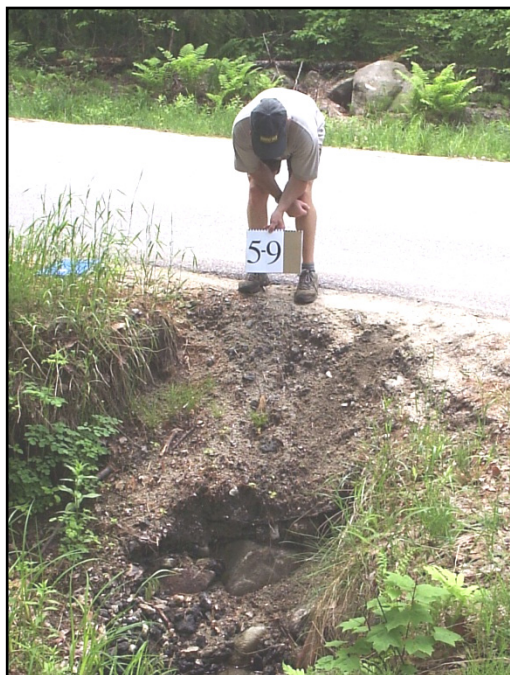
*A Pleasant River Watershed Survey volunteer documents road shoulder erosion above a culvert washing into a tributary of the Pleasant River.*

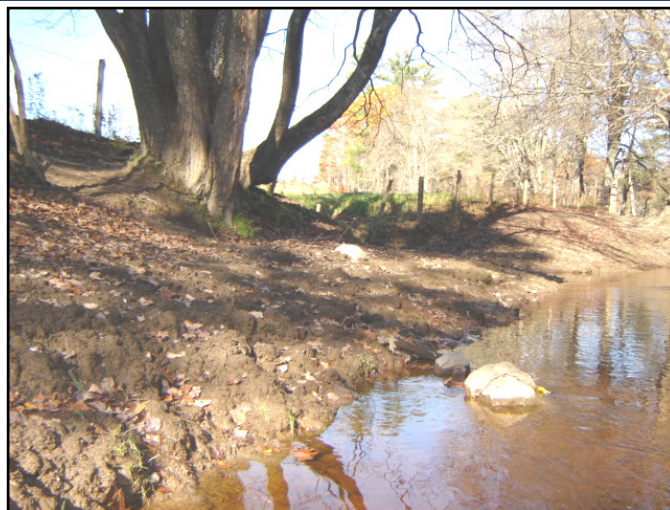
*Signs of cattle access to main stem of Pleasant River resulting in stream bank erosion.*

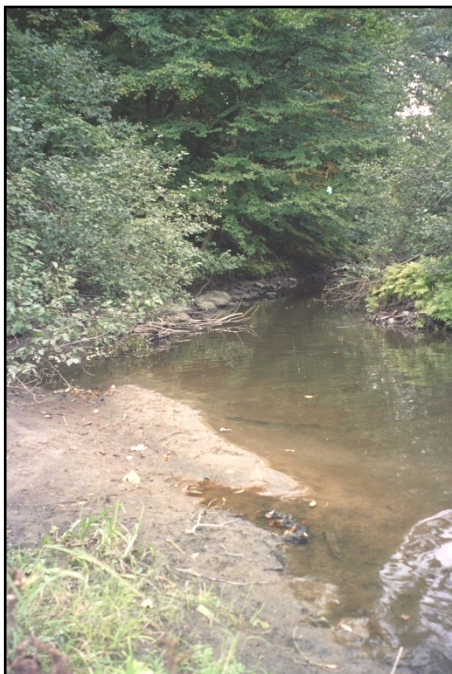
*Sediment delta along stretch of Pleasant River in which Brook Floater habitat has been documented. Photo Credit: Maine Dept. IF&W*

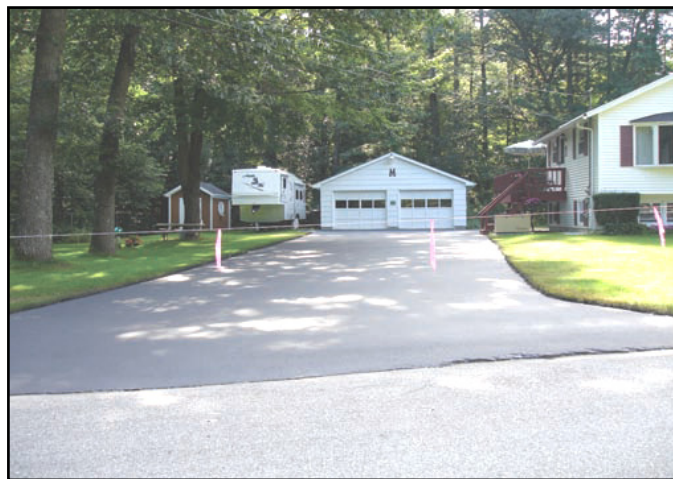
*Recently seal-coated driveway in the Pleasant River Watershed; Stormwater picks up harmful polyaromatic hydrocarbons (PAHs) from seal-coating washing them into nearby streams and waterbodies.*

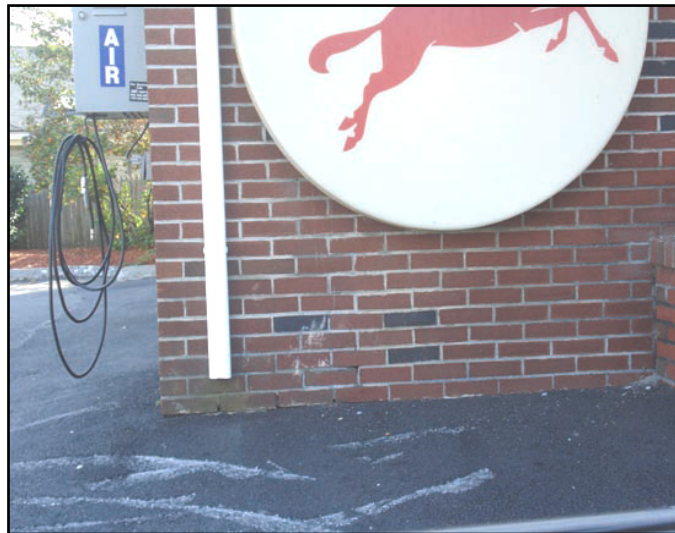
*Downspouts draining onto impervious surfaces rather than being filtered into the ground are considered potential "hotspots" due to the potential pollutants the stormwater can pick up and wash into the Pleasant River.*

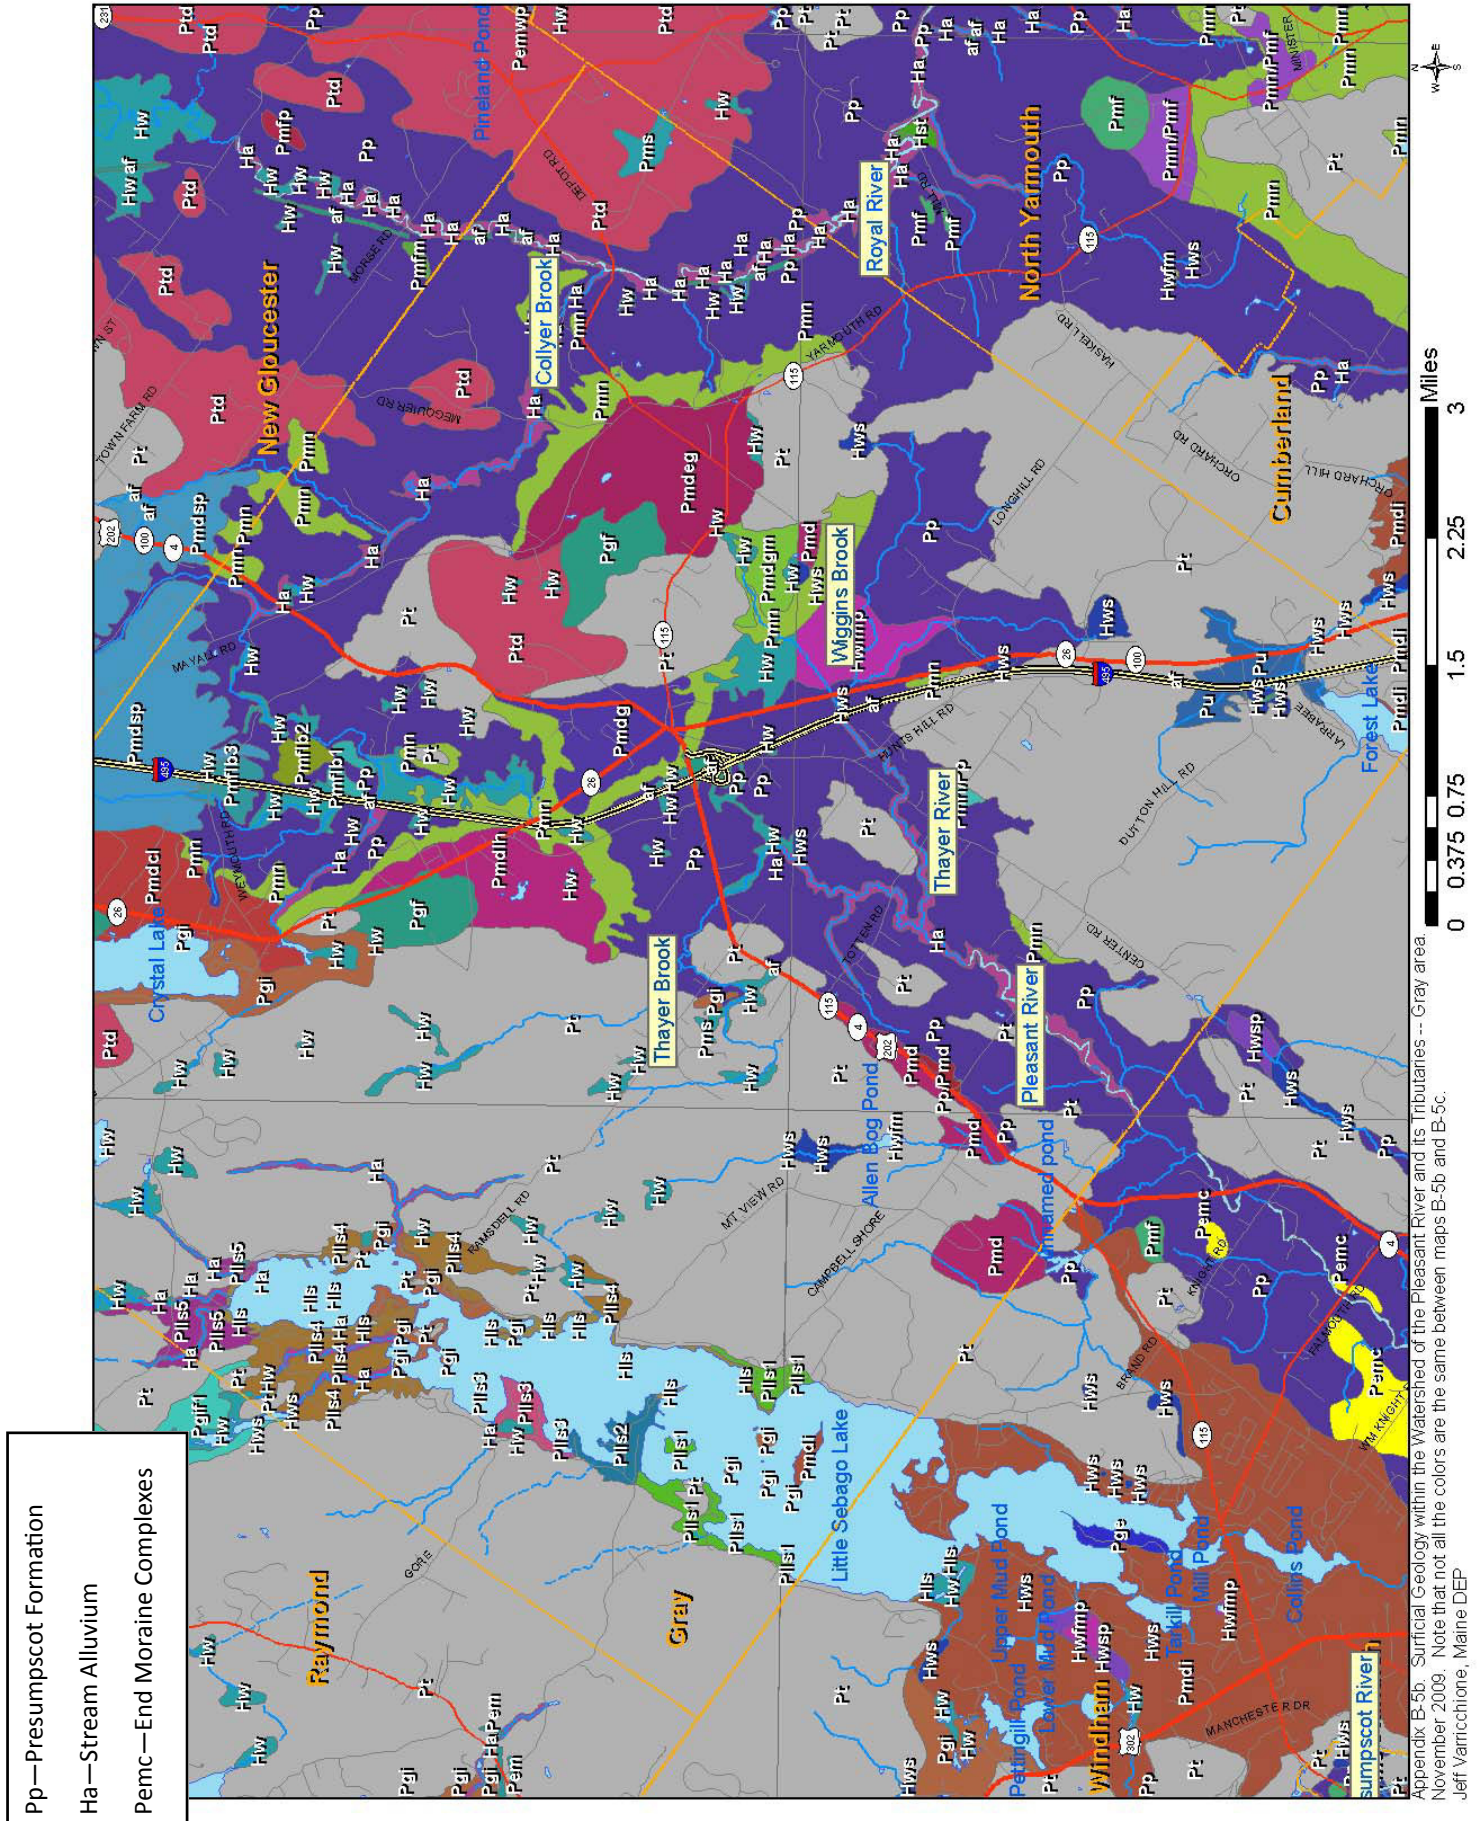
# Appendix A: Geology Map-Gray

According to geological maps, the dominant surficial geology is composed of thick deposits of silt and sand as a result of the retreat of the glaciers from the last Ice Age with the Atlantic Ocean following right up to the foot of the glaciers. They surround the Pleasant River and Wiggins Brook and are called the Presumpscot Formation, which is comprised mostly of a fine-grained marine mud (silt and clay with local sandy beds and lenses). Stream Alluvium is a modern sediment deposit along the Pleasant River, Wiggins Brook and Thayer Brook. It is composed of sand, silt, and minor amounts of gravel on flood plains. The River corridor between Windham Center Road and Swett Road (including the area around Pope Road) is comprised largely of end moraines which are Ice Age deposits which are a mixture of till, sand and gravel, in part or wholly covered by the Presumpscot Formation.<sup>5</sup> (see Appendix A: Geology Maps, p. 22-23)

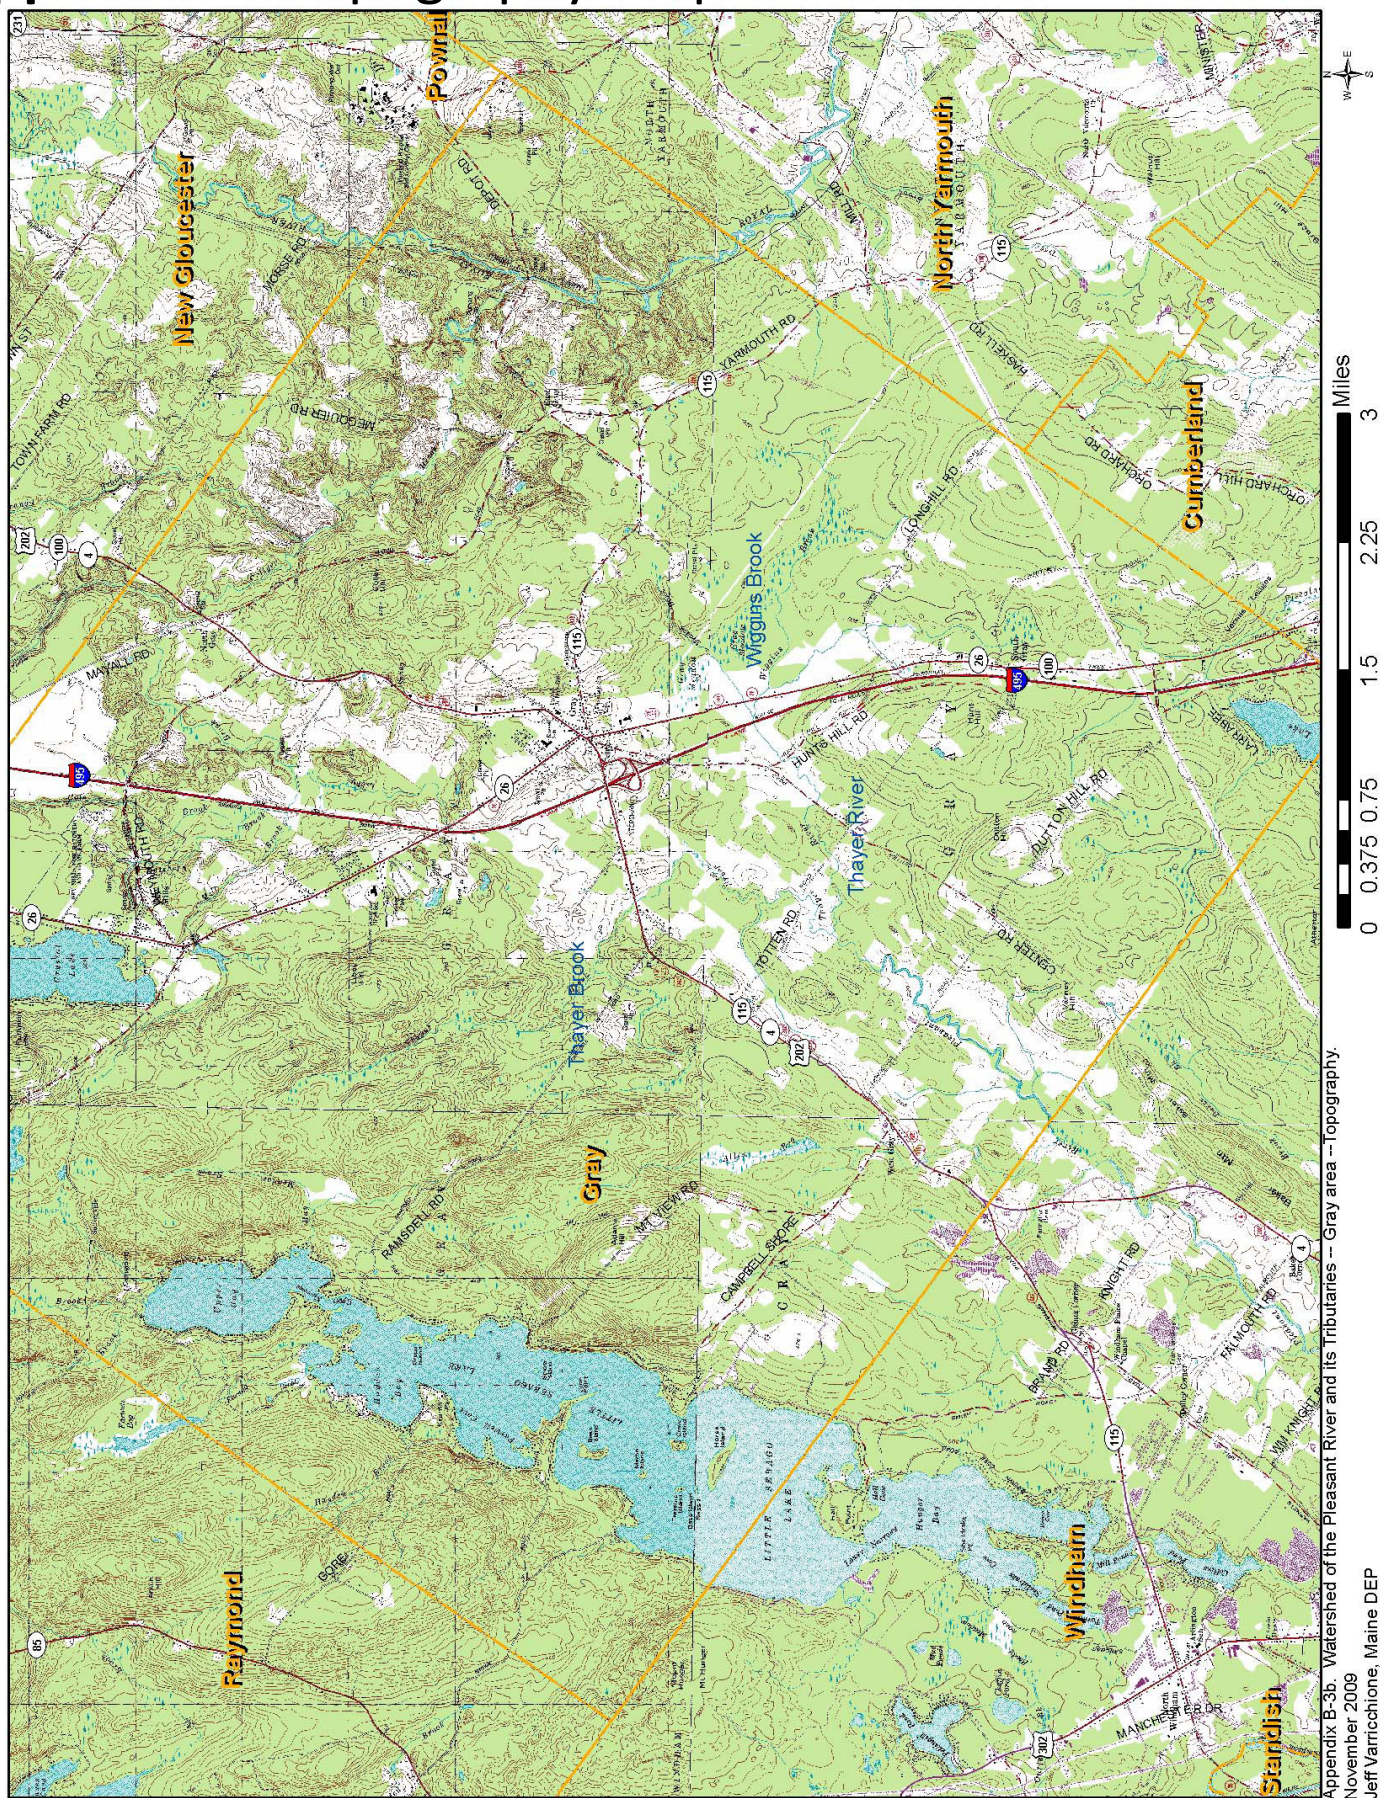
# Appendix A: Topography Map-Pleasant River Watershed

Appendix B-3b. Watershed of the Pleasant River and its Tributaries -- Gray area -- Topography.  
November 2009  
Jeff Varricchio, Maine DEP

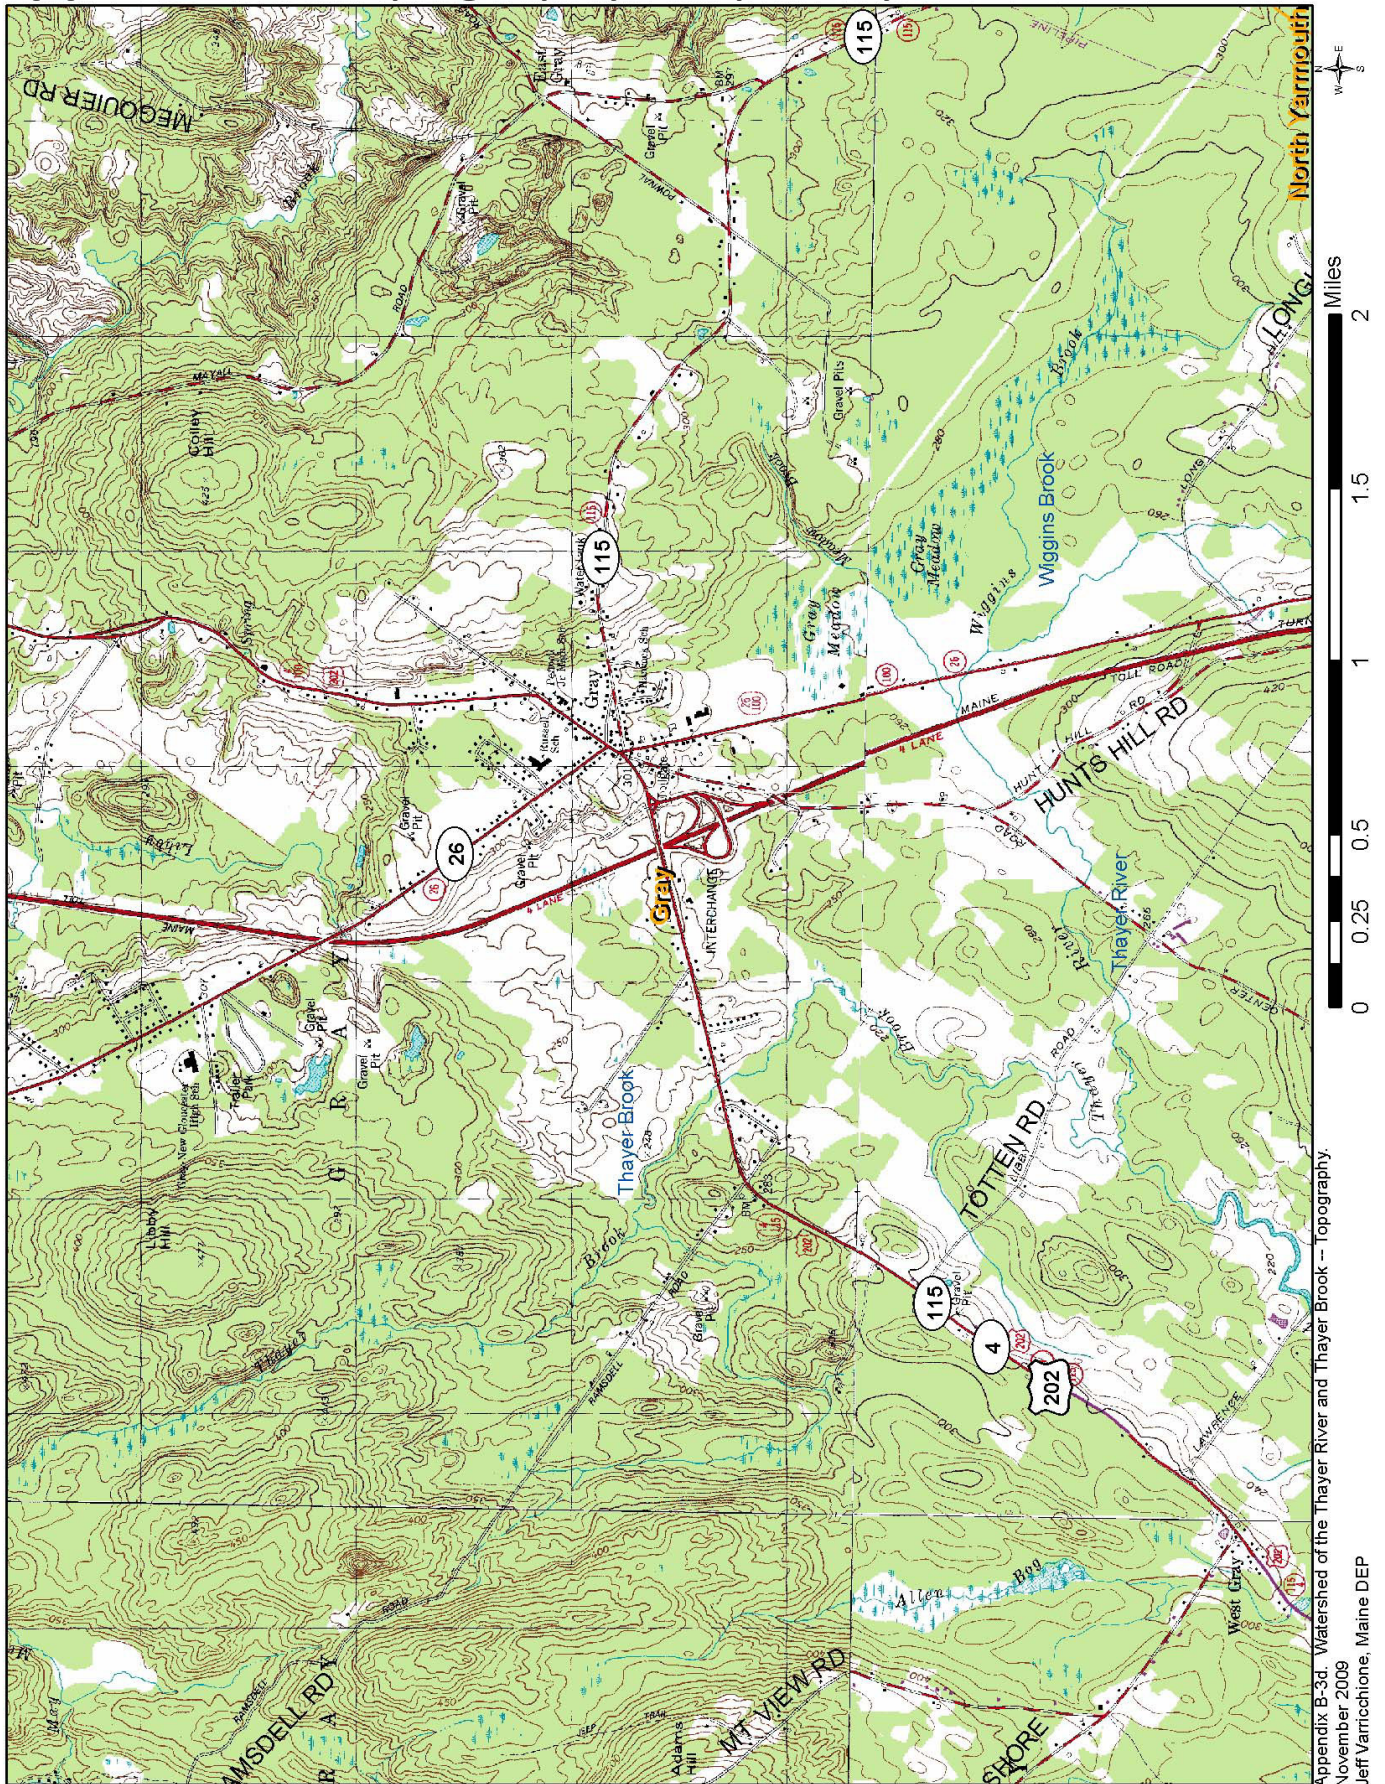
# Appendix A: Topography Map-Gray

Appendix B-3d. Watershed of the Thayer River and Thayer Brook -- Topography.  
 November 2009  
 Jeff Varricchio, Maine DEP

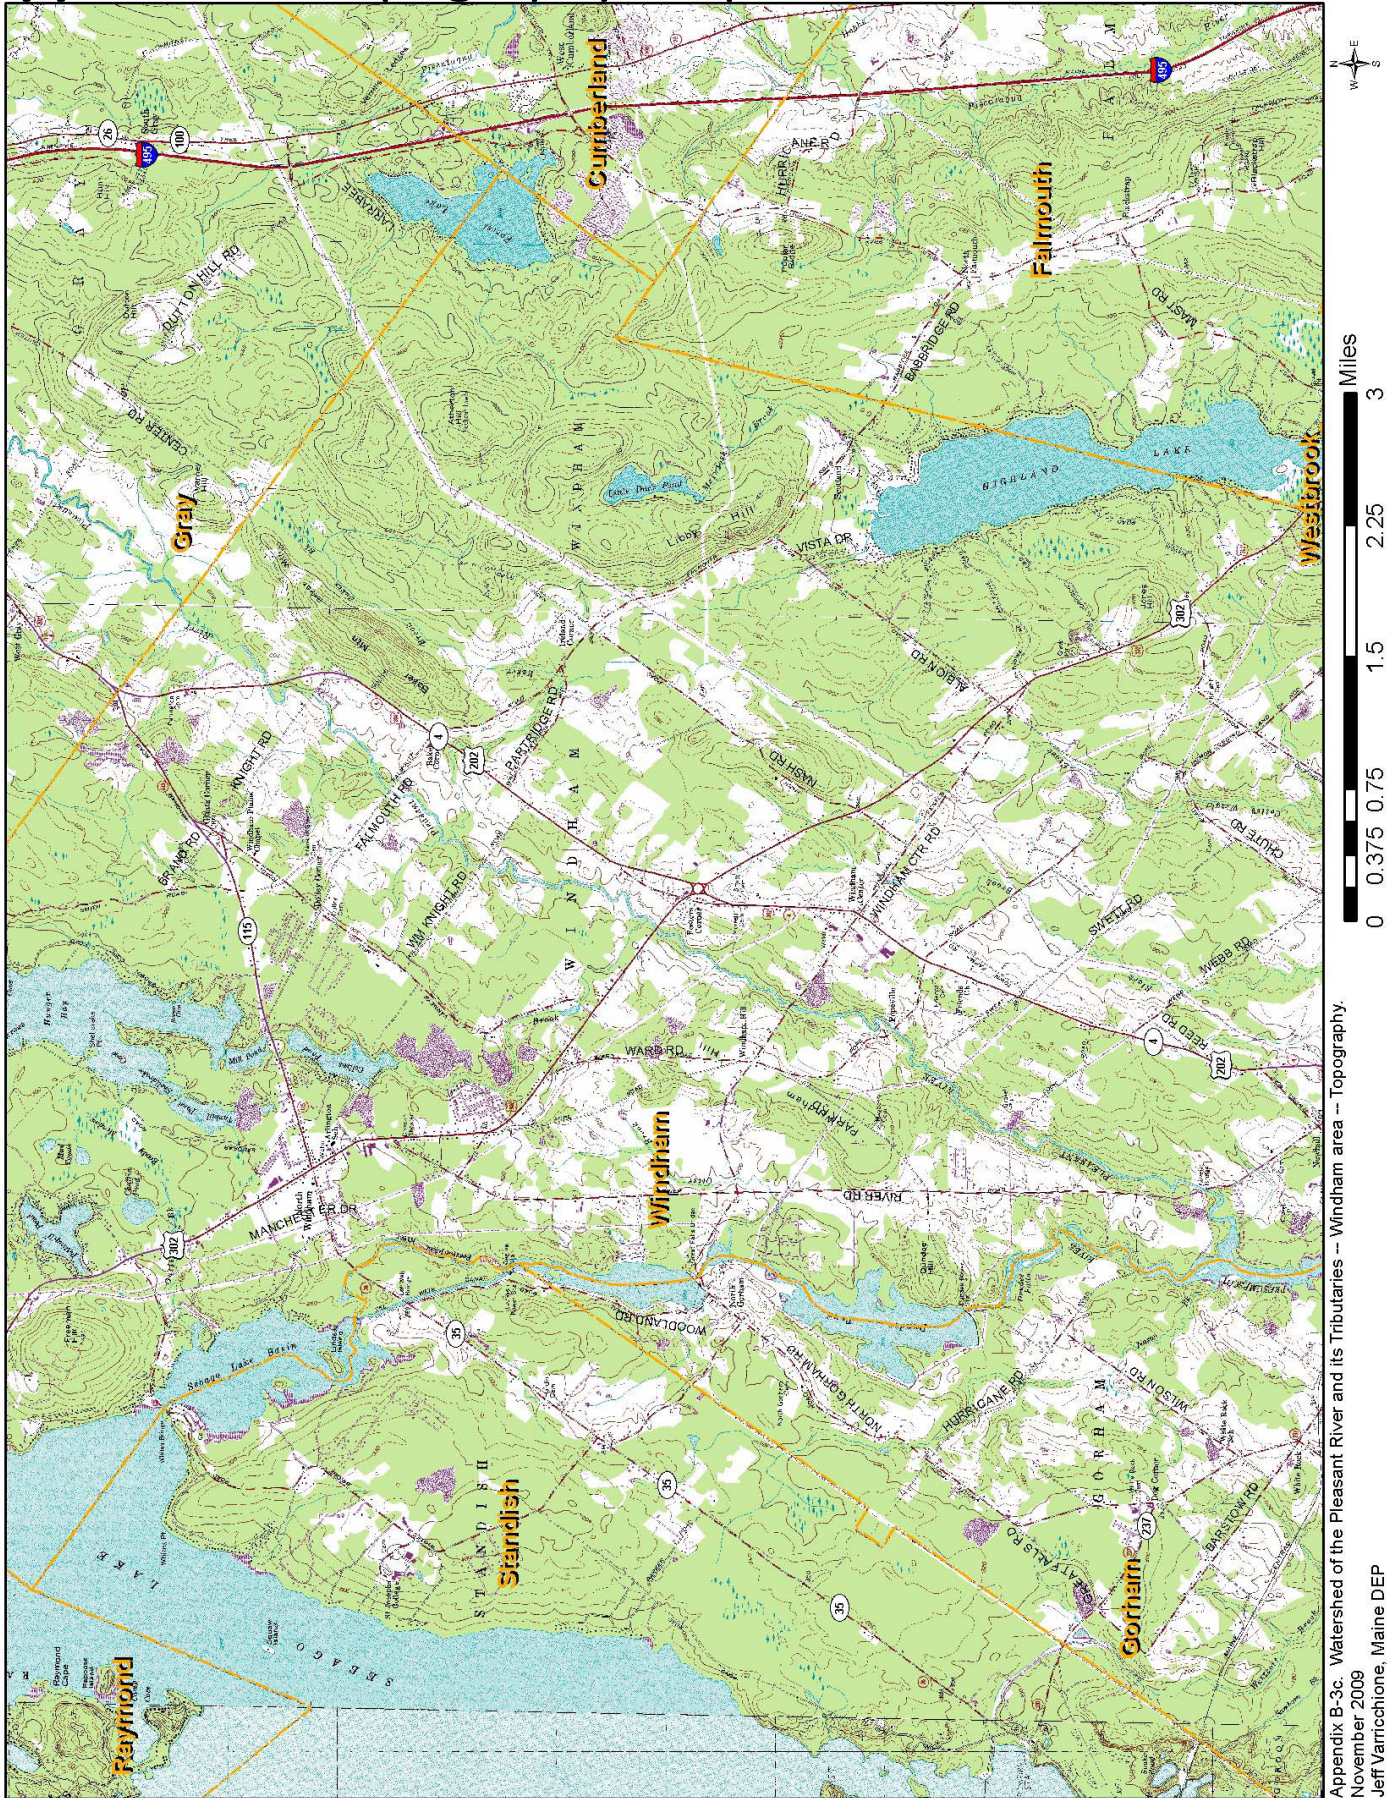
# Appendix A: Topography Map-Windham

Appendix B-3c. Watershed of the Pleasant River and its Tributaries -- Windham area -- Topography.

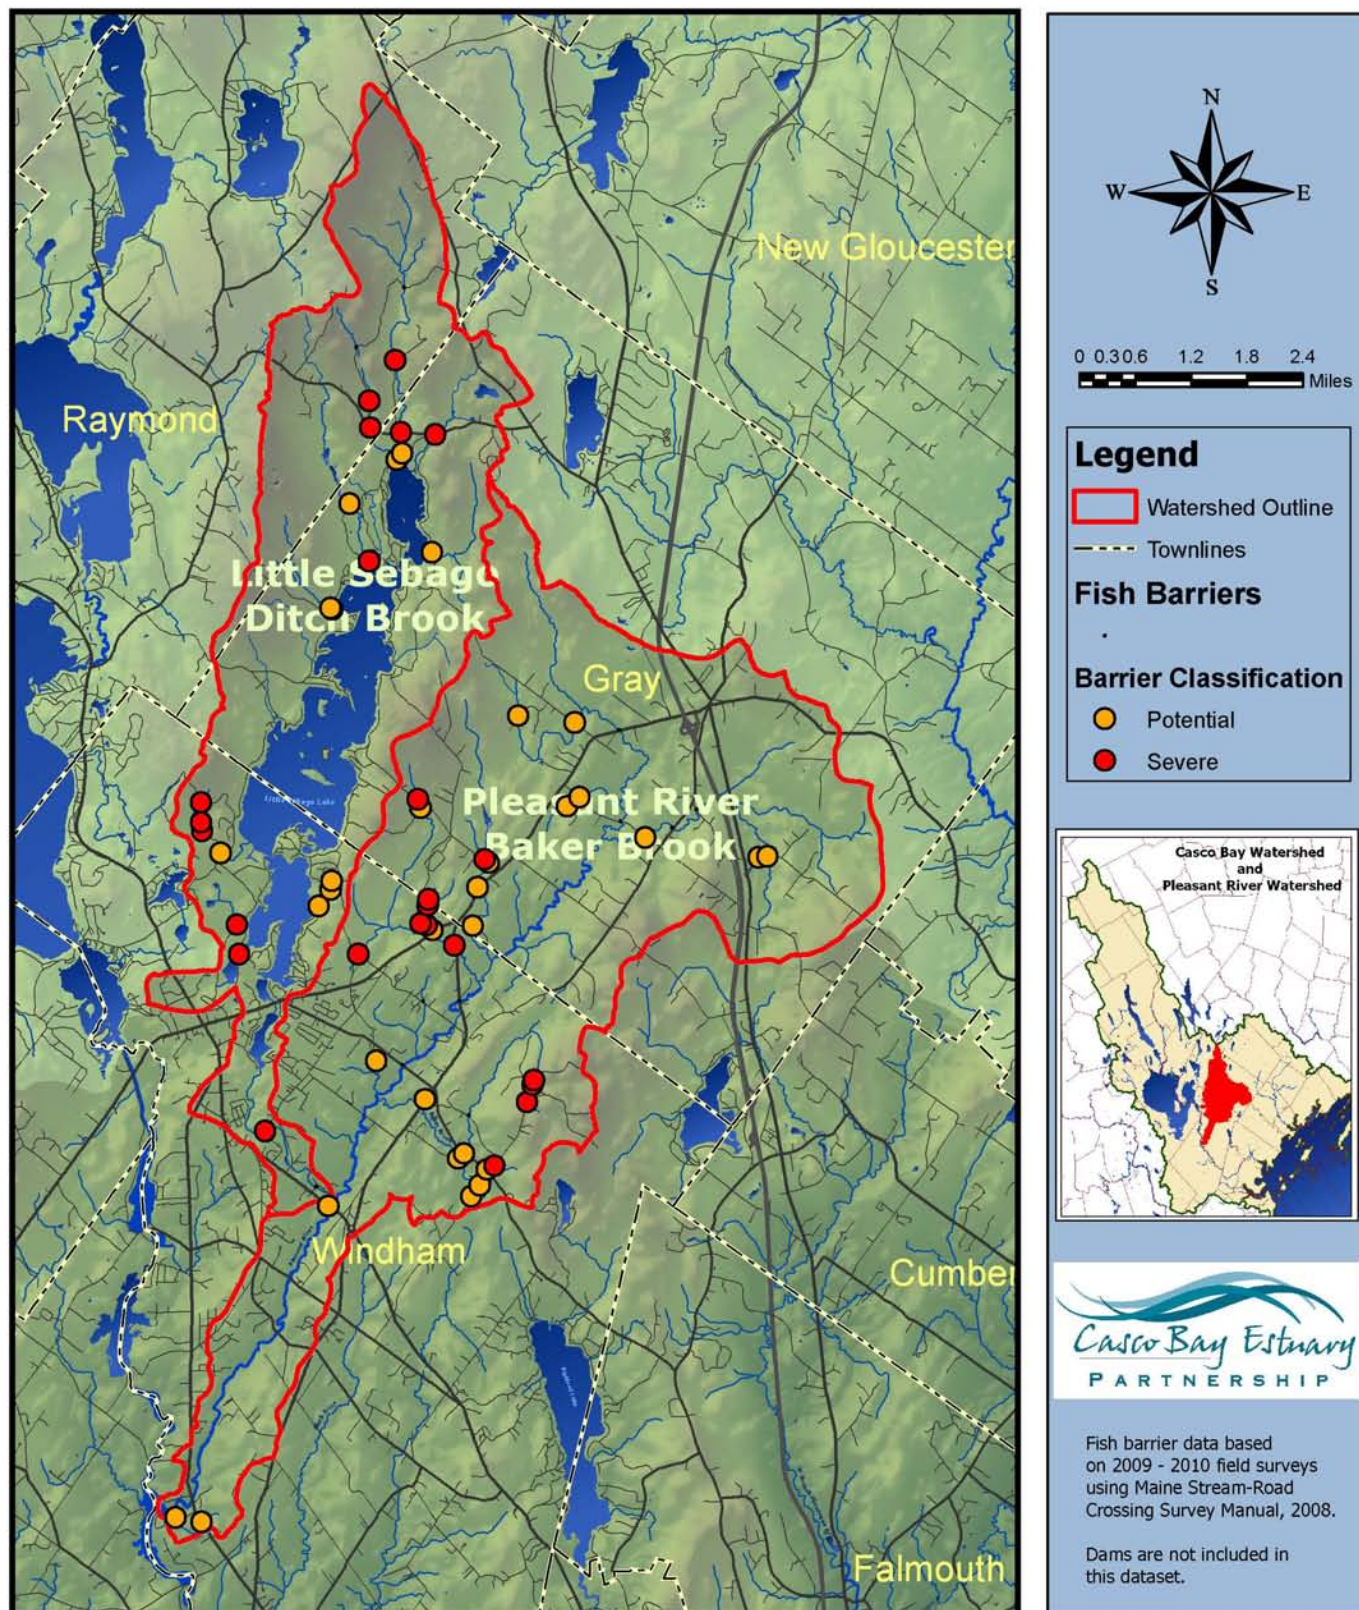
# Appendix A: Pleasant River Fish Barriers Map

## Pleasant River Watershed Fish Barriers Casco Bay Watershed, Maine

Casco Bay Estuary Partnership (CBEP) in conjunction with the US Fish and Wildlife Service's Gulf of Maine Coastal Program conducted a survey of fish passage barriers throughout the Casco Bay Watershed in 2009-2010. Preliminary data for the Pleasant River Watershed and the larger connecting Little Sebago Lake Watershed identified over 40 sites in which potential and severe fish passage barriers were observed. Stream road crossings were assessed using the *Maine Road-Stream Crossing Manual*. See Appendix A, p. 28 and 29 for preliminary map and survey data for the Pleasant River Watershed. A full data set is available through the Casco Bay Estuary Partnership.
