Feasibility of mitigating physical disturbances to eelgrass in northern Casco Bay: Impacts and Options

MER Assessment Corp.

28 February 2008

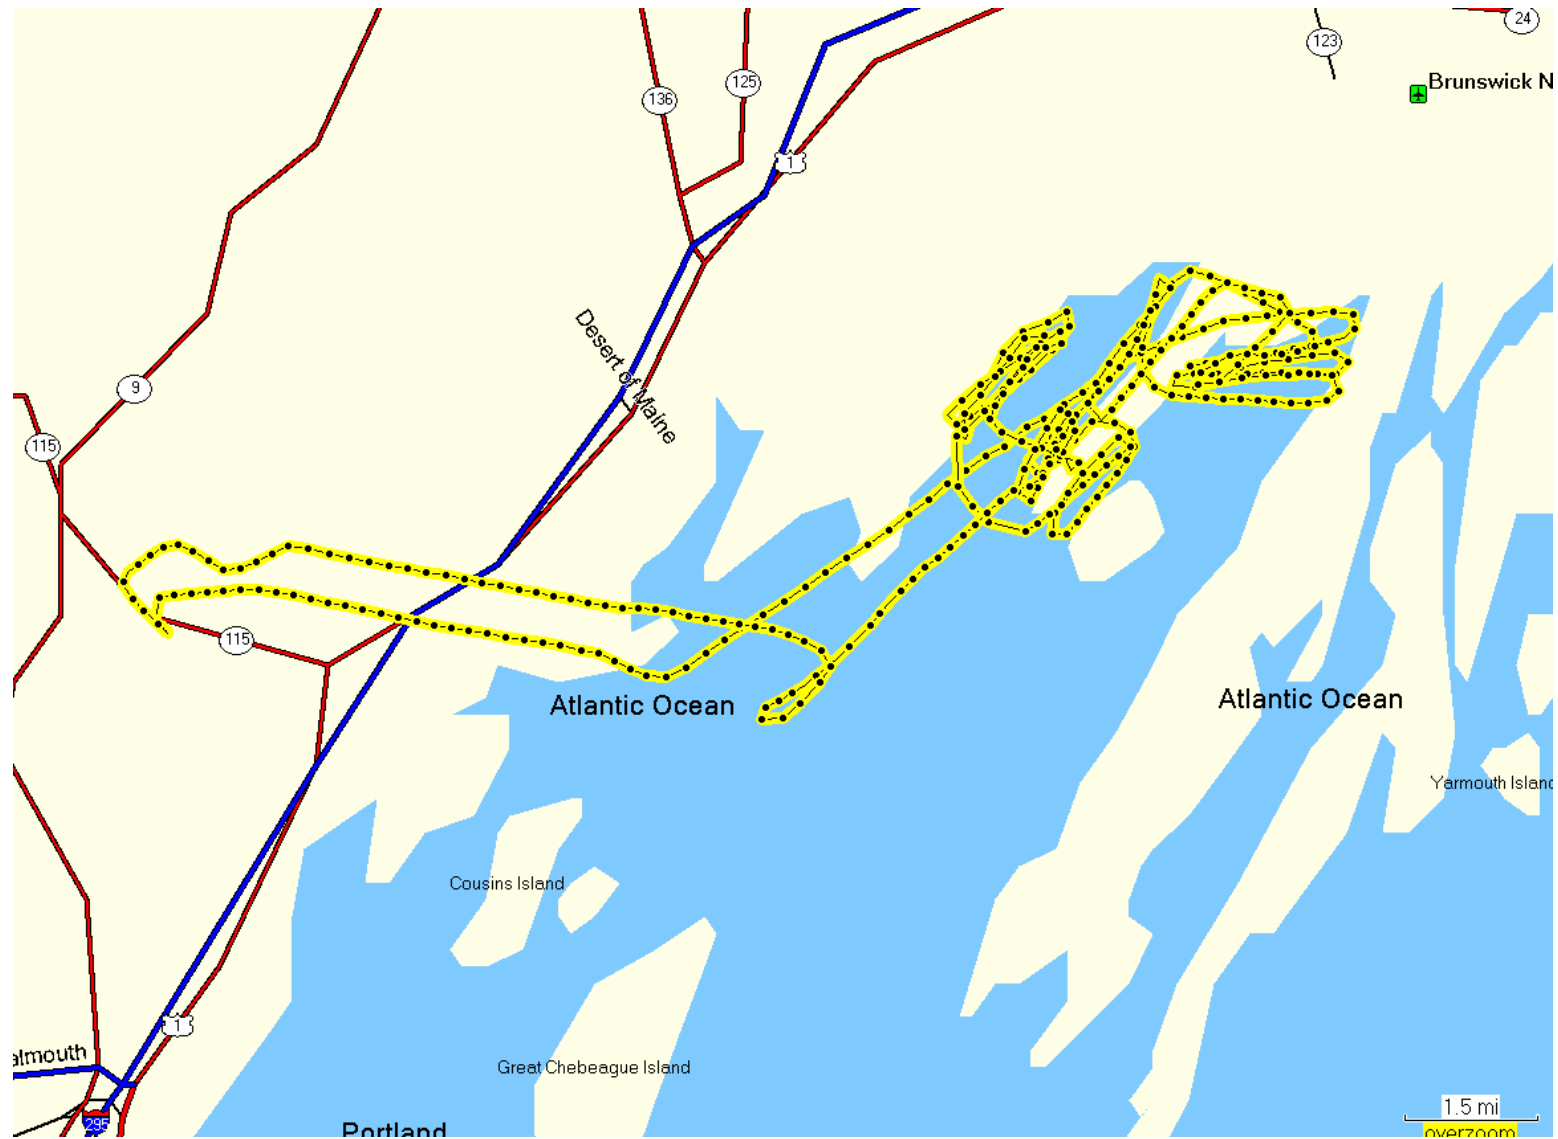
Figure 2 Flight path of August 30, 2007 aerial photography.

An effort was therefore undertaken to produce a new series of lower altitude aerial photos that would allow a more detailed and up-to-date view of physical damages to eelgrass. To accomplish this, vertical aerial photographs were taken from an Aeronca 7AC aircraft in level flight attitude between 06:20 to 06:50 on August 30, 2007. On that date, a -0.9 ft. low tide at Flying Point, Freeport was predicted to occur at 06:48. A Nikon D70 35mm digital camera equipped with a Nikon 18-55mm f/3.5 - 5.6G lens was strut mounted and controlled through a USB 2.0 cable attached to an IBM T43 ThinkPad using Nikon Camera Control Pro software. Focus was fixed with tape at infinity. Focal length was set at 35 mm resulting in an equivalent focal length of 53 mm for minimal distortion. Aperture speed was 1/200th second with aperture varying depending on light, typically f 5.6. Altitude flown was 2,600 ft. MSL +/- 100 ft. Airspeed was held at 75 mph with groundspeed varying between 65 and 85 mph with a 10 mph tail/headwind. Position and altitude for photography was independently tracked at 10 second intervals using a handheld Garmin GPS 60; flight path is shown in Figure 2. Additional flights to increase aerial photo coverage were planned, but were constrained by the need to coordinate tide height with time of day for proper light (early morning), weather, water clarity, and access to restricted air space around the Brunswick Naval Air Station approach.

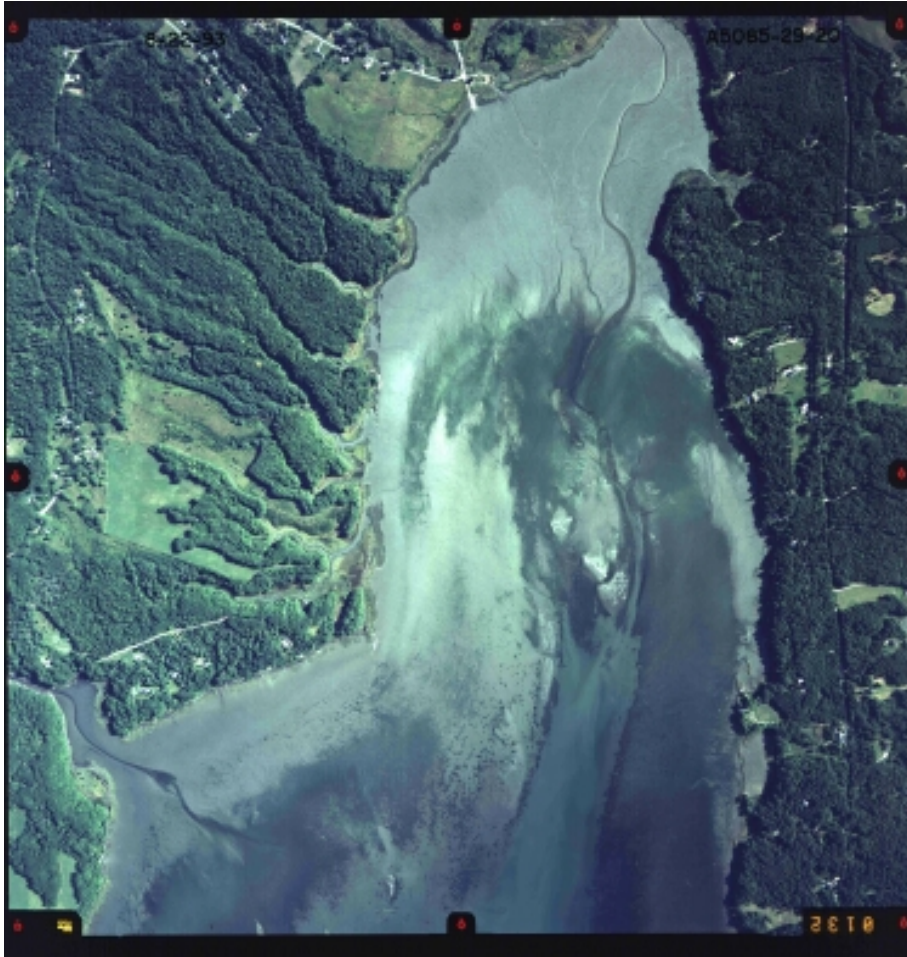
Figure 3 Aerial photos of upper portion of Maquoit Bay taken in 1993 (a) and 2001 (b) showing extent of expansion of eelgrass over the period

The comparison between the 1993 and 2001 aerial photographs of the northern Casco Bay region shows the dynamic nature of eelgrass distribution in the area over time. The increase in extent and density of eelgrass over this period in Maquoit Bay has been previously reported by Neckles et al. (2005). In upper Maquoit Bay, shown in Figure 3(a) 1993 and 3(b) 2001, eelgrass is seen having extended around the area of Bunganuc Rock (indicated by the arrow and “1” in Figure 3(b)), across much of the area along the western Bunganuc Bluffs shore (indicated by the arrow and “2” in Figure 3(b)), and along the eastern shore north just above the small projection of land (indicated by the arrow and “3” in Figure 3(b)); the mussel dragging scars caused by mussel dragging in June 1999 and studied by Neckles et al. (2005) are indicated by the arrow and “4”.

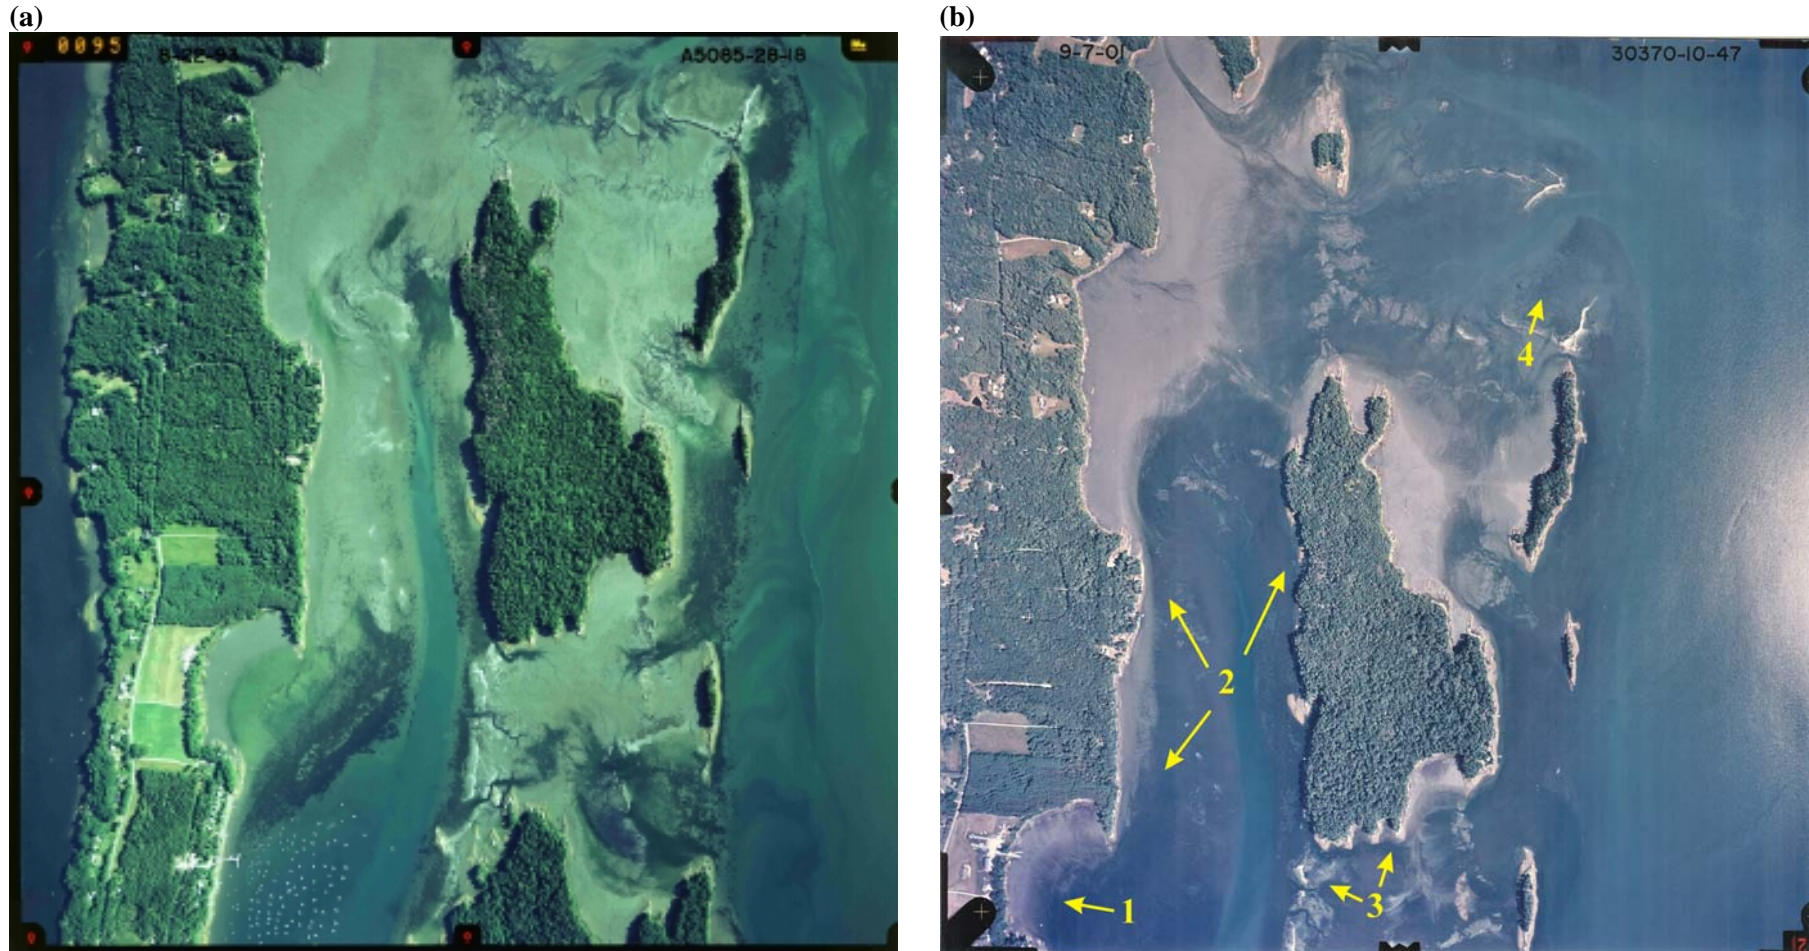
Figure 4 Aerial photos of upper half of Merepoint Bay taken in 1993 (a) and 2001 (b) showing extent of expansion of eelgrass over the period

Similar changes in eelgrass distribution in Merepoint Bay, primarily in the upper section, are shown in Figure 4(a) 1993 and (b) 2001. In 2001 eelgrass had extended into most of Smith Cove (indicated by the arrow and “1” in Figure 4(b)), and had covered much of the area between Merepoint Neck and Whites Island, (indicated by the arrow and “2” in Figure 4(b)), an area having only sparse cover in 1993. Similarly, the area between the north end of Birch Island and south end of Whites Island, nearly devoid of eelgrass in 1993, showed a substantial increase in eelgrass cover in 2001, (indicated by the arrow and “3” in Figure 4(b)). Finally, the area between Whites and Scrag Islands, (indicated by the arrow and “4” in Figure 4(b)), extending north of Crow Island and beyond into Miller Cove, (not shown in Figure 4(a)), areas nearly devoid of eelgrass in 1993, also showed substantial increase in eelgrass cover in 2001. The aerial photos taken in 2007 indicate that eelgrass continues to persist in the areas occupied in 2001, at least within the areas covered by the aerial transects.

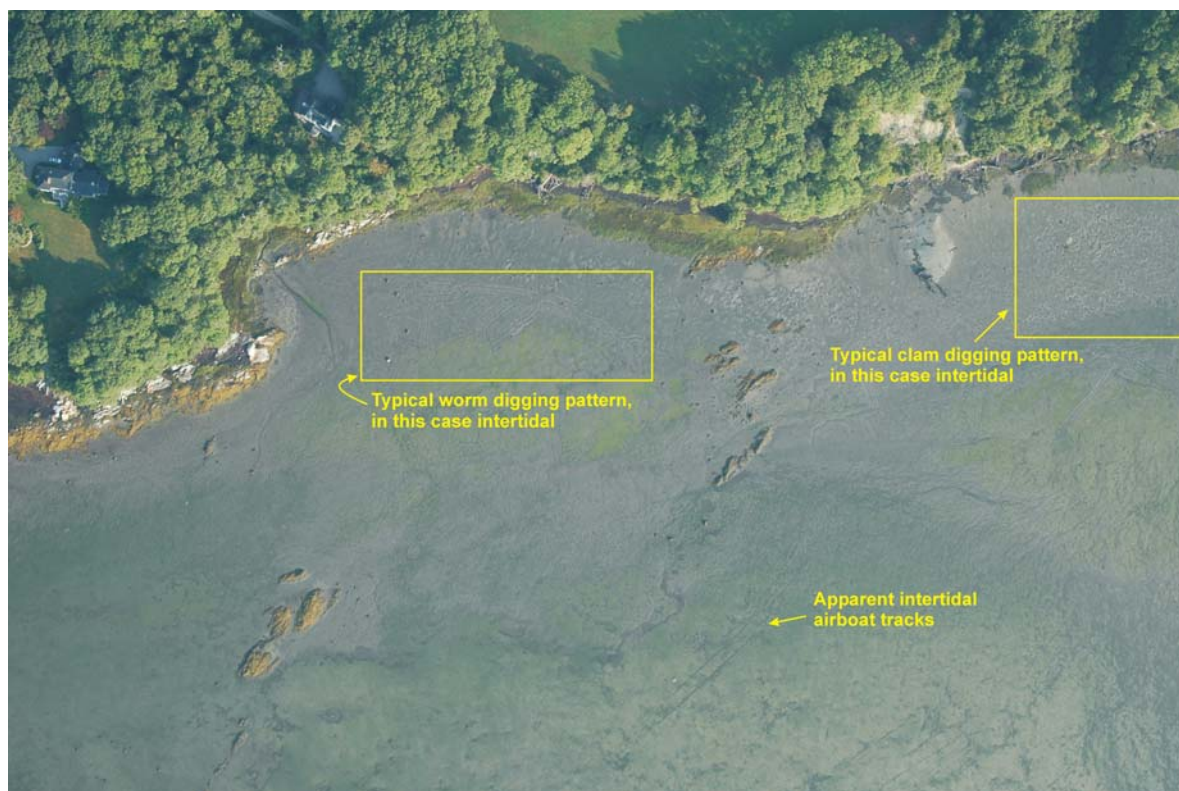
Figure 5 Clam and worm harvesting patterns in intertidal area of Maquoit Bay, August 30, 2007

Blood worm and sand worm harvesting takes place in the intertidal area, but can extend into the extreme lower intertidal zone where eelgrass may be encountered. However, as with soft-shell clams, worm harvesting is only allowed using hand implements (12 MRSA §6771). Worm harvesting does take place in northern Casco Bay, but is extremely limited (pers. comm., Dan Devereaux, Brunswick Marine Warden). Worm harvesting is methodical and creates linearly symmetrical patterns as opposed to the more chaotic and unpredictable patterns of clam harvesting, both shown in Figure 5; propeller scars and clam harvesting patterns are shown in Figure 6.

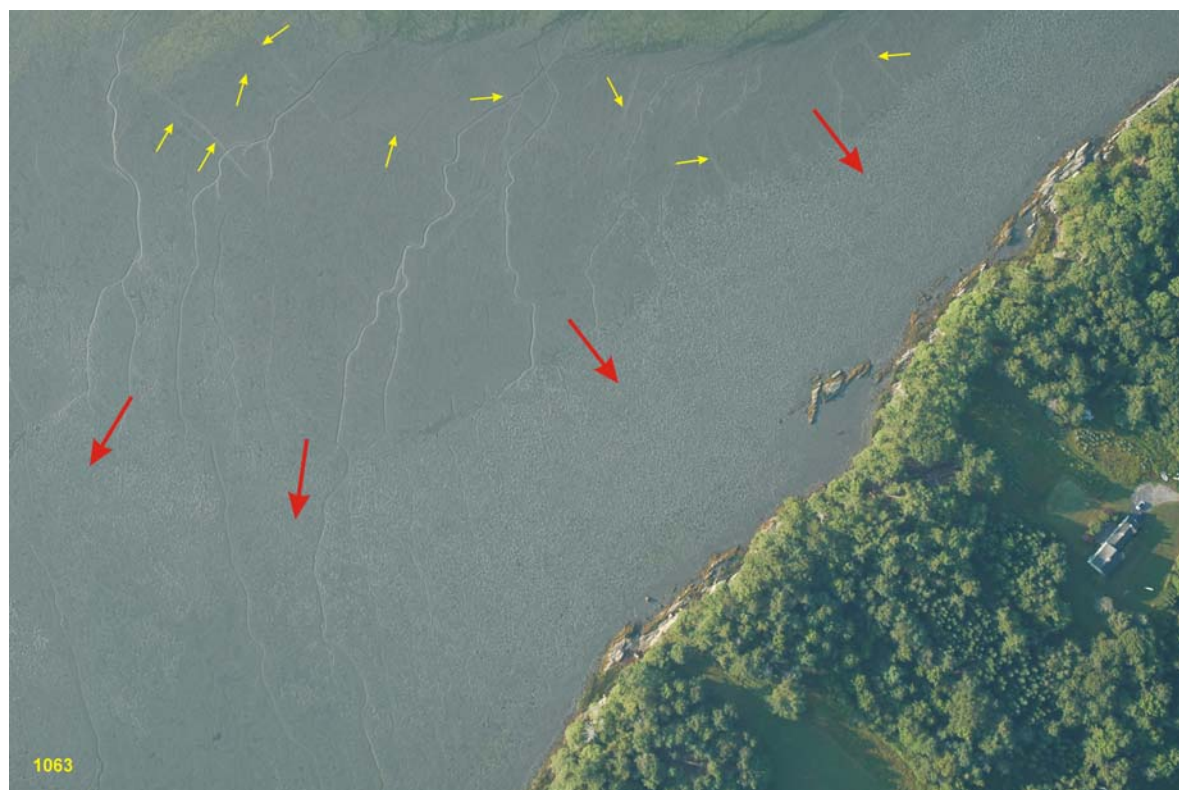
Figure 6 Propeller scars (small yellow arrows) and clam harvesting patterns (larger red arrows) in intertidal area of Merepoint Bay, August 30, 2007

Propeller scars are visible within the intertidal and subtidal areas where damage to or removal of eelgrass is evident. Scars within the intertidal area appear to be caused by clam diggers arriving at flats between 2 to 3 hours before low water. In such cases, little impact to eelgrass would be anticipated since these are usually small aluminum boats in the 12-14 foot class powered by 15-25 hp outboards, many of them short-shafted, crossing the eelgrass well before low water; departure from the flats usually mirrors time of arrival, thus height of tide is usually similar.

Propeller damage is found primarily associated with floats where boats routinely arrive and depart over the same bottom. Propeller scars are found outside of these areas that are characteristically curved or hook-shaped indicating an apparent inadvertent intrusion into shallow water followed by an attempt to return to deeper water; such intrusions into shallow water are likely caused by boaters unfamiliar with the area. Although there are few discernable examples of such occurrences, as the number of boaters increases over time the number of such occurrences is also likely to increase. One possible way of avoiding such damage would be to install navigational aids along the sides of the main channels within northern Casco Bay to maintain boaters within channels and direct them away from eelgrass areas. The navigational aids would end at the end of the channel, which in most navigable waters indicates the end of a channel opening into deeper water, thus ending restrictions on direction of navigation. In this case, however, the end of the navigational aids would indicate little or no water ahead at low water and a yellow cautionary buoy might be installed in the middle of the end of the channel indicating "End of Channel".

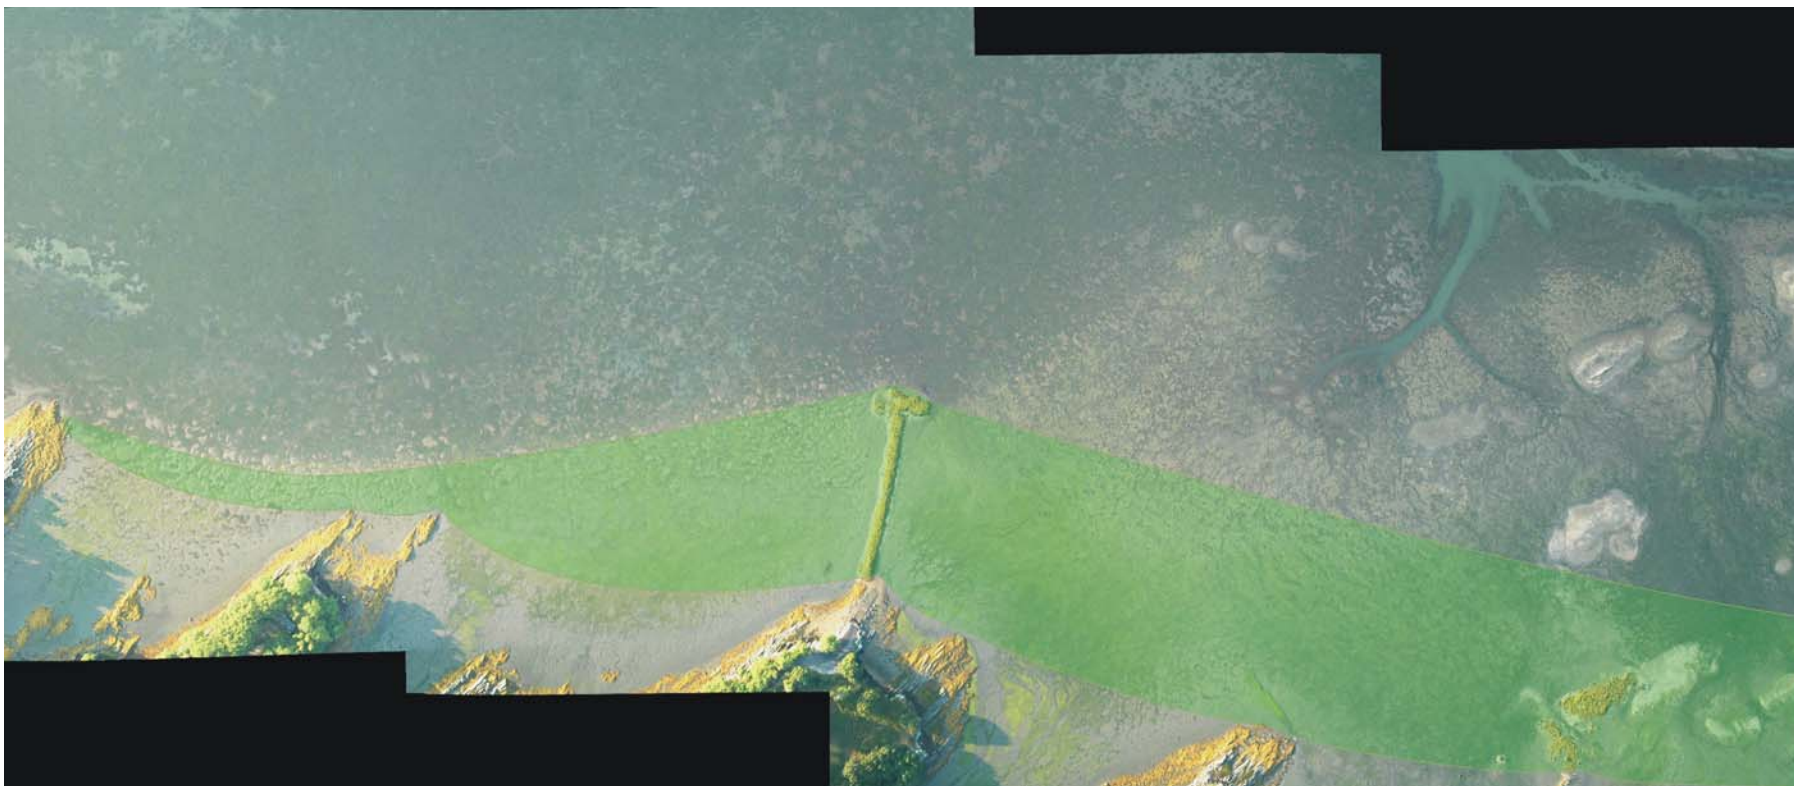
The largest man-made structure extending from the shoreline into the eelgrass habitat within northern Casco Bay is the stone pier at Simpson Point. The pier, or “wharf”, was constructed in 1899 and extends perpendicularly from shore approximately 400 feet (Brunswick Telegraph: June 21, 1899, p.3 Brief Notes). The article references the “new wharf” being built “out into the channel” suggesting that the waters off Simpson Point were deeper at the time and that sedimentation over the past 100+ years has caused the general uppermost area of Merepoint Bay to become shallower.

A review of the 2007 aerial photos of the Simpson Point landing area that include the stone pier (aerial photos 1031-1033) show that the shoreward, upper boundary of the eelgrass band stretches from the rocky point of land just to the east, westward over to the end of the stone pier. Further to the east, however, the shoreward boundary of the eelgrass band stretches from one rocky point to the next. A likely reason for this may be that sediment has slowly accumulated on either side of the stone pier over time causing this area to become intertidal or too shallow at low water to support eelgrass; unfortunately, no historical photos exist to support the assumption that eelgrass existed in this area at any time in the past. Nevertheless, had eelgrass existed in the area prior to the construction of the stone pier and had the pattern of distribution been similar to what exists today, the area may have supported an additional 18+ acres of eelgrass, as shown later in Figures 6 and 7.

Figure 7 Stone pier at Simpson Point showing possible eelgrass coverage (green overlay) following removal of the structure.

Removal of the stone pier at Simpson Pt. represents, perhaps, the largest eelgrass physical disturbance mitigation possibility. However, since the structure has been in place for a little over 100 years it is difficult to determine if the area surrounding the pier was covered with eelgrass at the time of construction and therefore whether it would become suitable habitat for eelgrass following removal of the structure; unfortunately, at the time of construction in 1899 the Brunswick Telegraph did not carry photographs and we are currently unaware of any historical photos of the area.

Based on the eelgrass distribution pattern along the shoreline adjacent to, but beyond the influence of, the stone pier it is estimated that more than 800,000 ft² or 18 acres of eelgrass habitat might be created if the stone structure were removed and the surrounding area were to become revegetated with eelgrass (see Figure 7). Furthermore, it is also difficult to determine if the lack of eelgrass around the structure today is due to sedimentation around the stone pier that, over time, has raised the seafloor to the point that it is no longer suitable as eelgrass habitat. If so, removal of the stone pier by itself may not be sufficient to insure reoccupation of the area by eelgrass; additional removal of sediment may be required if tidal currents alone fail to return the area to its former depth. Clearly, additional work would need to be done to provide high-resolution bathymetry of the area surrounding the pier and the hydrodynamics of the area would need to be studied to develop the necessary models to predict sediment redistribution within the area following removal of the pier.

Removal of the pier is undoubtedly technically feasible; however, the total financial cost of removal, including pre-removal studies, project permitting, physical removal, and follow-up monitoring of effectiveness would be substantial. Additionally, although temporary, there would likely be an environmental cost associated with the disturbance created during the removal process, all of which would need to be considered during project planning.
