Mill Brook Stream Bank Stabilization and Habitat Enhancement Project

Cumberland County Soil and Water Conservation District

Mill Brook Stream Bank Stabilization and Habitat Enhancement Project September 2007

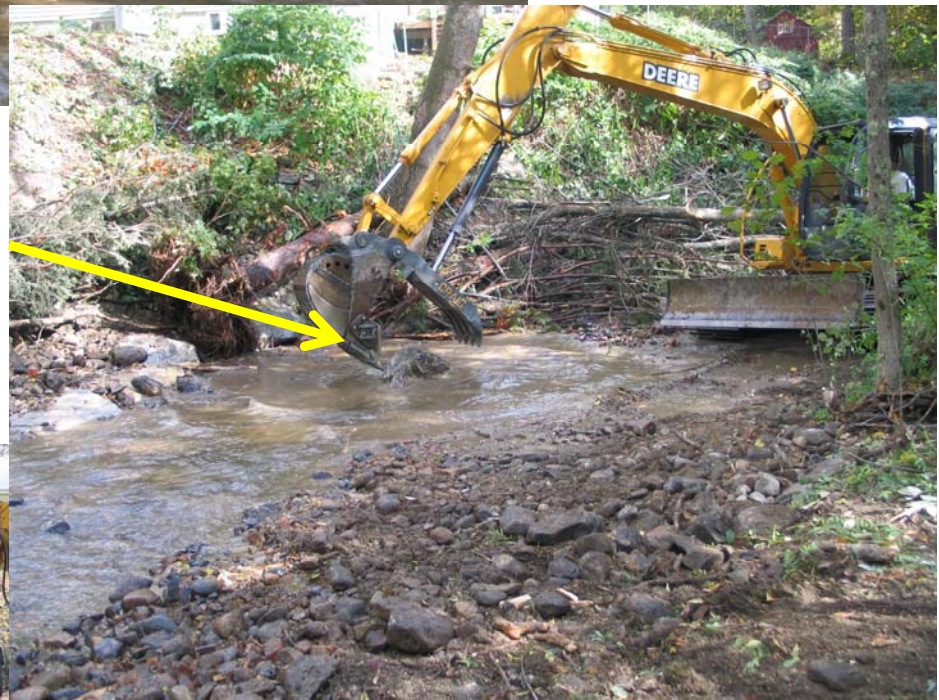
Temporary dam removed and feathering of stream bed
