Restoration of Riparian Buffer at the Former Smelt Hill Dam Site, Falmouth, Maine

Casco Bay Estuary Partnership

Final Report

June 30, 2006

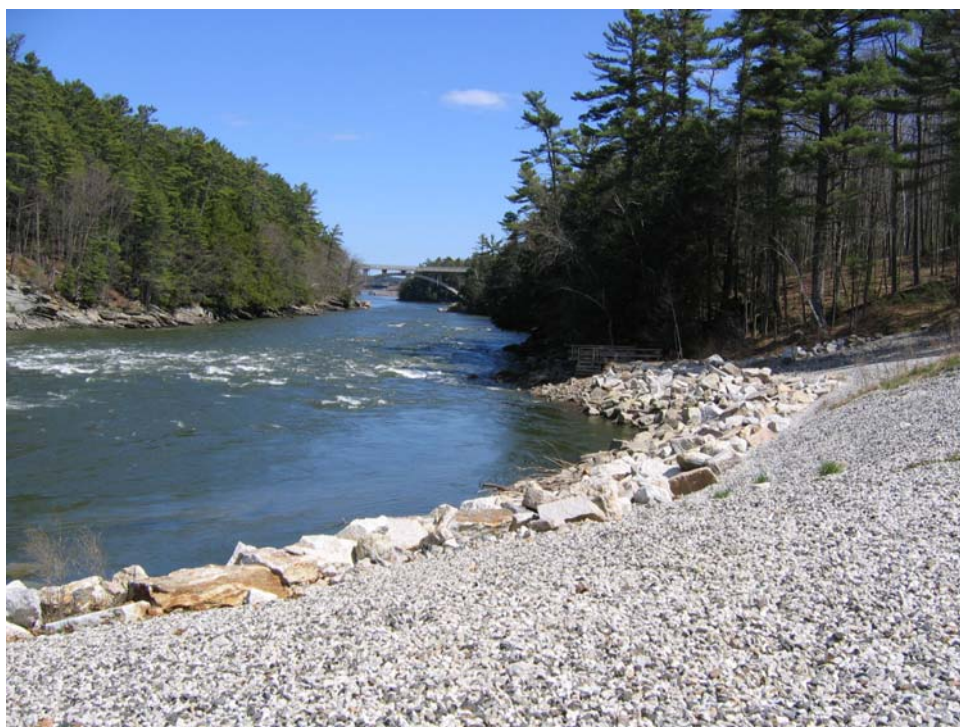
May 2005. Presumpscot River southern shore facing downstream at site of Smelt Hill dam removal.

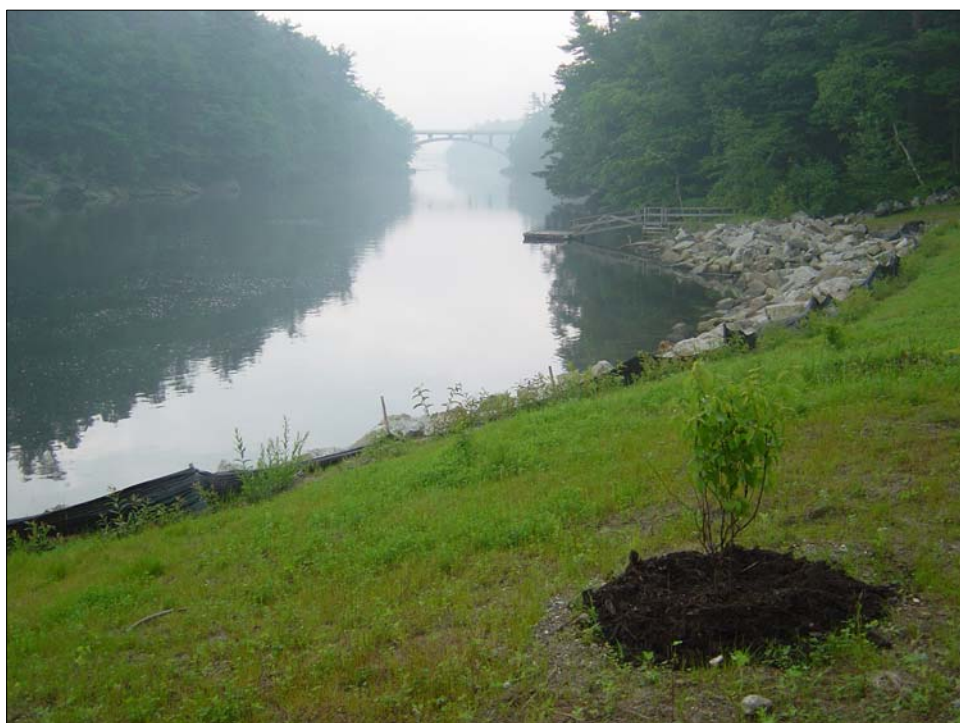
June 2006. Presumpscot River southern shore facing downstream at site of Smelt Hill dam removal. Note willow waddles planted during fall 2005 flourishing in front of silt fence along the length of the site.

- Phase I:
 - 100% of the willow waddles planted in the fall of 2005 show extensive leafing and appear to be establishing a solid vegetated strip along the length of the riverbank.

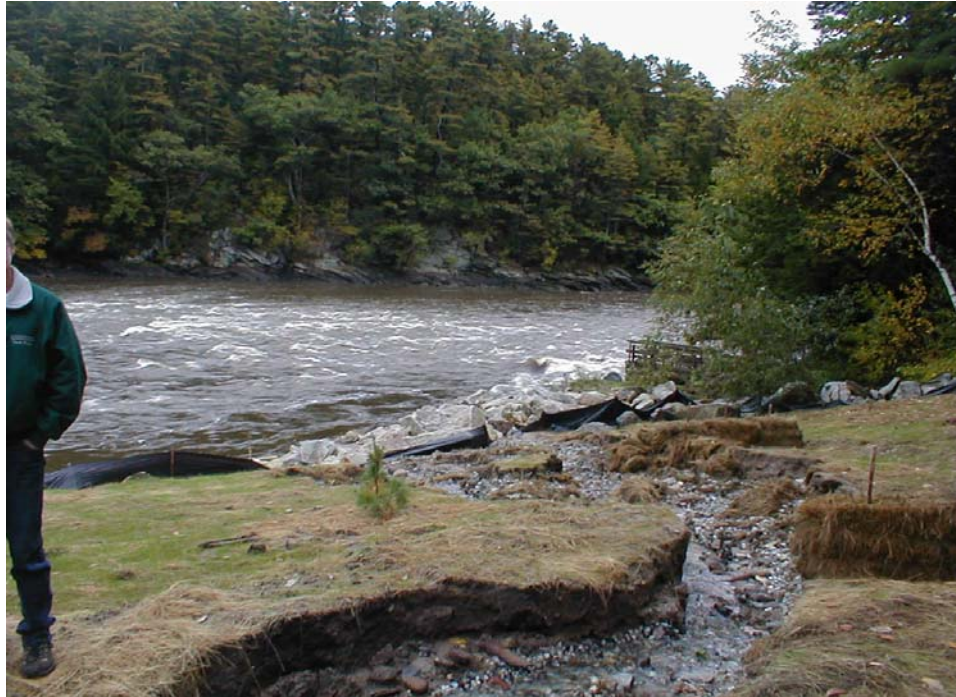
Fall 2005. Smelt Hill swale, lower run, after over 10 inches of rain falls in the area in one week.

During the period between October 8 and October 15 2005, the closest climate monitoring station recorded rainfall totals of 10.68 inches, more than 6 inches of which occurred over a two-day period on October 8th and 9th. For the month, the area received over 10 inches above normal precipitation totals. The record rain fall revealed complexities in the hydrology of the site which were not evident prior to project implementation, and three additional drainage channels emerged on site during the storms. Rapid response and dedicated repair and erosion control efforts by NEA personnel prevented large scale erosion at the site, but significant erosion did occur, particularly in the swale and in newly formed drainage channels outside the swale. Consequent sediment movement presented an immediate need for adaptive management. At this time, CBEP consulted with representatives from the Maine Coastal Program, Maine State Planning Office, and Maine Department of Environmental Protection, as well as several consultants to identify adaptive management alternatives to achieve long-term site stability.

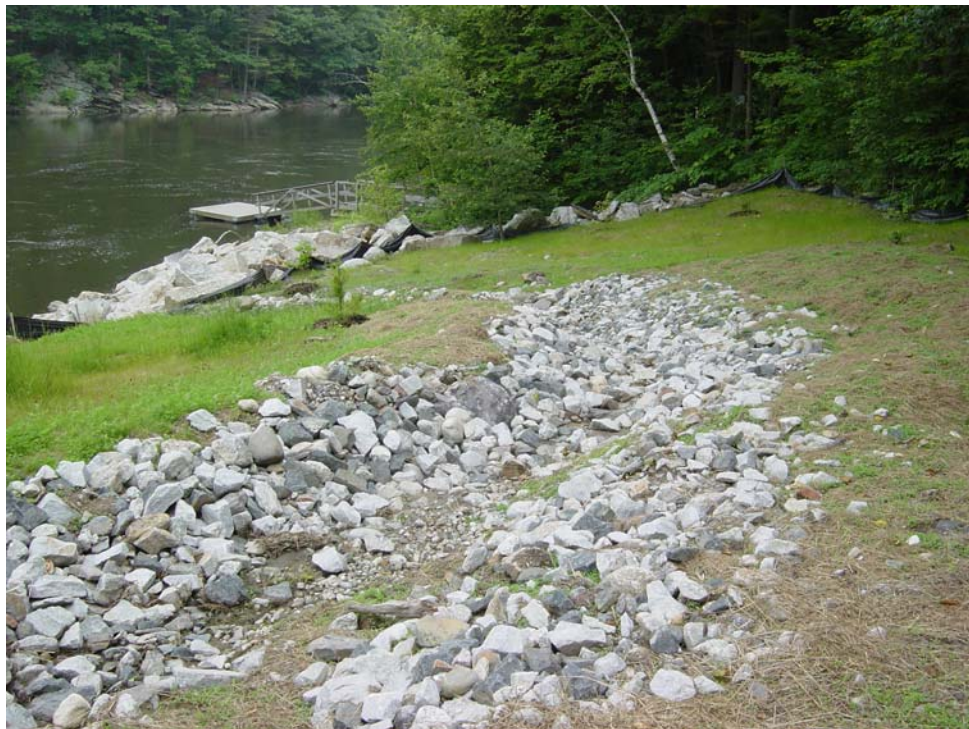
June 29, 2006. Smelt Hill swale, lower run, post Phase II adaptive management implementation.

recommendations. In late April 2006, live stakes were planted adjacent to drainage channels and the entire site was reseeded. Between June 20 and June 27, 6-12 inch rip-rap, 1-2 foot boulders, and erosion control mulch were delivered and used to prevent further erosion, create a series of settling basins and checks dams, strengthen the swale, build up berms adjacent to drainage channels, and stabilize other areas around the site as needed. Additional work is scheduled for the site in July 2006, including additional revegetation work, planting, swale stabilization and erosion repair by the newly formed Presumpscot River Youth Conservation Corps (PRYCC). The PRYCC will also be working with abutting landowners to reduce on-site flow of sediment from erosion occurring above the site on private property by creating additional settling basins and stabilizing eroding channel banks. Once all implementation activities on site have been concluded, the original silt fencing will be removed.

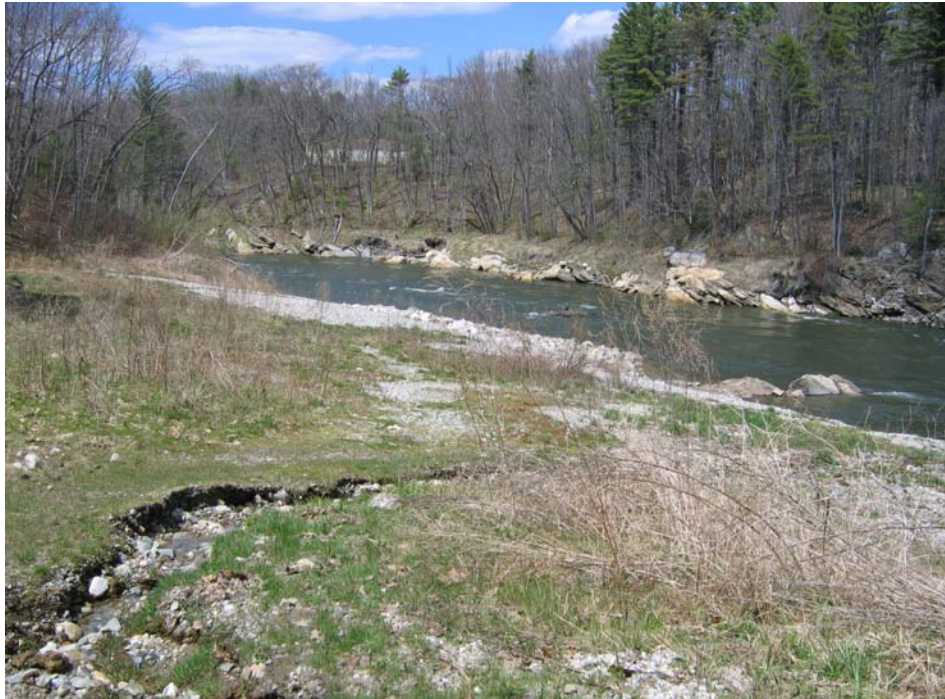
April 2005. Original stormwater runoff channel pre project implementation.

Address stormwater runoff & erosion: There was also a need to improve stormwater runoff at the site. Prior to project implementation, stormwater runoff had created a deepening and widening gully during significant rain events. A significant headcut had formed and was migrating up the slope. Most of the stormwater appeared to be coming from an existing catch basin and culvert outlet, rather than the road itself. A small, crushed rock trail leading down from one house lot may have exacerbated the erosion by channelizing the stormflow and not allowing it to spread out through the woods. The gully downstream of the culvert outlet but upstream of the project site showed signs of recent erosion, with the channel widening and eroding down to boulder or bedrock material and resulting in sediment deposition into the Presumpscot River. The storm flow exited the woods at the access road and then ran in the eroded gully down across the riprap slope. The upper riprap (crushed rock) had slumped in a few areas due to the runoff over the slope.

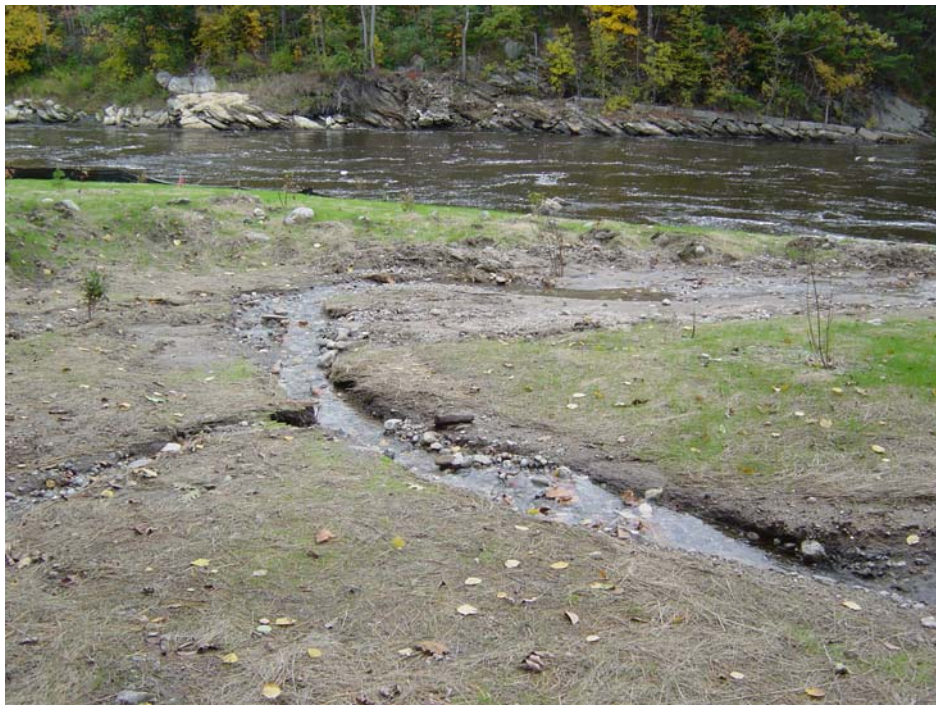
Fall 2005. Grassed swale following October rain events.

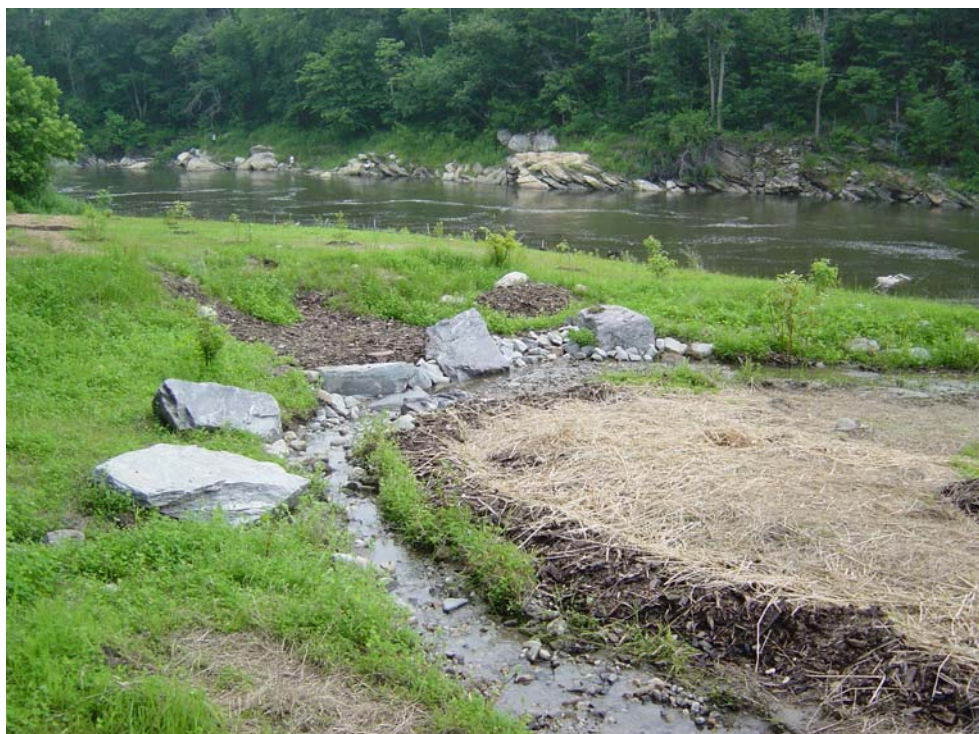
June 2006. Swale after Phase II adaptive management. Hayed area will be reseeded by Presumpscot Youth Conservation Corps the second week of July.

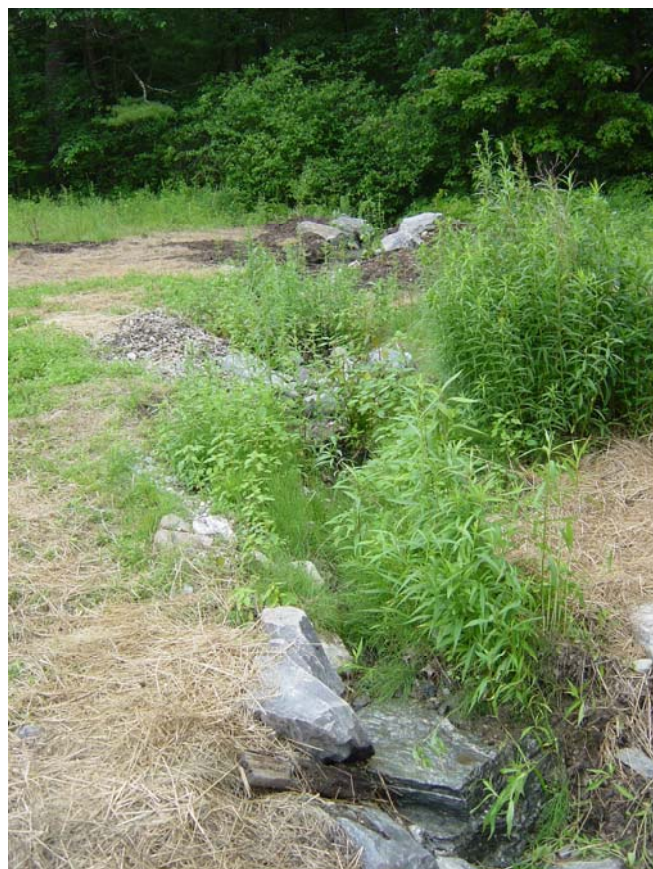
June 29, 2006. This drainage channel emerged during heavy rains in October 2005. Phase II adaptive management installed large boulders and some of the plants seen in the background. The Presumpscot River Youth Conservation Corps will continue this naturalization process at other low flow drainages on the site in July 2006.

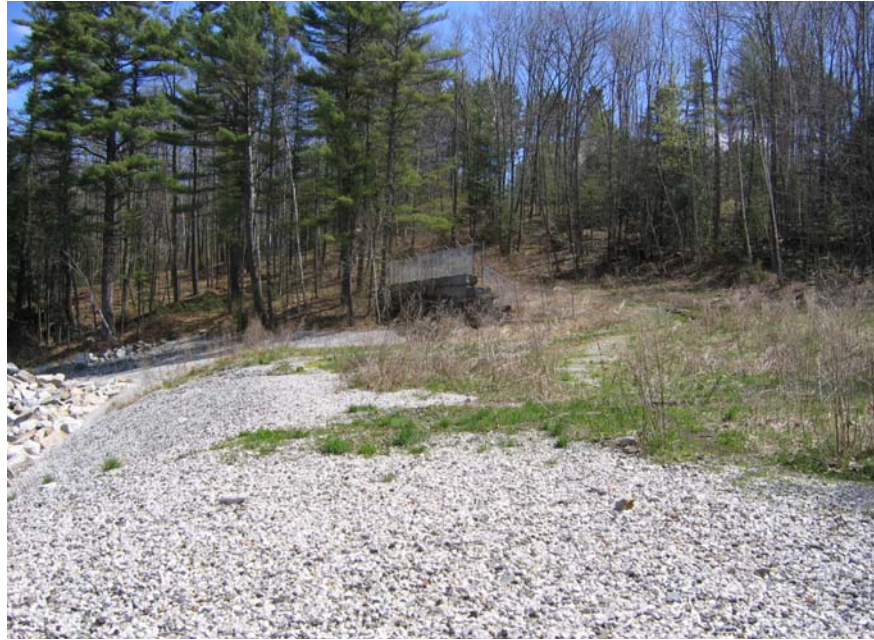
April 2005. The site pre-project implementation.

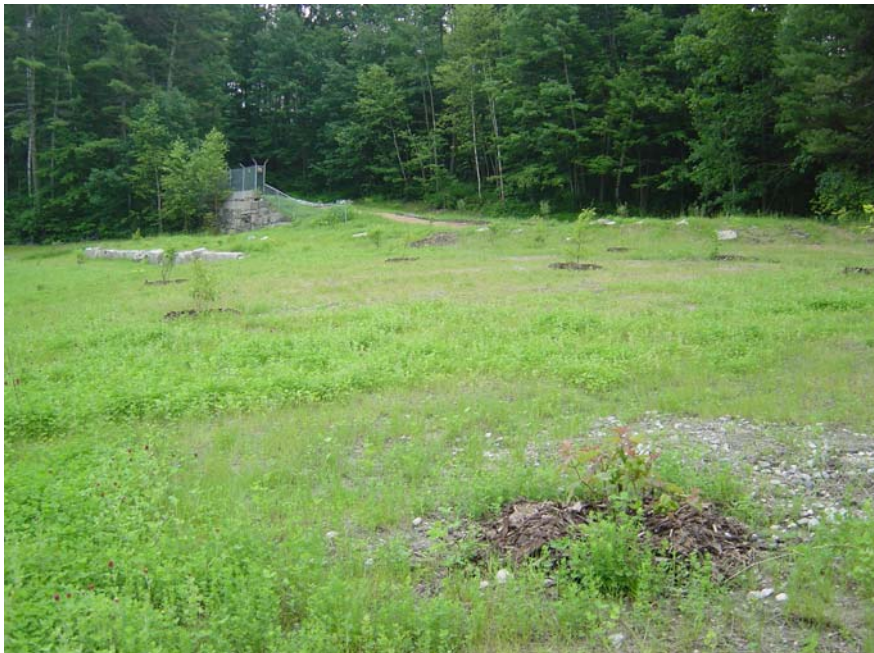
June 29, 2006. Site post- Phase II implementation. Note granite wall to the left, which was unearthed during Phase I regrading activities.

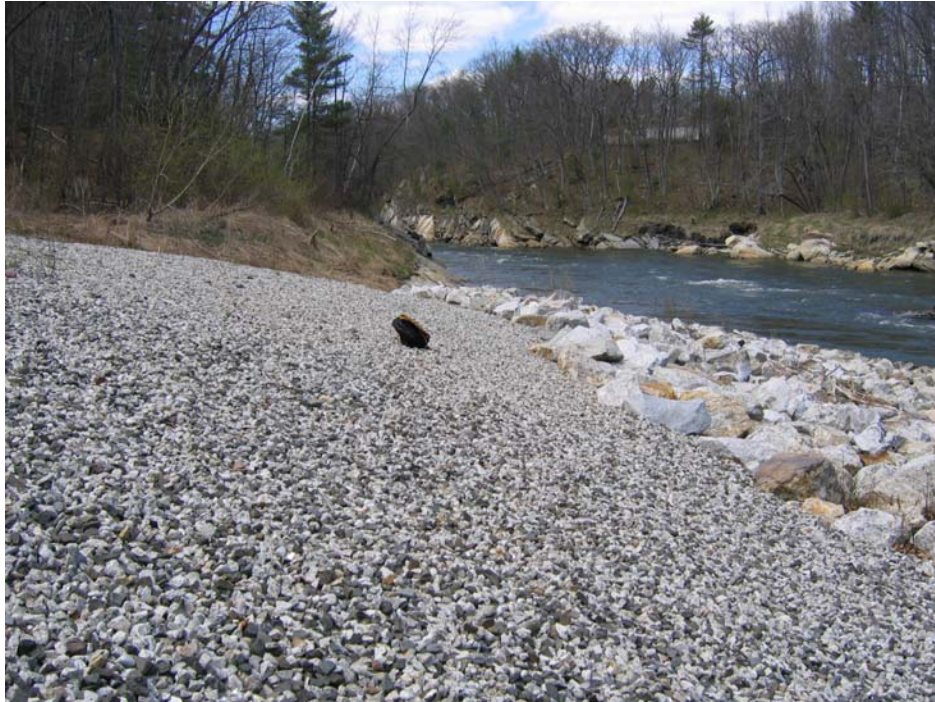
June 29, 2006. Site post- Phase II implementation. Note granite wall to the left, which was unearthed during Phase I regrading activities.

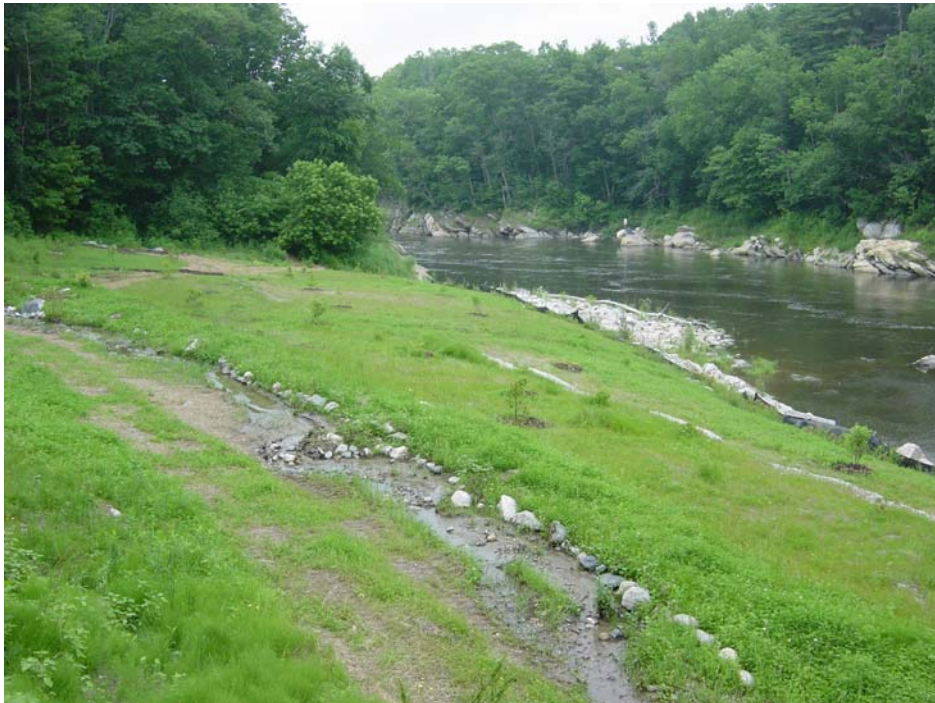
June 29, 2006. Site post- Phase II implementation. Note granite wall to the left, which was unearthed during Phase I regrading activities.
