## Habitat Restoration Inventory Summary Report for the Royal River, Spruce Creek, and Lower Kennebec River Estuary

**HABITAT RESTORATION INVENTORY  
SUMMARY REPORT  
FOR THE  
ROYAL RIVER, SPRUCE CREEK, AND LOWER KENNEBEC  
RIVER ESTUARY  
VOLUME I**

**DECEMBER 2005**

**Prepared by: Northern Ecological Associates, Inc.  
451 Presumpscot Street  
Portland, Maine 04103**

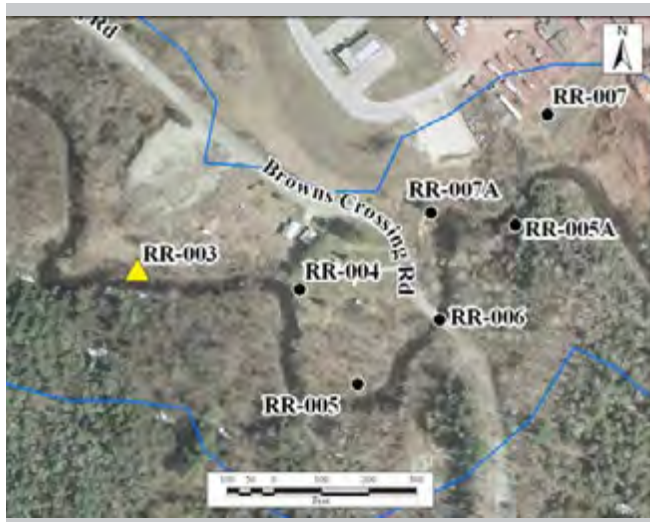
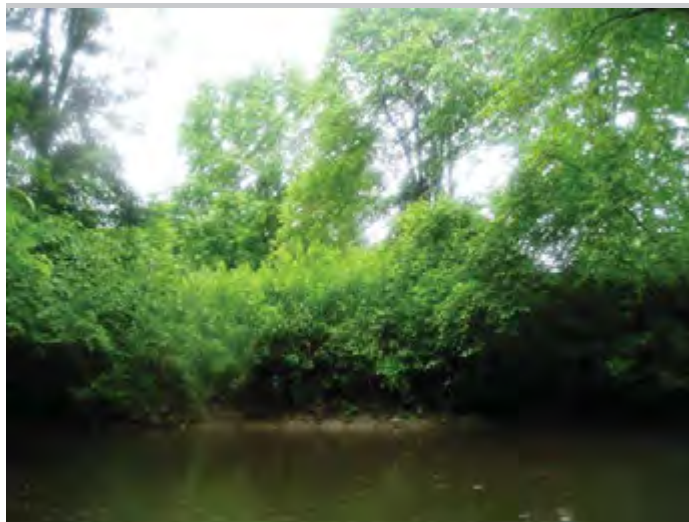
Narrow, low quality buffer. Existing shrubs and herbs are good, however more plantings are desirable.

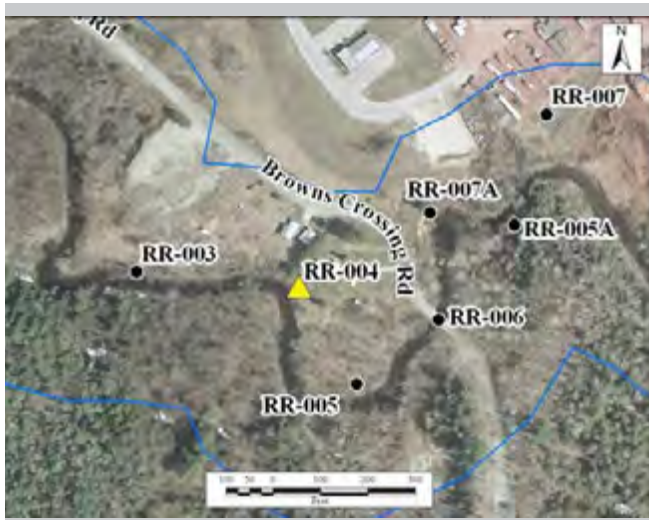
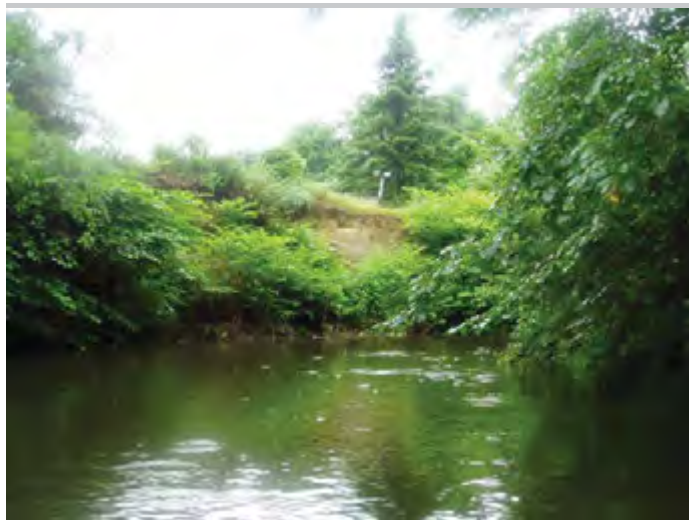
Narrow buffer of herbs to top of bank, then mowed lawn. No overstory vegetation. Eroding bank (10-foot high by 100-foot wide), vegetated in part with Japanese knotweed.

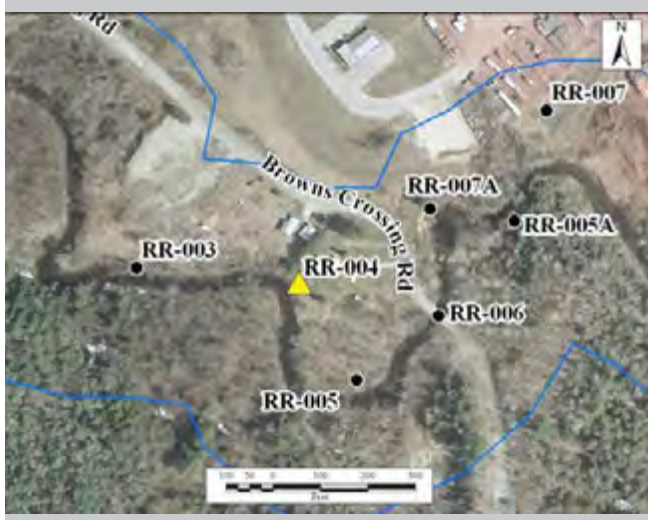
Japanese knotweed stand, approximately 75 x 10 feet.

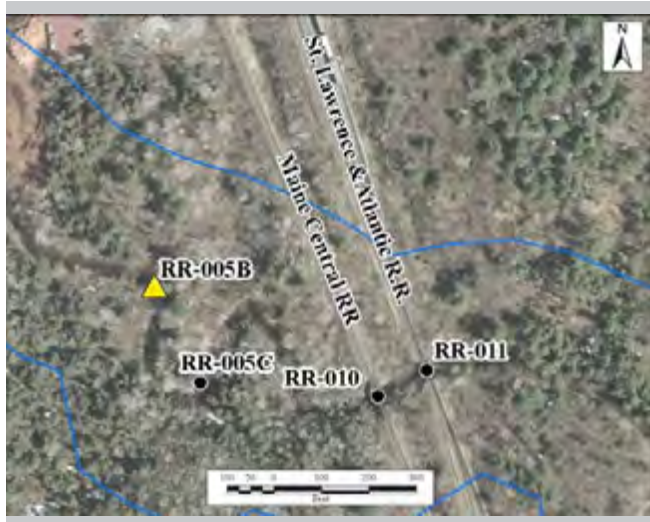
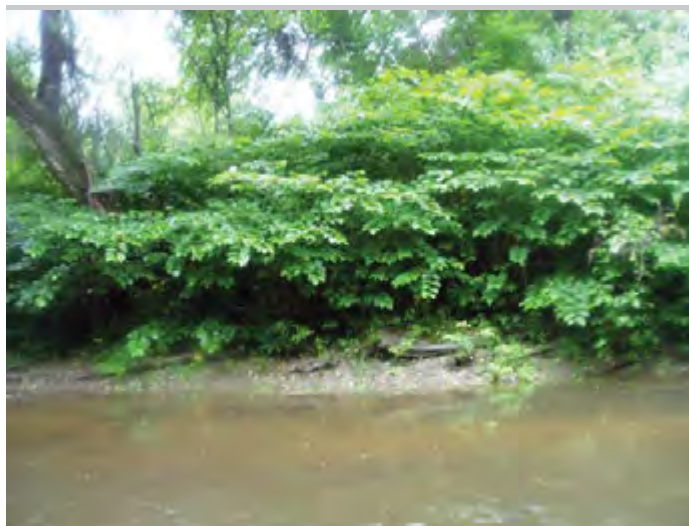
Japanese knotweed stand, approximately 75 x 10 feet.

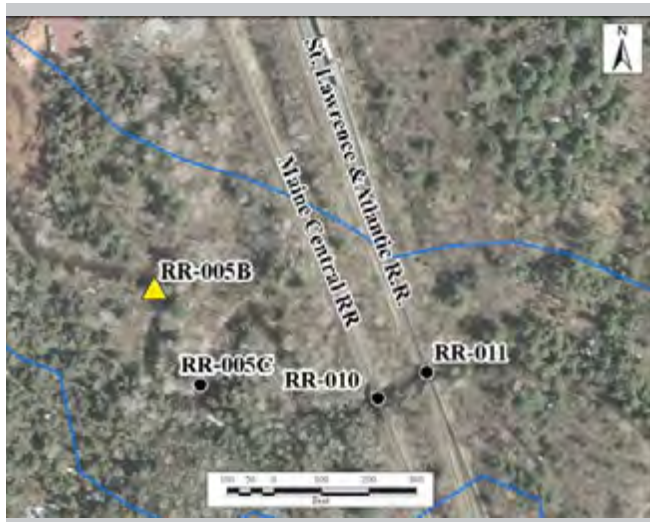
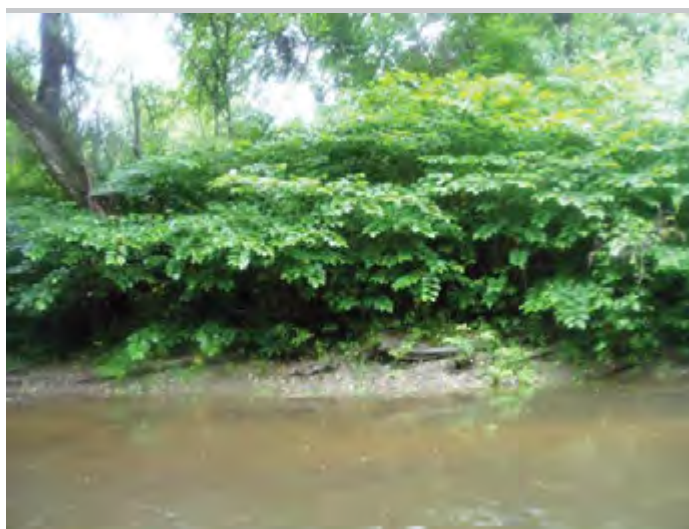
Japanese knotweed stand, approximately 40 x 10 feet.

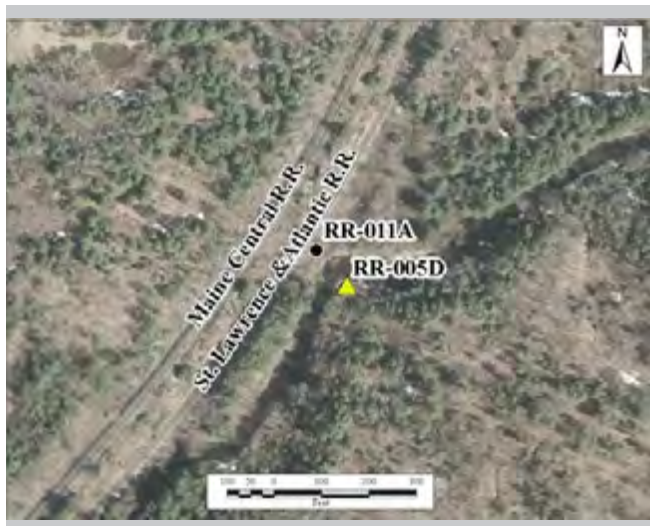
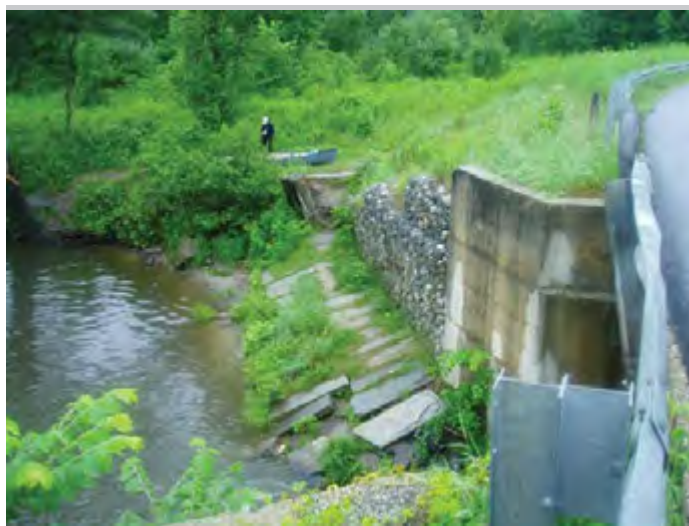
Japanese knotweed stand, approximately 20 x 6 feet.

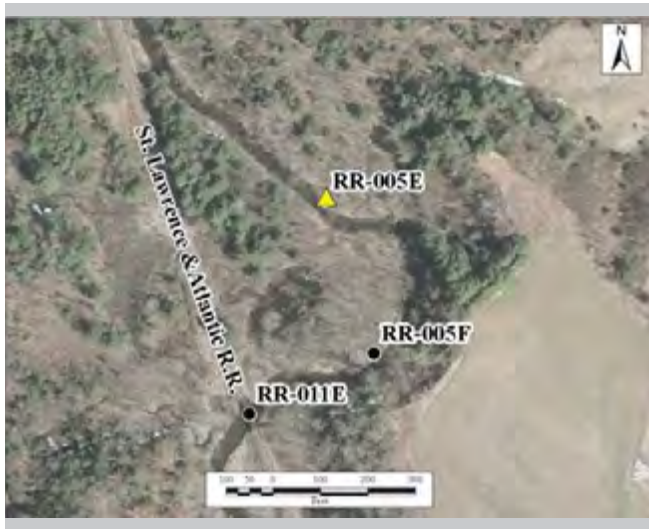
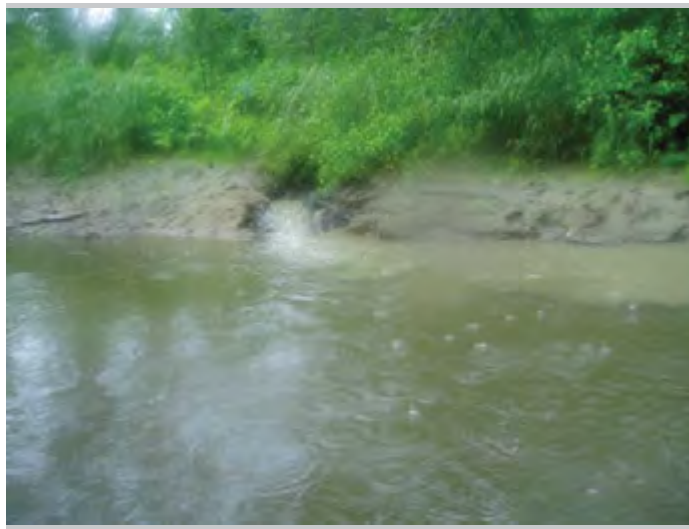
Japanese knotweed stand, approximately 50 x 10 feet. Tributary with high turbidity dumping into river.

**Sources of Degradation (13 possible):** Drainage issue, Invasive plant species

**Total Degradation Score (higher score indicates a higher level of degradation):** 0.75

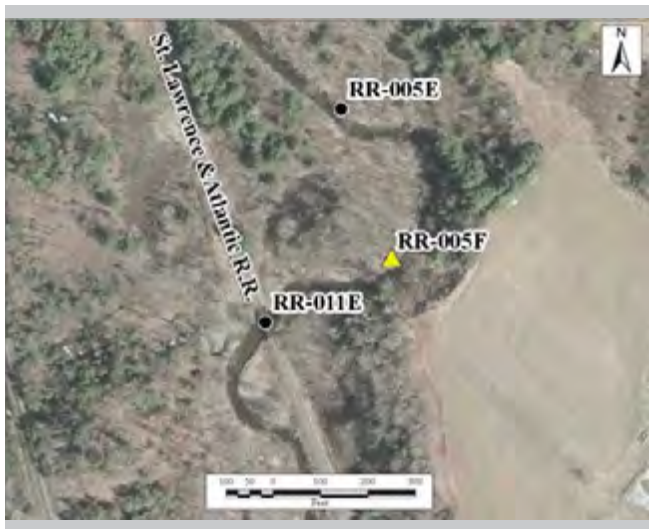
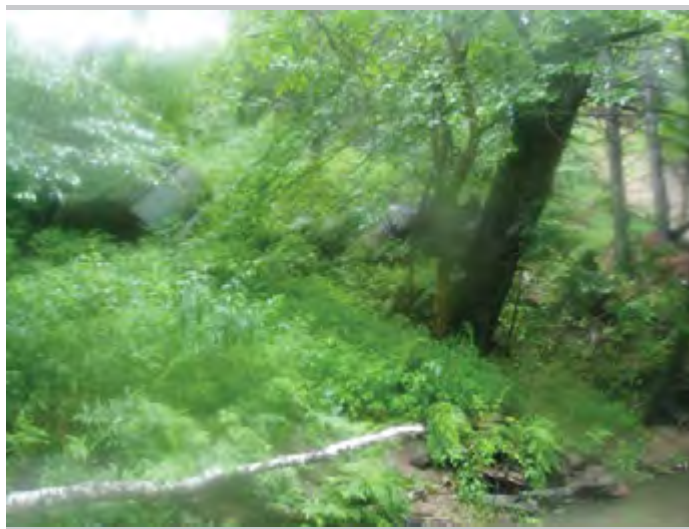
Trash/debris/old cars dumped on one side of the bank. Japanese knotweed along 75 foot section, and bank erosion along 25 foot section of other bank.

**Sources of Degradation (13 possible):** Fill/debris/trash, Invasive plant species, Unstable bank

**Total Degradation Score (higher score indicates a higher level of degradation):** 0.65

May require multiple treatments to fully eradicate. Heavy equipment may be needed to remove cars. Potential hazardous material (i.e., oil and gas) removal.

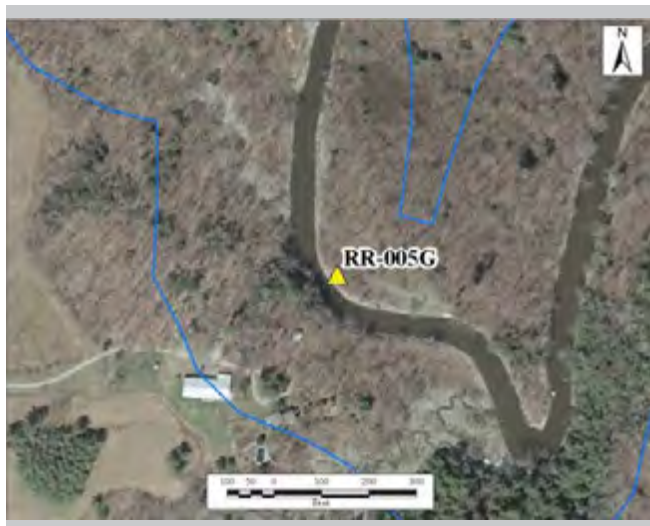
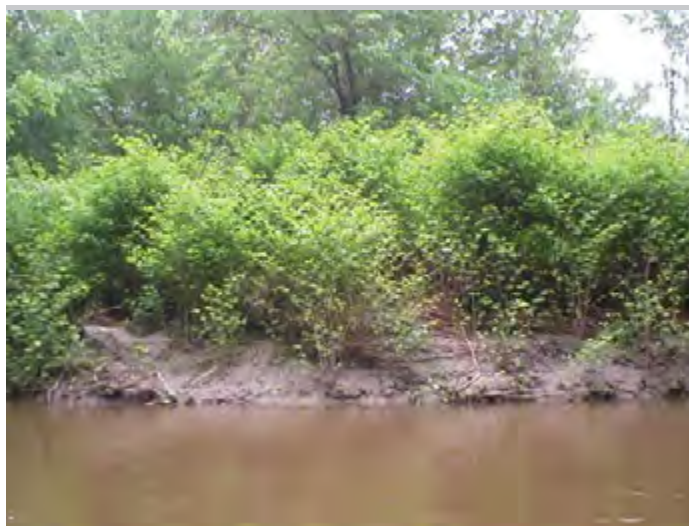
Japanese knotweed approximately 100 x 20 feet.

**Sources of Degradation (13 possible):** Invasive plant species

**Total Degradation Score (higher score indicates a higher level of degradation):** 0.50

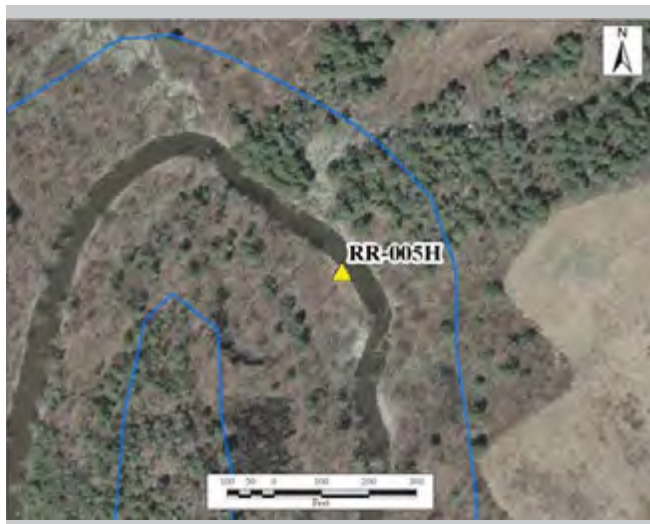
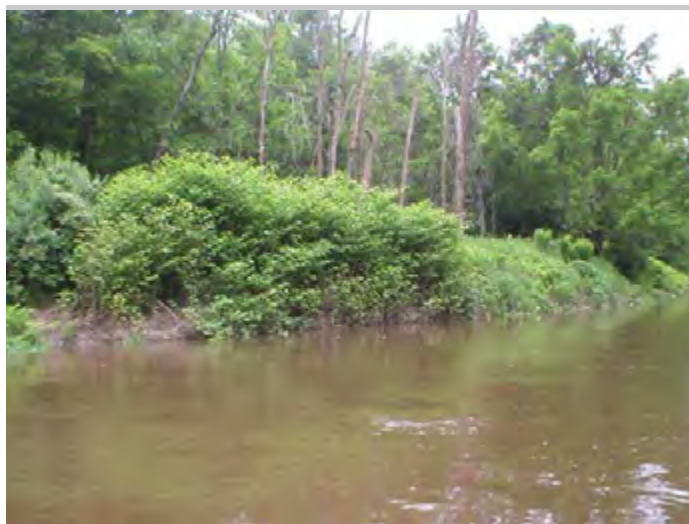
Japanese knotweed stand 40 x 15 feet.

**Sources of Degradation (13 possible):** Invasive plant species

**Total Degradation Score (higher score indicates a higher level of degradation):** 0.25

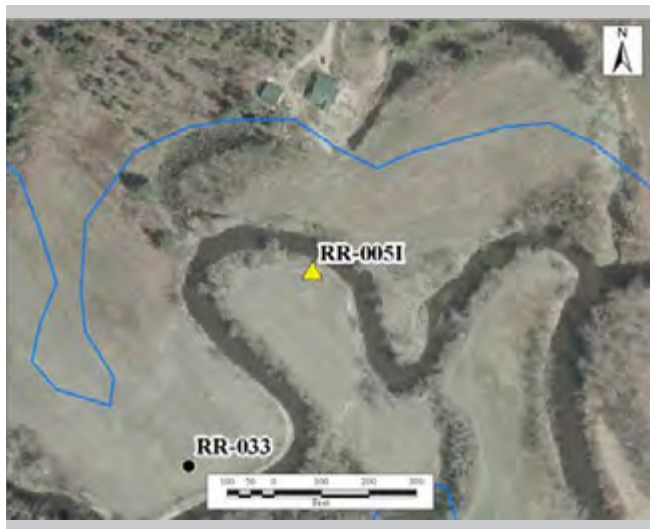
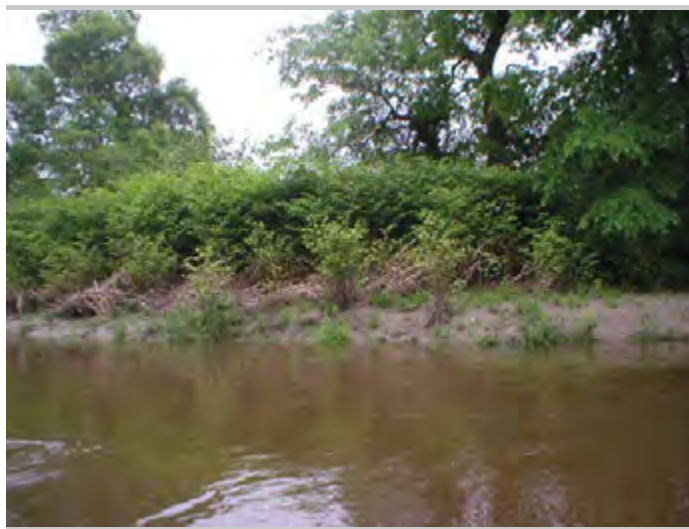
Japanese knotweed stand, approximately 10 x 75 feet.

**Sources of Degradation (13 possible):** Invasive plant species

**Total Degradation Score (higher score indicates a higher level of degradation):** 0.40

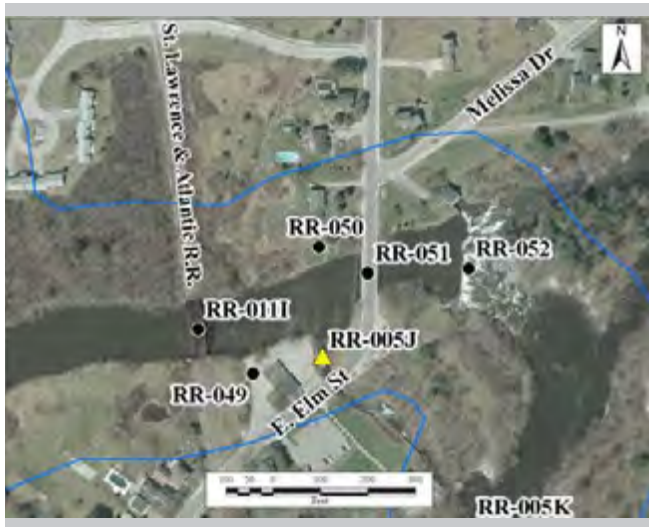
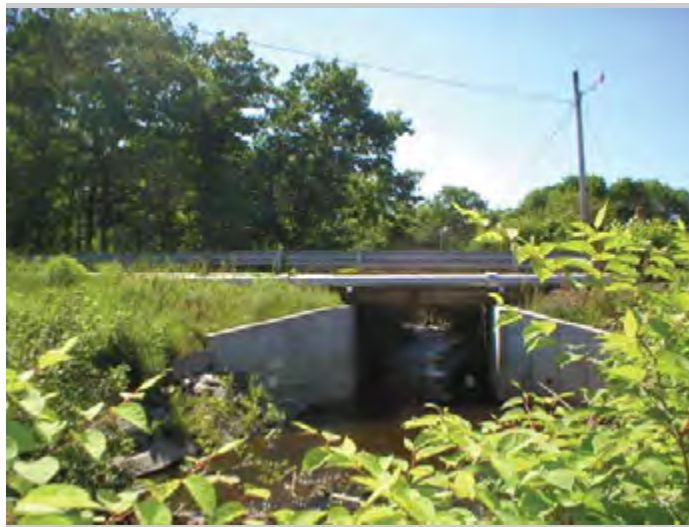
Japanese knotweed stand, approximately 10 x 60 feet located on north side of East Elm Street, Yarmouth.

**Sources of Degradation (13 possible):** Invasive plant species

**Total Degradation Score (higher score indicates a higher level of degradation):** 0.25

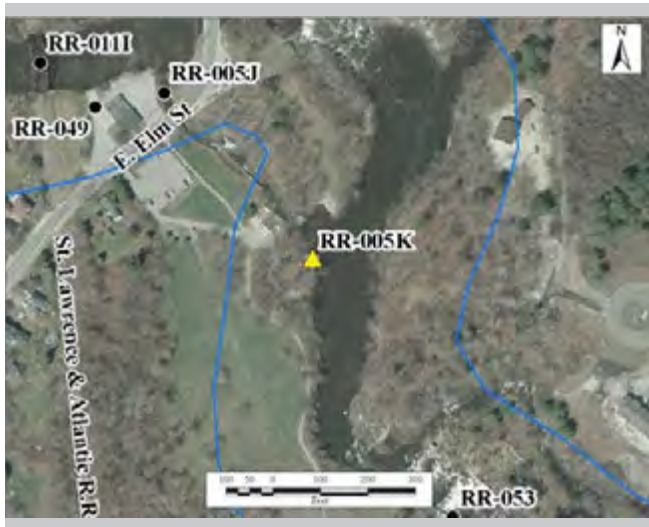
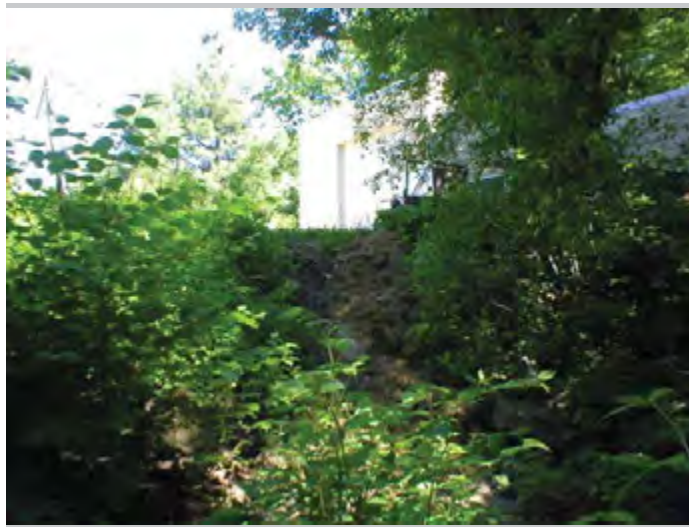
Japanese knotweed stand on west bank of the Royal River, approximately 15 x 40 feet. Dumped lawn clippings and debris impeding natural vegetation growth behind town park maintenance buildings.

**Sources of Degradation (13 possible):** Fill/debris/trash, Invasive plant species

**Total Degradation Score (higher score indicates a higher level of degradation):** 0.50

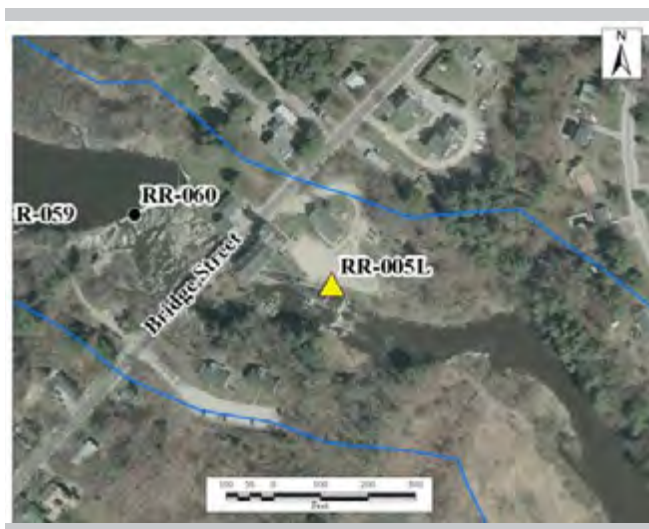
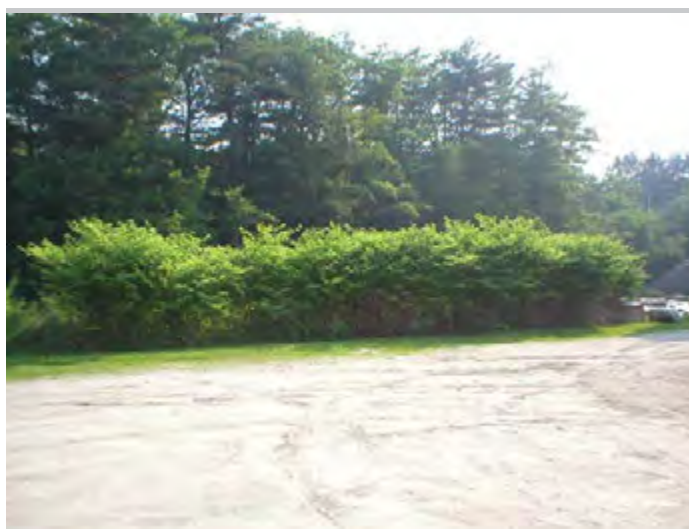
Japanese knotweed stand, approximately 6 x 60 feet. Lack of adequate buffer between dirt parking lot and river.

**Sources of Degradation (13 possible):** Invasive plant species, Land cleared

**Total Degradation Score (higher score indicates a higher level of degradation):** 1.20

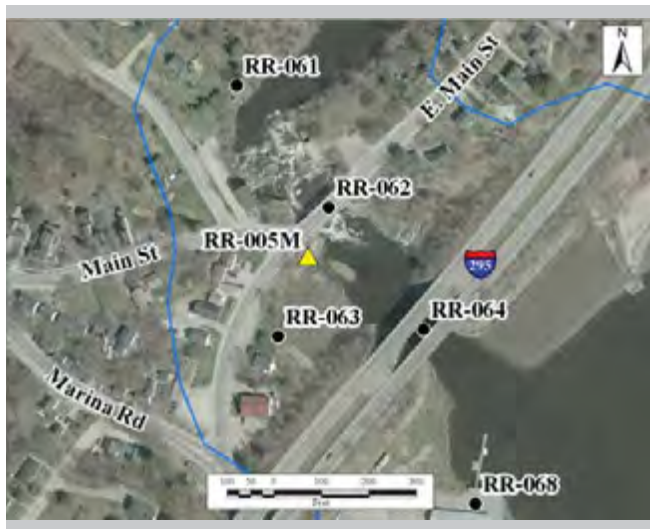
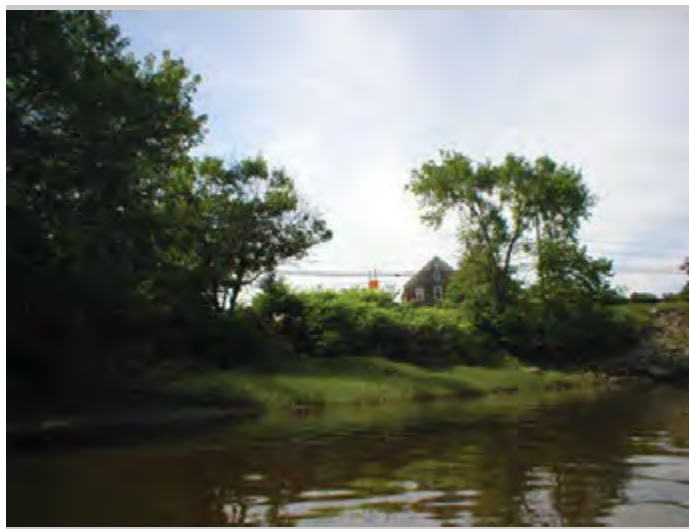
Japanese knotweed stand along road edge, approximately 75 x 15 feet. Lack of adequate buffer (herb/ shrub) along southeast side of road way.

**Sources of Degradation (13 possible):** Invasive plant species, Land cleared

**Total Degradation Score (higher score indicates a higher level of degradation):** 0.65

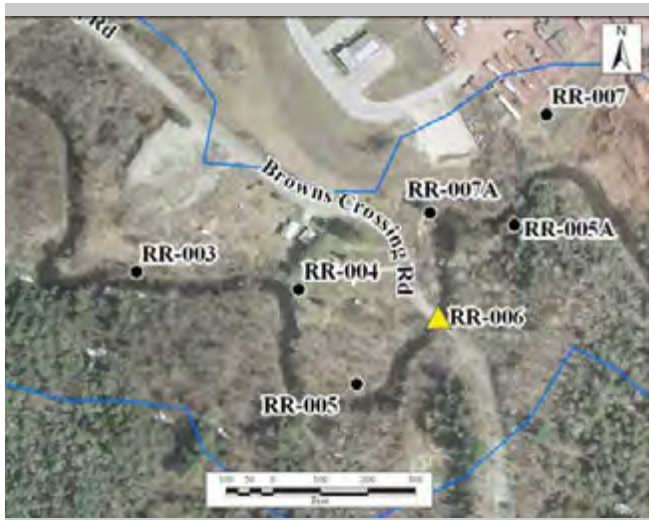
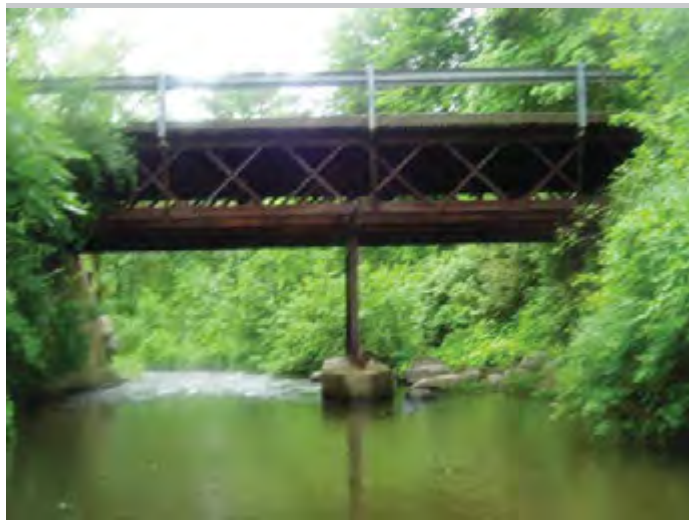
Browning Crossing Road bridge. Majority of stream flow on east side. Constriction is not a real issue. At high flow, water would flow on both sides of central cement block. Banks are generally stable with some rip-rap rocks placed. Some erosion on west side banks.

**Sources of Degradation (13 possible):** Land use activity a potential contaminant source, Right-of-way (highway, utility, railroad), Unstable bank

**Total Degradation Score (higher score indicates a higher level of degradation):** 0.30

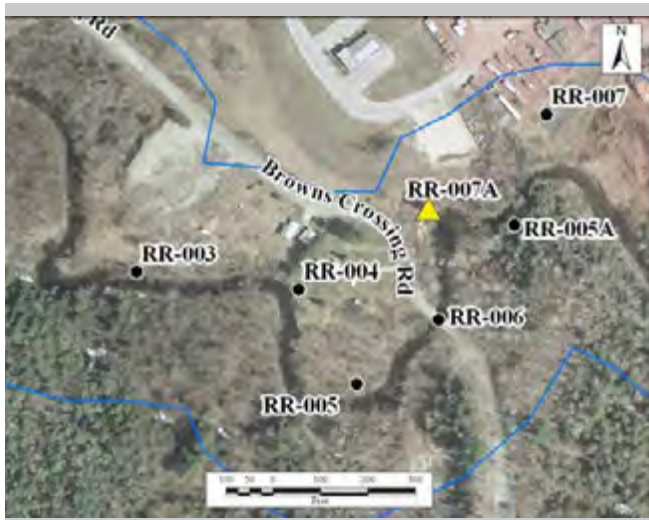
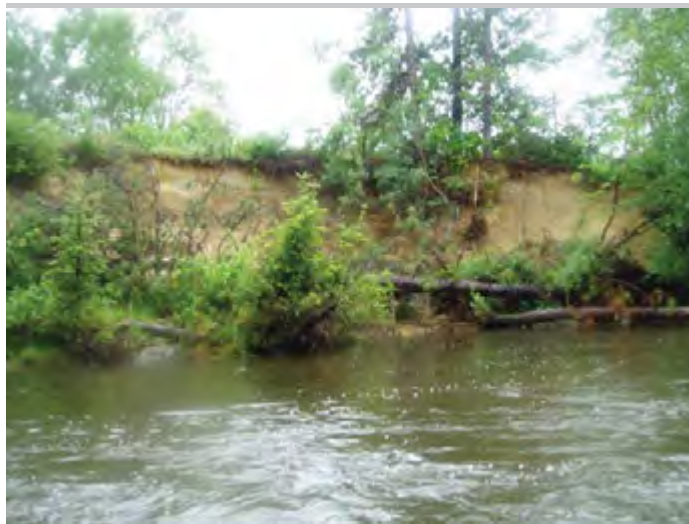
Severely eroding bank and substantial tree loss. Bare soil on banks with minimal buffer between river and Morin Brick Company parking area.

**Sources of Degradation (13 possible):** Impervious surface, Unstable bank

**Total Degradation Score (higher score indicates a higher level of degradation):** 2.00

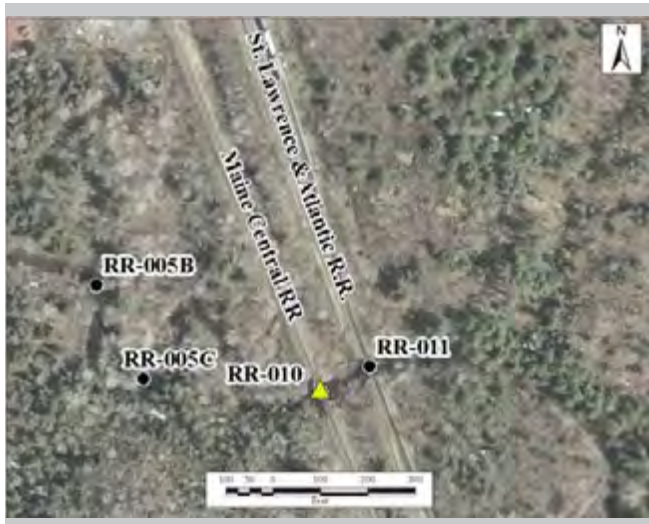
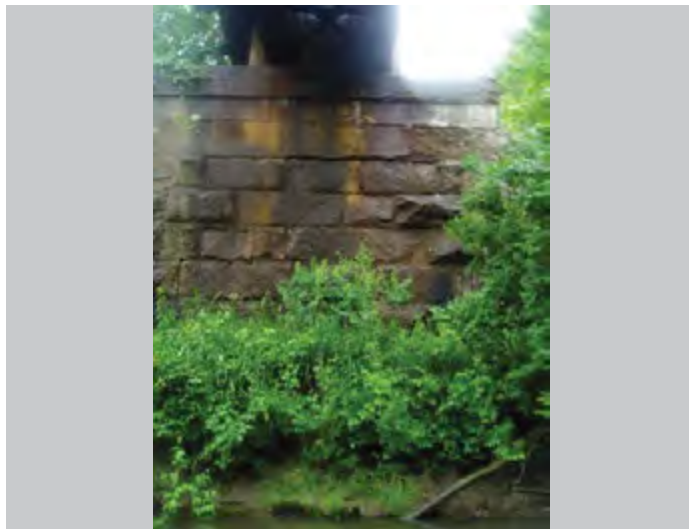
Railroad bridge crossing. Banks stable, no erosion; banks held in place with placed, cut stone. Banks well vegetated with herbs, shrubs, and trees, except for maintained ROW. Not a constriction.

**Sources of Degradation (13 possible):** Land use activity a potential contaminant source, Right-of-way (highway, utility, railroad), Rip-rap (or other artificial hard structure)

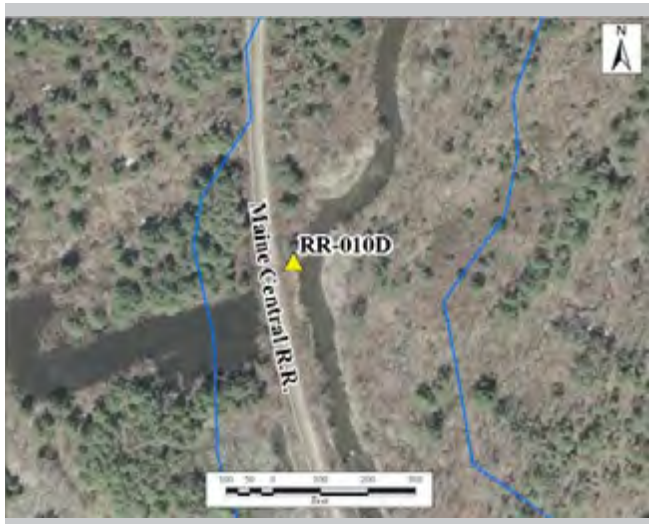
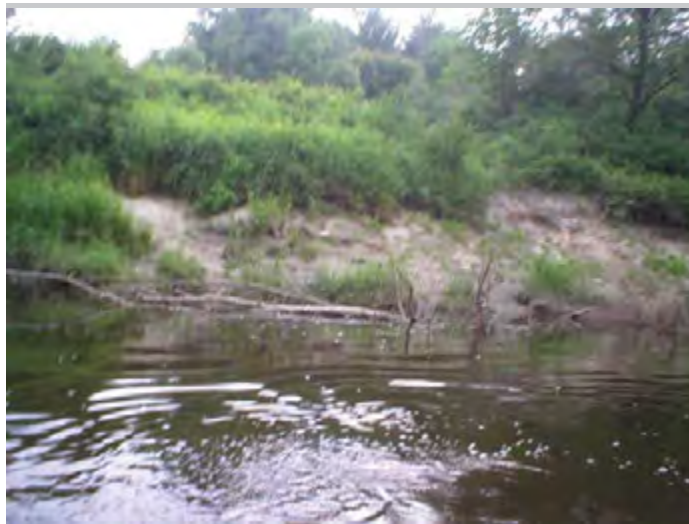
Eroding shoreline adjacent to railroad tracks. Erosion cutting toward railroad tracks and bank may eventually need significant stabilization. Narrow, maintained buffer between railroad tracks and river.

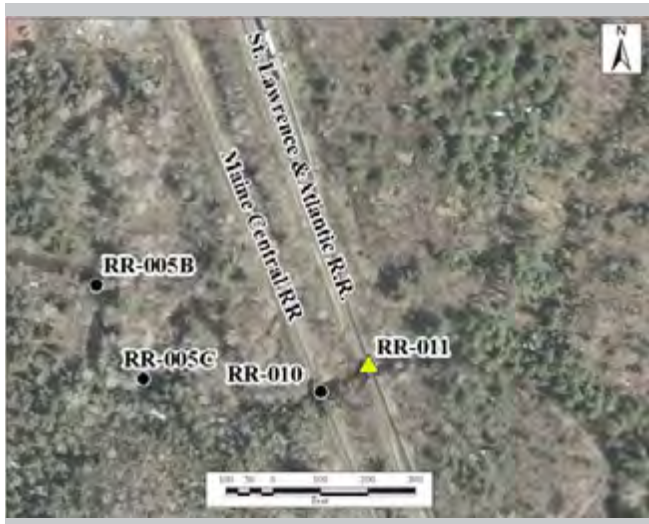
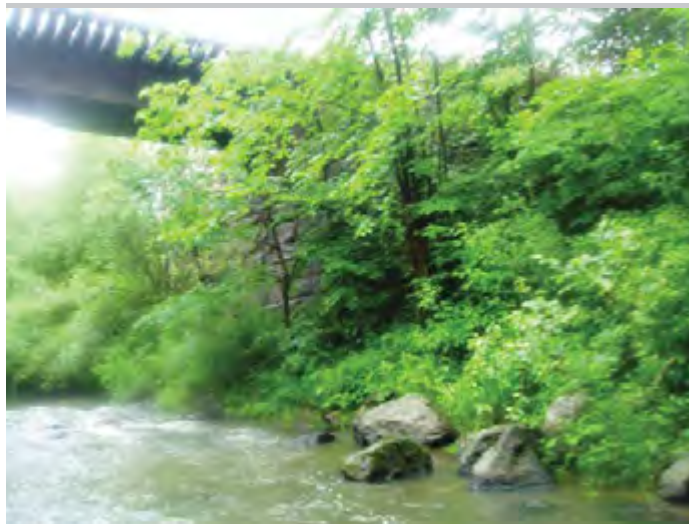
Railroad bridge crossing. Banks stable, no erosion; banks held in place with placed, cut stone. Banks well vegetated with herbs, shrubs, and trees, except for maintained ROW. Not a constriction.

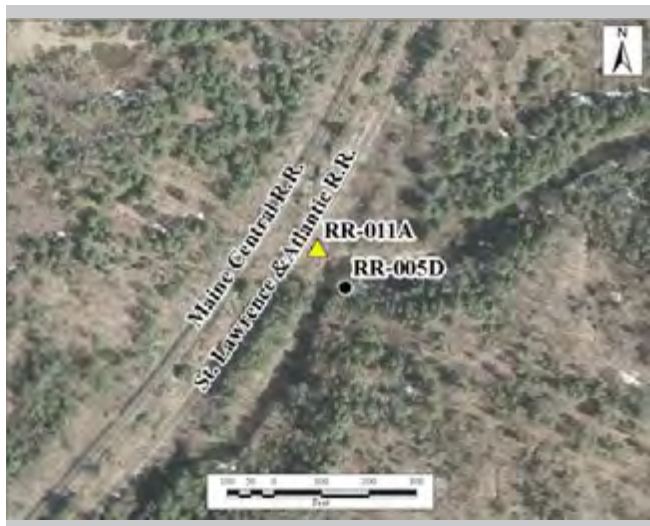
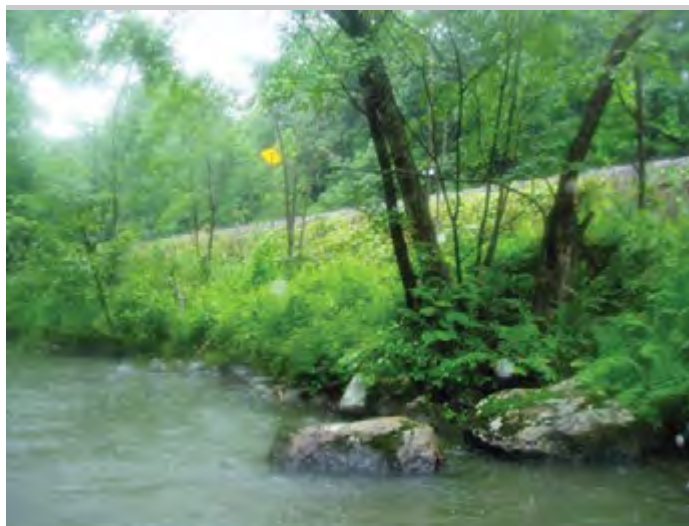
Railroad Right-of-way (ROW) maintained through cutting back of vegetation. Banks stable, not eroding. Lack of buffer is only issue. Shrubs and herbs, few trees.

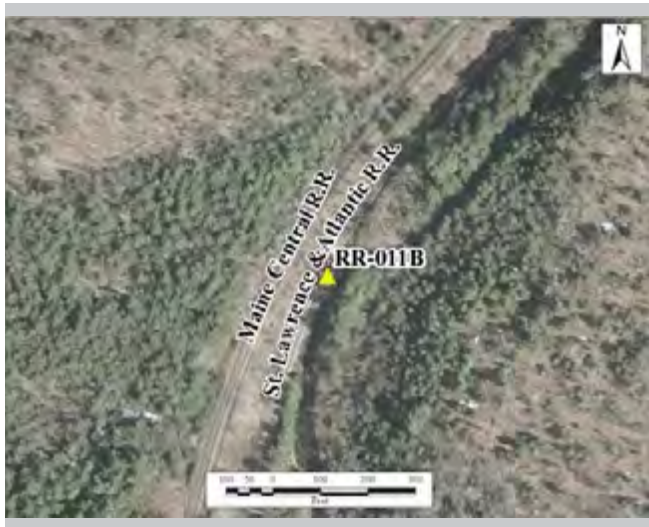
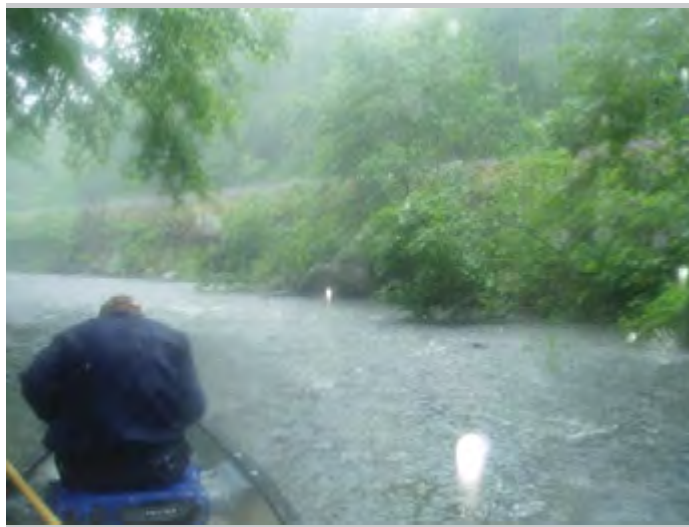
Railroad ROW maintained through cutting back of vegetation. Banks steep, but stable, not eroding. Lack of buffer is only issue.

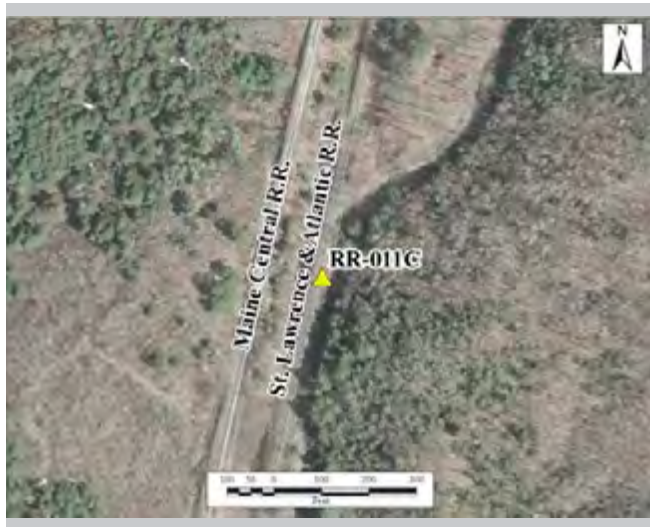
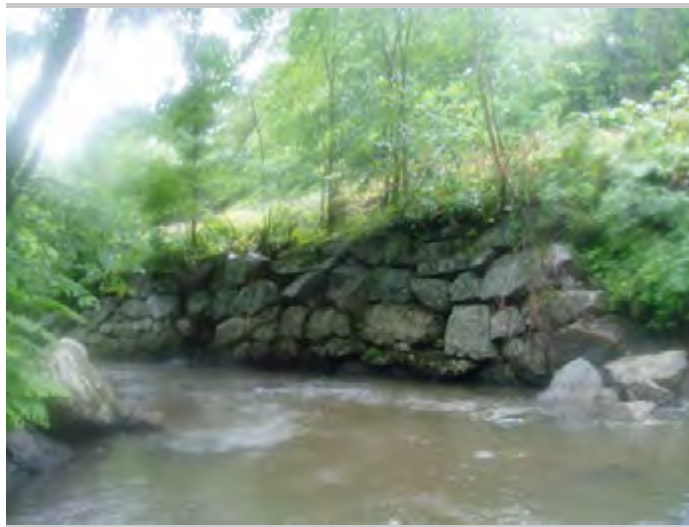
Railroad ROW maintained through cutting back of vegetation. Banks stable, not eroding. Placed, cut rock walls stabilize railroad bed, but also impede vegetation growth. Shrub and herb growth dense, despite cutting.

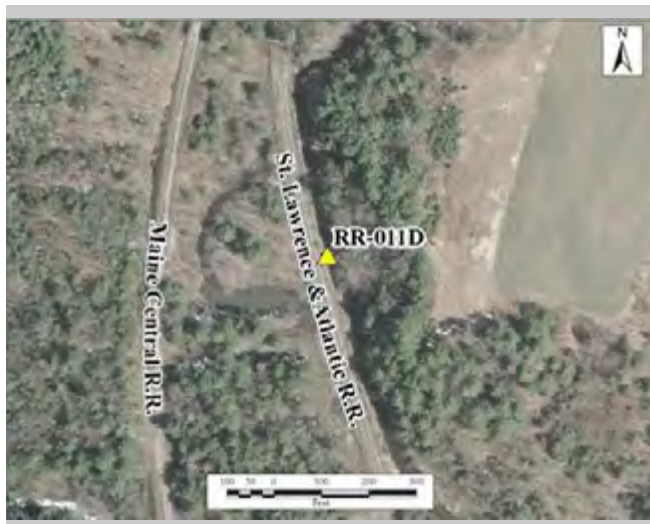
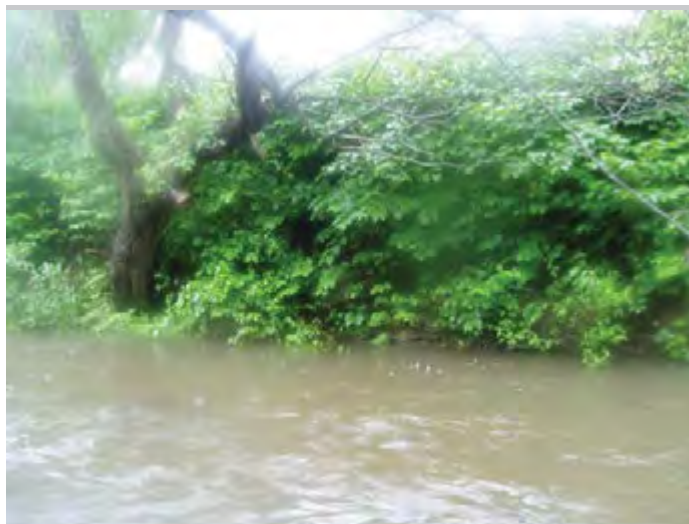
Railroad ROW maintained through cutting back of vegetation. Banks stable, not eroding. Well vegetation with shrubs and herbs.

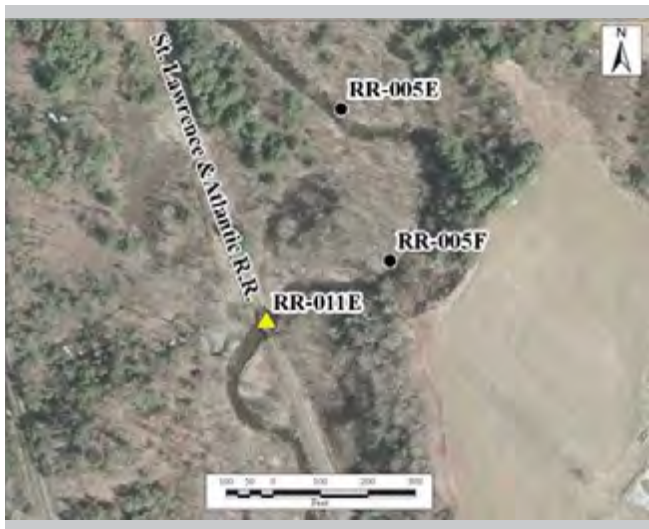
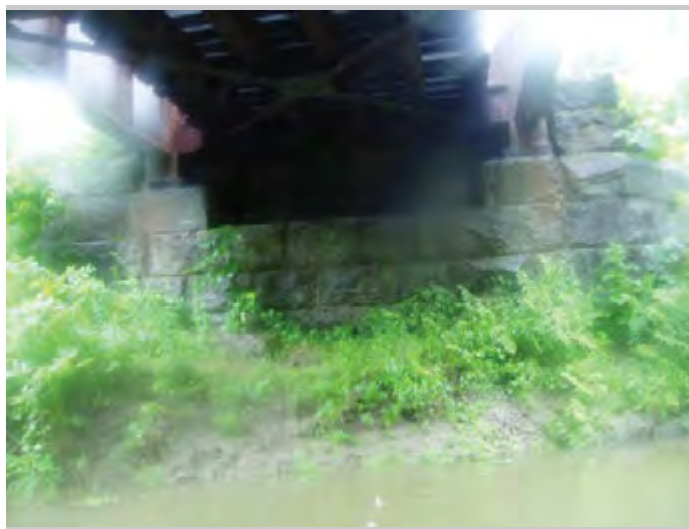
Railroad bridge crossing. ROW maintained through cutting back of vegetation. Banks stable, not eroding. Sediment deposition under bridge, with herbs revegetating in places. Banks stabilized with placed, cut rock.

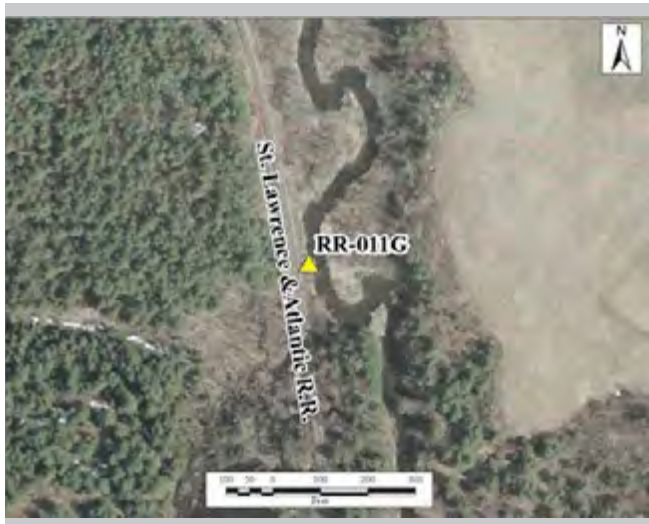
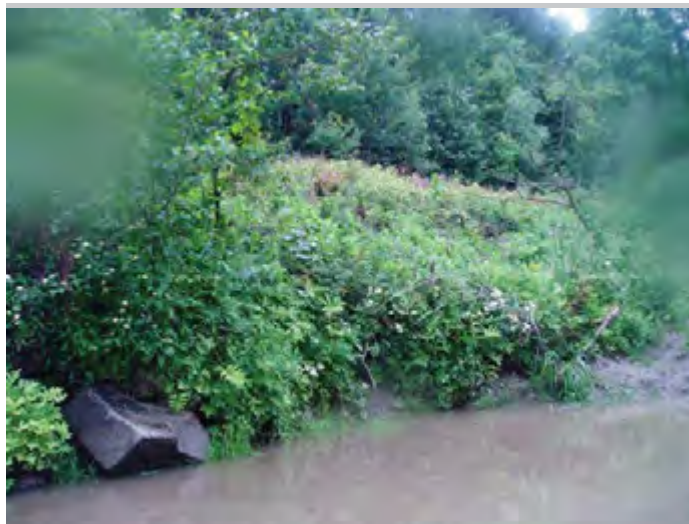
Railroad ROW maintained through cutting back of vegetation. Banks stable, not eroding. Narrow buffer (less than 10 feet) of herbs and shrubs.

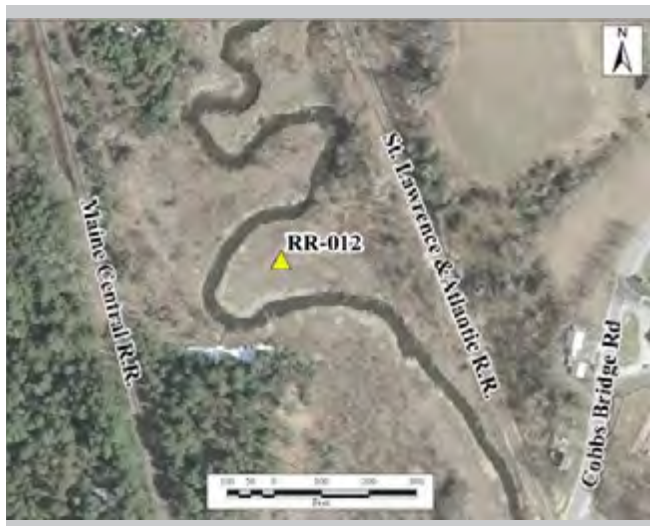
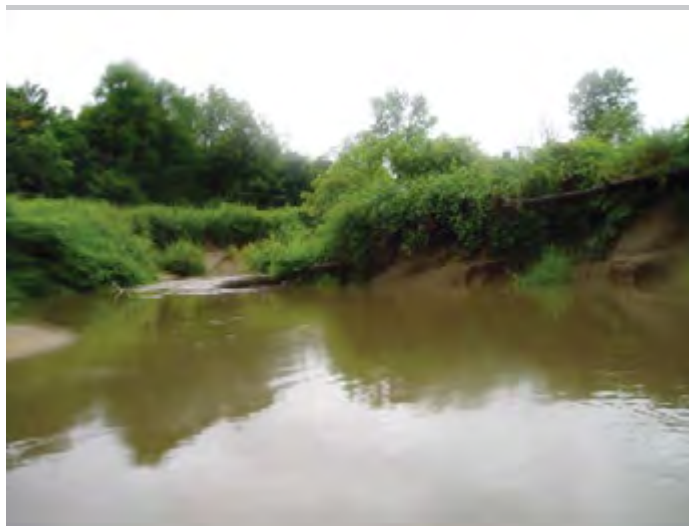
Buffer issue. Lack of shrubs and trees along river banks. Old pole leaning toward river.

**Sources of Degradation (13 possible):** Land cleared, Unstable bank

**Total Degradation Score (higher score indicates a higher level of degradation):** 0.95

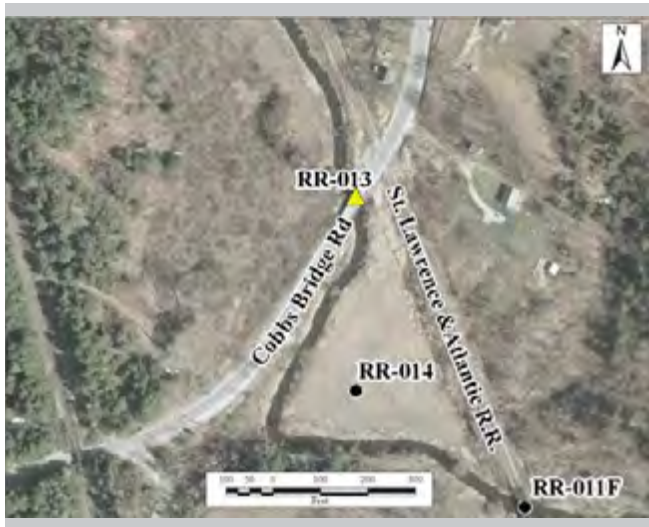
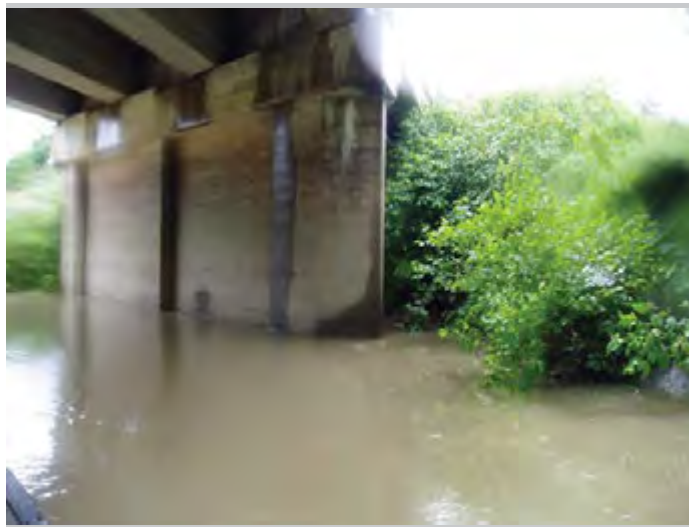
Cobbs Bridge Rd crossing. Cement bridge is a slight constriction of river. Banks are stable, not eroding. Buffer predominately herbs.

**Sources of Degradation (13 possible):** Land use activity a potential contaminant source, Right-of-way (highway, utility, railroad)

**Total Degradation Score (higher score indicates a higher level of degradation):** 0.80

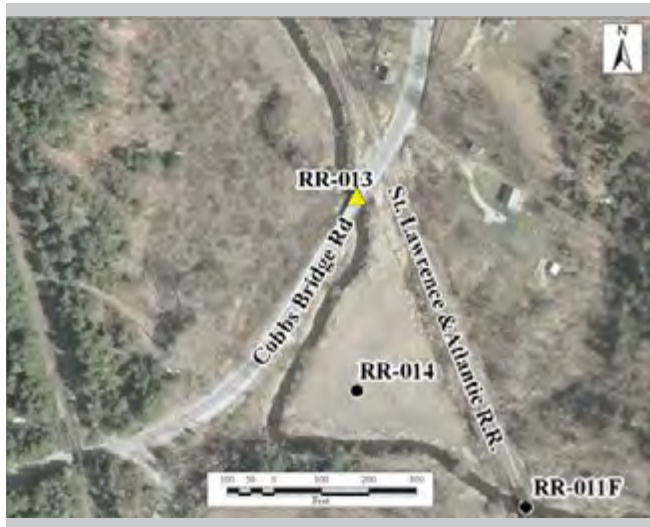
Appears to be a fallow farm, situated between the river and railroad. Vegetation comprised of milkweed and other early successional species.

**Sources of Degradation (13 possible):** Land cleared

**Total Degradation Score (higher score indicates a higher level of degradation):** 0.75

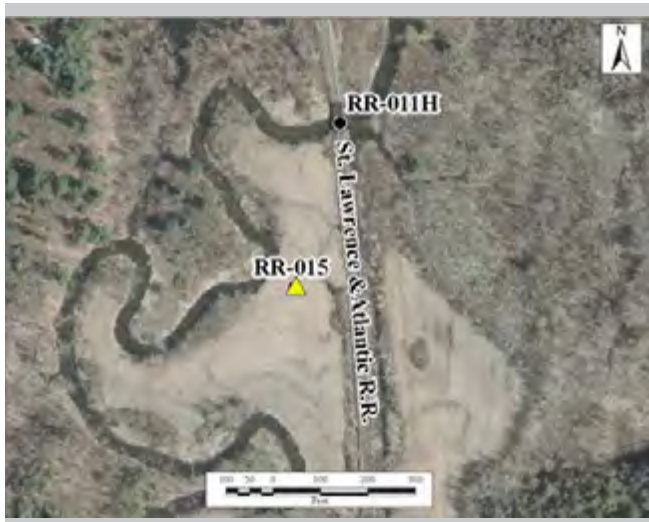
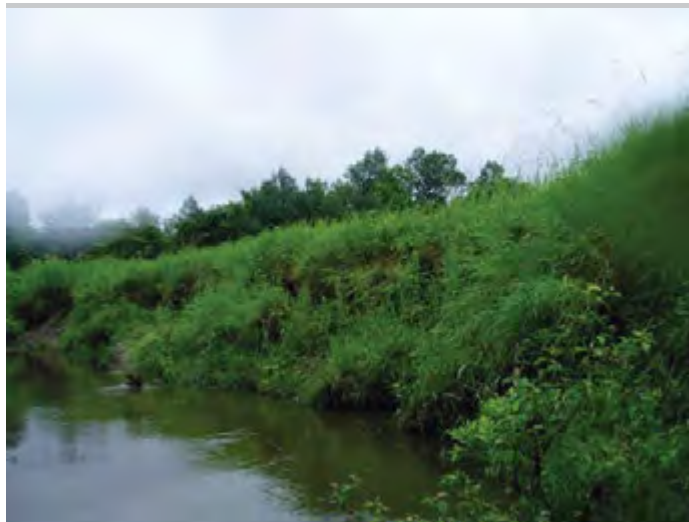
Buffer issue. Buffer comprised of herbs with few shrubs, eroding in places, but not necessarily unnaturally.

**Sources of Degradation (13 possible):** Land cleared

**Total Degradation Score (higher score indicates a higher level of degradation):** 0.85

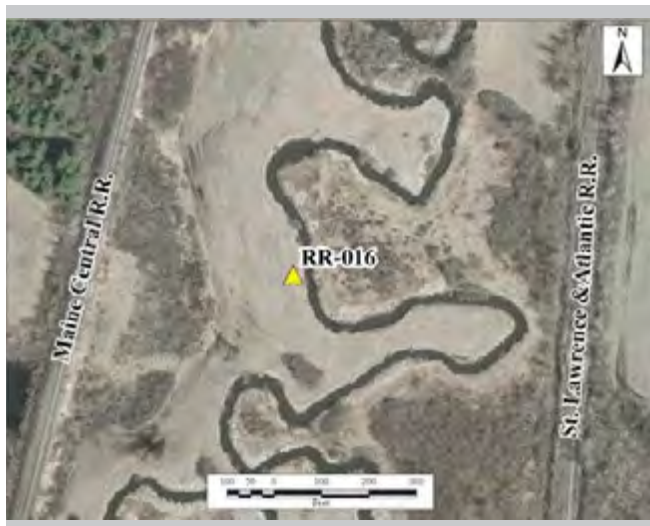
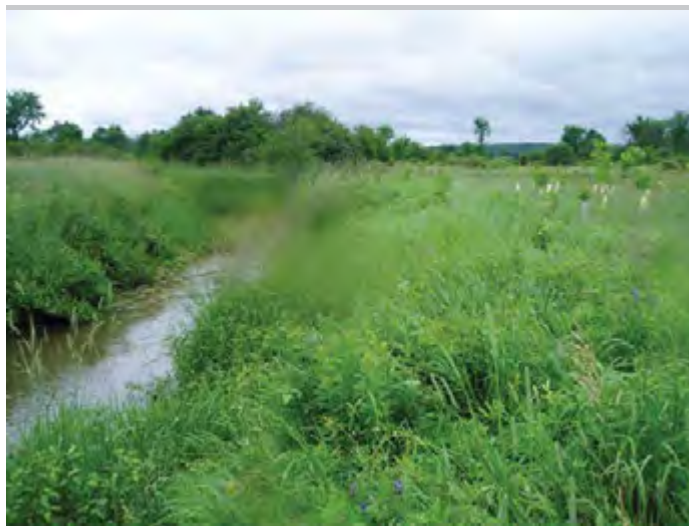
Tree farm with no real shrub/tree buffer - herbs only. Base of banks are stabilized with coir/coconut fiber matting on outside bank corners for approximately 700-feet in length.

**Sources of Degradation (13 possible):** Land cleared

**Total Degradation Score (higher score indicates a higher level of degradation):** 0.75
