## Habitat Restoration Inventory Summary Report for the Royal River, Spruce Creek, and Lower Kennebec River Estuary

**HABITAT RESTORATION INVENTORY  
SUMMARY REPORT  
FOR THE  
ROYAL RIVER, SPRUCE CREEK, AND LOWER KENNEBEC  
RIVER ESTUARY  
VOLUME I**

**DECEMBER 2005**

**Prepared by: Northern Ecological Associates, Inc.  
451 Presumpscot Street  
Portland, Maine 04103**

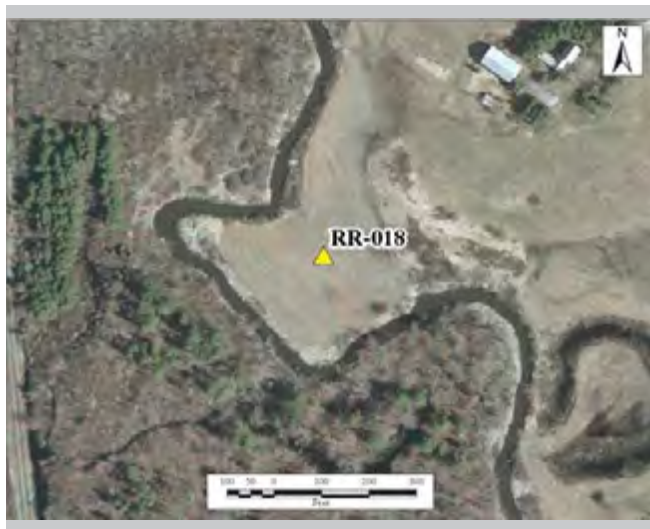
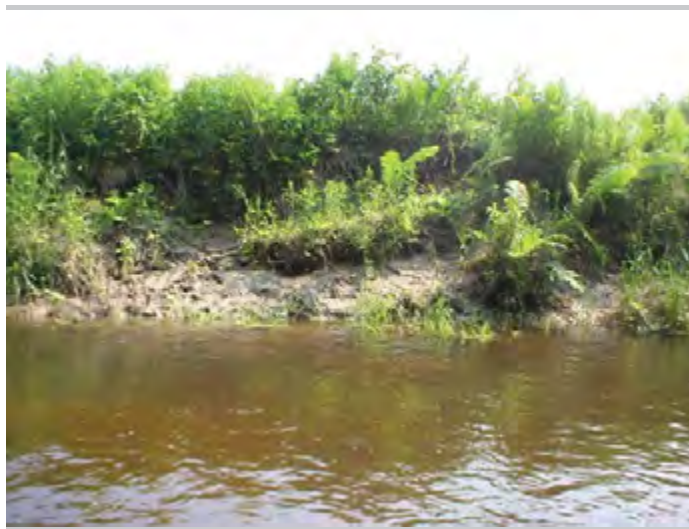
Narrow buffer of herbs, shrubs, and few trees, then agriculture. Steep banks (approx. 75% slope) are marginally vegetated leaving exposed ground, erosion, and slumping areas.

**Sources of Degradation (13 possible):** Land cleared, Unstable bank

**Total Degradation Score (higher score indicates a higher level of degradation):** 1.30

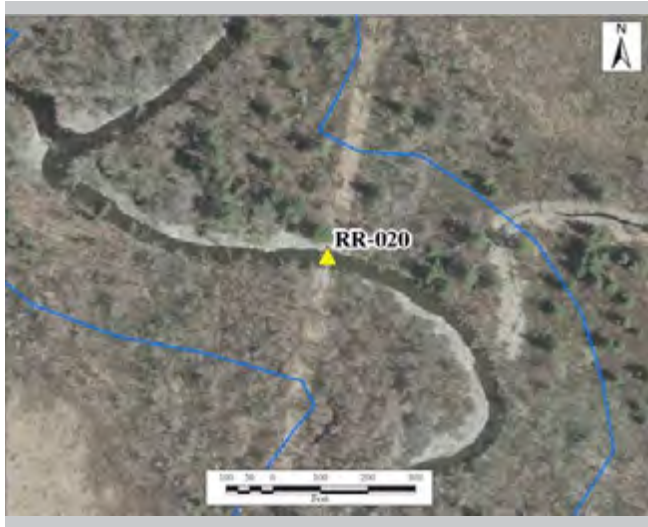
Pipeline right-of-way. Mostly dense vegetation cover of herbs only. Some minor exposed ground and erosion near water's edge, possibly due to animal trails. Banks approximately 5-feet high with slopes of about 25 to 50%.

**Sources of Degradation (13 possible):** Right-of-way (highway, utility, railroad), Unstable bank

**Total Degradation Score (higher score indicates a higher level of degradation):** 0.80

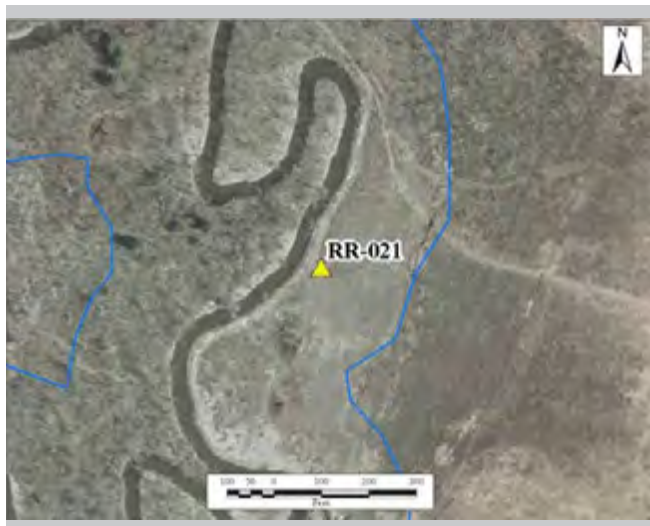
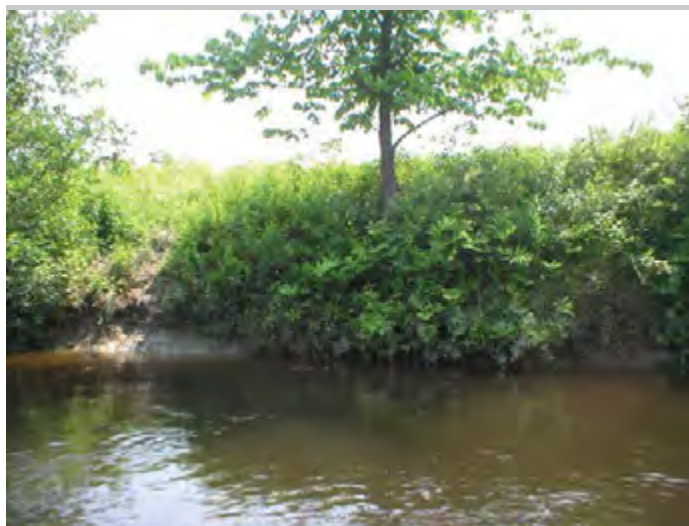
Narrow buffer (10 feet) of herbs, shrubs, and few trees, then open field. Bank slopes are steep, ranging from approximately 50 to 70%.

**Sources of Degradation (13 possible):** Land cleared

**Total Degradation Score (higher score indicates a higher level of degradation):** 0.40

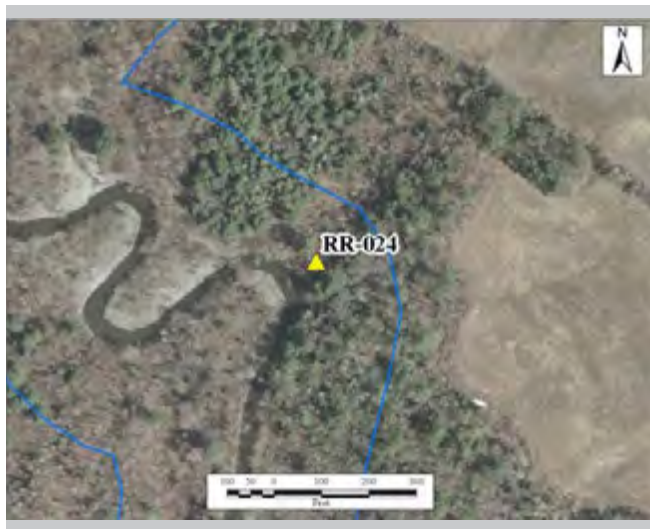
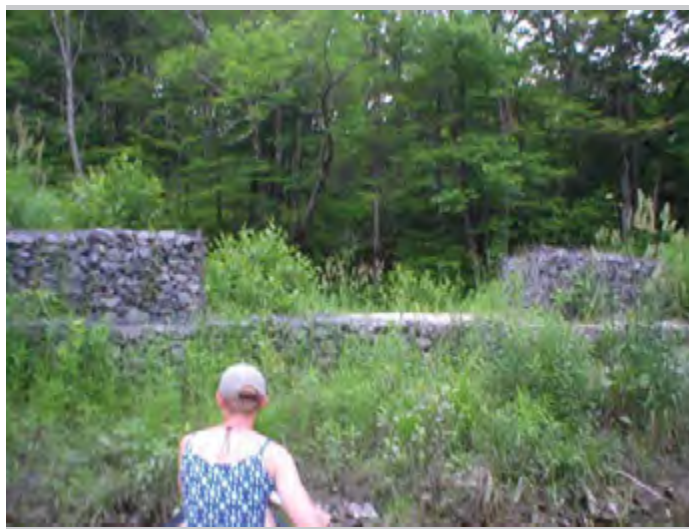
Wire rock bundles forming retaining wall (20-feet long by 2-feet wide). Cement holding tank behind wall (unknown purpose).

**Sources of Degradation (13 possible):** Rip-rap (or other artificial hard structure)

**Total Degradation Score (higher score indicates a higher level of degradation):** 1.25

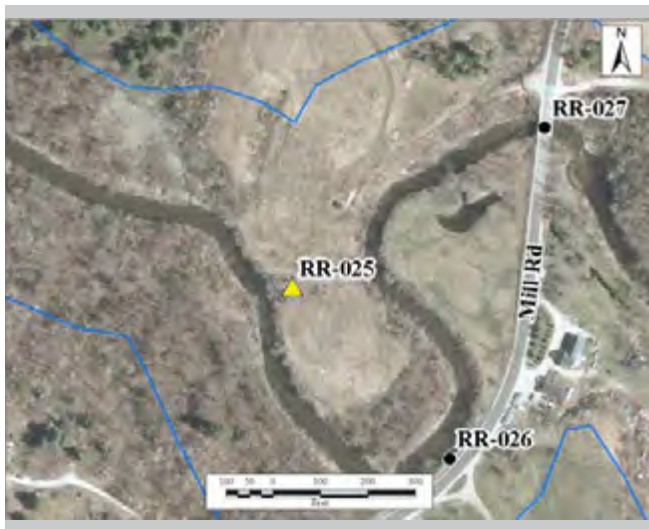
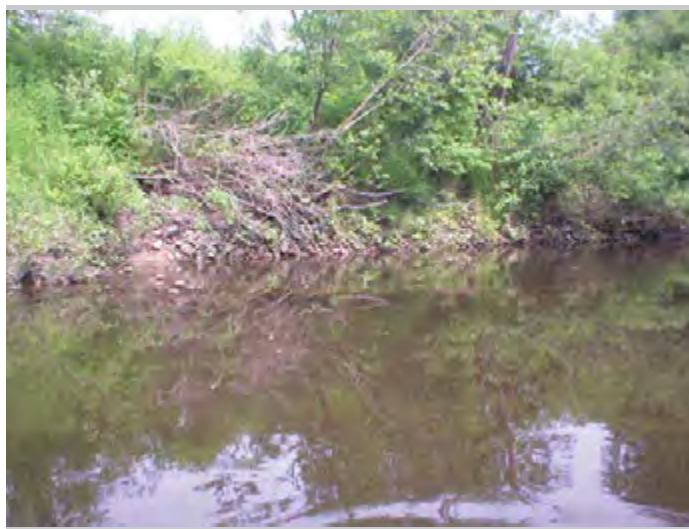
Narrow buffer (approximately 10 feet) of herbs and shrubs, few trees. Brick fill and trash/debris used to stabilize banks. Steep slopes about 10 feet high.

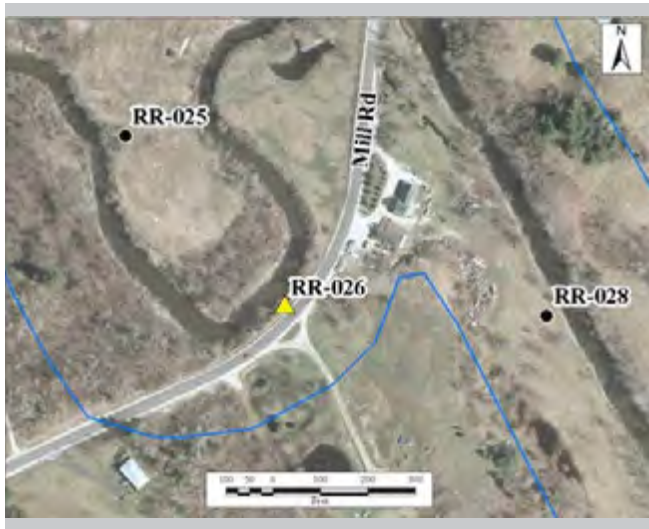
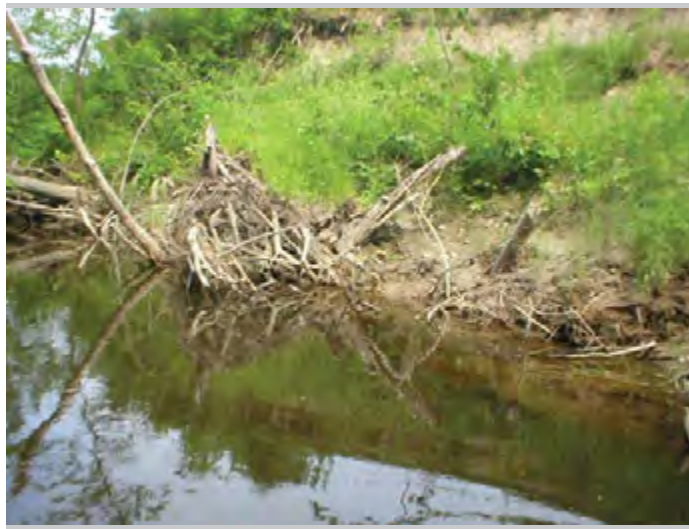
Mill Road runs adjacent to river. Banks are high (~ 20-feet), steep (~ 75%), eroding, slumping, and have bare ground areas.

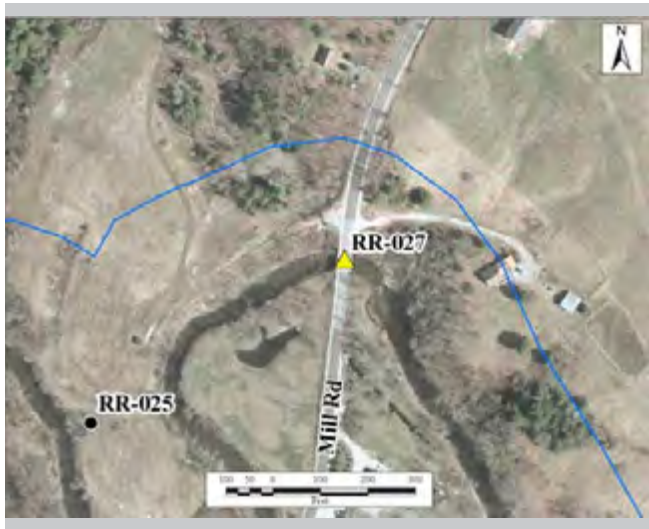
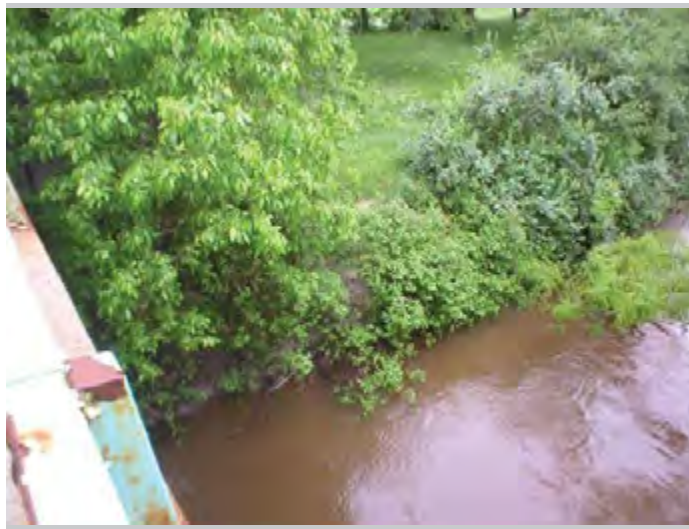
Mill Road bridge crossing. Most of buffer intact, comprised of herbs, shrubs, and trees. Some signs of erosion associated with mowed lawn to the south side of river / west of bridge.

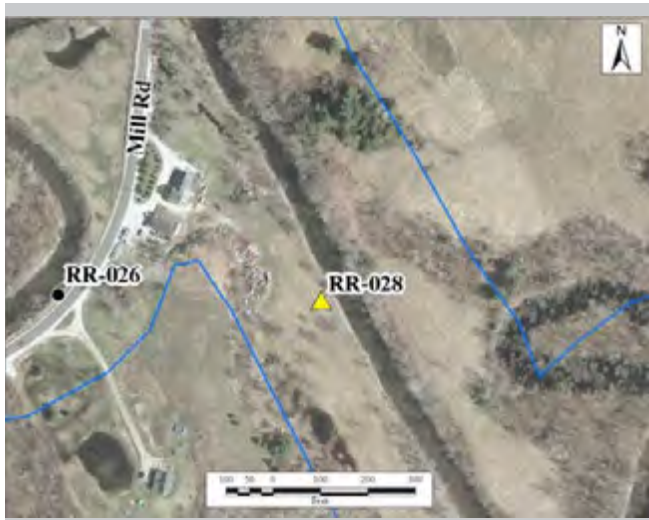
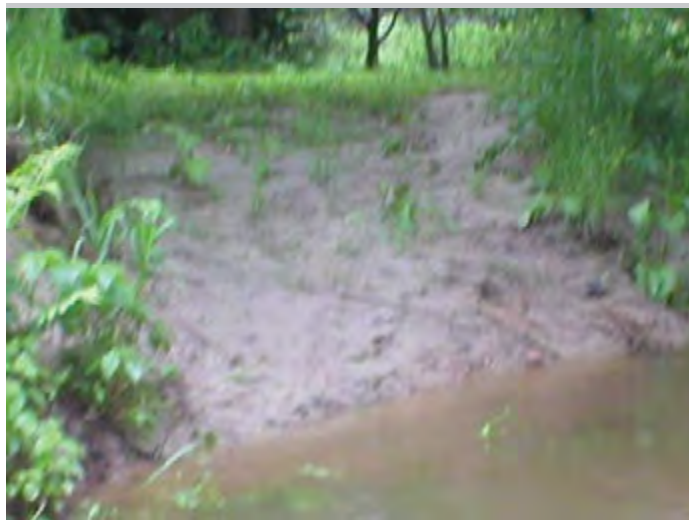
Narrow buffer of herbs, with few shrubs or trees, then mowed field. Access point to river is mowed lawn with dirt access road. Most of banks have steep slopes, with substantial erosion in places. Rubber hose leads from parcel into river. Some yard debris, erosion, and bare ground areas.

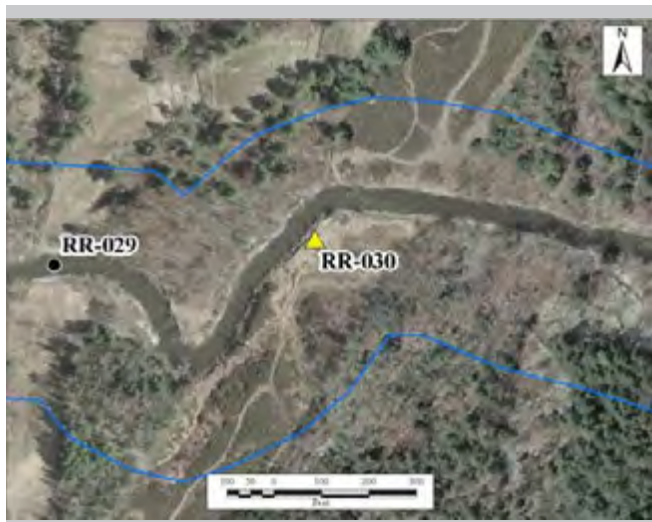
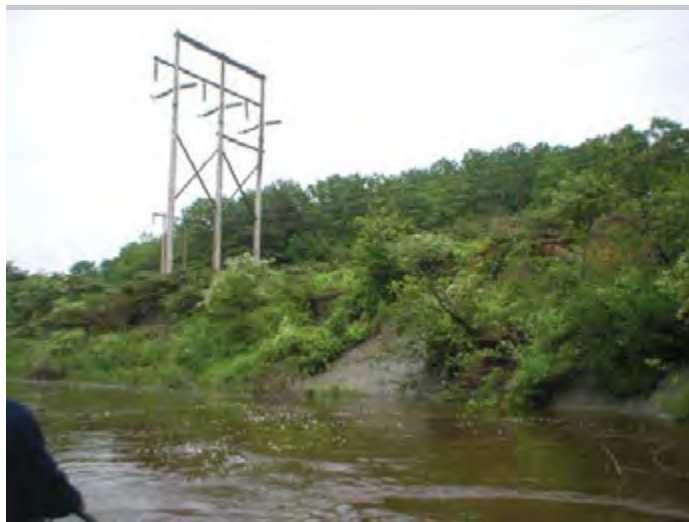
Powerline right-of-way. Buffer is comprised of herbaceous vegetation with some shrubs. Active major and minor erosion, which is impacting a power line structure in one area.

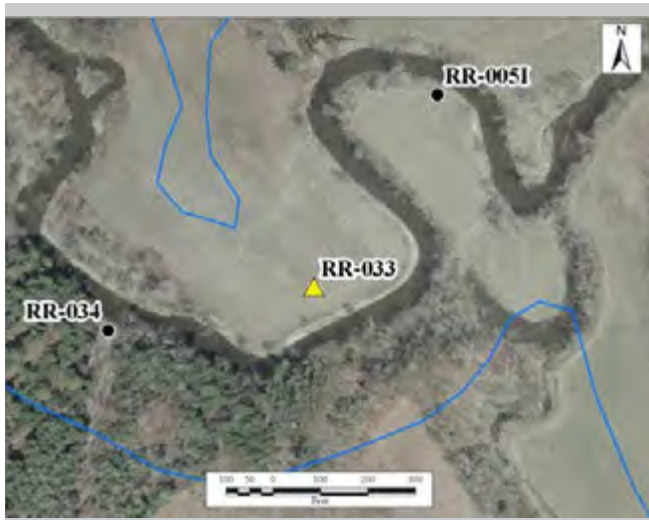
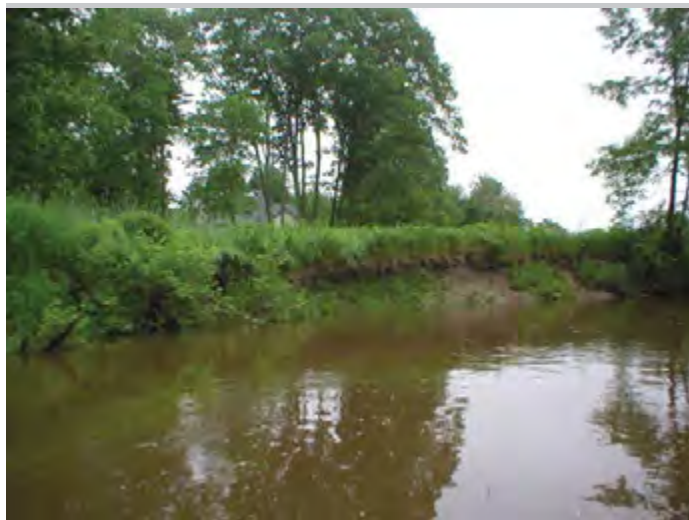
Mowed fields with narrow buffer (0-20 ft) of herbs, shrubs, and scattered trees to top of slope, then buffer widths varier. Some signs of erosion of slopes/banks, banks 10-15 feet with slope of 45 degrees. Some erosion causing over-hanging banks.

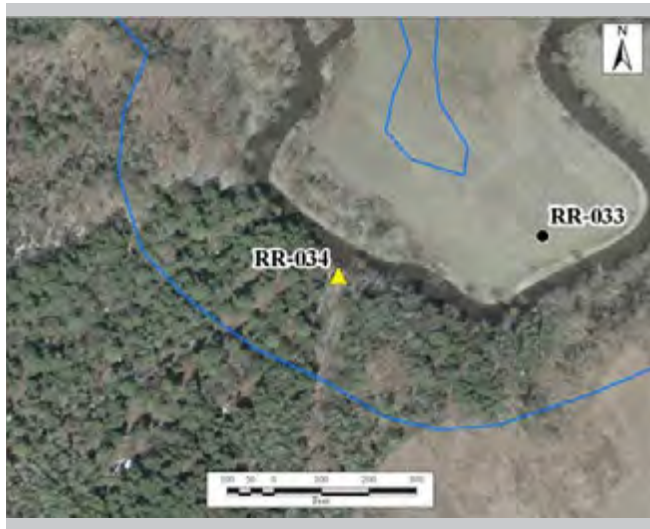
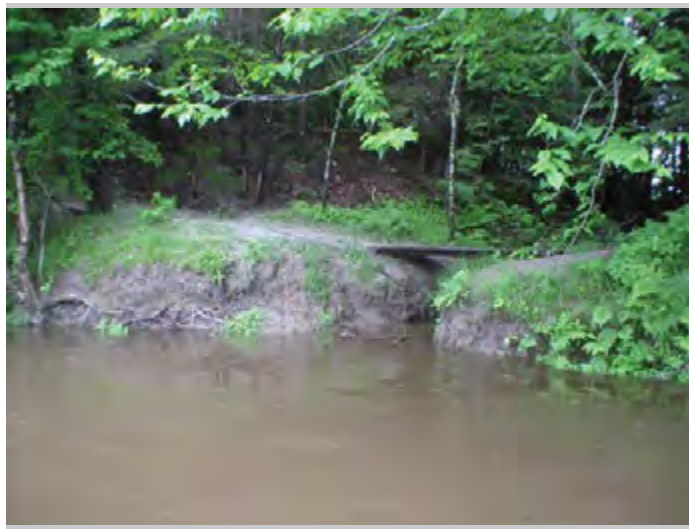
Walking trail has created erosion problem. Trail is too close to river.

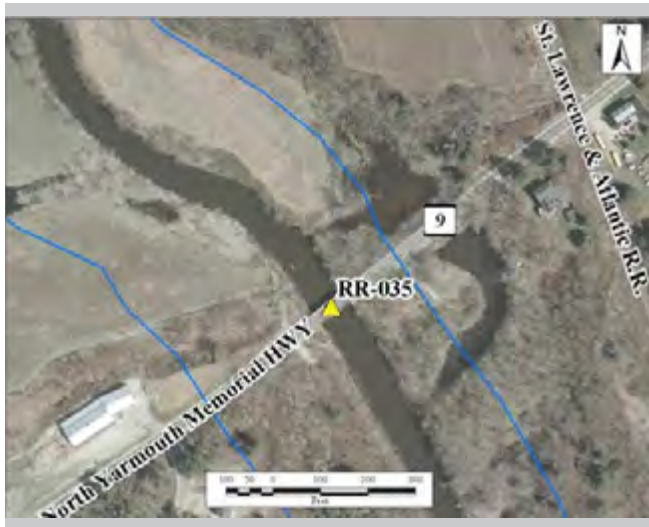
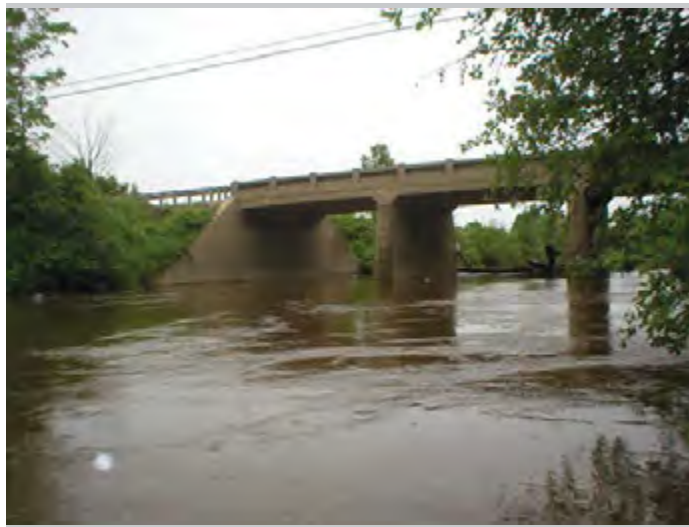
North Yarmouth Memorial Highway road crossing. Hardened cement bridge base and 2 supports. Floating logs and debris have formed a blockage on one side of bridge.

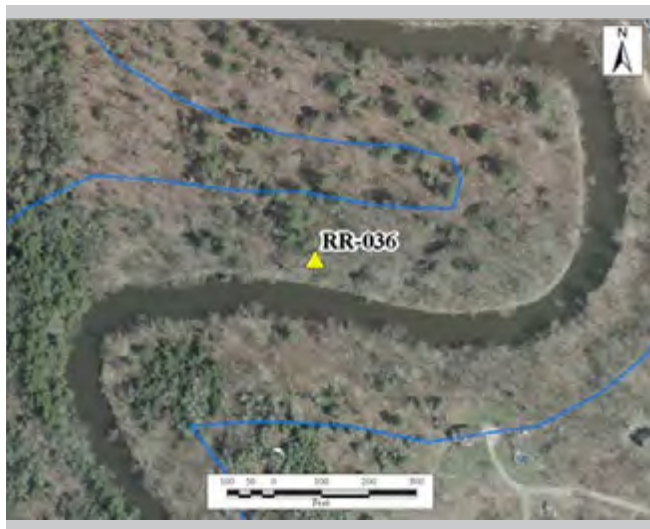
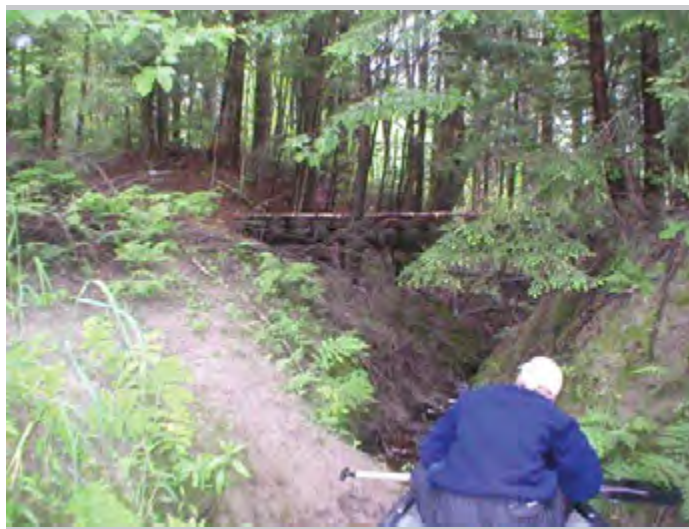
Old trail is a minor source of erosion due to unstable banks. Bridge crossing intermittent stream has eroding banks. Steep slopes >45 degrees are bare in many places.

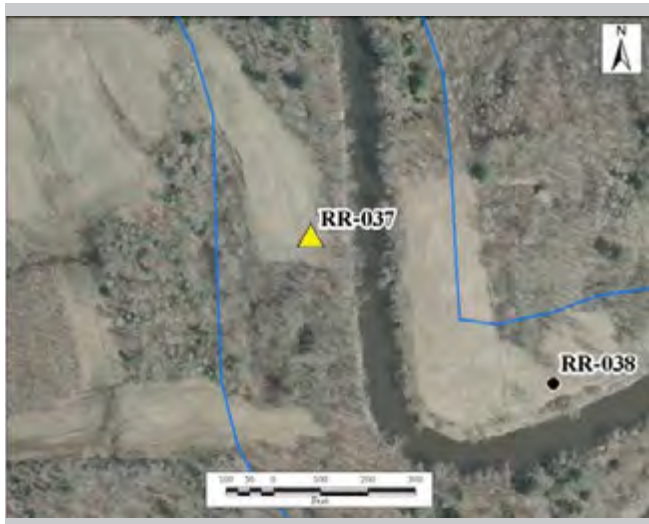
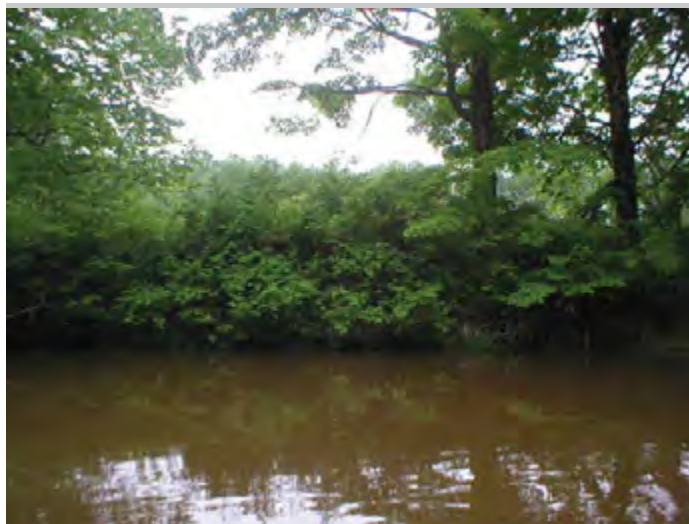
Narrow buffer (40 feet) of herbs, shrubs, and trees, then agriculture. No evidence of erosion.

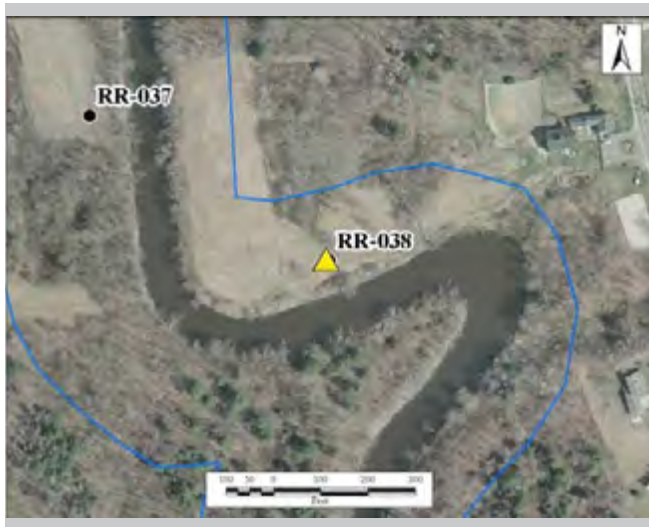
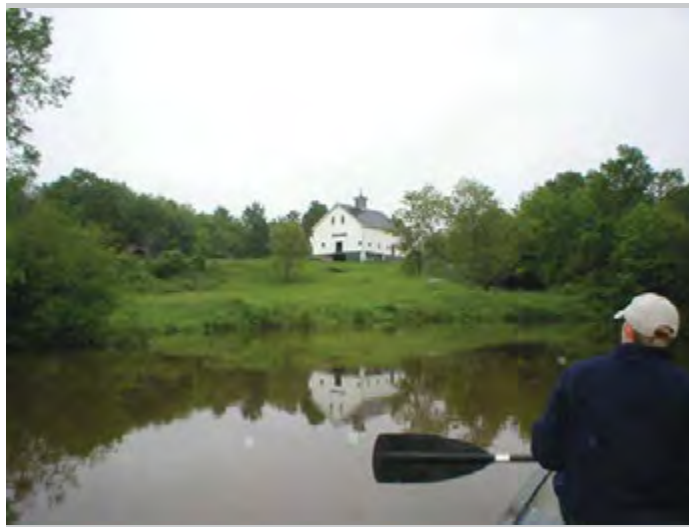
Narrow buffer (0-25 feet), then agricultural fields. Field grasses, not open filled fields.

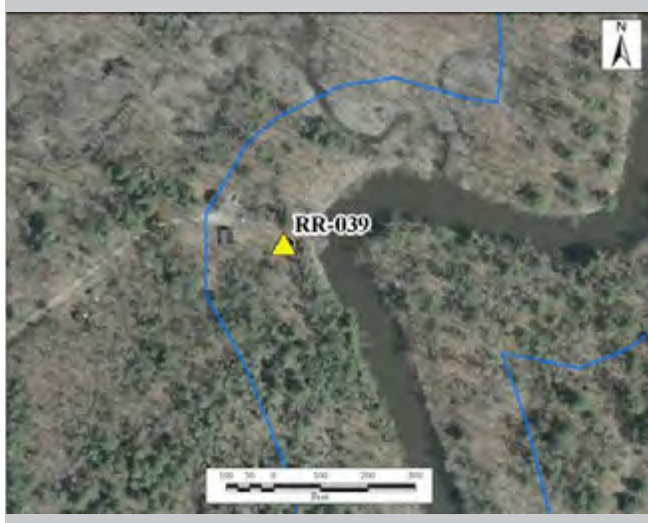
Viewing deck over looking Royal River. Nice buffer of herbs, trees, some shrubs.

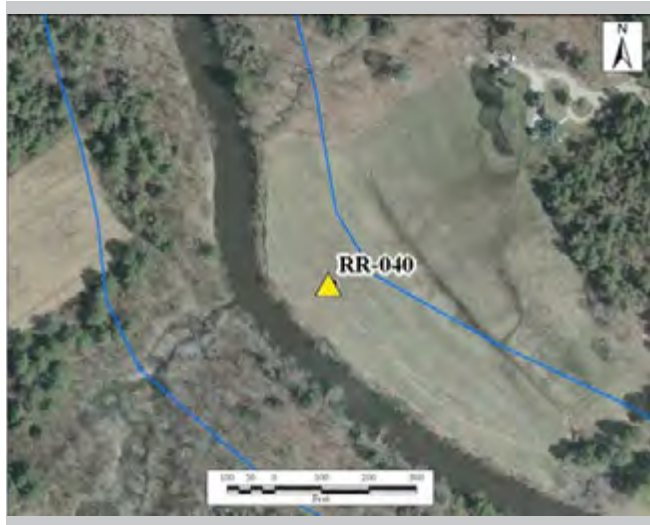
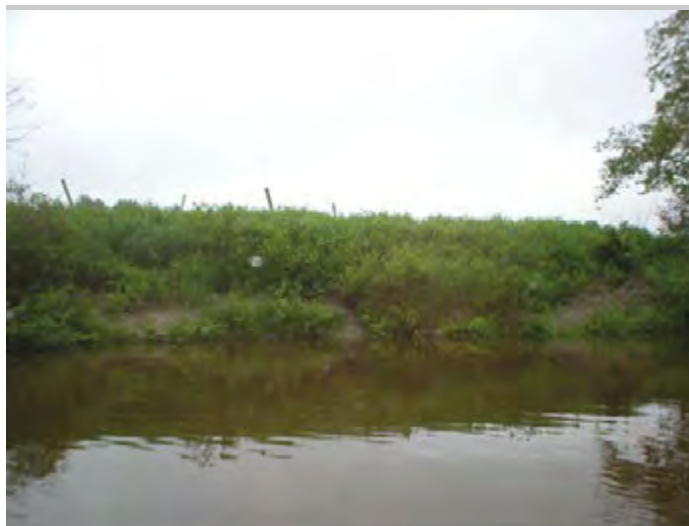
Narrow buffer (15-20 feet) vegetated with herbs, shrubs and trees to top of bank (approximately 15 - 20 feet high). Then agriculture field begins.

**Sources of Degradation (13 possible):** Land cleared

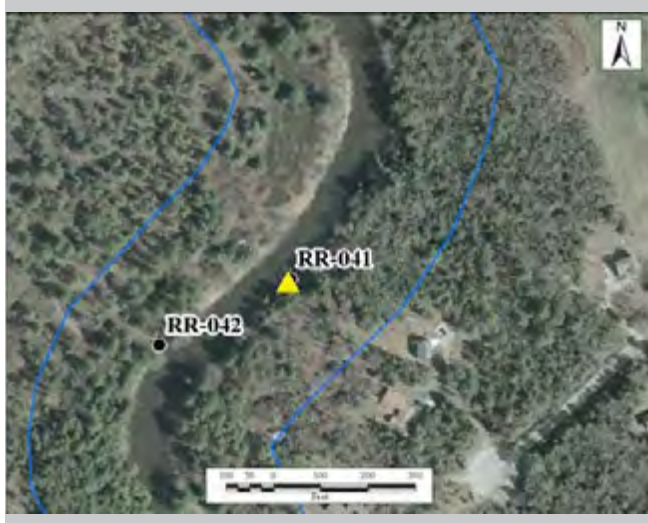
Campsite and canoe access point. Bank erosion evident next to fire pit, some bare ground. Chairs and canoe impeding on plant growth.

**Sources of Degradation (13 possible):** Land cleared, Unstable bank

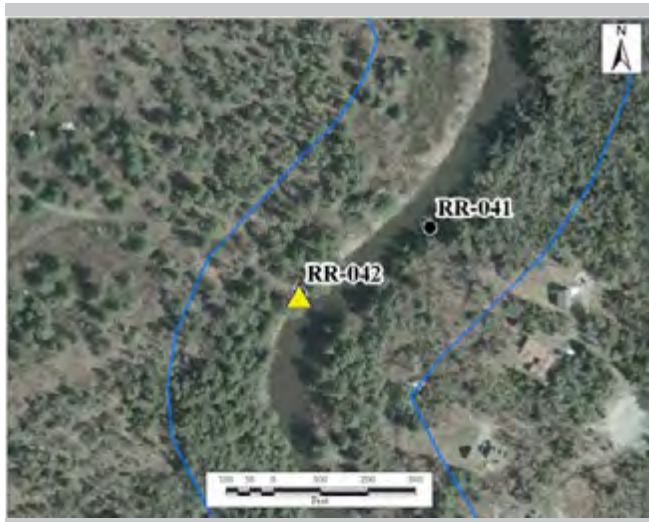
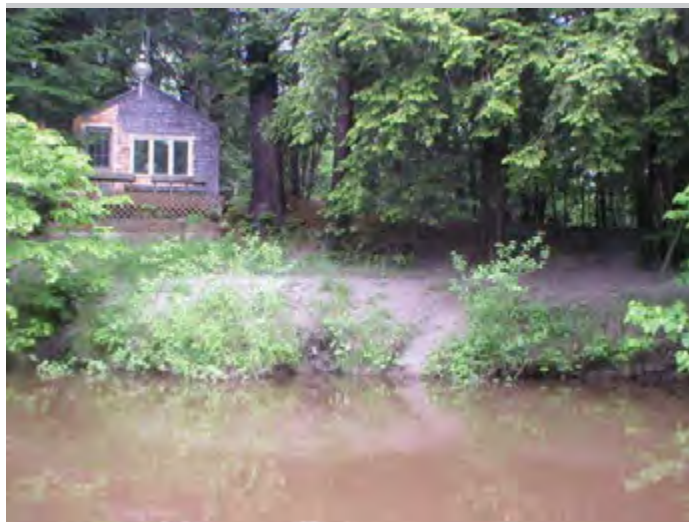
Small cottage with deck built on top of banks. Signs of erosion of banks in front and upstream of cottage probably from foot traffic. Slopes steep (75 degrees), and not well vegetated (herbs and few shrubs). Hemlock overstory with mosses and low, sparse herbs. Downstream are rope swings with bare ground underneath, potential erosion source.

**Sources of Degradation (13 possible):** Unstable bank

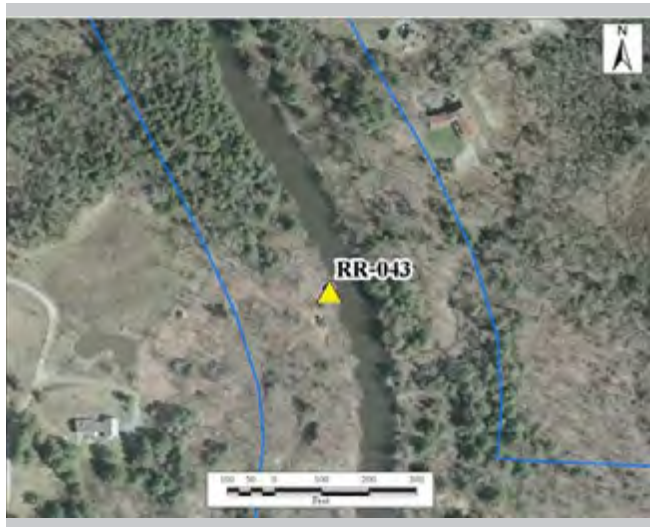
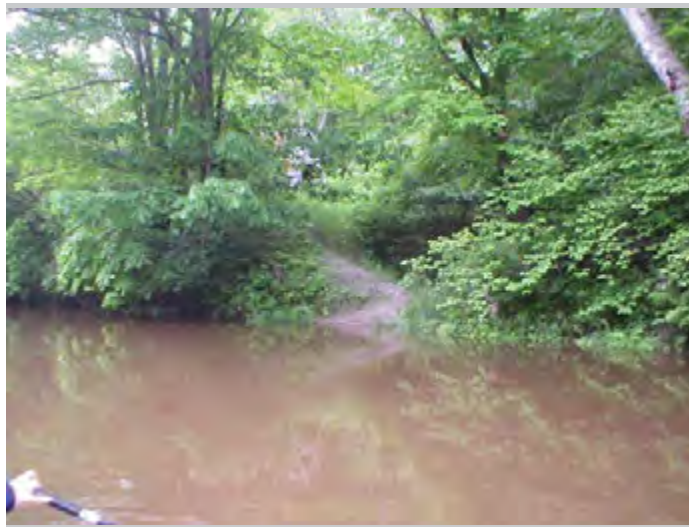
Eroding bank (approximately 25 feet wide) associated with access to river from old, apparently unused shack. Buffer intact with herbs, shrubs and trees.

**Sources of Degradation (13 possible):** Unstable bank

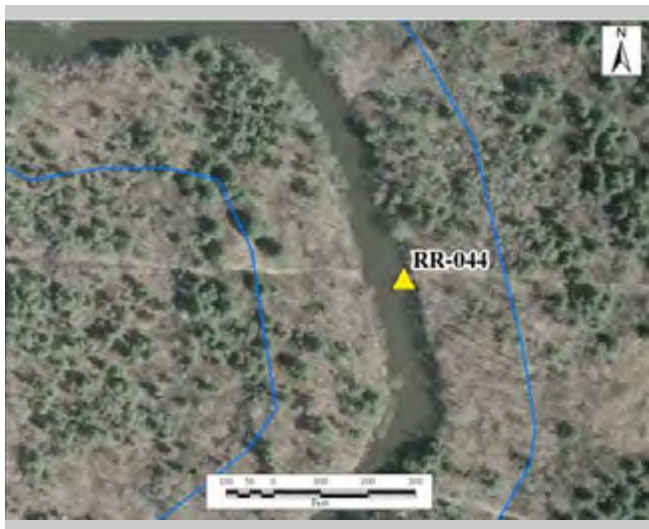
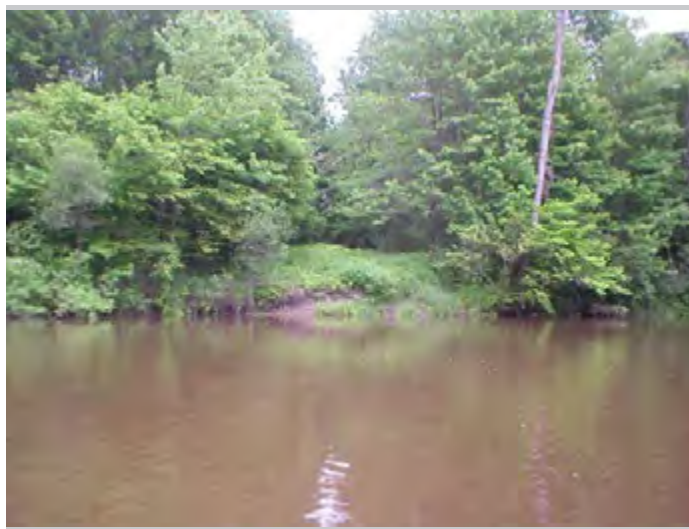
Water line right-of-way, Caldwell Boston water marker. Some bare ground, minor erosion occurring on both sides of river. Steep slopes (>45 deg) with herbaceous cover.

**Sources of Degradation (13 possible):** Right-of-way (highway, utility, railroad), Unstable bank

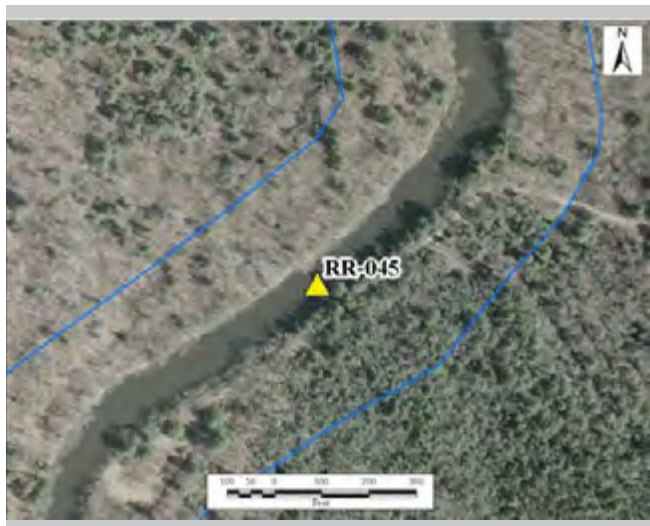
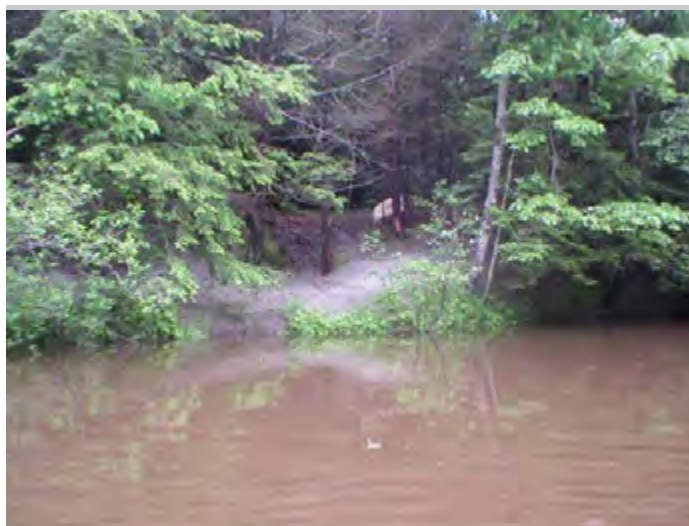
Appears to be an old canoe access point (approx 25 feet wide). Bare sandy soils, with some erosion potential.

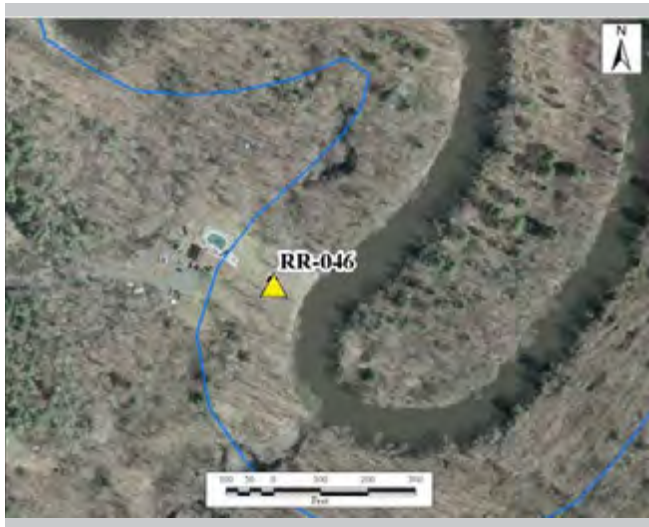
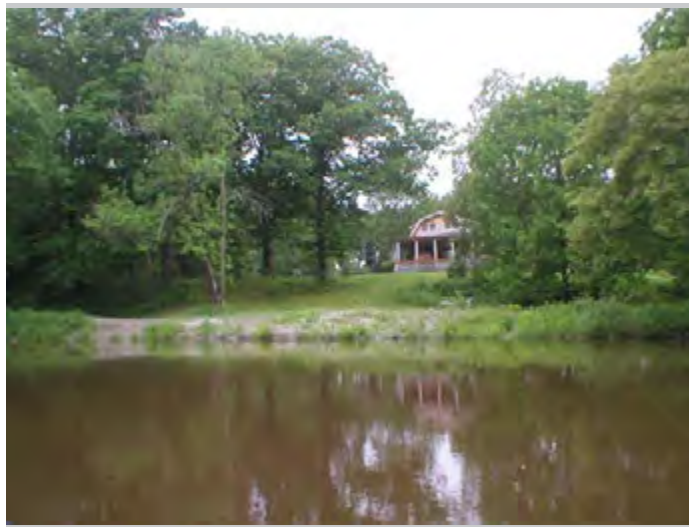
No real buffer; one of the worst residential sites. Mowed lawn to top of bank, some bare ground on bank and sparse herbs. Bank not steep 2 feet high, then sloping upwards towards house. All mowed.

**Sources of Degradation (13 possible):** Land cleared, Unstable bank

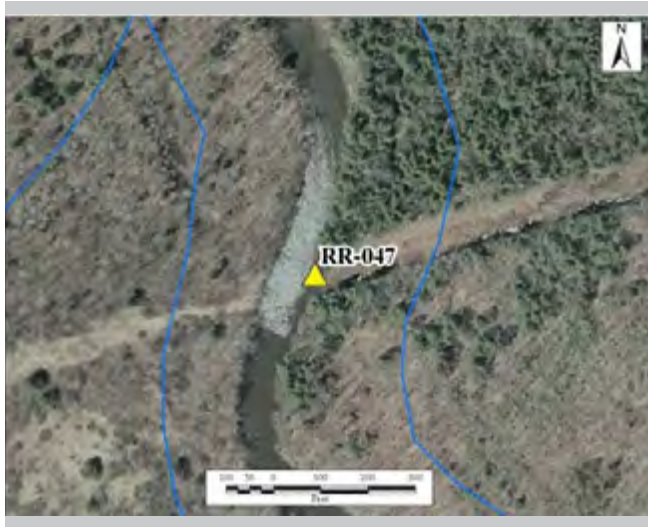
Powerline right-of-way. Maintained with herb and shrub cover. Few shrubs on west bank; some bare ground with minor erosion potential.

**Sources of Degradation (13 possible):** Right-of-way (highway, utility, railroad)

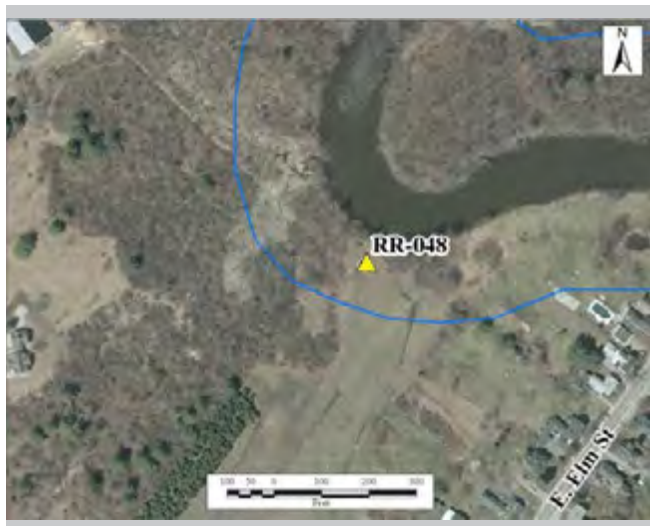
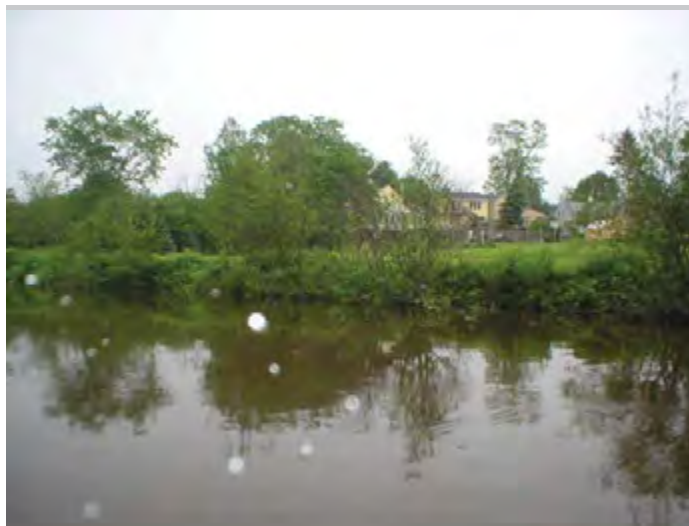
Narrow buffer (approx 5 feet) comprised of shrubs and herbs or only herbs, then mowed lawn. Some bare ground with minor erosion potential.

**Sources of Degradation (13 possible):** Land cleared, Unstable bank

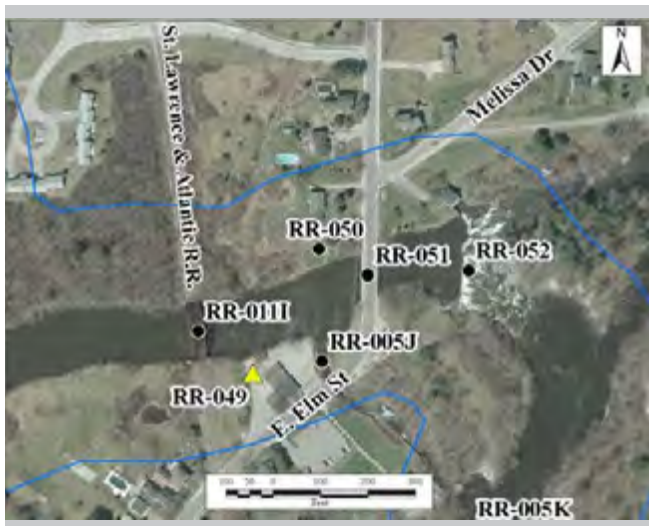
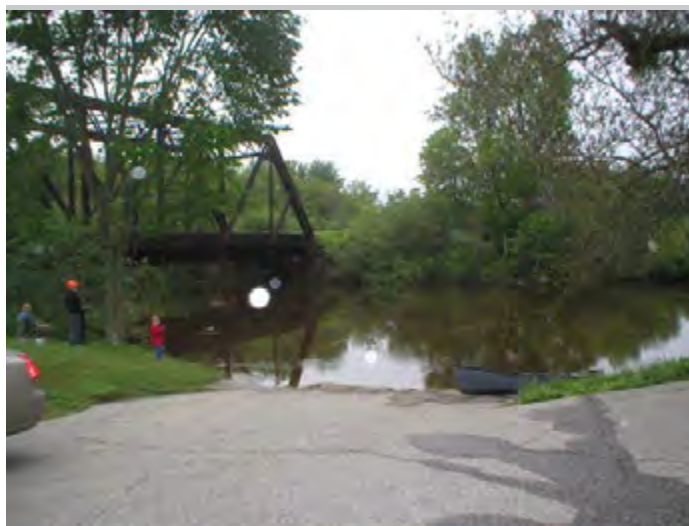
Boat launch at Yarmouth Water District. No real buffer, mowed lawn to top of bank. Hardined shoreline. Lots of sand on asphalt parking lot may wash into river.

**Sources of Degradation (13 possible):** Fill/debris/trash, Impervious surface, Land cleared, Land use activity a potential contaminant source

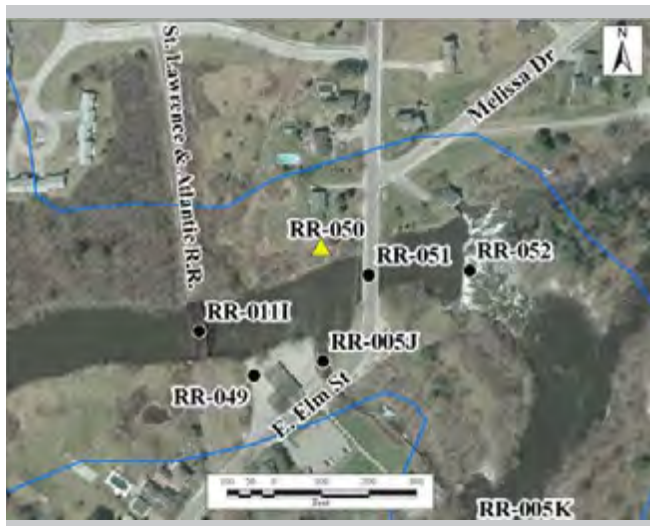
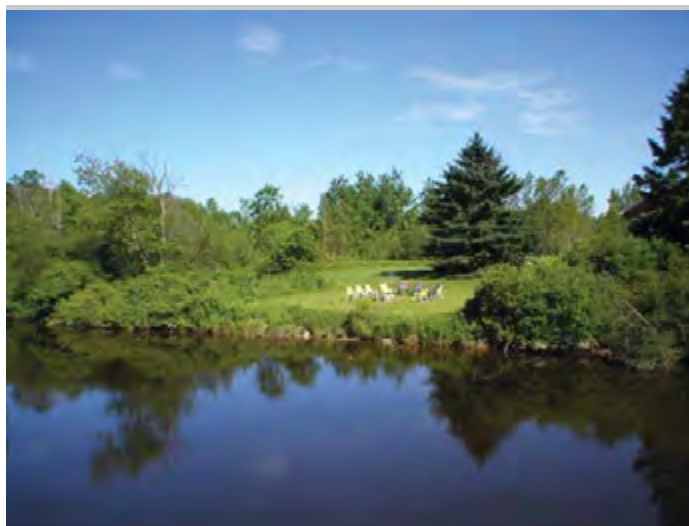
Narrow buffer (6 feet) of herbs and low shrubs, then mowed lawn.

**Sources of Degradation (13 possible):** Land cleared

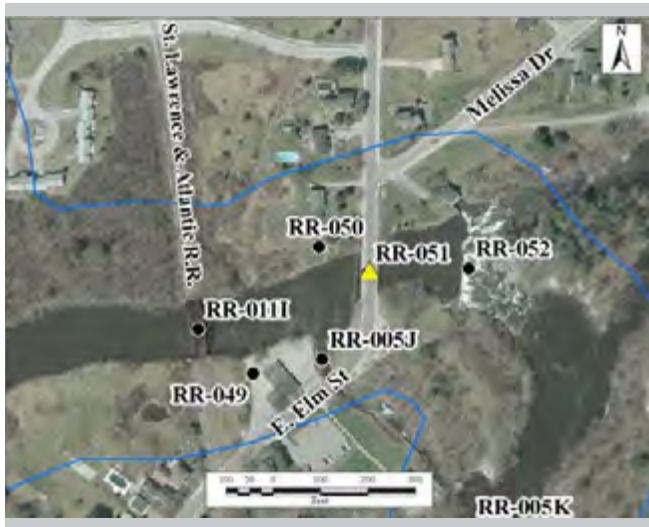
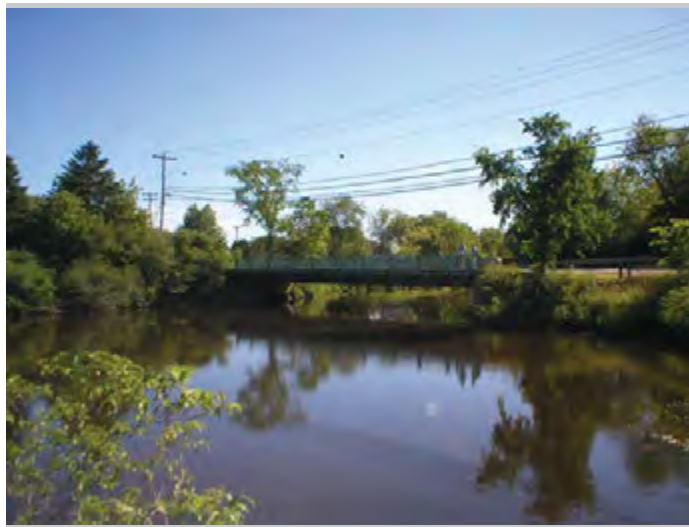
East Elm St bridge. Concrete on rock ledge and concrete footings, with riprap banks. Slight constriction of river. Buffer, where present, is comprised of shrubs and herbs. Road containments reach river directly via openings in roadway at sides of bridge.

**Sources of Degradation (13 possible):** Impervious surface, Land use activity a potential contaminant source, Rip-rap (or other artificial hard structure)

Bridge looks like it may be due to be replaced - rebar is exposed in many places.

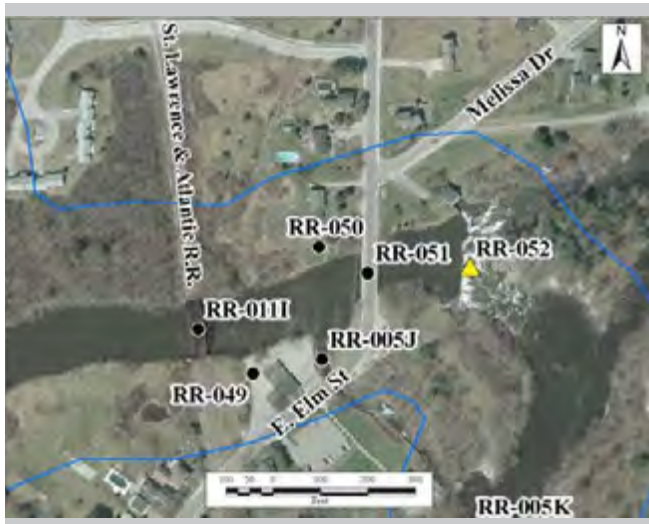
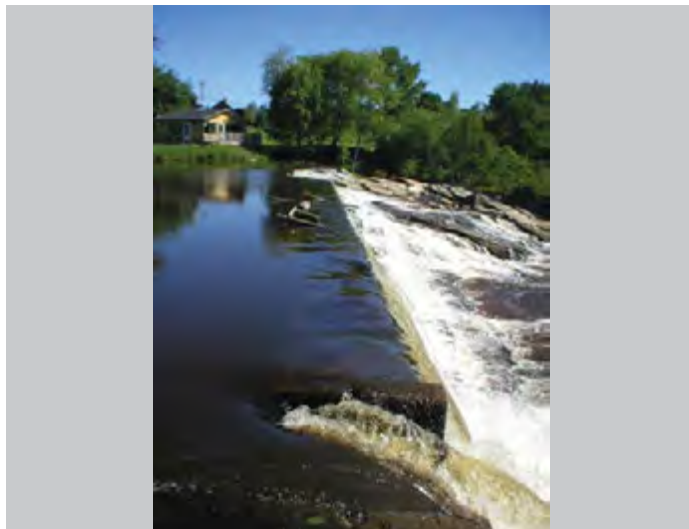
Dam near East Elm St, adjacent to Yarmouth Town Park. Buffer of herbs, shrubs, trees. Fish ladder intact, but tree limbs may be blocking lower entrance and debris is accumulated at top of fish ladder, and may impede fish passage.

**Sources of Degradation (13 possible):** Dam/obstruction, Fill/debris/trash, Impervious surface, Land cleared

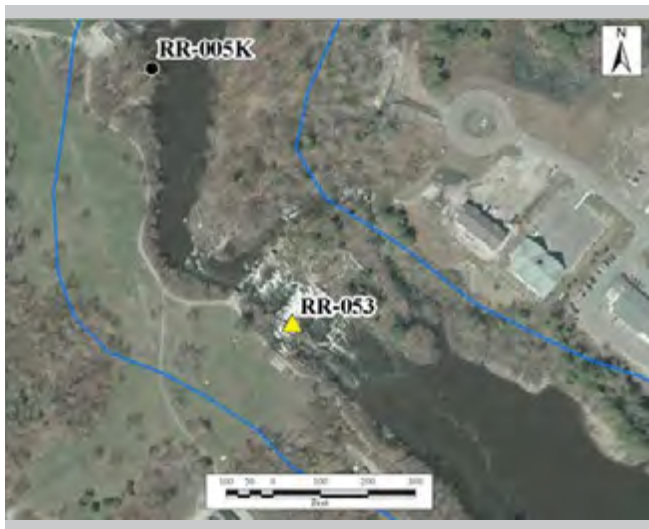
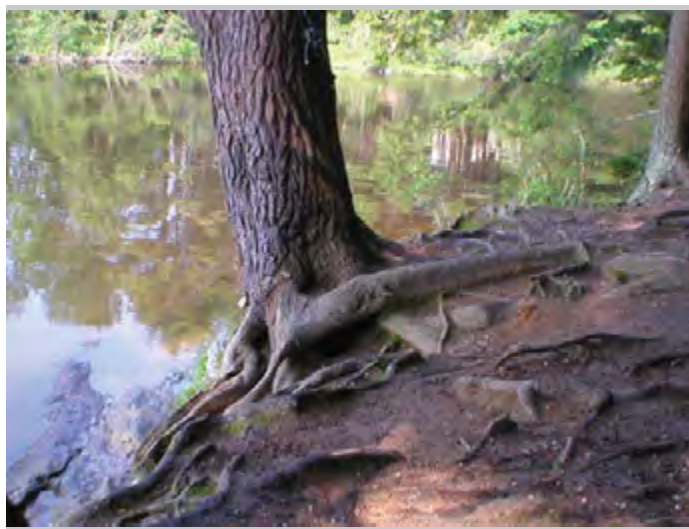
Royal River Park. Rip-rap hardened shoreline, culverts with ranges of erosion. Narrow buffer but high quality, mowed lawns. Erosion on several walkways near river. Historic mill structures. Japanese knotweed patches.

**Sources of Degradation (13 possible):** Culvert issue, Invasive plant species, Land cleared, Land use activity a potential contaminant source, Rip-rap (or other artificial hard structure), Unstable bank

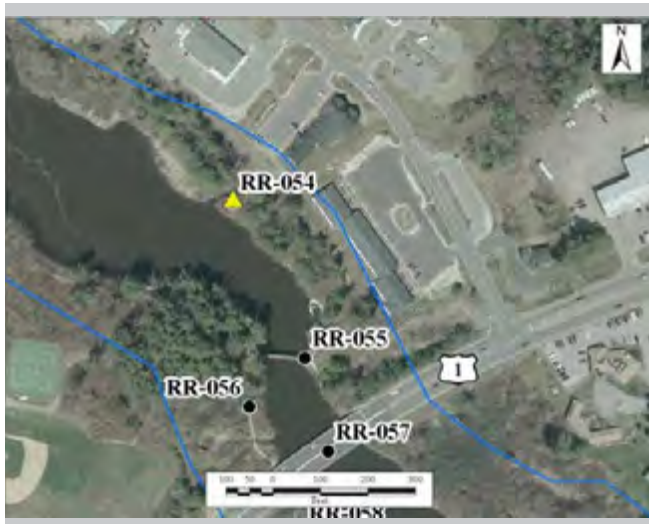
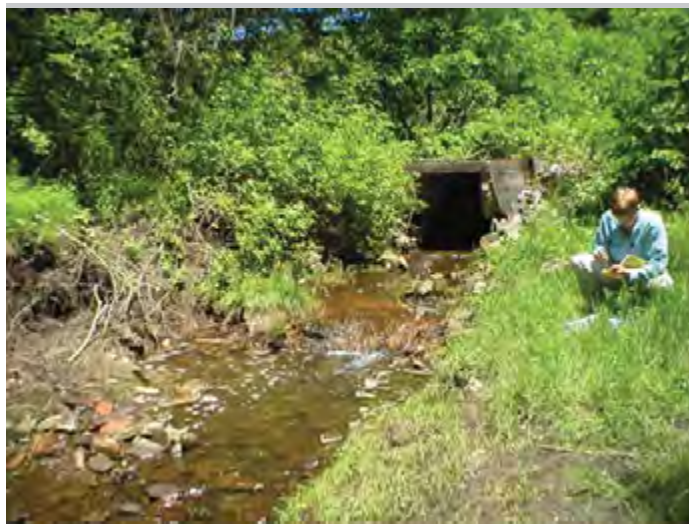
Box culvert that drains catch basins from parking lots at commercial/business complex. Note soap suds in water. Eroding banks, likely scoured during high velocity flow through culvert. Fill/debris present in channel.

**Sources of Degradation (13 possible):** Culvert issue, Fill/debris/trash, Unstable bank

Dumpster in parking lot leaking and staining asphalt, located near a catch basin above culvert of interest.
