## Habitat Restoration Inventory Summary Report for the Royal River, Spruce Creek, and Lower Kennebec River Estuary

**HABITAT RESTORATION INVENTORY  
SUMMARY REPORT  
FOR THE  
ROYAL RIVER, SPRUCE CREEK, AND LOWER KENNEBEC  
RIVER ESTUARY  
VOLUME I**

**DECEMBER 2005**

**Prepared by: Northern Ecological Associates, Inc.  
451 Presumpscot Street  
Portland, Maine 04103**

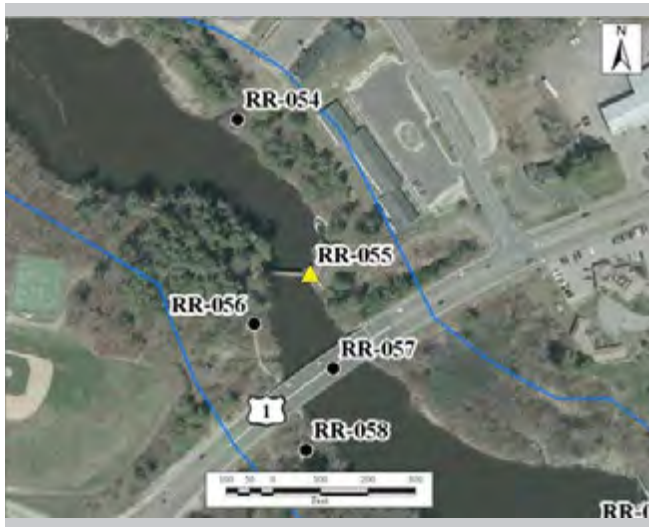
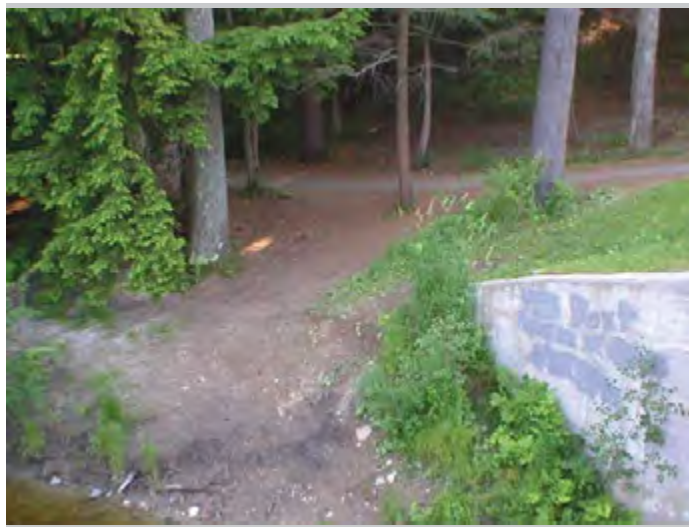
Foot bridge over Royal River. Not constricting. Banks lack solid vegetation layer, bare ground in places. Access point in southwest corner bare, potential erosion. Riprap swale next to bridge.

**Sources of Degradation (13 possible):** Land cleared, Rip-rap (or other artificial hard structure), Unstable bank

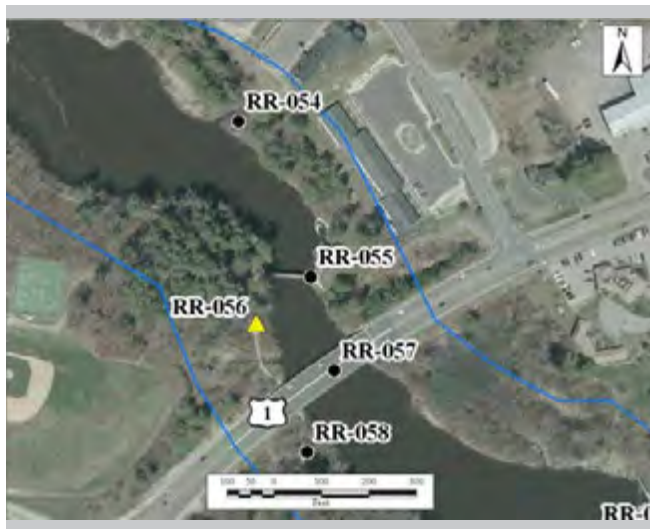
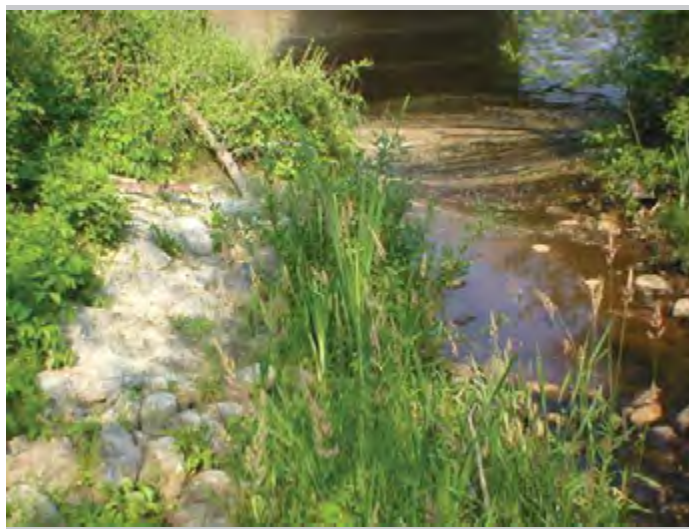
Large box culvert (4 x 4 feet) with in fenced enclosure; water of unknown origin. Water flow approximately 50 gallons/min. Filters over cobble/gravel, then under bridge and into river.

**Sources of Degradation (13 possible):** Culvert issue

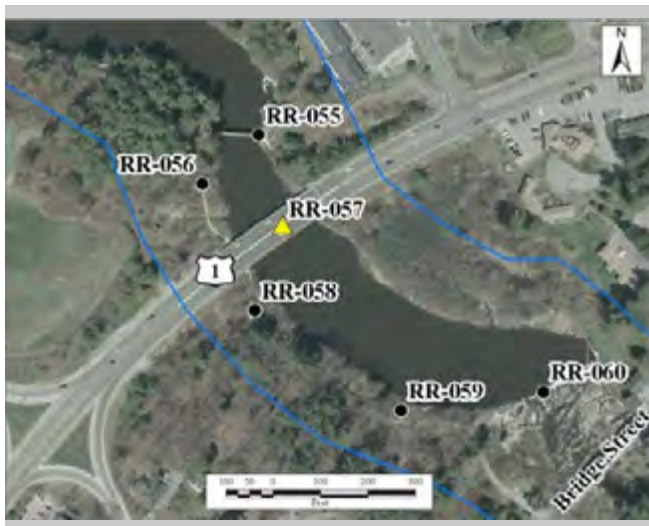
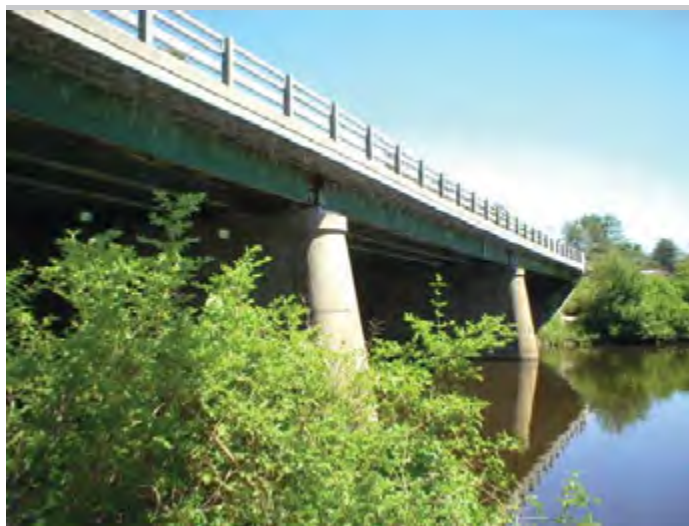
Route 1 bridge crossing. Not constricting flow. Banks stable, minimal erosion. Walking trail under bridge on southwest side has some minor erosion. Buffer of herbs, shrubs, and trees.

**Sources of Degradation (13 possible):** Land use activity a potential contaminant source, Right-of-way (highway, utility, railroad), Unstable bank

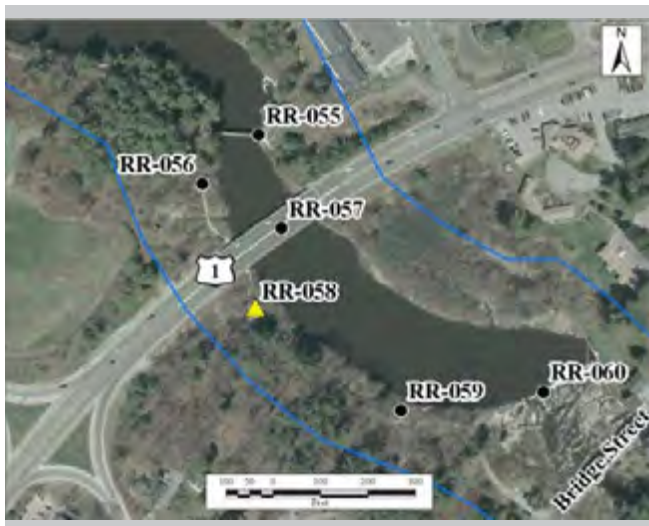
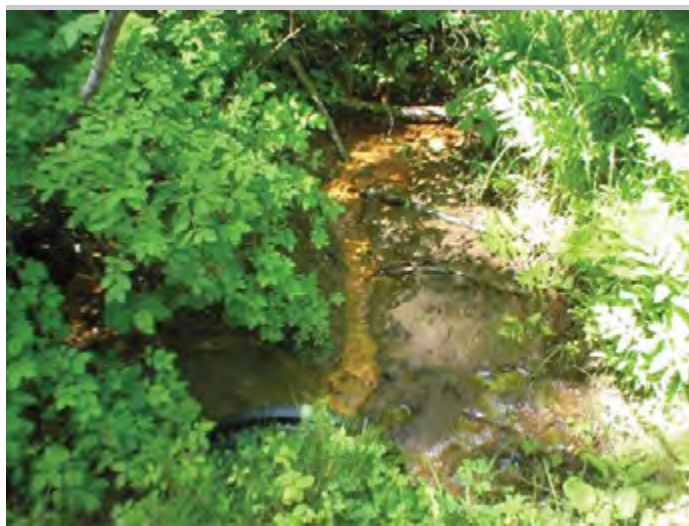
Iron leachate from unknown source. Runoff from direction of Route 1.

**Sources of Degradation (13 possible):** Land use activity a potential contaminant source,  
Unknown

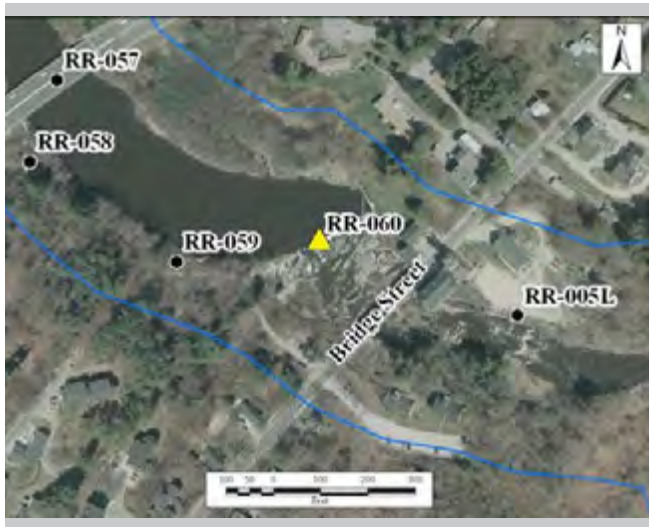
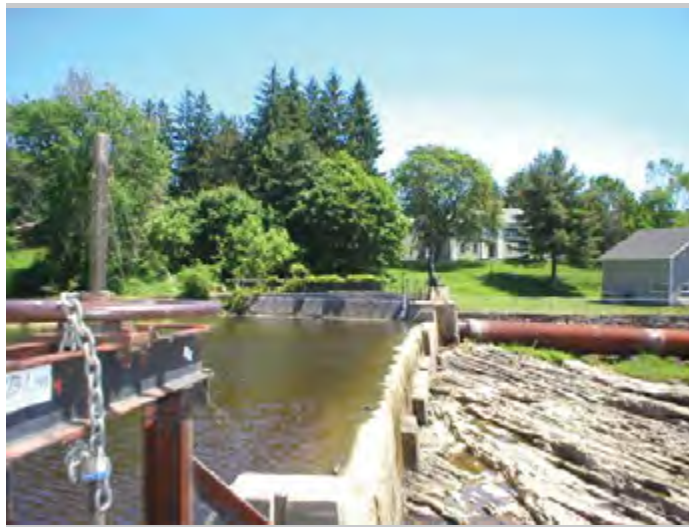
Sparhawk Mill dam with fish ladder. Cement dam with drainage pipe on east side, fish ladder on west side. Debris accumulated at top entrance to fish ladder. No water over dam currently, 8 foot drop to rock ledge. Sediment accumulated behind dam. Buffer of mowed lawn on east side.

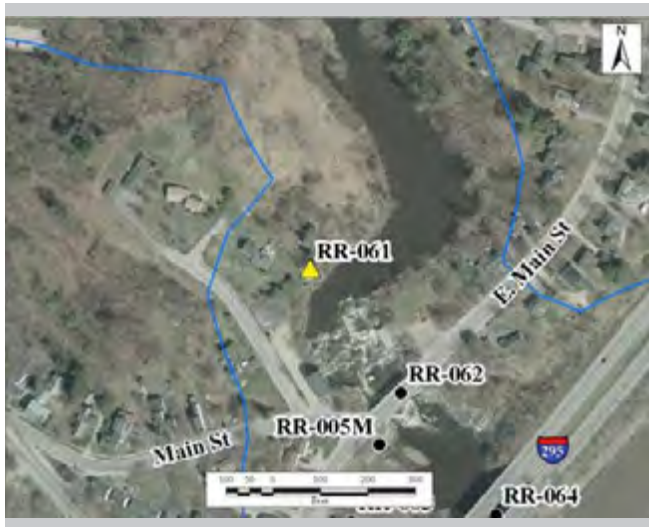
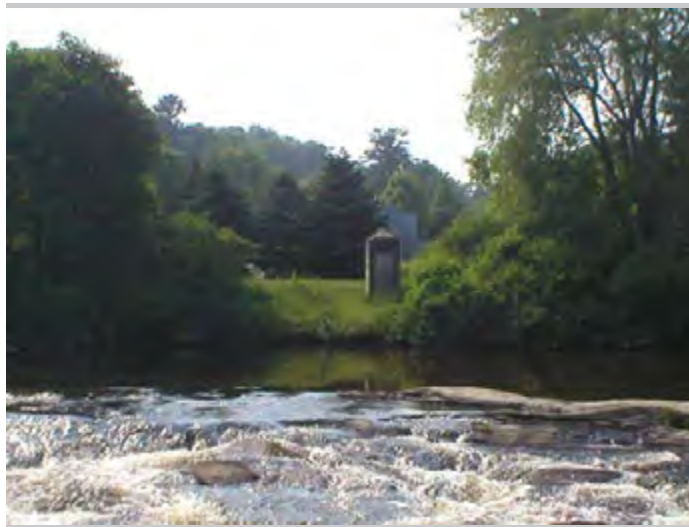
Buffer issue. Narrow, 12' wide mowed lawn section to edge of river.

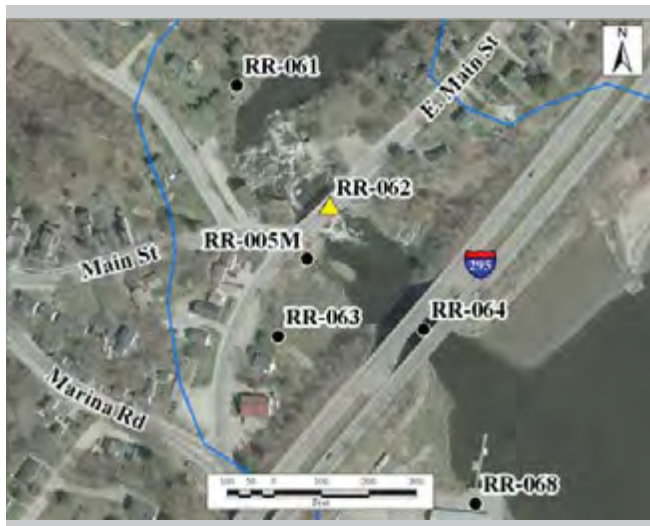
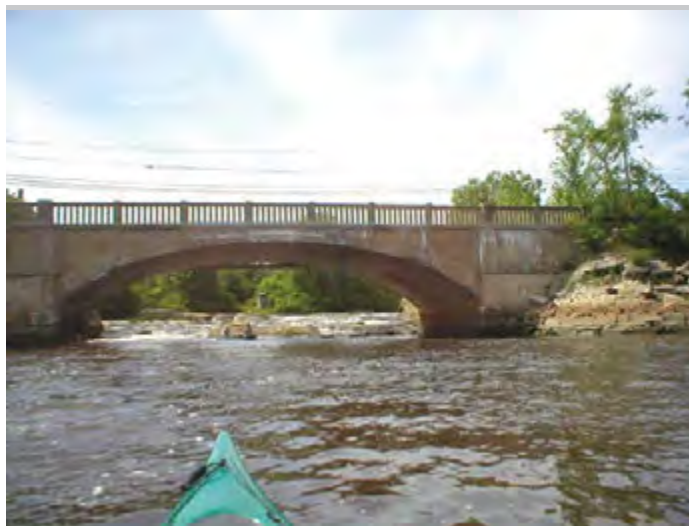
East Main St bridge. Old Grist Mill Site in buffer zone north of bridge, with some erosion issues. Riprap and cut, placed rock wall banks, cement bridge. Constriction of river. Some bare ground on banks on downstream sides, potential erosion. Culverts from road drain directly into river. Japanese knotweed along southeast bank.

**Sources of Degradation (13 possible):** Culvert issue, Invasive plant species, Land use activity a potential contaminant source, Right-of-way (highway, utility, railroad), Rip-rap (or other artificial hard structure)

**Total Degradation Score (higher score indicates a higher level of degradation):** 3.40

Option 1: Stabilize banks and enhance with plantings. Herbicide or mechanical removal of Japanese knotweed. Option 2: Replace and widen bridge opening to remove constriction.

Cost considerations include: plantings/landscaping, invasive species control, biostabilization/erosion sediment control, mob/demob, and engineering designs. Bridge replacement and stone/riprap removal costs would be substantially higher.

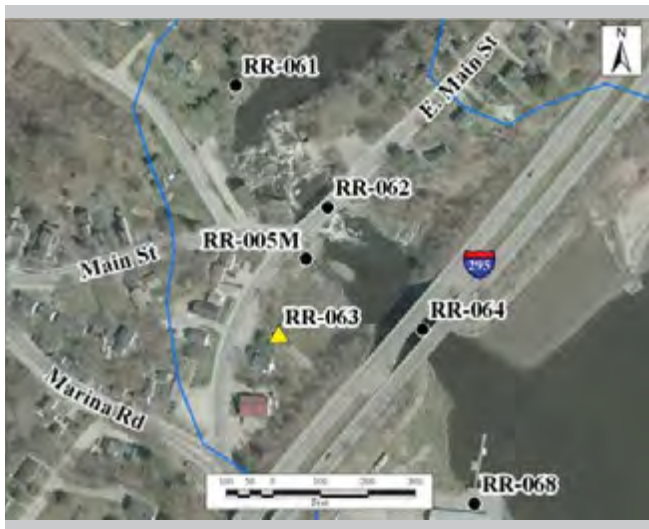
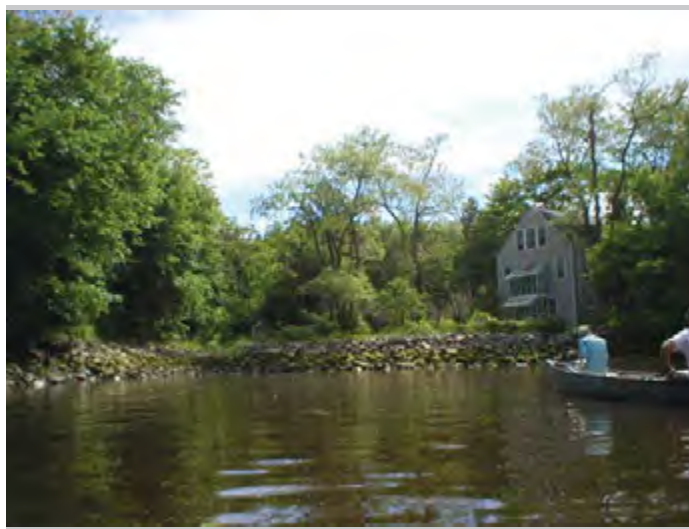
Lack of buffer. Hardened shoreline, with mowed lawn to edge of riprap, then cultivated shrubs and trees.

**Sources of Degradation (13 possible):** Land cleared, Rip-rap (or other artificial hard structure)

**Total Degradation Score (higher score indicates a higher level of degradation):** 1.35

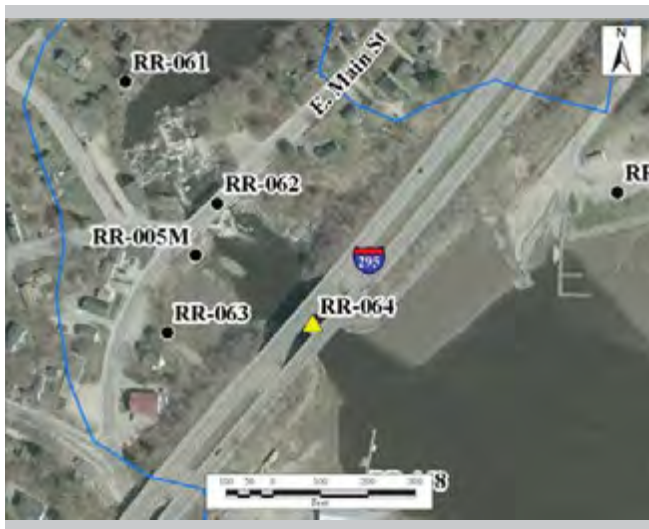
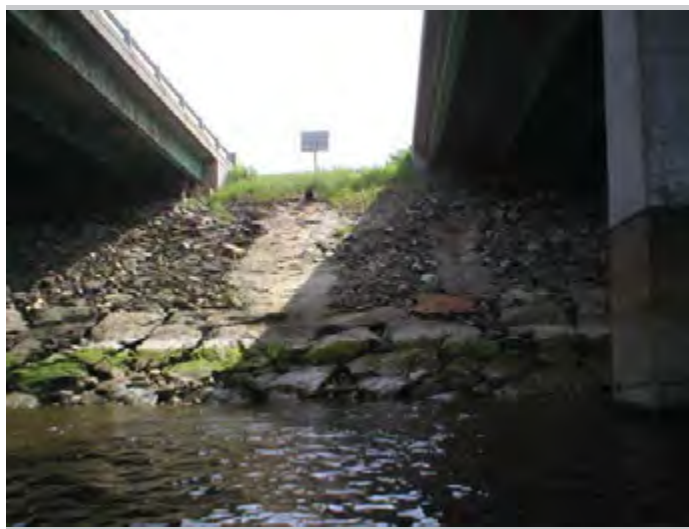
Route 95 bridge crossing. Riprap banks are stable, not eroding. Constriction of river. Vegetated with some herbs, shrubs, some trees. Culverts drain over steep, cement swale.

**Sources of Degradation (13 possible):** Culvert issue, Drainage issue, Impervious surface, Land use activity a potential contaminant source, Right-of-way (highway, utility, railroad), Rip-rap (or other artificial hard structure)

**Total Degradation Score (higher score indicates a higher level of degradation):** 3.90

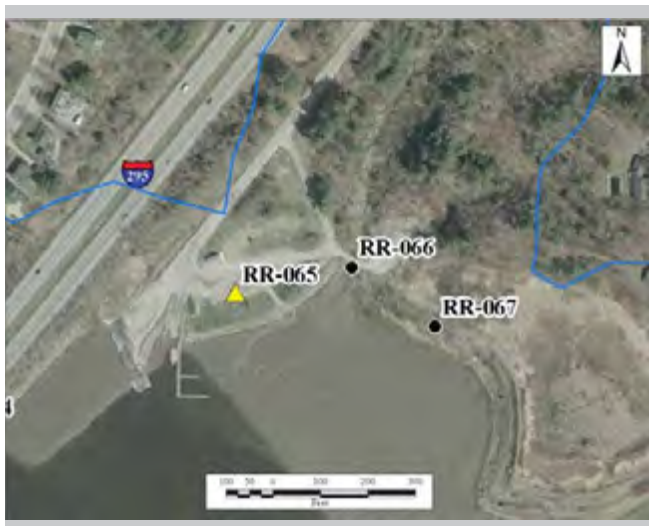
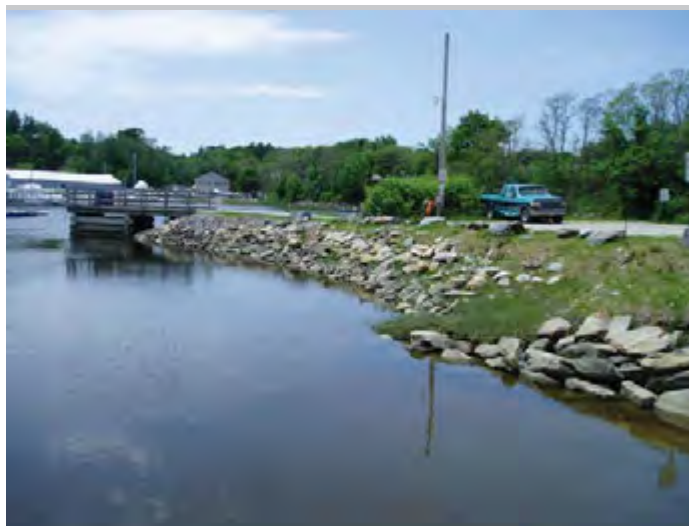
Yarmouth Public Boat Launch. Shoreline almost entirely riprap with some sparse vegetation, mowed lawn from top of slope. In places lawn is compromised by vehicle parking. Paved and gravel parking areas. Japanese knotweed. Active marina with docks.

**Sources of Degradation (13 possible):** Culvert issue, Dock/pier/jetty that extends out into channel, Impervious surface, Invasive plant species, Land cleared, Land use activity a potential contaminant source, Rip-rap (or other artificial hard structure), Unstable bank

**Total Degradation Score (higher score indicates a higher level of degradation):** 4.30

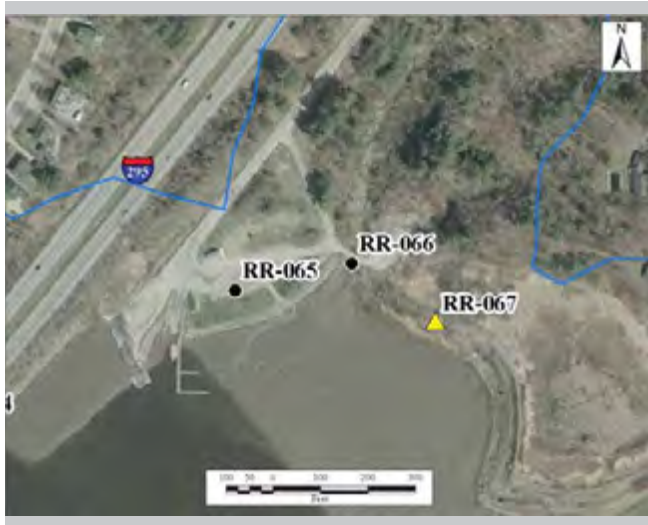
Phragmites stand, approximately 100 x 40 feet.

**Total Degradation Score (higher score indicates a higher level of degradation):** 0.90

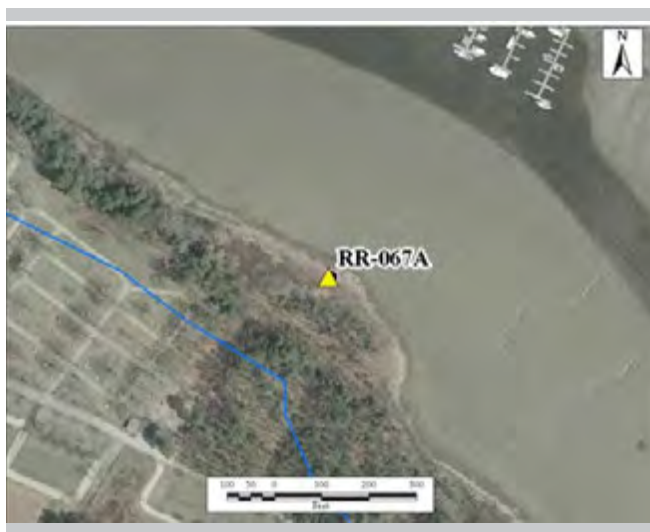
Two Phragmites stands in close proximity, approximately 150 x 30 feet and 60 x 12 feet.

**Total Degradation Score (higher score indicates a higher level of degradation):** 0.60

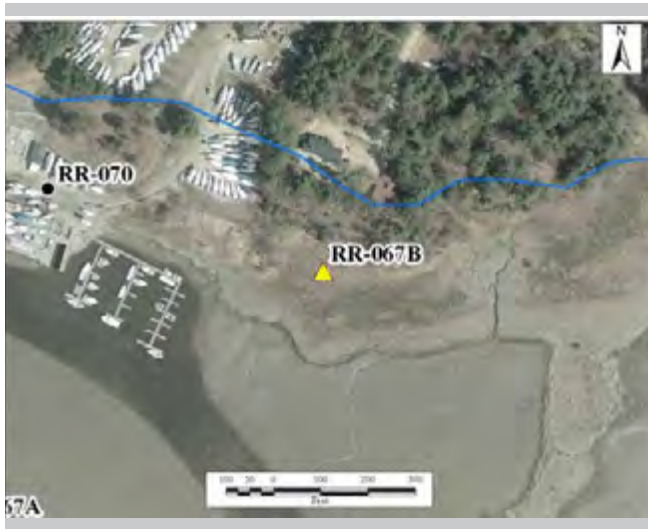
Phragmites stand, approximately 100 x 40 feet. Located adjacent to Royal River Boatyard Marina (RR-070).

**Total Degradation Score (higher score indicates a higher level of degradation):** 0.40

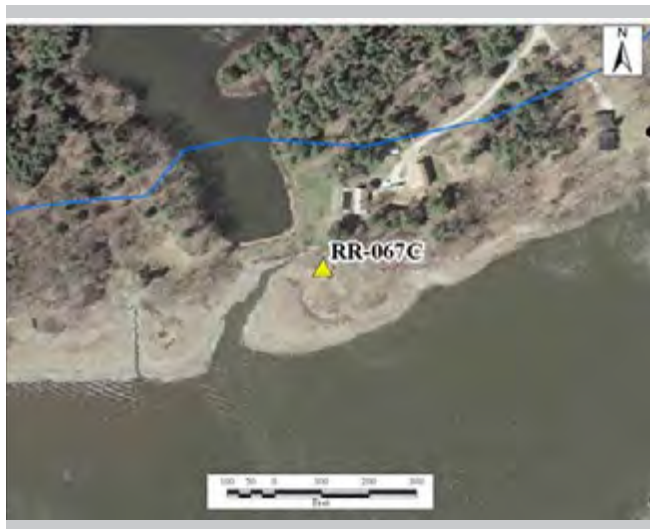
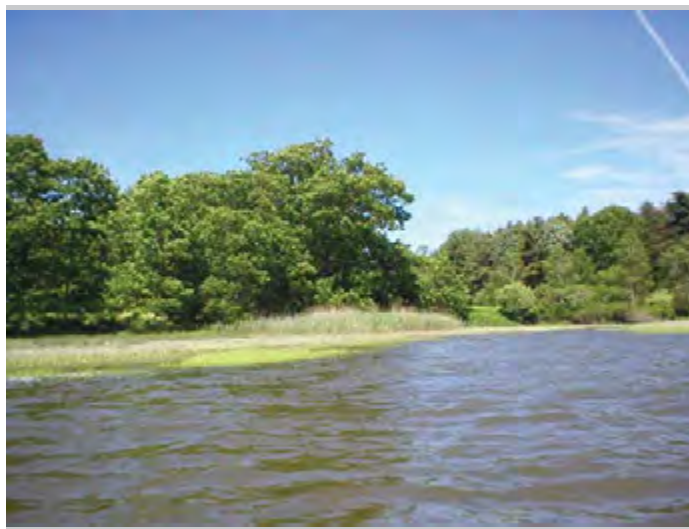
Three Phragmites stands in close proximity, approximately 30 x 50 feet, 40 x 40 feet and 30 x 80 feet.

**Total Degradation Score (higher score indicates a higher level of degradation):** 0.60

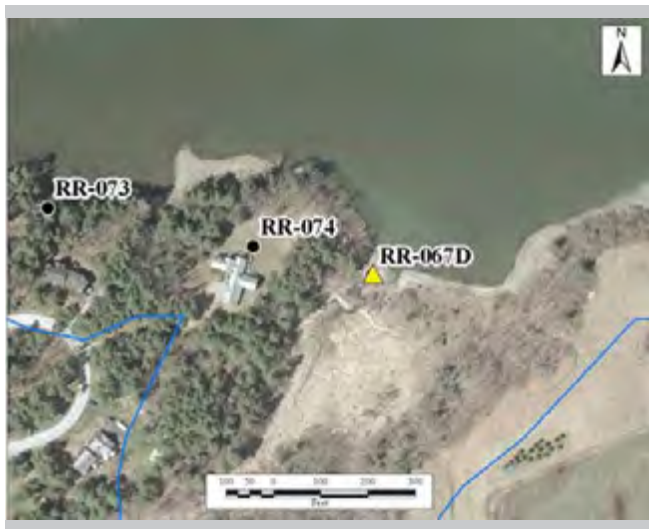
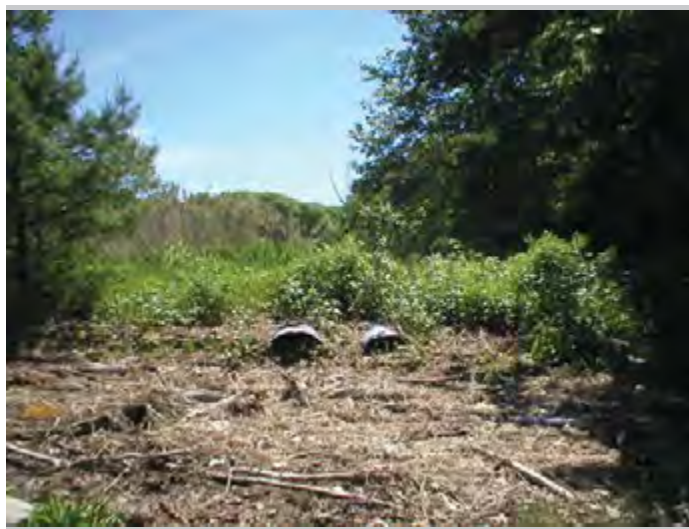
Phragmites stand approximately 15 x 50 feet. Old hay road with two corrugate metal culverts, set too high for tidal exchange and blocked with vegetation and silt. Behind hay road and Phrag is what appears to be a man-made berm with spotty patches of Phragmites (5-10% cover) across the area (approx. 500 x 200 feet).

**Sources of Degradation (13 possible):** Culvert issue, Drainage issue, Invasive plant species

**Total Degradation Score (higher score indicates a higher level of degradation):** 2.40

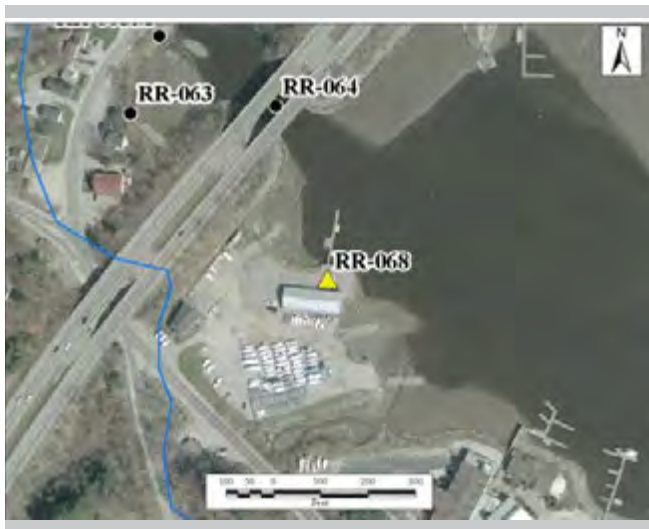
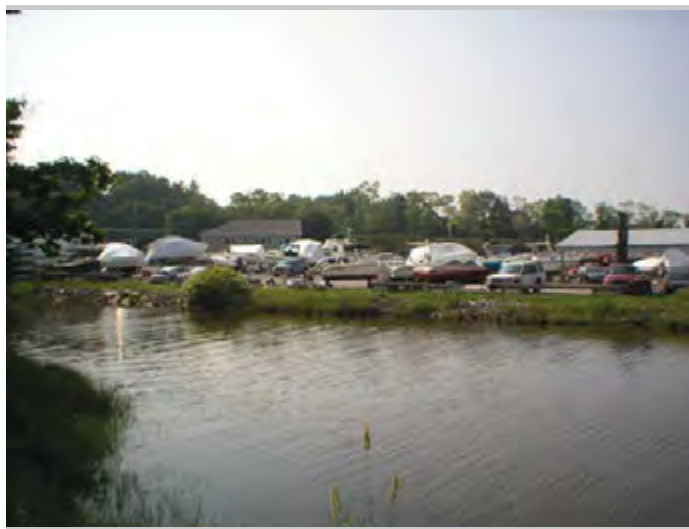
Yarmouth Marina and Boat Yard. Gravel parking areas. Docks with many boats. Parts of shoreline are riprap and parts vegetated with herbs. Some hardened shoreline (bulkhead). Shoreline appears stable, not eroding. Some paved areas.

**Sources of Degradation (13 possible):** Dock/pier/jetty that extends out into channel, Impervious surface, Land cleared, Land use activity a potential contaminant source, Rip-rap (or other artificial hard structure)

**Total Degradation Score (higher score indicates a higher level of degradation):** 3.95

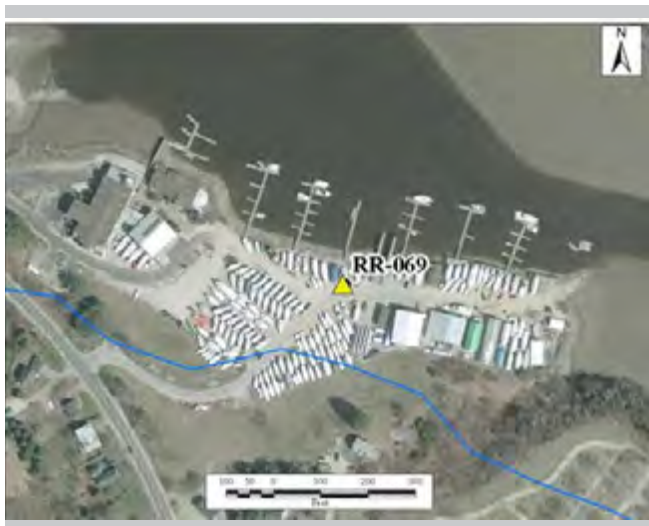
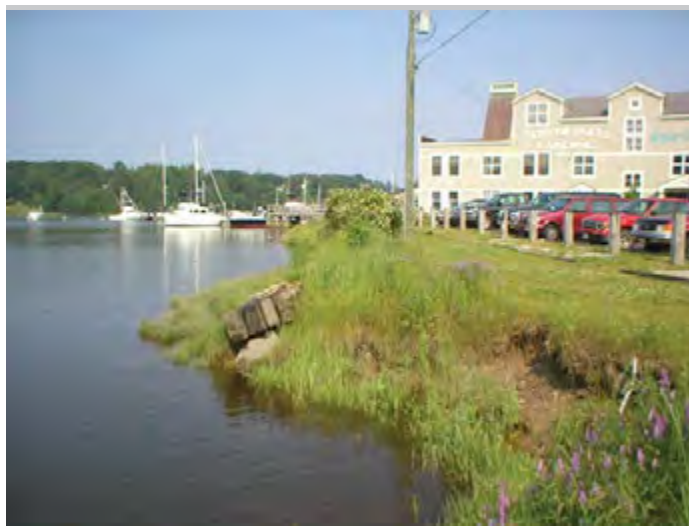
Lower Falls Landing Marina. Docks with lots of boats and moorings. Shoreline eroding in places, natural and riprap shorelines. Smell of gas and paint. Mowed lawn to top of bank. Then maintained herbs and scattered shrubs on shoreline where vegetation is present.

**Sources of Degradation (13 possible):** Dock/pier/jetty that extends out into channel, Fill/debris/trash, Impervious surface, Land cleared, Land use activity a potential contaminant source, Rip-rap (or other artificial hard structure), Unstable bank

**Total Degradation Score (higher score indicates a higher level of degradation):** 4.30

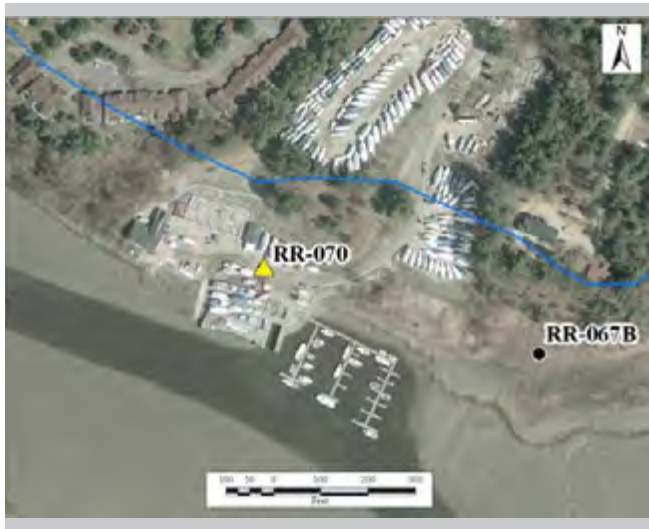
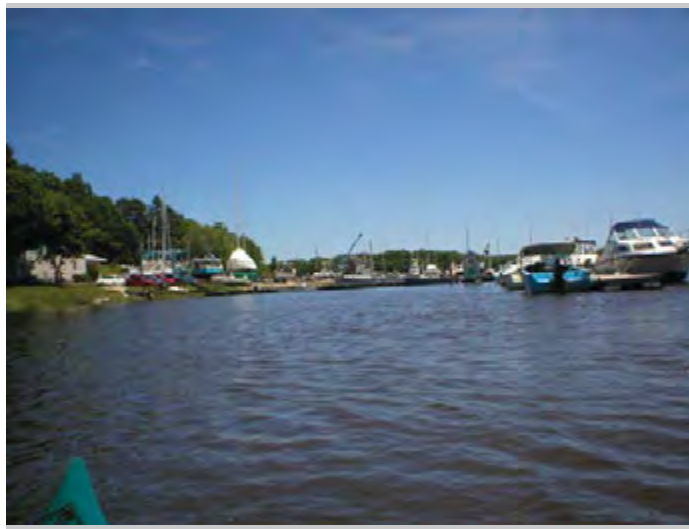
Royal River Boatyard Marina. Docks, boats, gas tank filling station. Gravel parking areas, rip-rap shoreline, some paved areas. Maintained buffer with herbs only. Banks stable, not eroding.

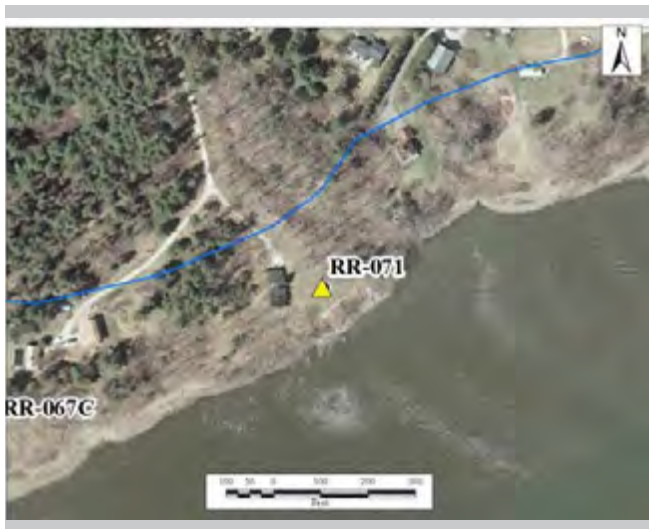
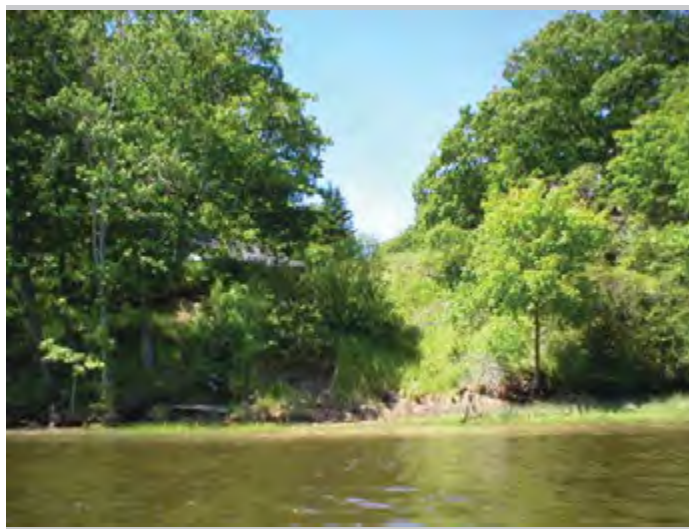
Slumping shoreline. Vegetated with forested buffer to top of slope, then mowed lawn. Large chunks of bank eroding away.

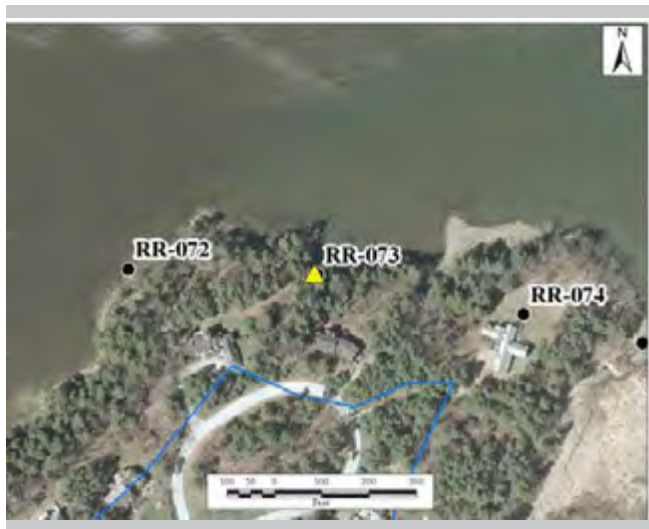
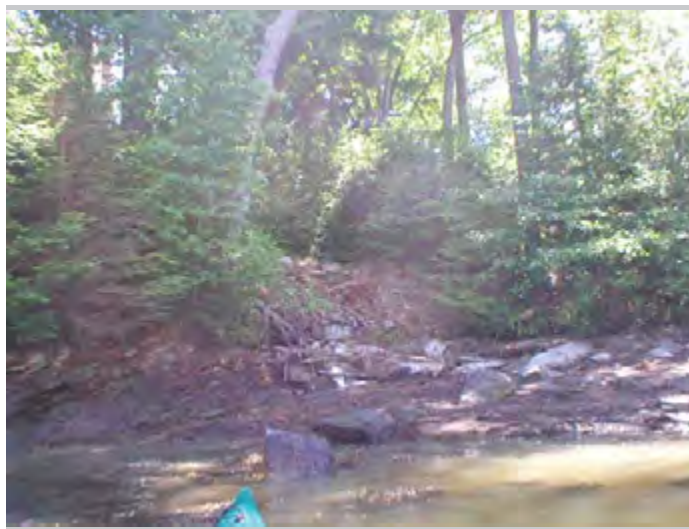
Path to access beach area has washed out. Appears that steps have been buried by debris.

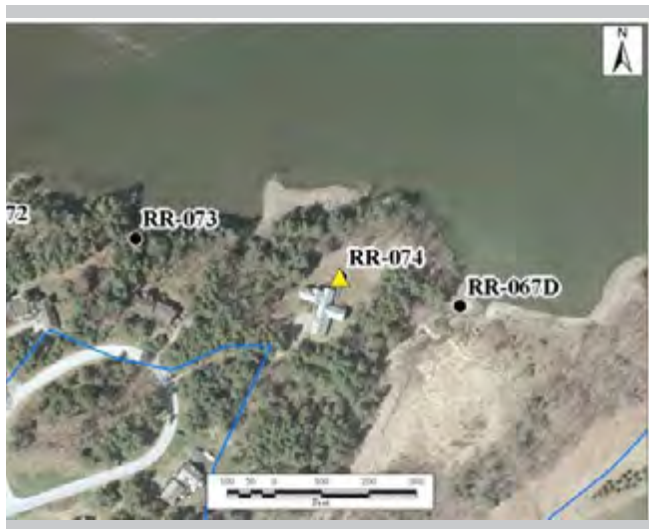
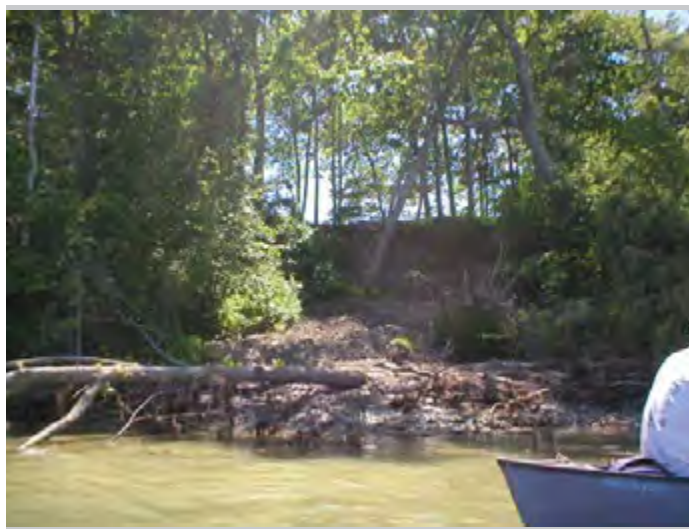
Severe erosion of banks. Large chunks of lawn have been undercut and fallen in. Mowed lawn to top of banks, then steep slope to river. Banks well vegetated with herbs, shrubs, trees, except where erosion has occurred.
