Libby Brook Watershed Survey Final Report

LIBBY BROOK WATERSHED SURVEY FINAL REPORT

Prepared by:
John MacKinnon, P.E.
Friends of the Royal River
January 2002

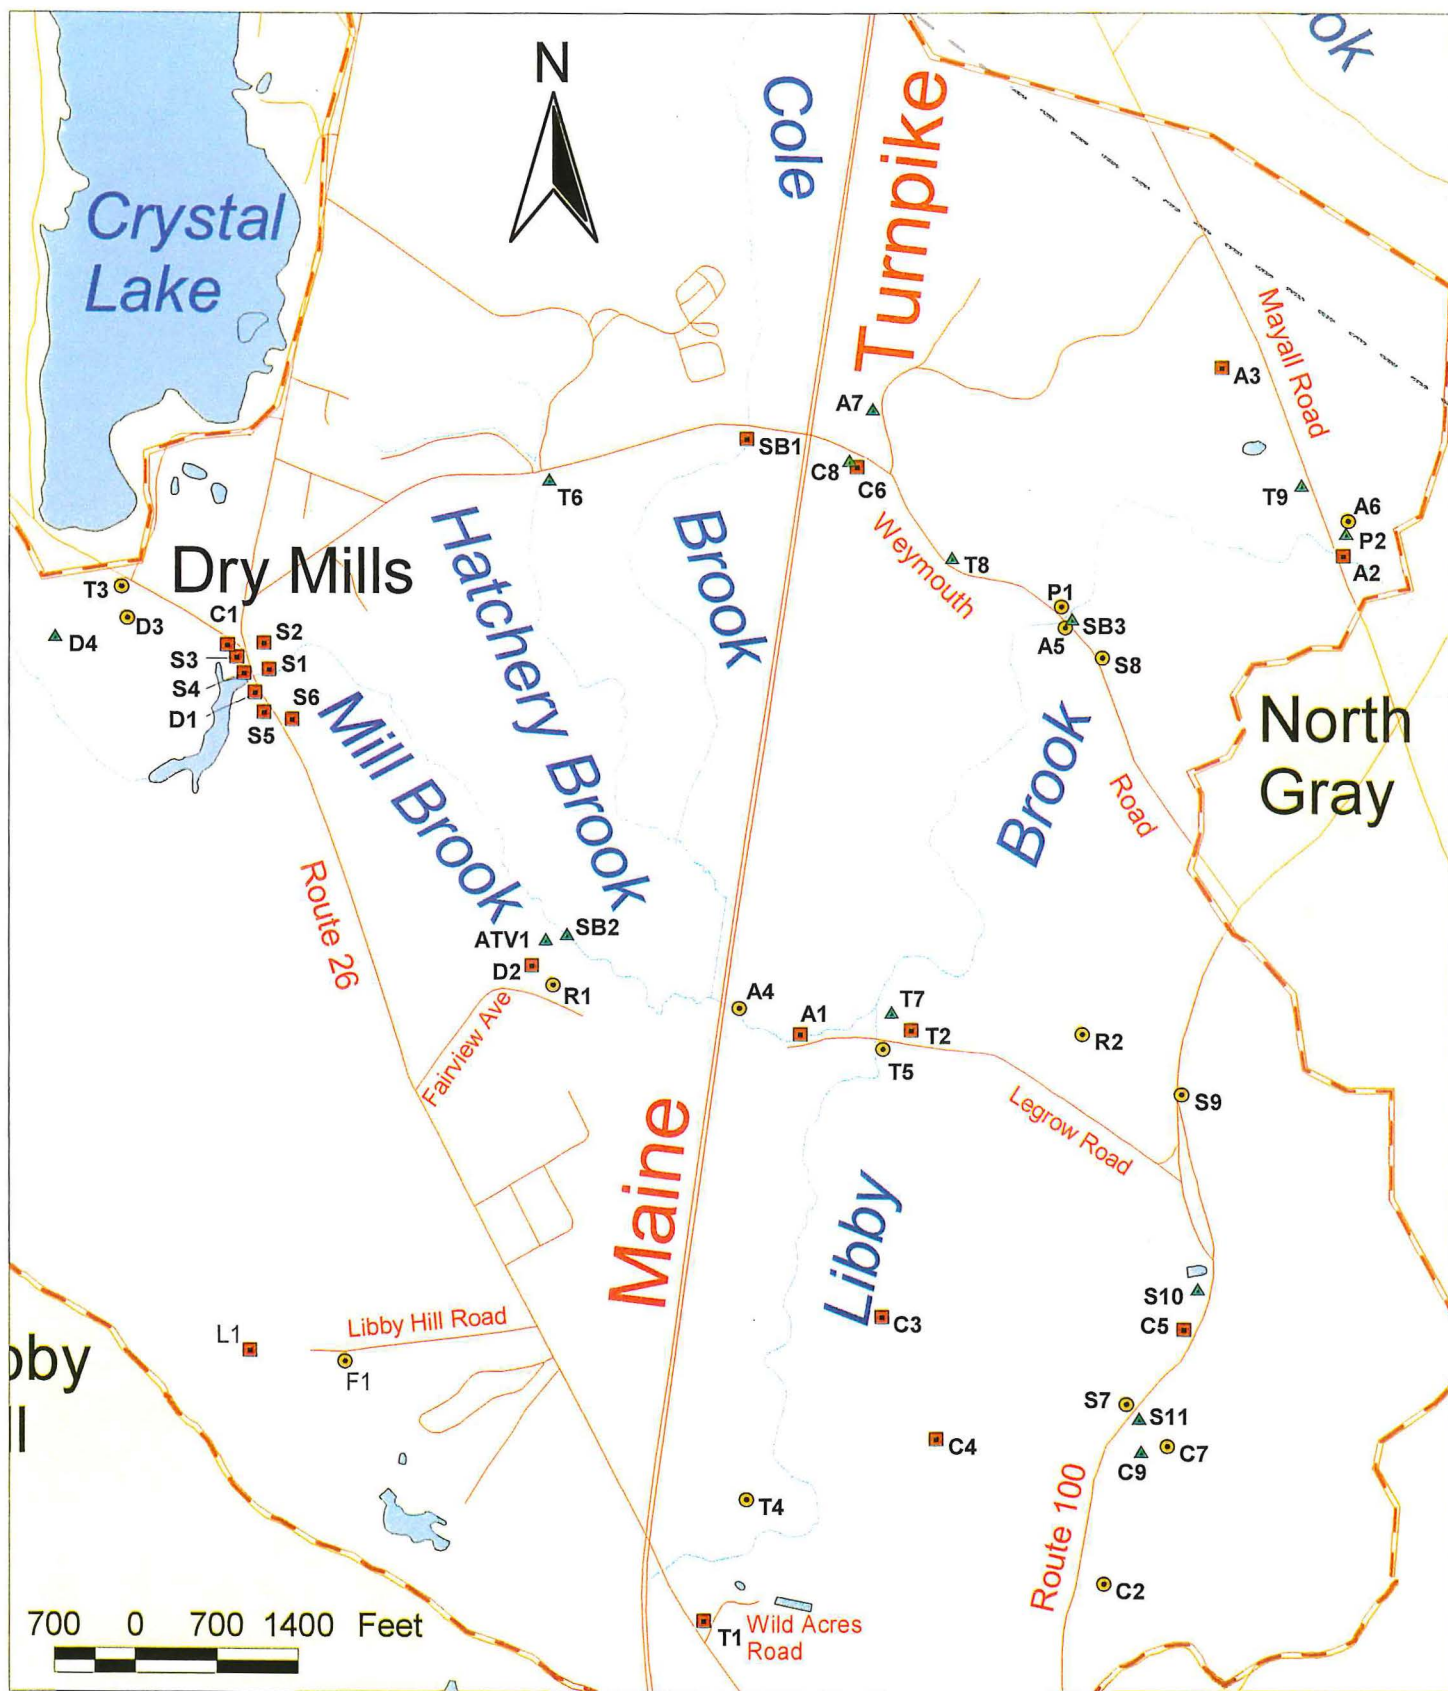
Figure 4
Watershed Survey
Site Locations

The first part of the survey using teams of trained volunteers identified 48 sites that appeared to be sources of polluted runoff. The second part of the survey using the technical team eliminated a few of the sites from the original list but added more, lengthening the list to a **total of 50 sites**. A table containing the survey findings is presented in Appendix B. The site locations are shown in Figure 4.
