Designed to Fail: Why Most Commonly Used Designs Will Fail and How to Fix Them

Richard C. Cote
Comprehensive Environmental Inc.

Presented at the Cold Climate Conference

Portland, Maine, November 5, 2003

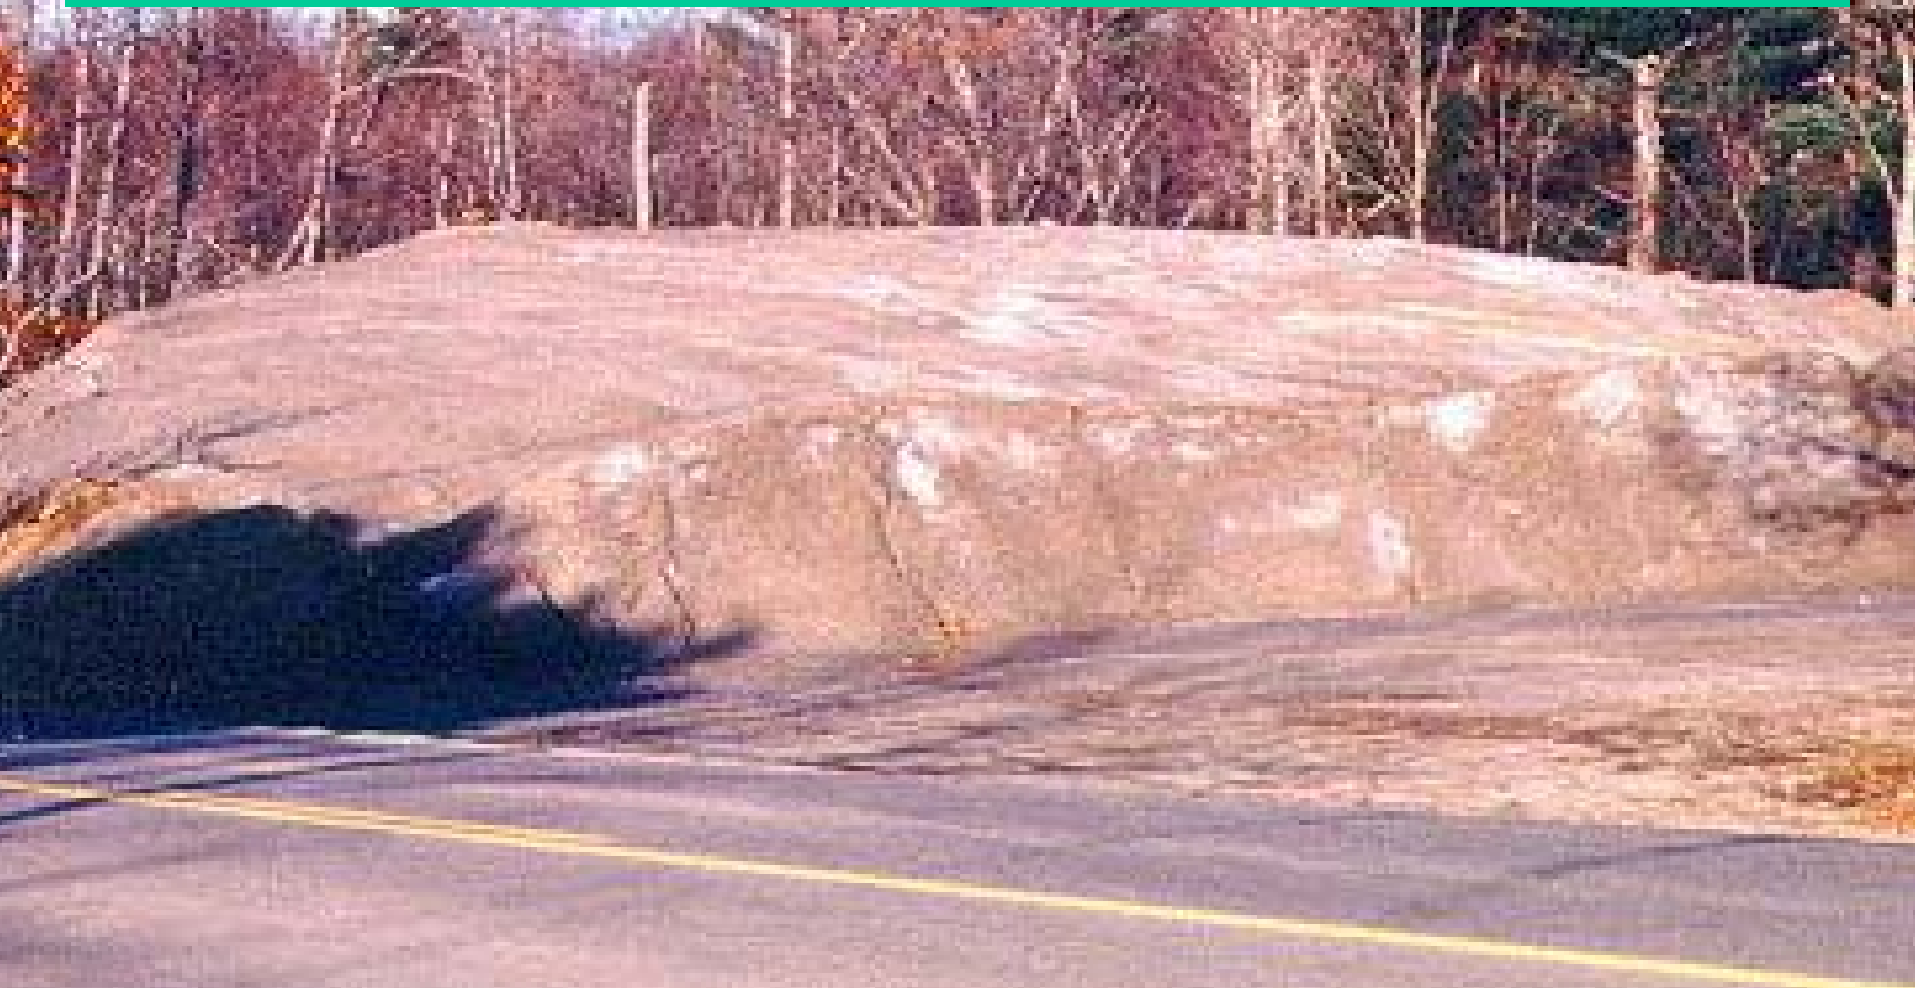
**Most important cold climate design issue:
S A N D**

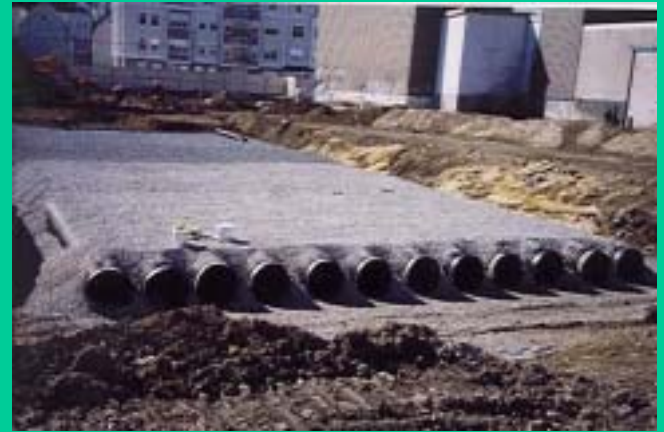
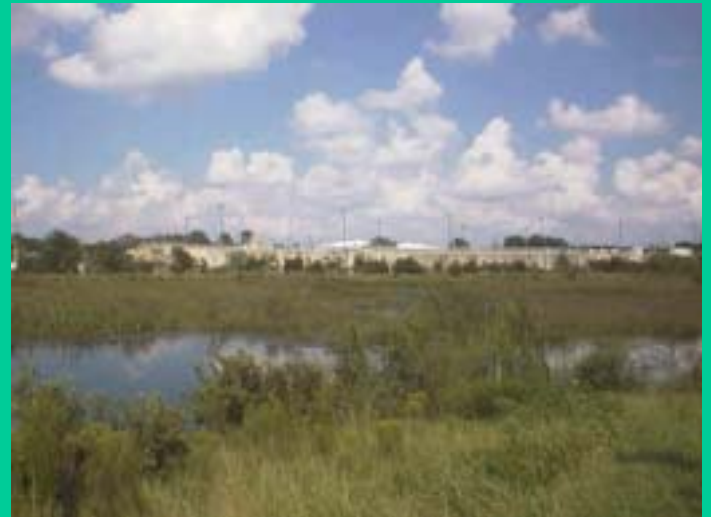
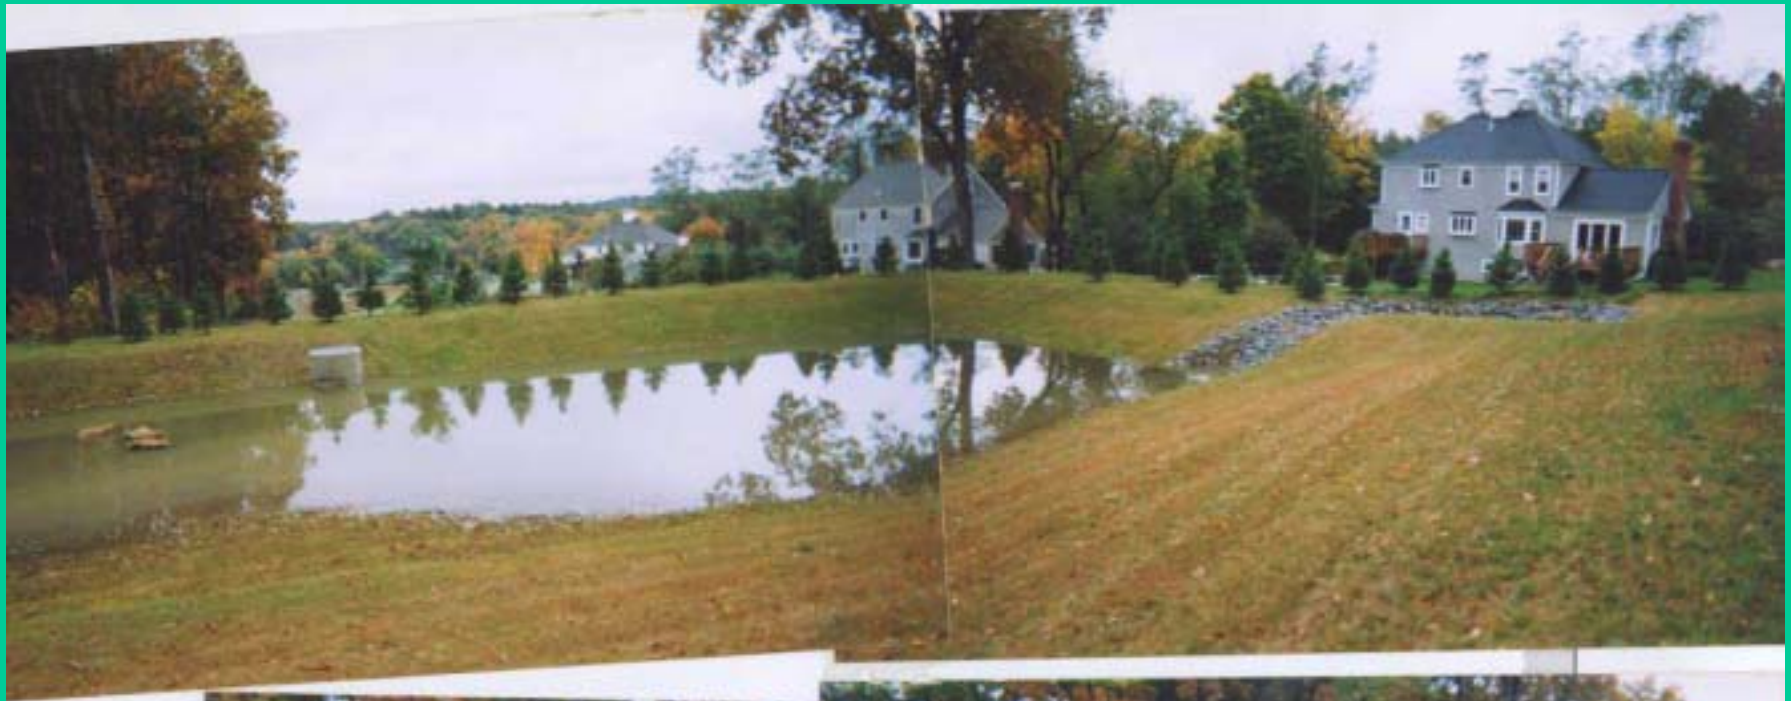
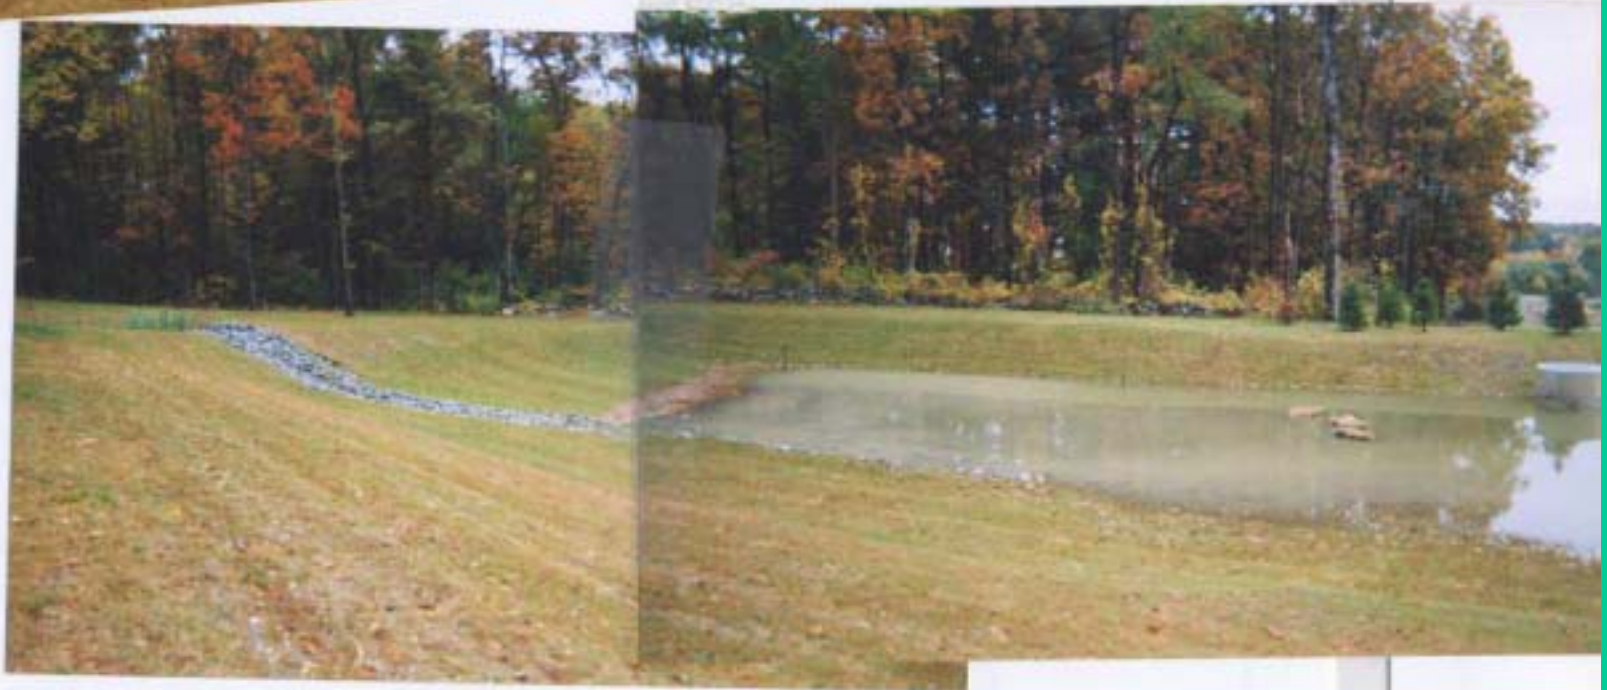
No. 3: No Pretreatment

- Problem:
 - Many BMPs are going in without adequate pretreatment
 - Most problematic:
 - Wetlands treatment
 - Underground units

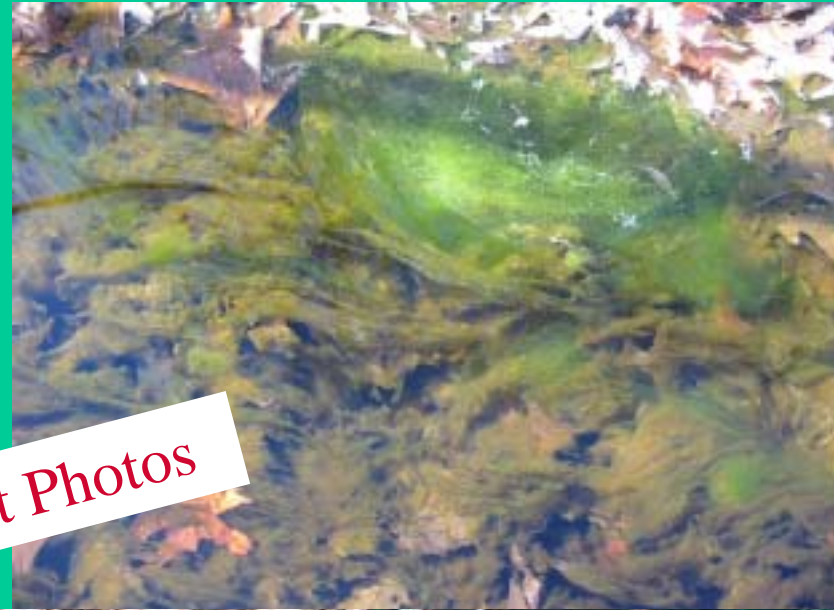
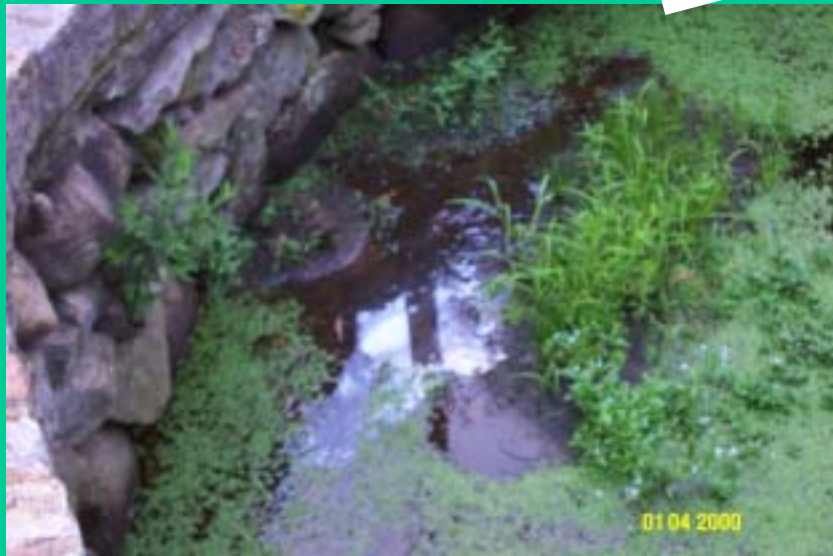
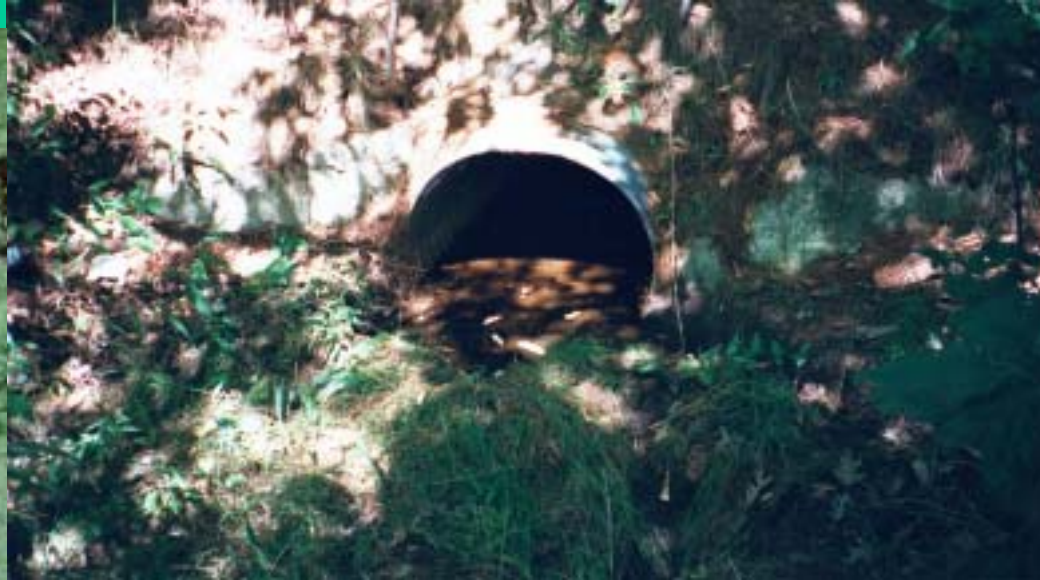
Post Treatment Photos

No. 4: Ineffective for site pollutants

- Problem: Use of proprietary units or other designs not known for removing nutrients surprisingly common in high nutrient situations
- Recommendation: Use tailored treatment train

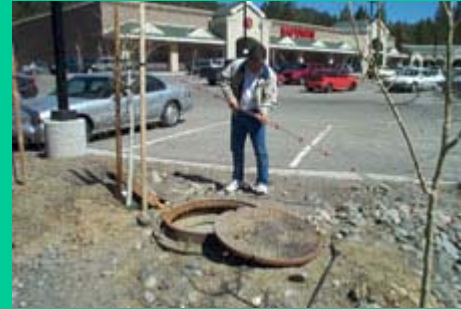
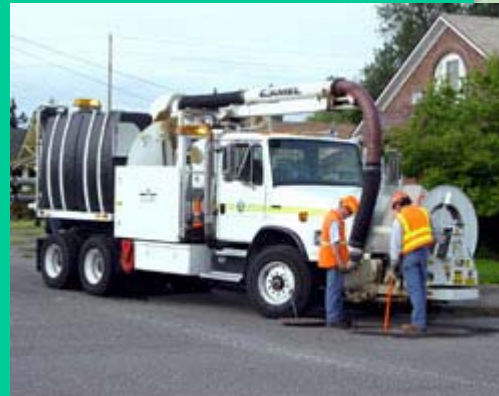
No. 6: Maintenance Needs Hidden

- Problem:
 - Most underground units are “out of sight, out of mind”
 - Some have bypasses to prevent backing up and flooding if not maintained
 - Some designs make it difficult for inspectors to see if maintenance is needed

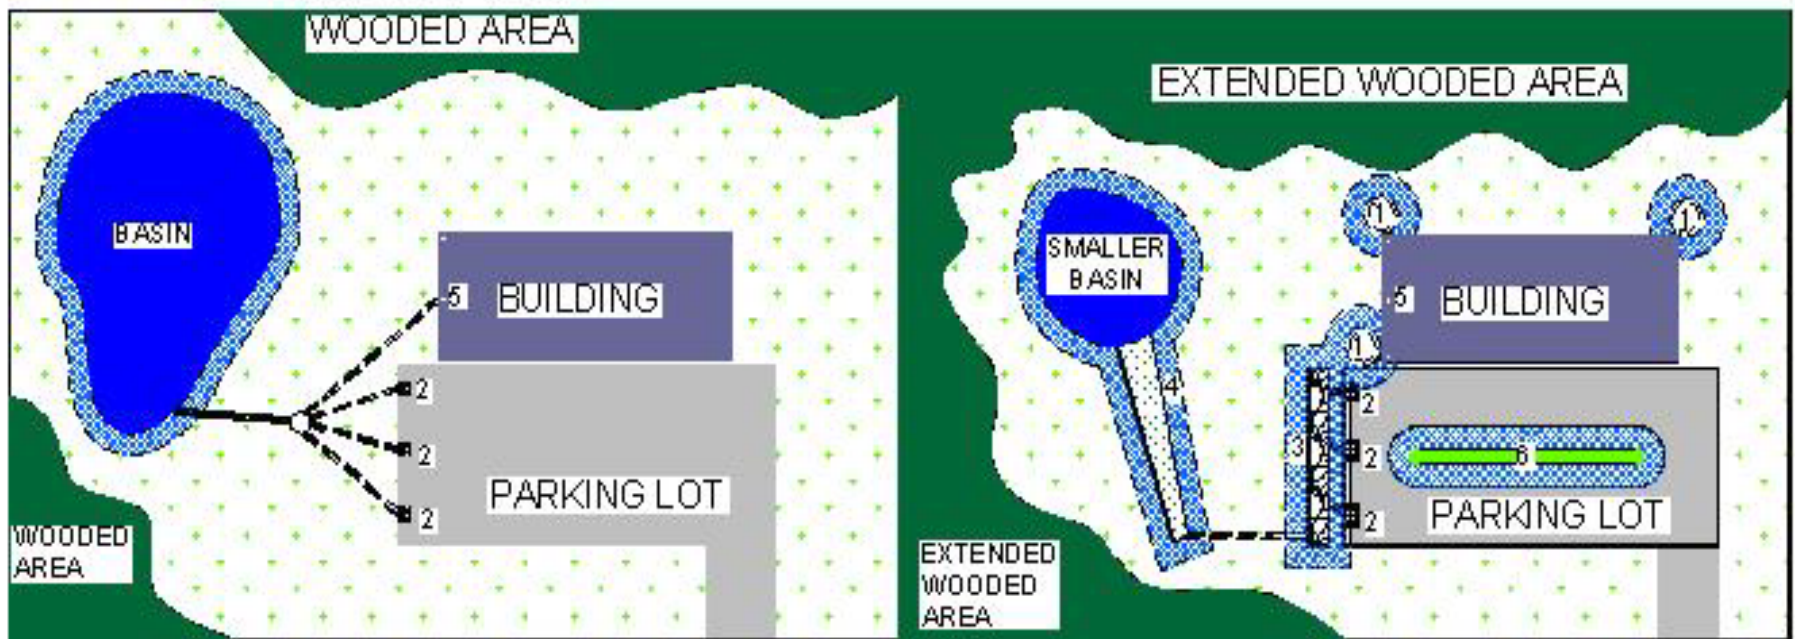
No. 8: One Size Fits All Approach

- Problem: many site engineers are using the same BMPs for every situation
- Recommendation: BMPs need site specific design that matches sites pollutants, site constraints and minimizes imperviousness to begin with
