## Recommendations for Future Restoration and Management Efforts for Mill Brook, Westbrook, Maine: Appendix C. Preliminary Culvert Photos

Casco Bay Estuary Partnership

**Preliminary Culvert Photos  
2003 & 2007**

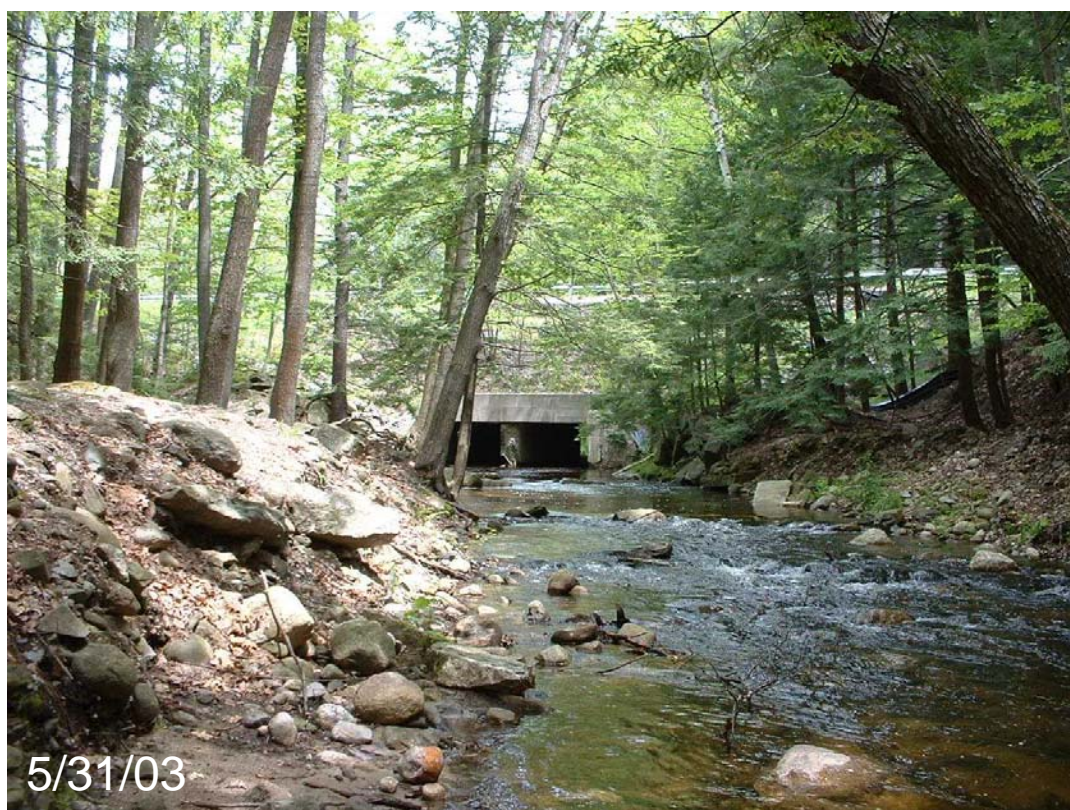
## Rte 302

Shallow water (at certain times of year) and flat, concrete bottom.

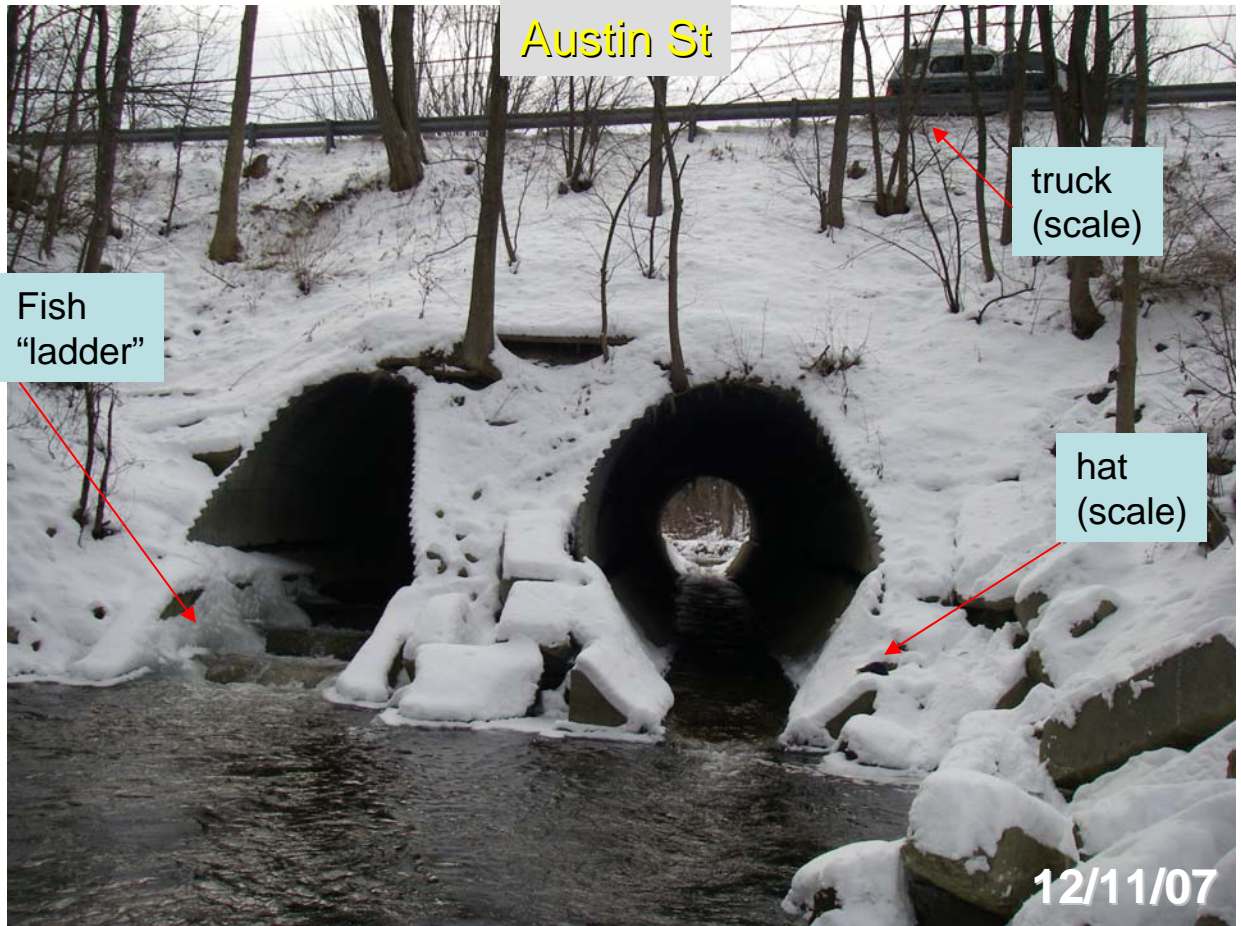
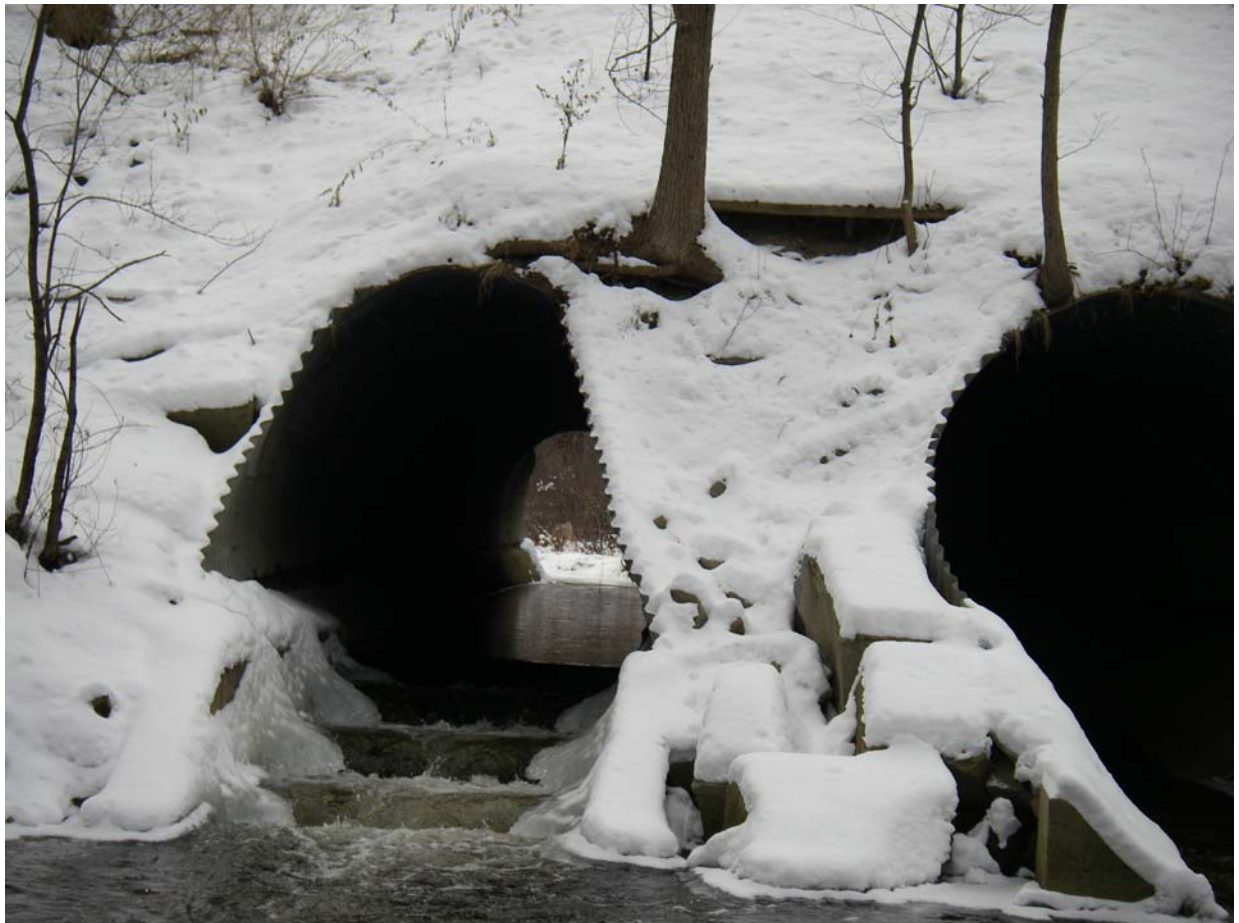
Austin St

Apparent, engineered log "dam" placed at upstream End of right culvert. Appears To be there to encourage fish to use other culvert.

This is a good idea. Still, the left culvert bottom is flat concrete and may still prove to be somewhat of a fish barrier.

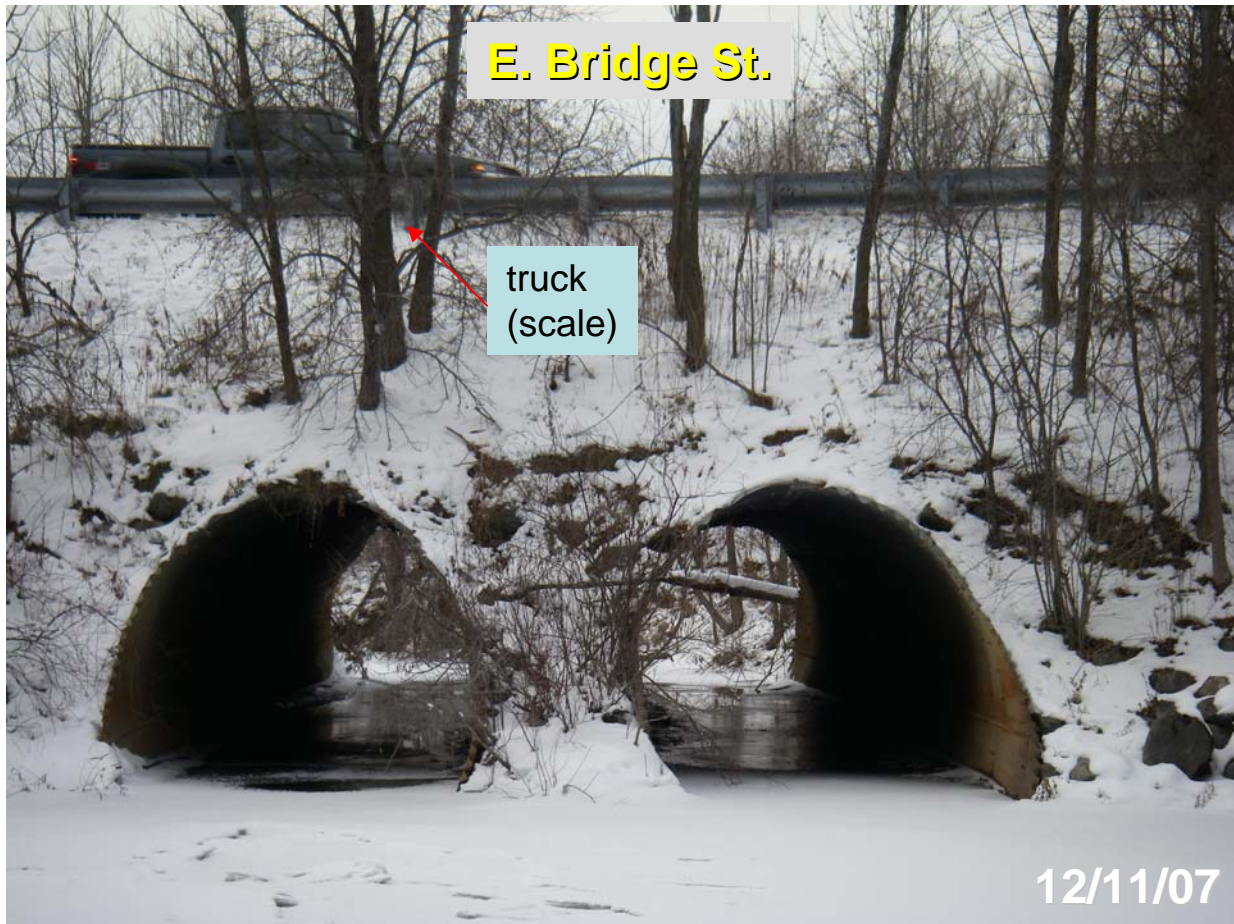
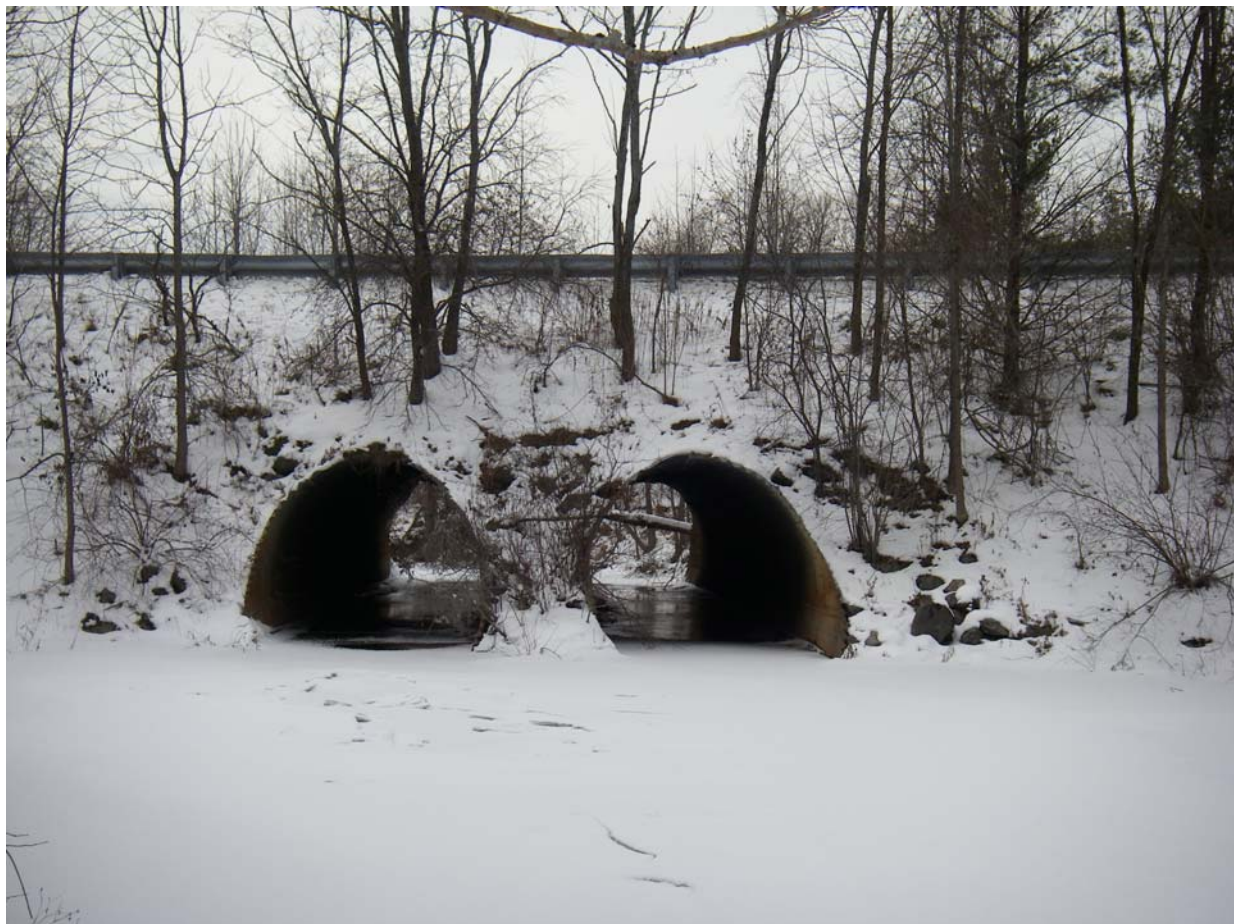
## E. Bridge St.

Photographs of the culverts underneath Bridge Street: A) taken on May 20, 2003; and B-C) taken on July 14, 2003.
