Recommendations for Future Restoration and Management Efforts for Mill Brook, Westbrook, Maine: Appendix E. Mill Brook Stream Habitat Walk

Mill Brook

Stream Habitat Walk

Cumberland County, Maine
May 31, 2003

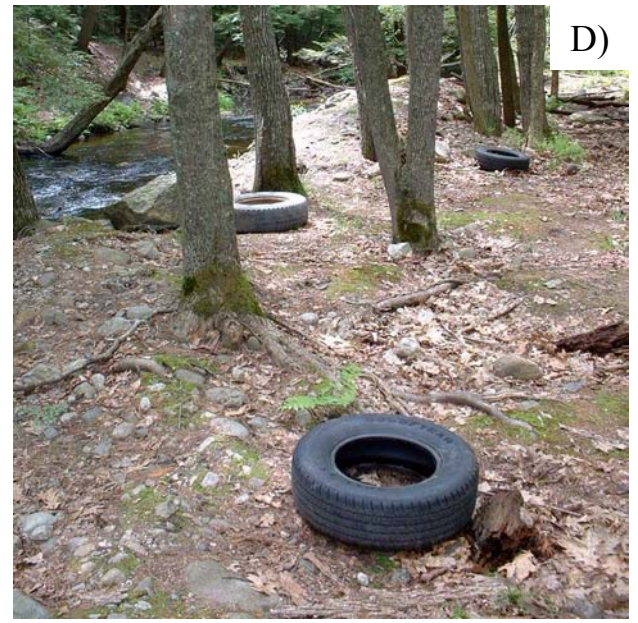
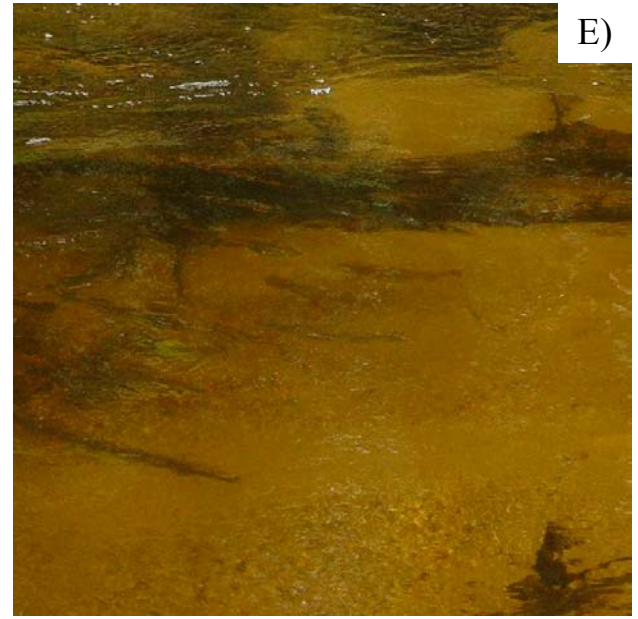
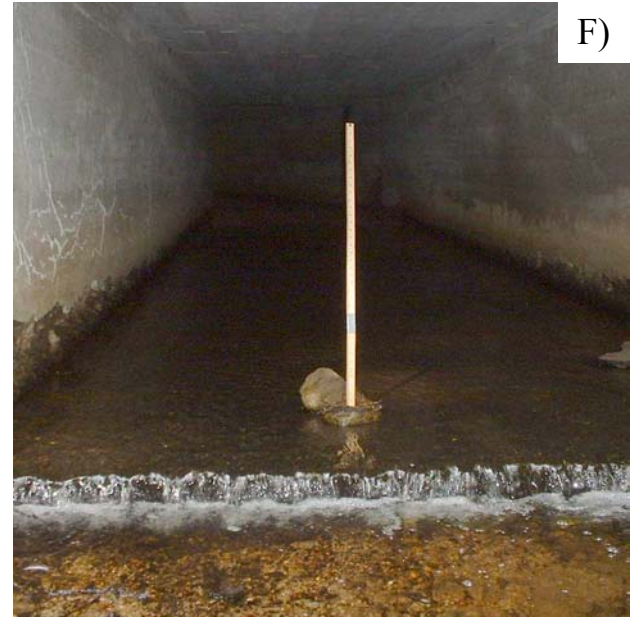
Site 1 photographs: A) scoured tree roots downstream of the Route 302 bridge/culvert; B) a woody debris dam and pool; C) a representative photograph of substrate in a run; D) trash on the streambank; E) alewives; and F) water level in the culvert (approx. 1 inch) (photo F taken on 7/14/03).

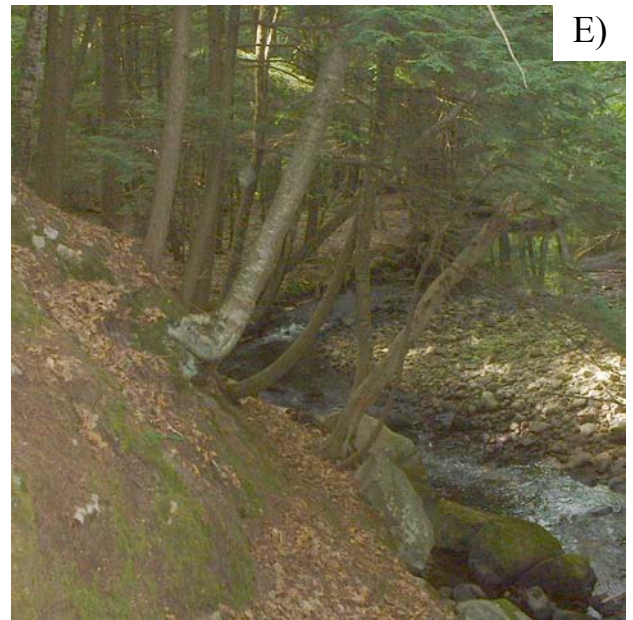
Site 2 photographs: A-B) signs of sediment inputs via a tributary containing some road runoff; C) sediment accumulation on the bank of Mill Creek opposite from the tributary input; D) a close-up photo of the tributary (notice the frog on the rock in the middle); and E) some “J-shaped” tree trunks on a nearby, steep bank, indicating relatively slow hillside erosion rates in the local area.

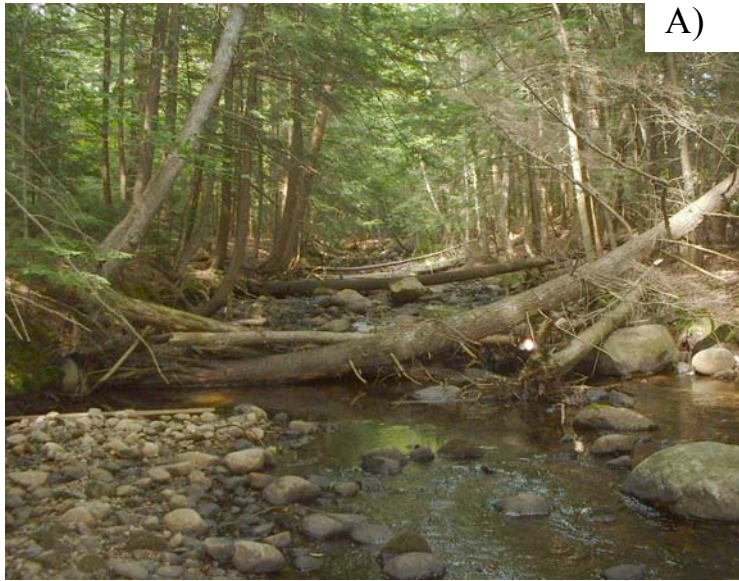
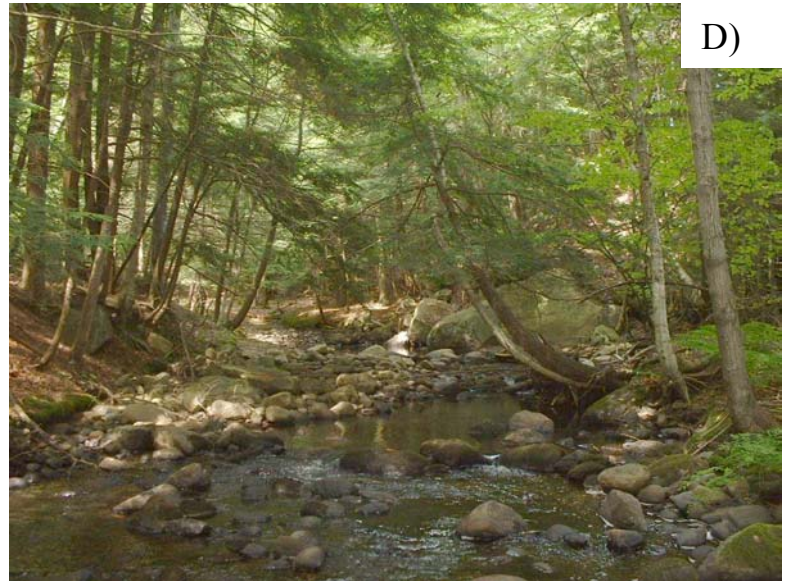
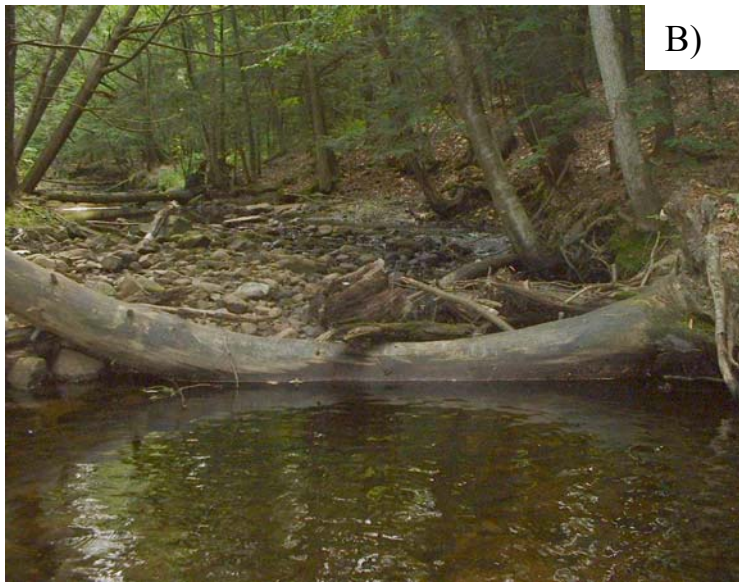
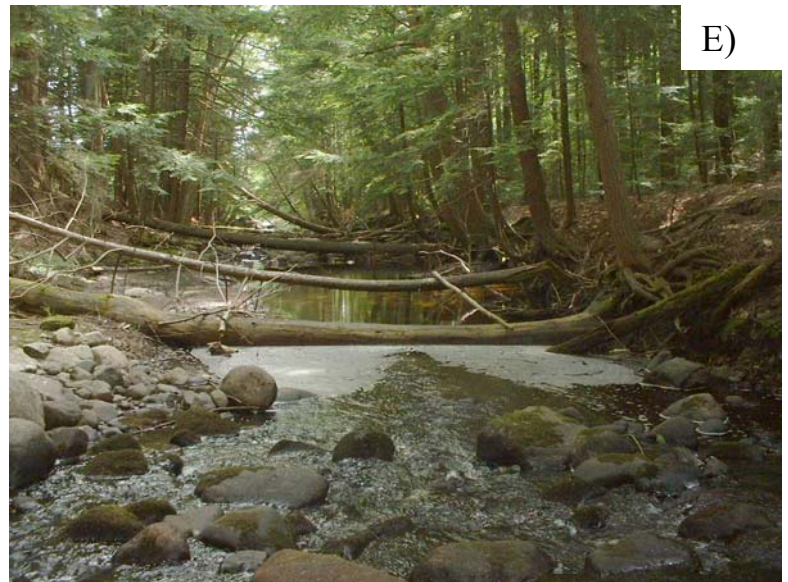
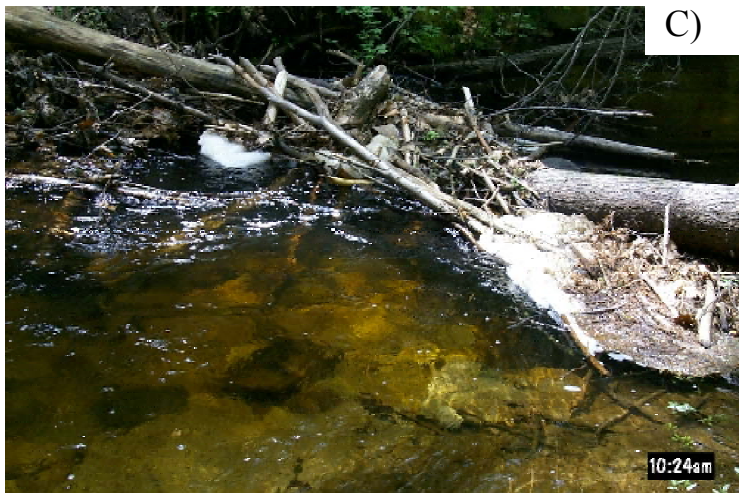
Site 3 photographs: woody debris dams (photos A, B, D, and E were taken on 7/14/03). Fallen large woody debris is important for creating stream habitat diversity and for trapping / retaining food resources for aquatic organisms. However, large numbers of fallen trees may sometimes indicate that the channel is trying to widen, in response to human impacts to the stream. More investigation may be needed to determine the types and stability of processes occurring in Mill Brook.

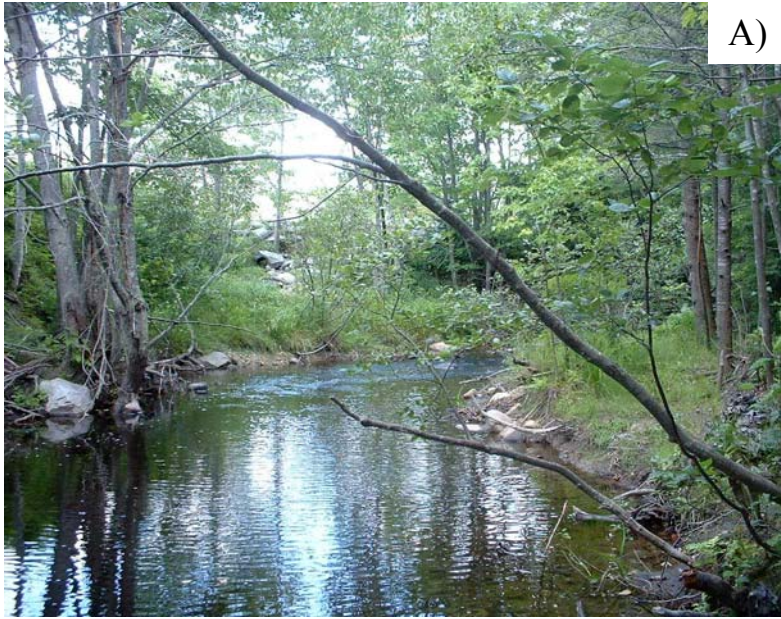
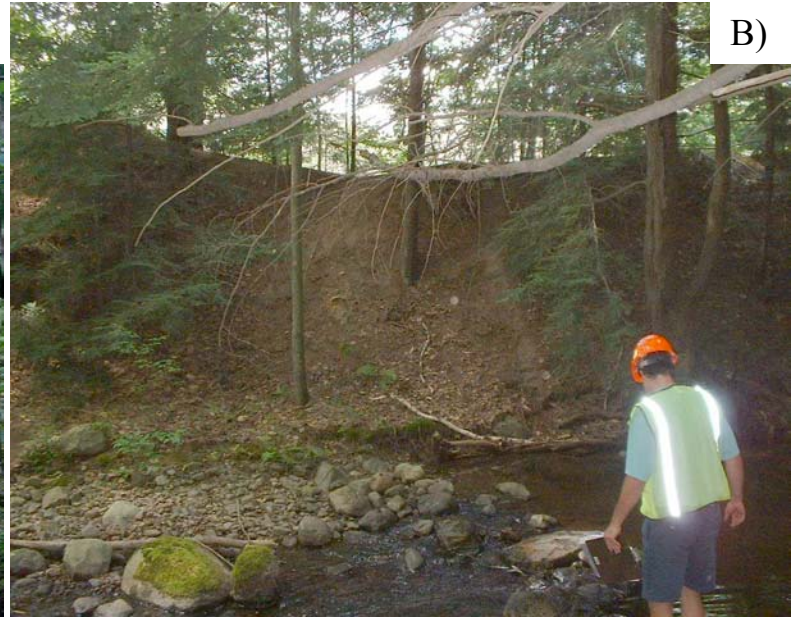
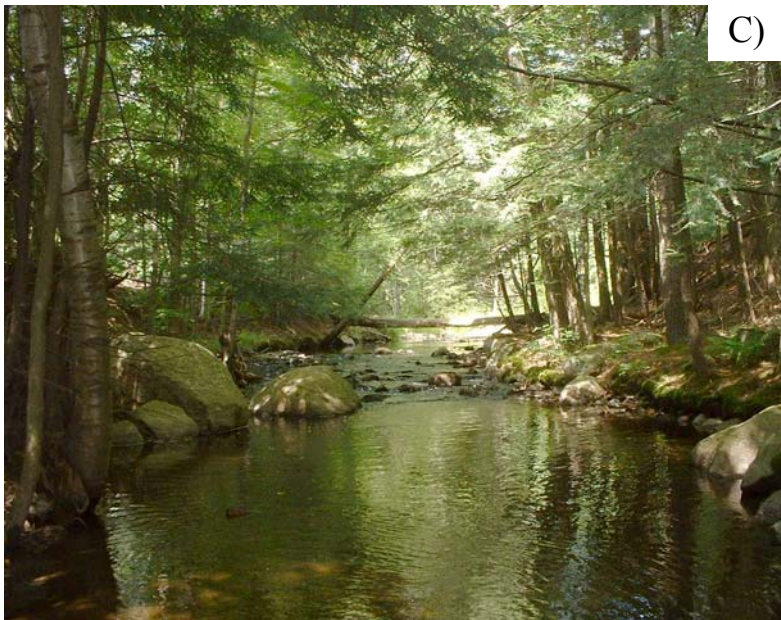
Site 4-B* photographs: A-B) Mill Brook and streamside areas in the vicinity of a gravel mining operation (note the berm wall on one side of the stream - it currently is serving as a barrier between a stormwater detention pond and the stream) and C-D) pools, riffles, and streamside forest. *These photos were taken on July 25, 2003, on a reconnaissance walk of this area, which is located downstream of Site 4 (see the map on page 2).

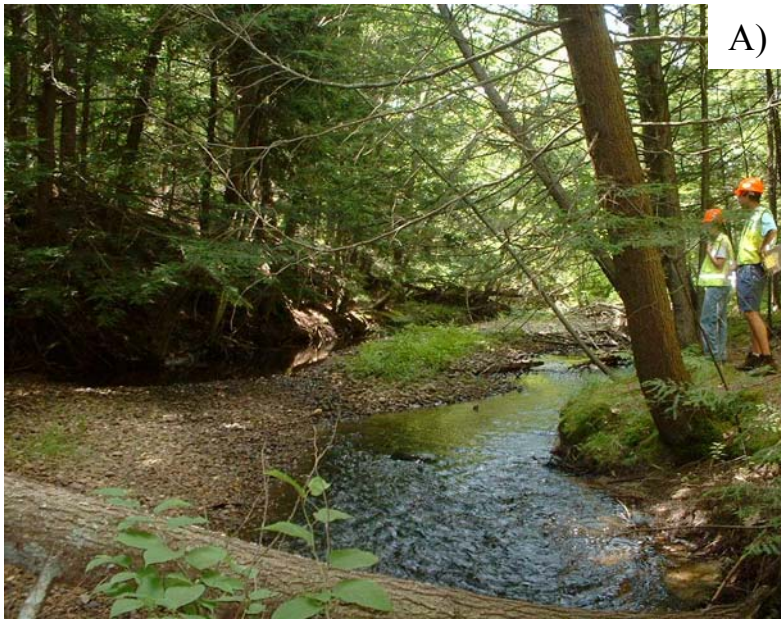
Site 4-B* photographs: A-B) signs of aggradation (that is, sediment accumulation or bar formation) in the middle of Mill Brook's channel and C-D) local ATV trail impacts. *These photos were taken on July 25, 2003, on a reconnaissance walk of this area.

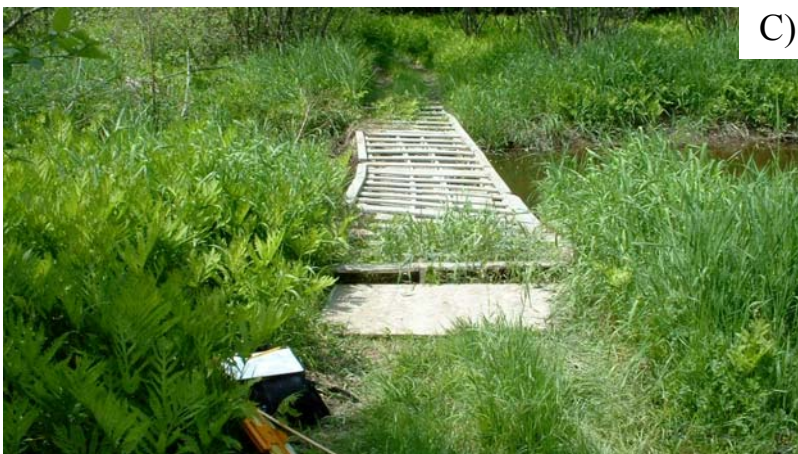
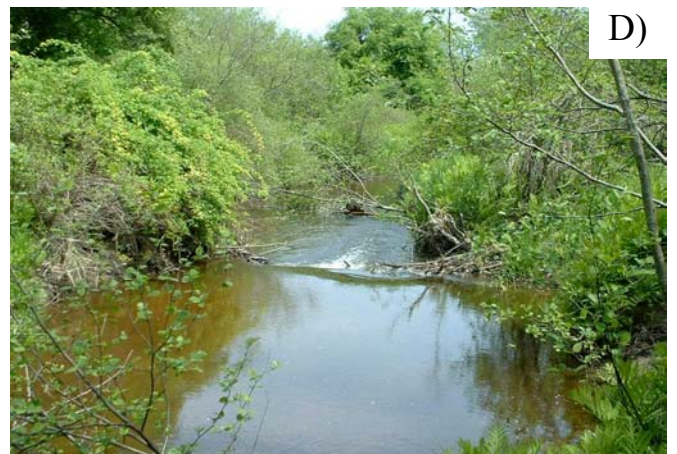
Site 5 photographs: A-B) Looking upstream and downstream from the ATV bridge shown in photo C; C) ATV bridge; and D) a small debris dam perhaps created by beaver.

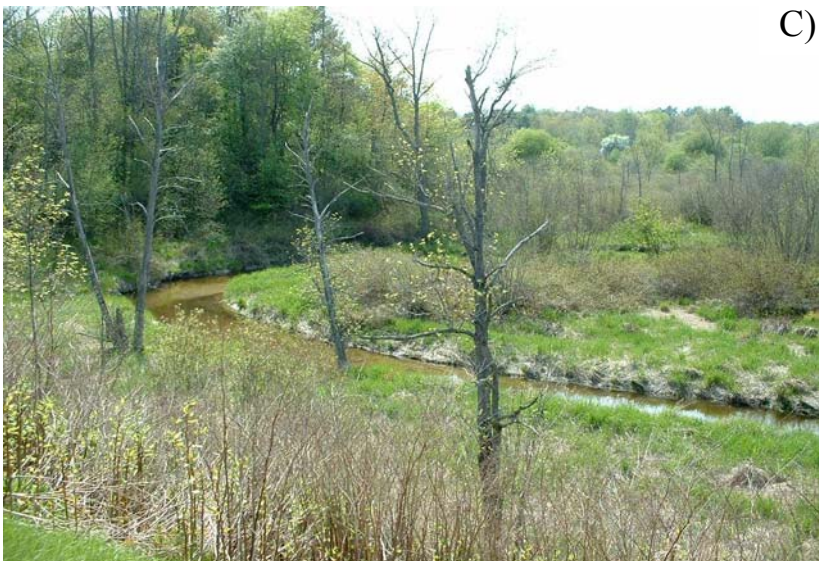
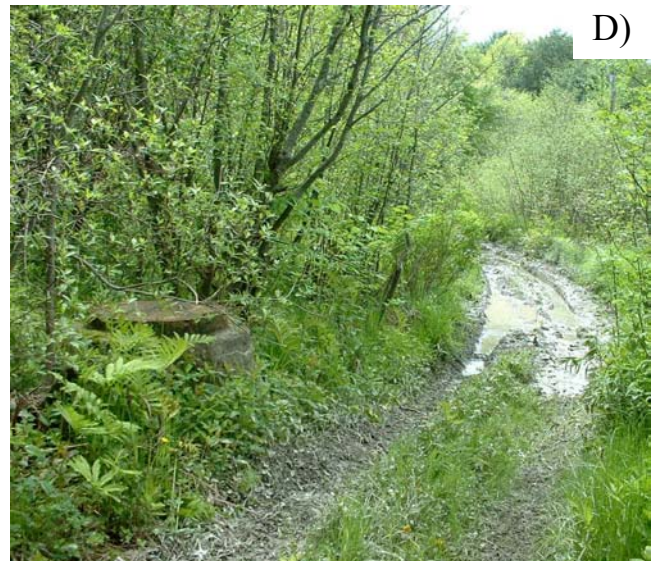
Site 6 photographs: A-C) meandering, low gradient, silty-sandy-bottomed stream; and D) a manhole above a sewer line and an ATV trail near Mill Brook. Photo C was taken on 5/20/03 and it is situated just upstream of Bridge Street.

Sites 5 & 6) Major concerns: Sediment pollution from badly eroding ATV trails, thermal stress from a general lack of many mature, tall trees in the riparian zone, and potential sewer line leaks.

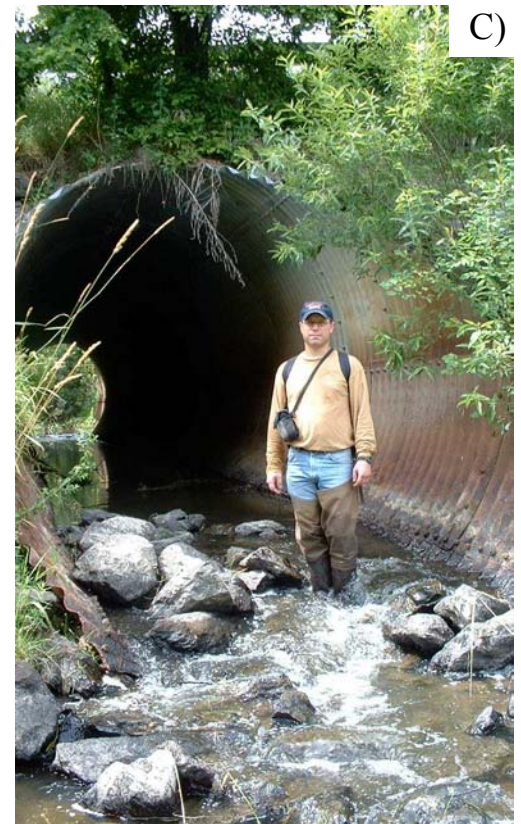
Photographs of the culverts underneath Bridge Street: A) taken on May 20, 2003; and B-C) taken on July 14, 2003.

- > Investigate potential fish passage issues at all the culverts on the stream.
- > Conduct more stream walks on sites not included in this survey, including small tributaries to Mill Brook which might provide cold water to certain areas of the brook that can provide cold-water refugia to fish such as salmonids during warm periods of the year.

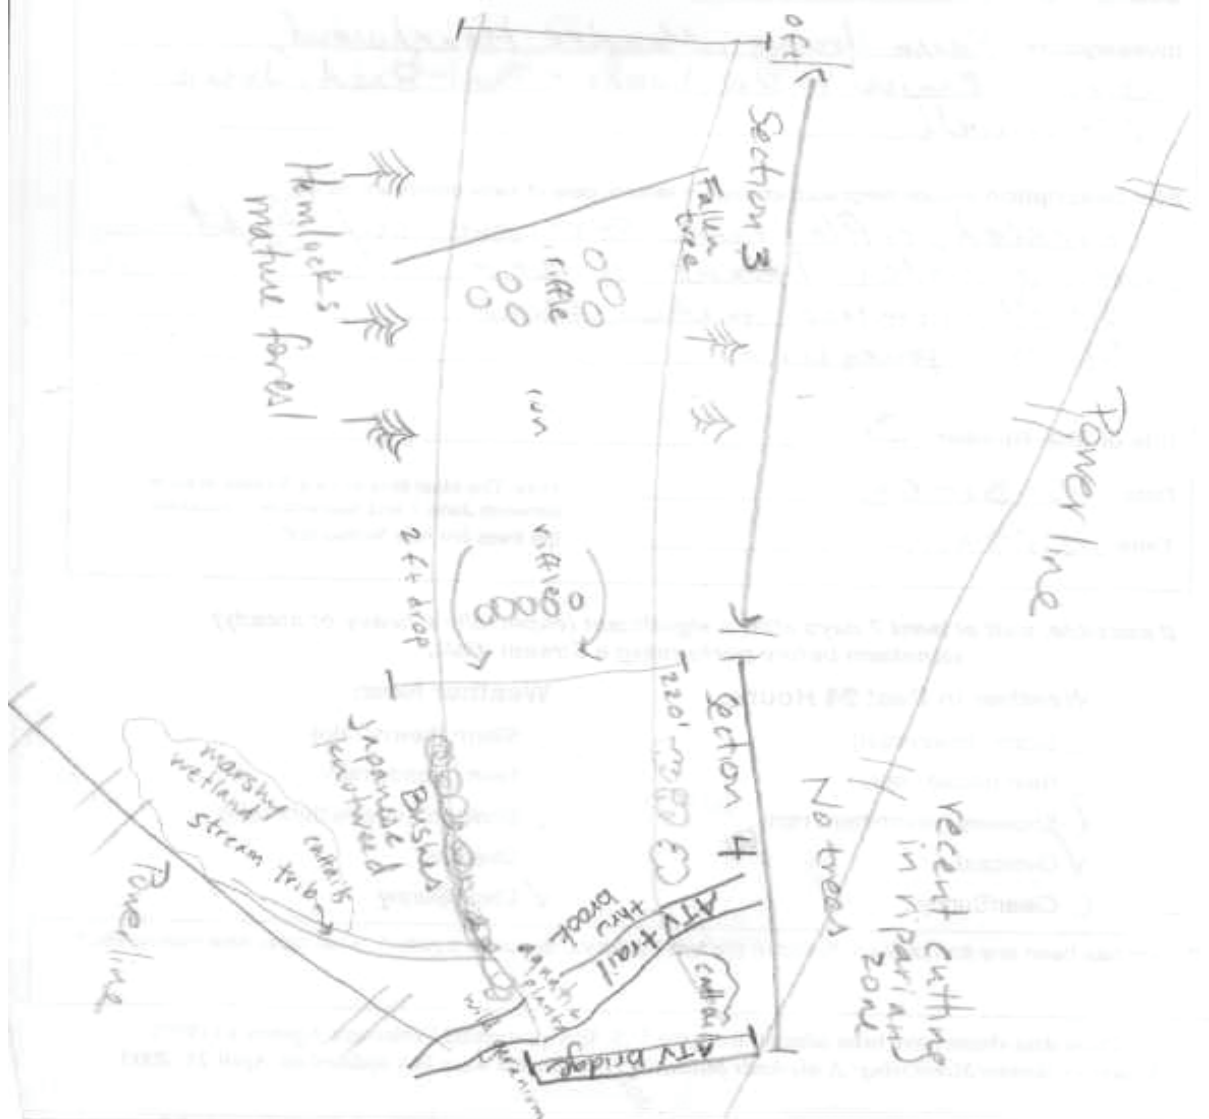
Sketch of Site

Forested, riffle, run section with fast moving water. Decent slope.

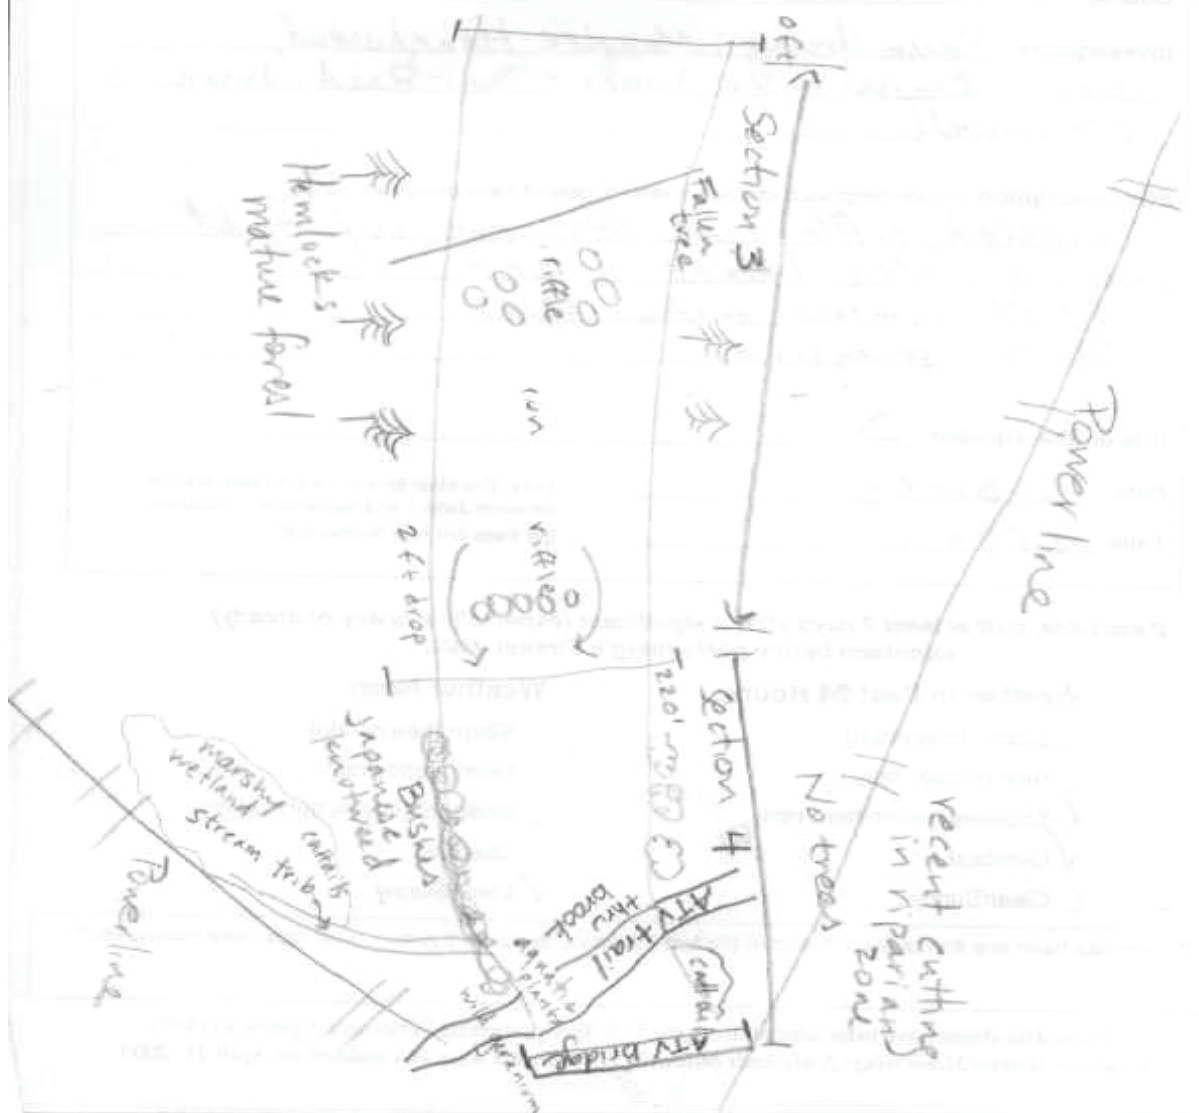
Sketch of Site

Powerline crossing. Recent cutting in the riparian zone. Mostly bushes, fast water movement and a riffle/run system.

East side of study area "hilly" powerline property. All vegetated but no trees. Bushes no higher than 10'. ATV use in Powerline trails. Trail crosses in stream but a bridge is available. Crayfish found on second visit. Many fish seen.

- > Further investigation regarding the riparian zone is recommended - especially at the powerline areas (near sites 4 and 4-B) and the lower brook sites (near sites 5 and 6). It would be worth knowing whether these areas, especially at the lower, apparently minimally-disturbed sites, would the vegetation type naturally be just a mix of shrubs, grasses, and smaller riparian trees (e.g., alder) as a result of what might be locally moist, hydric soils, or should there also be larger conifer and deciduous trees in the area? There may have historically been a large-scale tree harvest, perhaps about the time the sewer line was put in place. Another question might be: “Could anything be done to enhance the riparian vegetation conditions?”. In other words, are the conditions right for doing riparian vegetation restoration projects at the lower brook sites or powerline areas (assuming the landowners would permit it)?

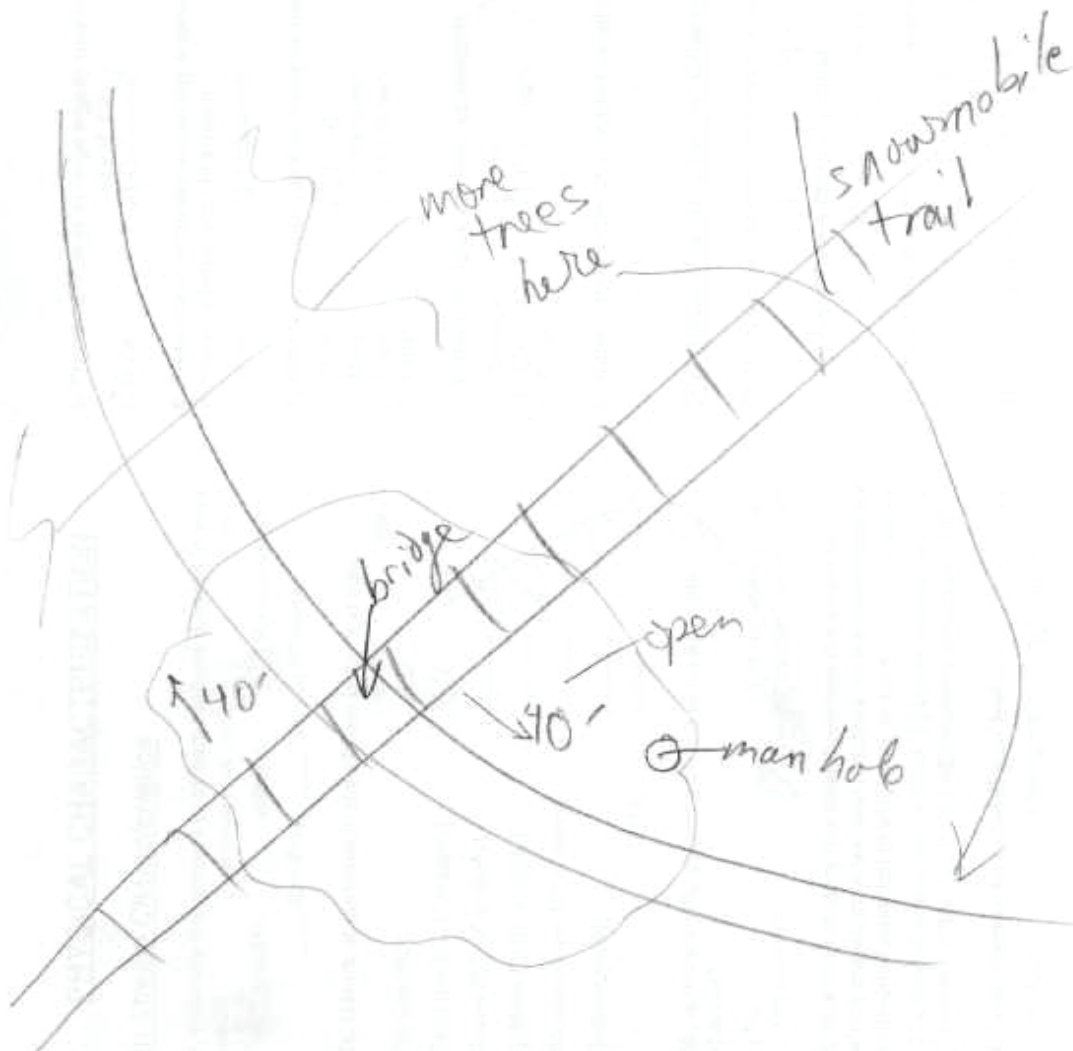
Sketch of Site

Low gradient, meandering, lots of snowmobile and ATV trails along stream

ATVs come close to stream destroying riparian areas. Leaky-sewer line. Smell evident in wet, screwed up ATV areas.

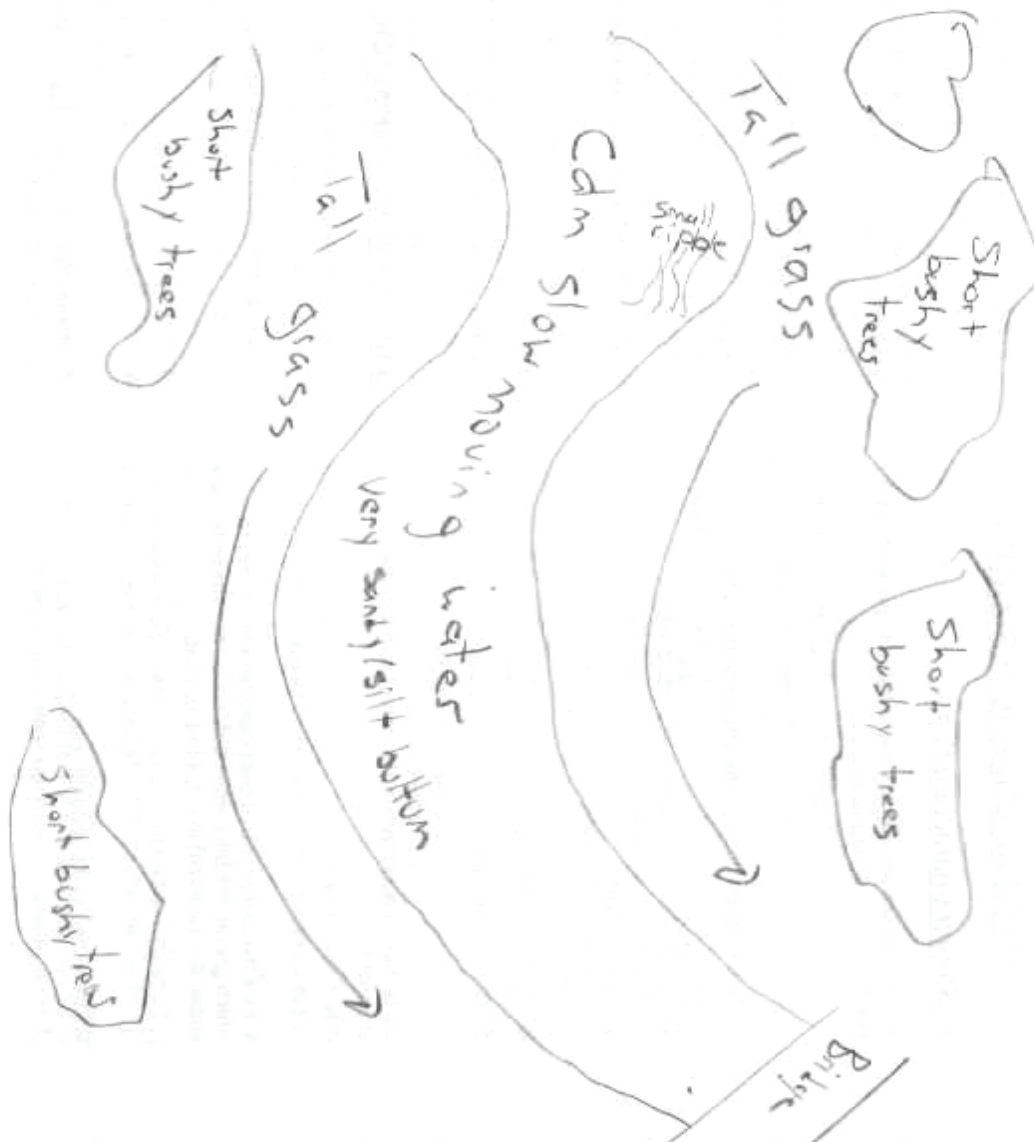
Sketch of Site

Low gradient, meandering, lots of snowmobile and ATV trails along stream
