Casco Bay Watershed Fish Barrier Priorities Atlas: Casco

Casco Bay Watershed

Fish Barrier Priorities Atlas

March 2012

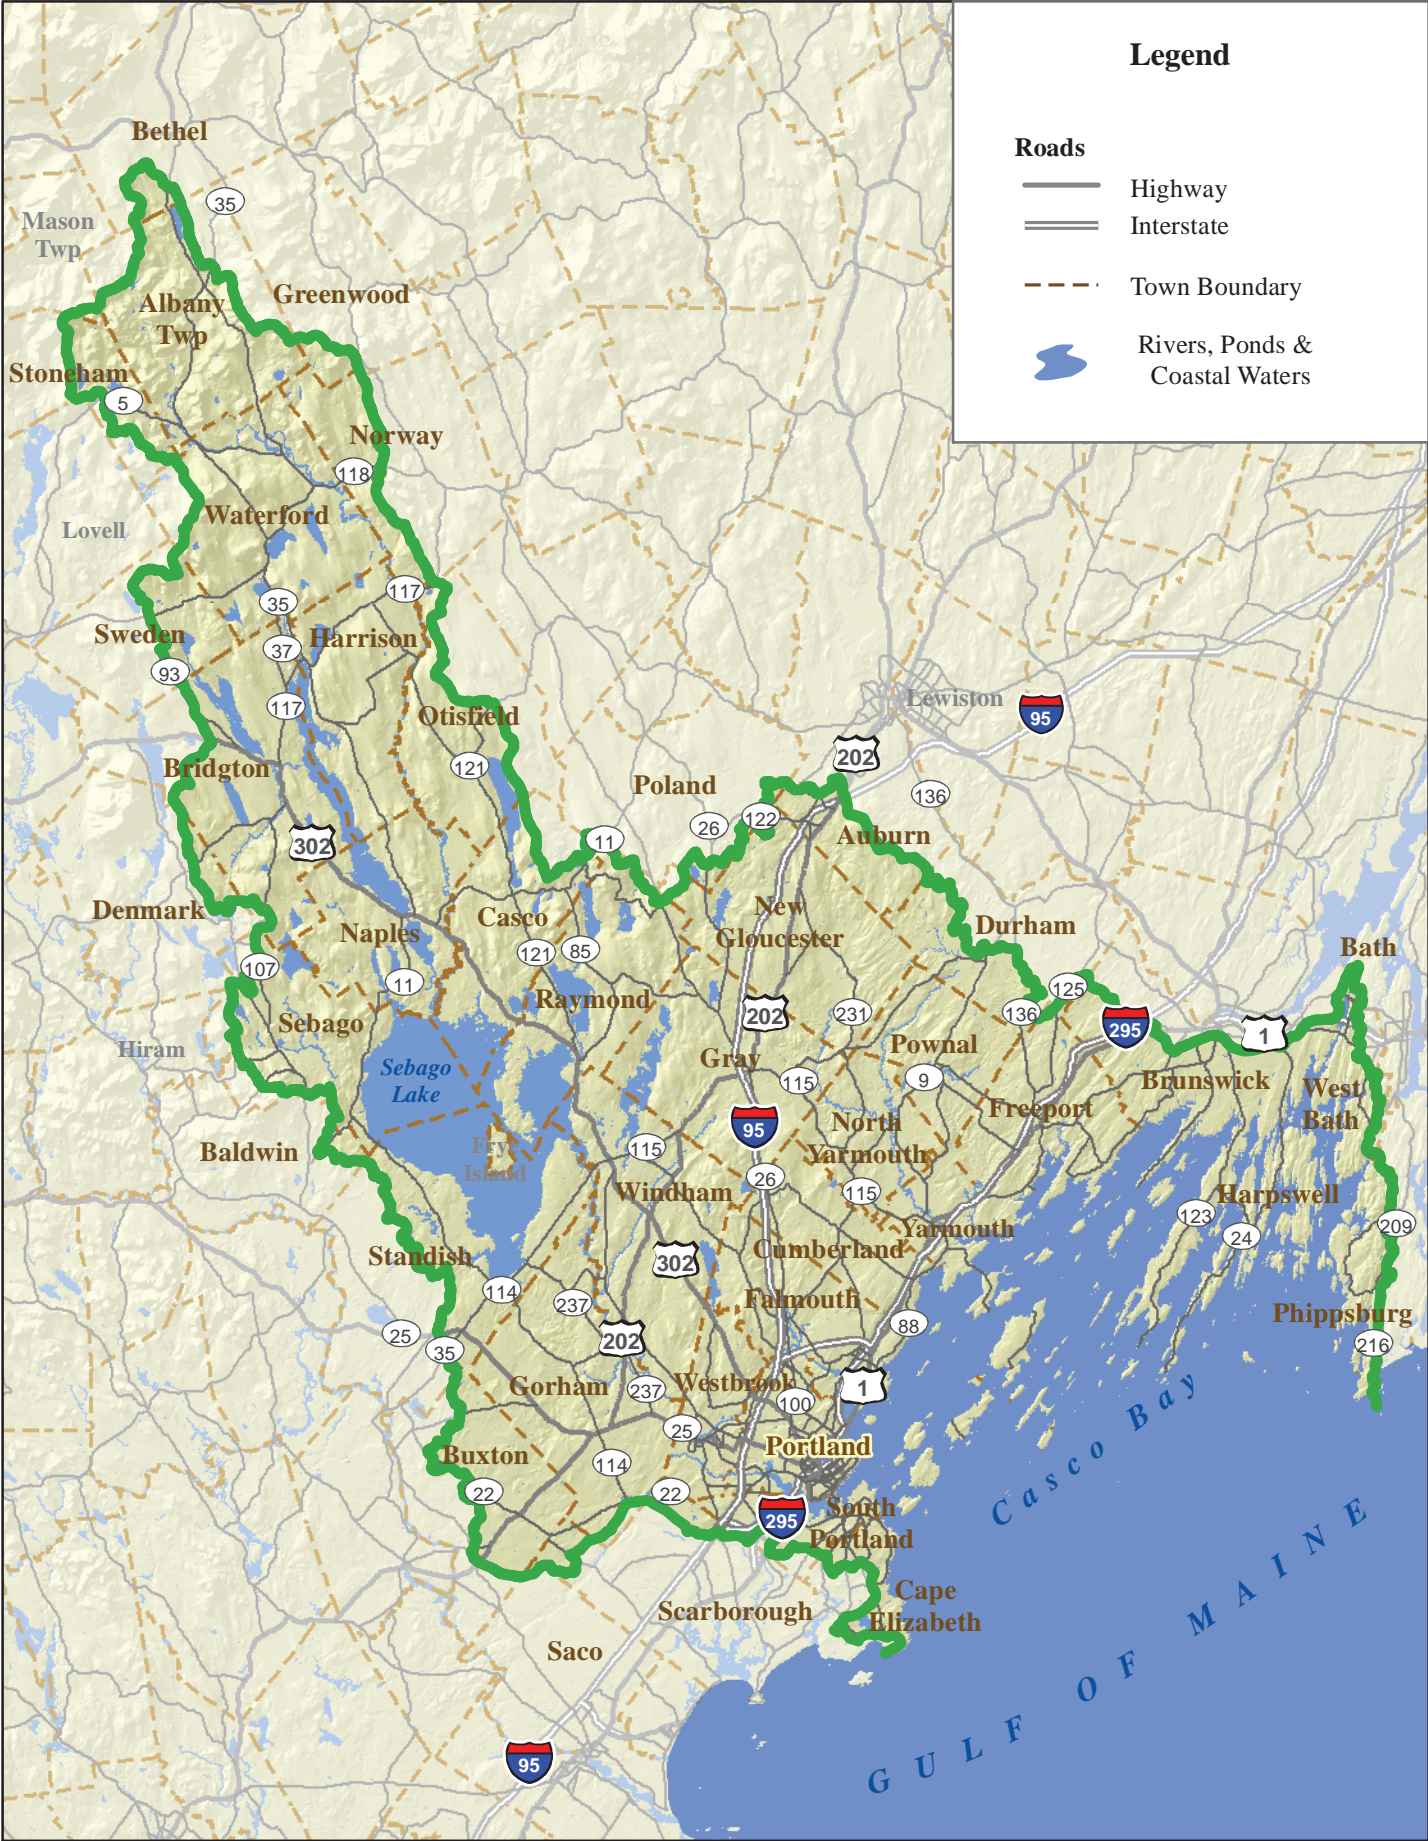
Index Map

Casco Bay Barriers by Town

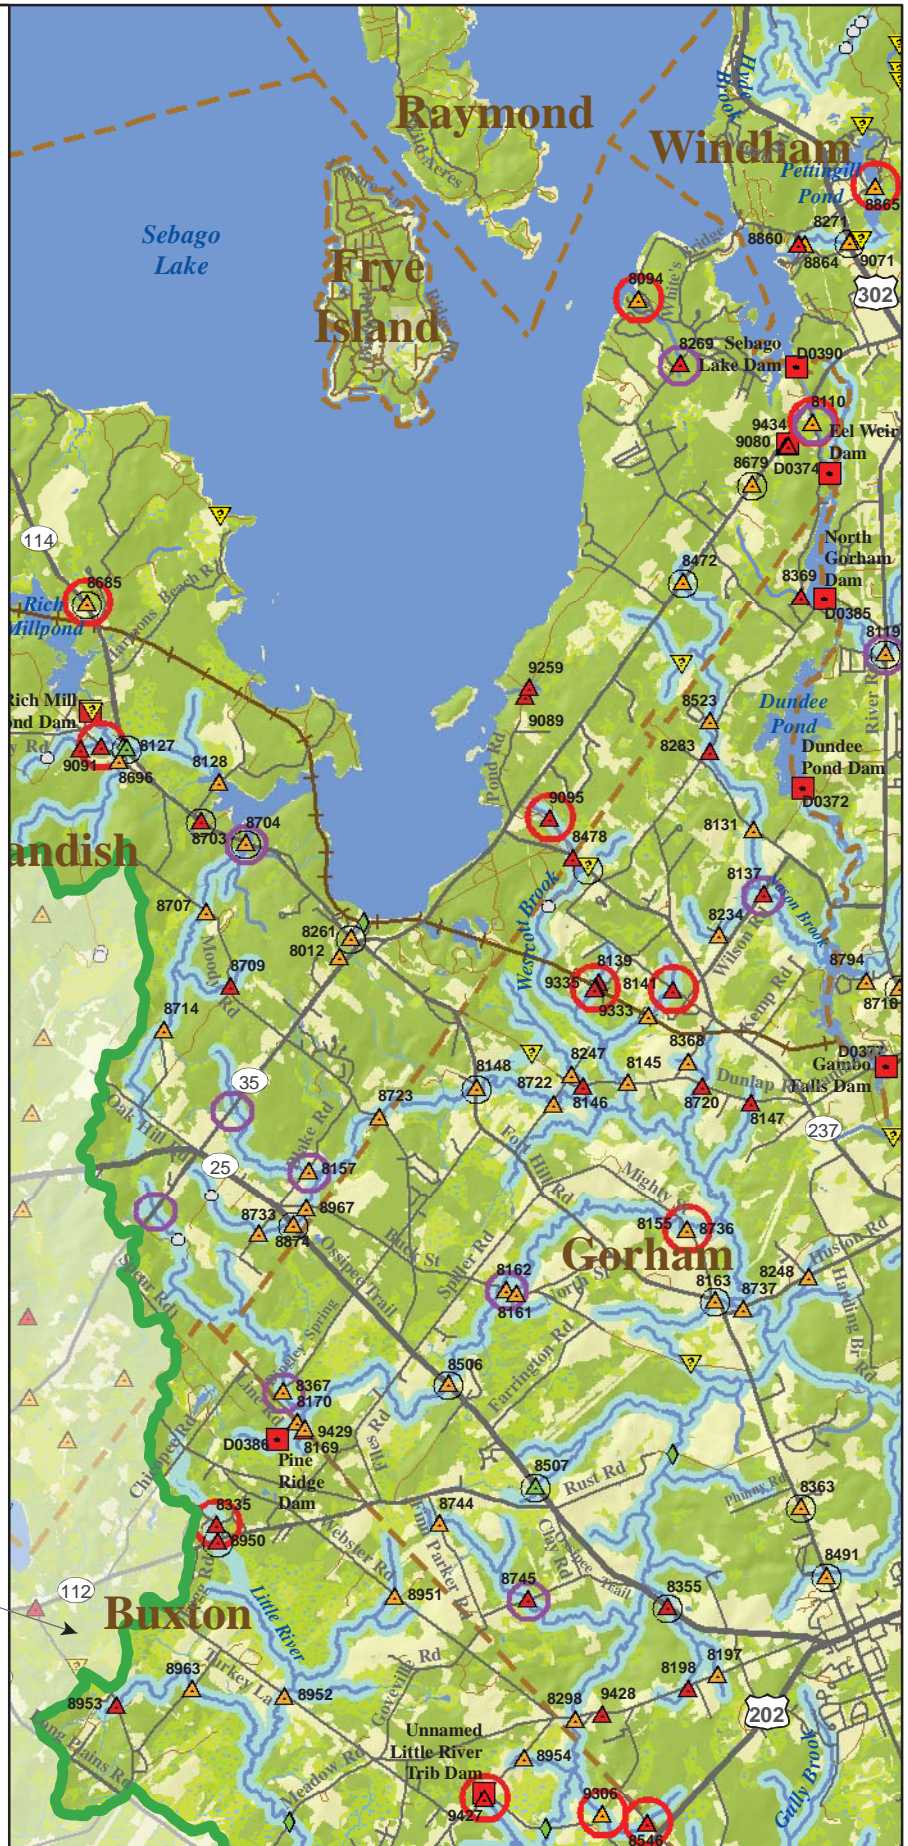
Casco Bay Barriers by Town

Crossing Barrier Type with SiteID

- ◆ Bridge (Passable)
- Debris/Beaver Dam (Impassable)
- ⚡ Waterfall (Impassable)
- MDOT Crossing
- Tidal Site
- Flood Hazard - Cumberland County EMA
- Flood Hazard - CBEP Analysis
- ~ Priority Stream

Scale Varies by Town
See scale bar at bottom of each map

The maps present data from Cumberland County Emergency Management Agency (CCEMA) and CBEP to show where flood hazards are likely to overlap with fish barriers. CCEMA, in cooperation with towns, has identified many road crossings as flood hazards based on past flood events. CCEMA sites are marked by purple circles, and do not always coincide with barrier survey sites because they may be located on intermittent streams or larger rivers crossed by bridges, which are generally passable for fish but may still entail flood hazards.

A second set of flood hazard sites was derived from the barrier survey data by CBEP Director Curtis Bohlen. In CBEP's analysis, the capacity of each crossing was compared to the expected flows for that specific crossing during a 25-year flood event. Where sufficient crossing data exists, flows were calculated based on the relationship between drainage area above the crossing, and the proportion of the drainage area occupied by National Wetland Inventory-defined wetlands. CBEP flood hazard sites are shown as red circles, and represent all crossing sites where the capacity of the crossing was less than 50% of the expected 25-year flood value. This is meant as a general indication of flood risk, but may be incorrect in some locations based on site-specific factors. As with CCEMA sites above, where these sites coincide with barrier sites, the combination of flood hazard with fish passage problems should place them high on any town's priority list for review and possible replacement.
