## **The Most Bang for the Buck: Developing a Watershed Restoration Plan for a Rapidly Urbanizing Vermont Watershed**

# **THE MOST BANG FOR THE BUCK: DEVELOPING A WATERSHED RESTORATION PLAN FOR A RAPIDLY URBANIZING VERMONT WATERSHED**

**Stormwater Management in Cold Climates**

**November 5, 2003**

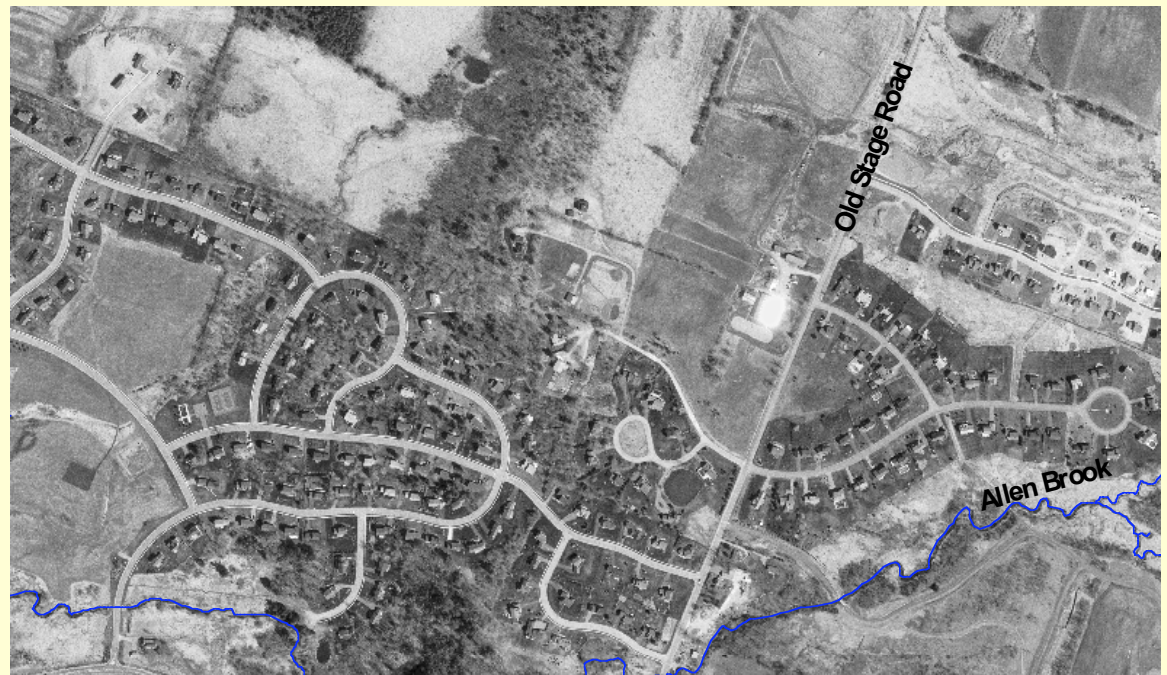
1978

OLD STAGE ROAD

1999

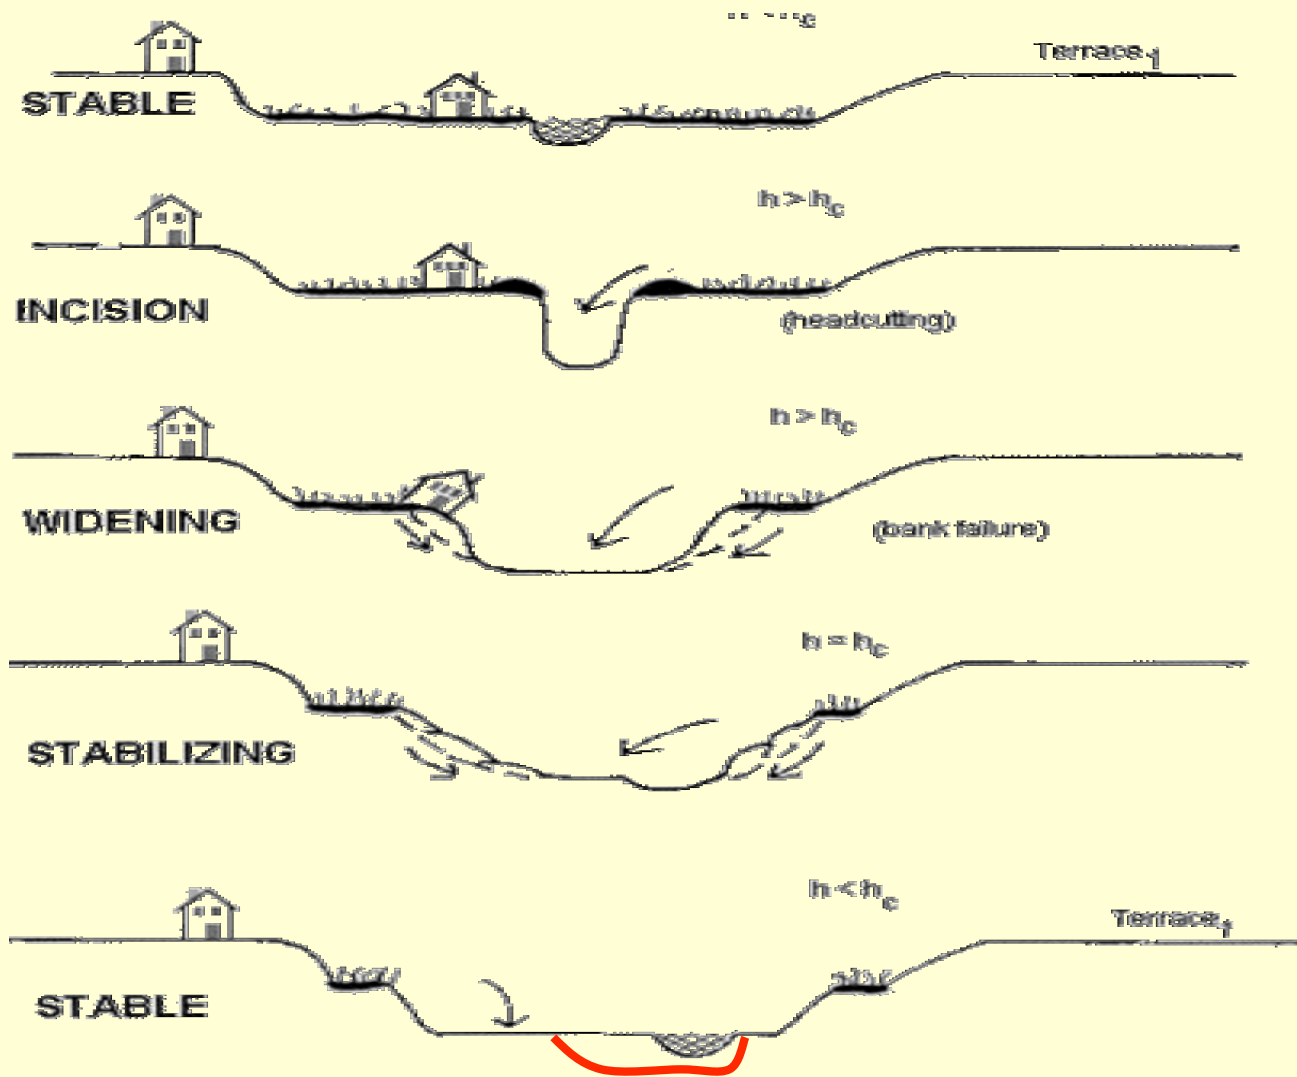
# CHANNEL EVOLUTION MODEL

(AFTER SCHUMM)

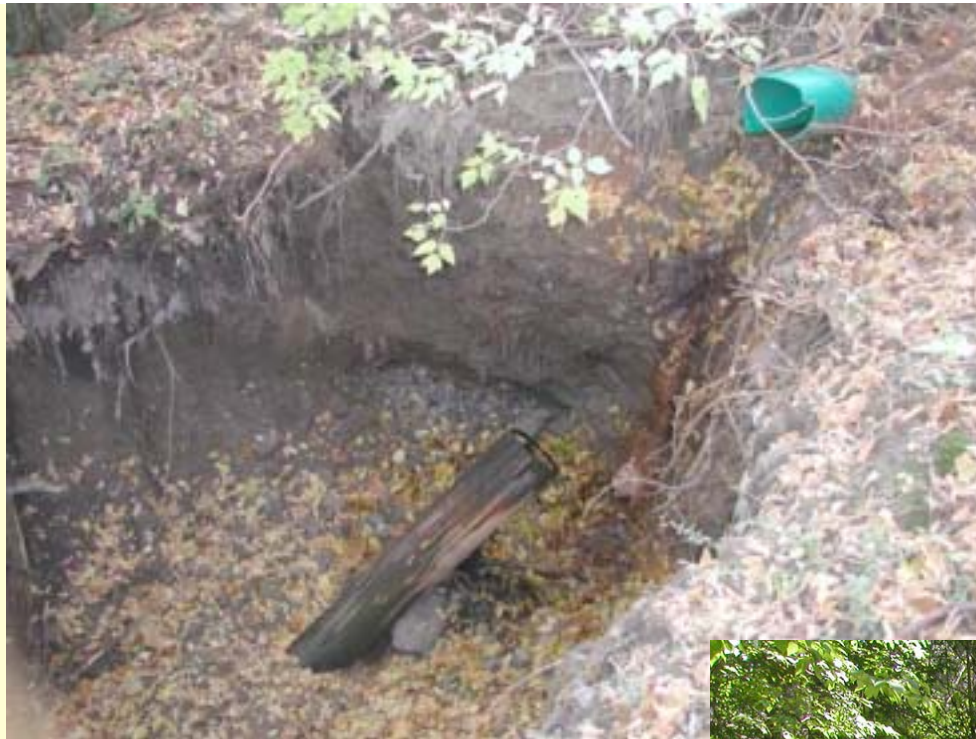
CONCENTRATED  
FLOW FROM  
STORMWATER

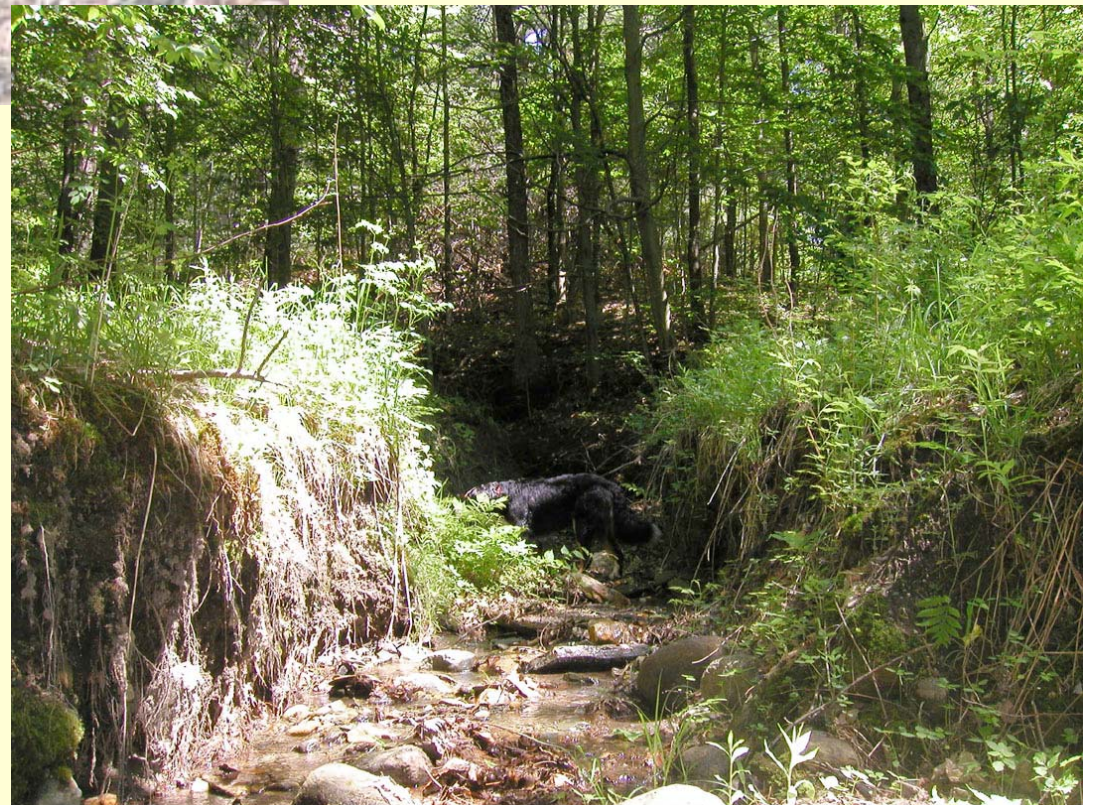
*and*  
CHANNEL  
ADJUSTMENT  
Stage 2

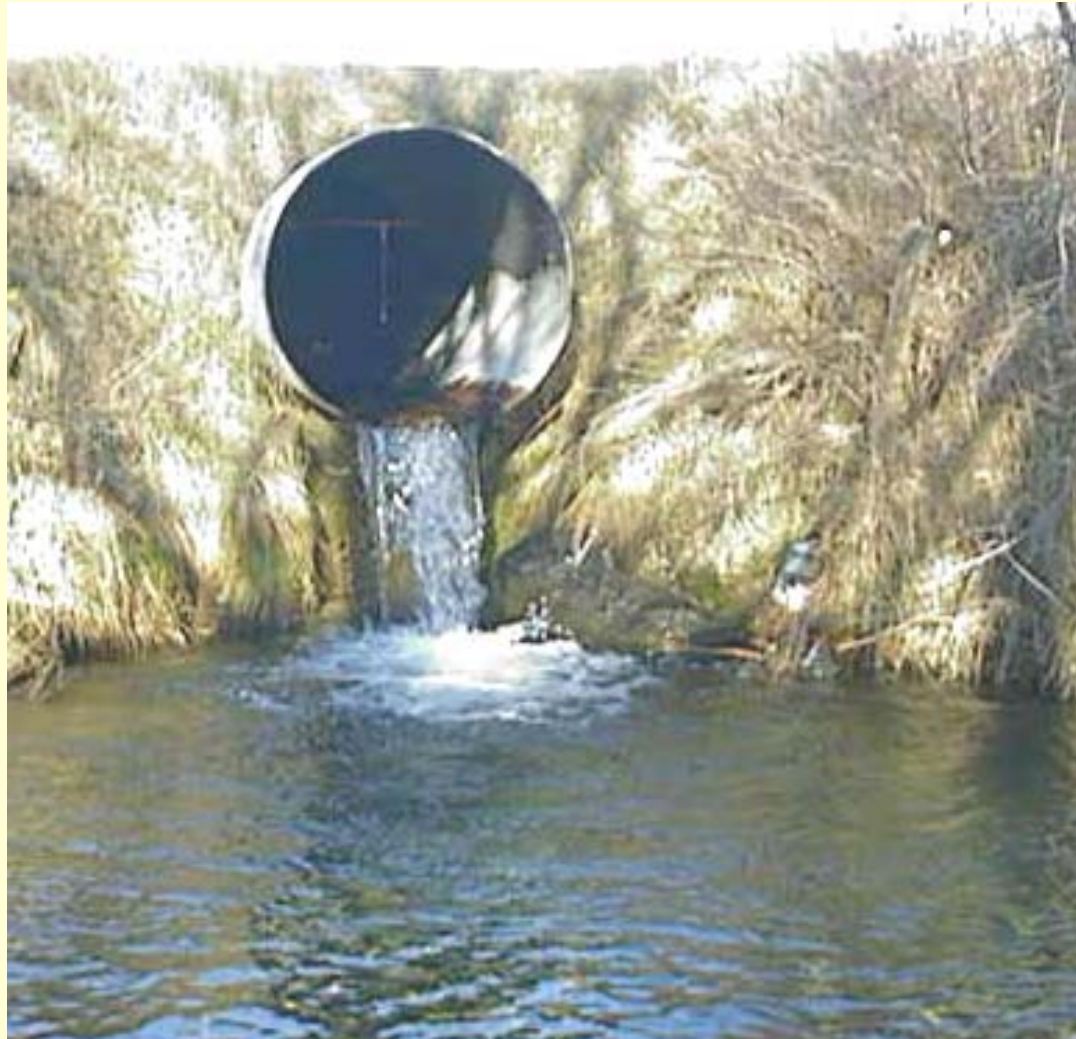
Scour downstream of undersized Culvert-ANR Photo

- USE BRIDGES
- NO DOUBLE CULVERTS
- BUILD WIDE ENOUGH FOR PREDICTED BUILD-OUT  
(use enlargement curve)

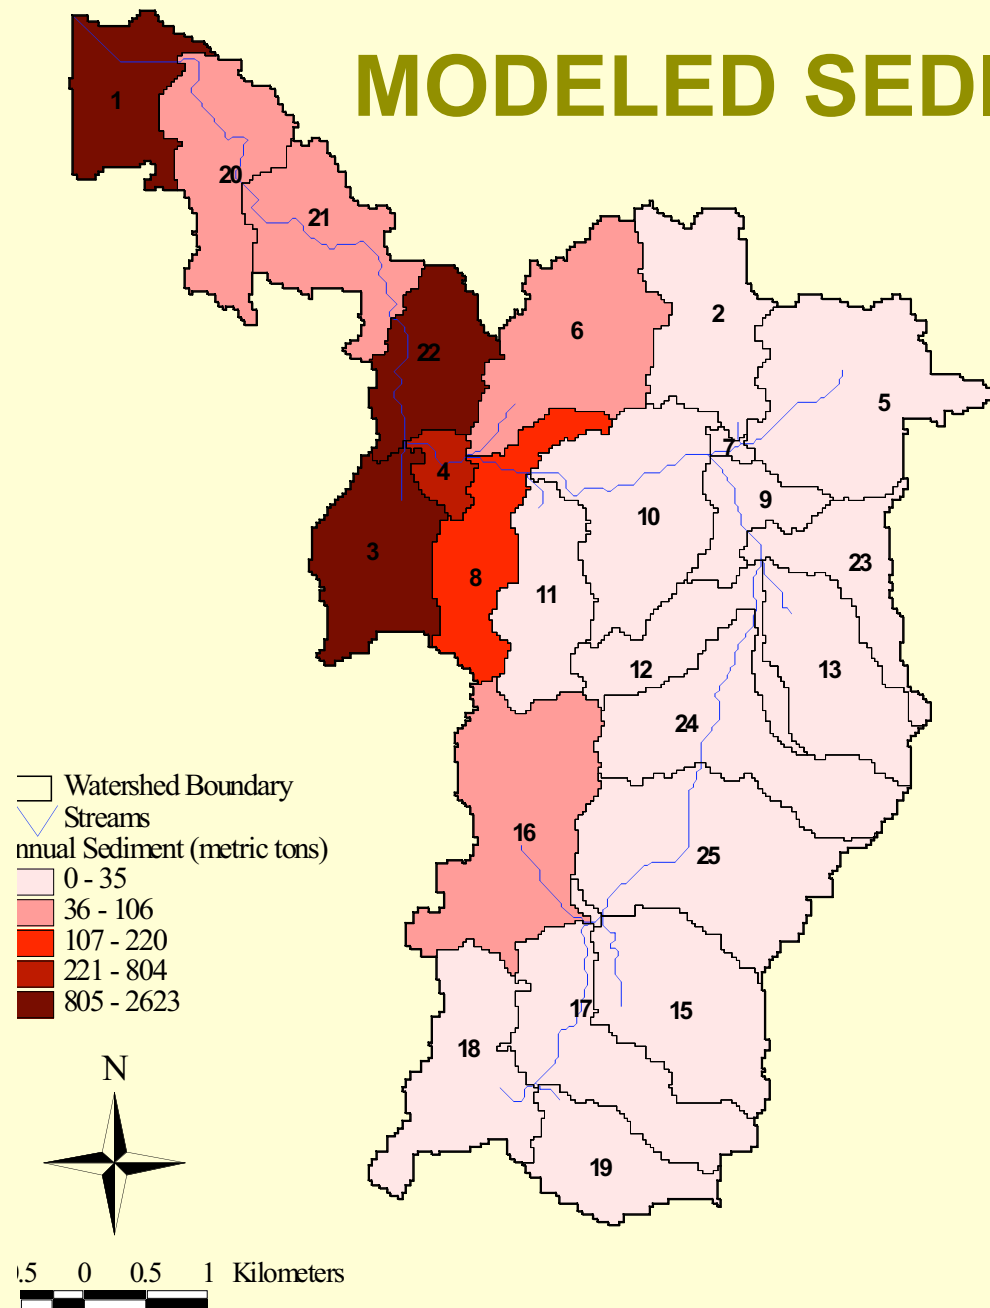
Average annual sediment load (metric tons/year) based on SWAT model outputs.  
Numbers on map indicate subbasins delineated for modeling purposes.

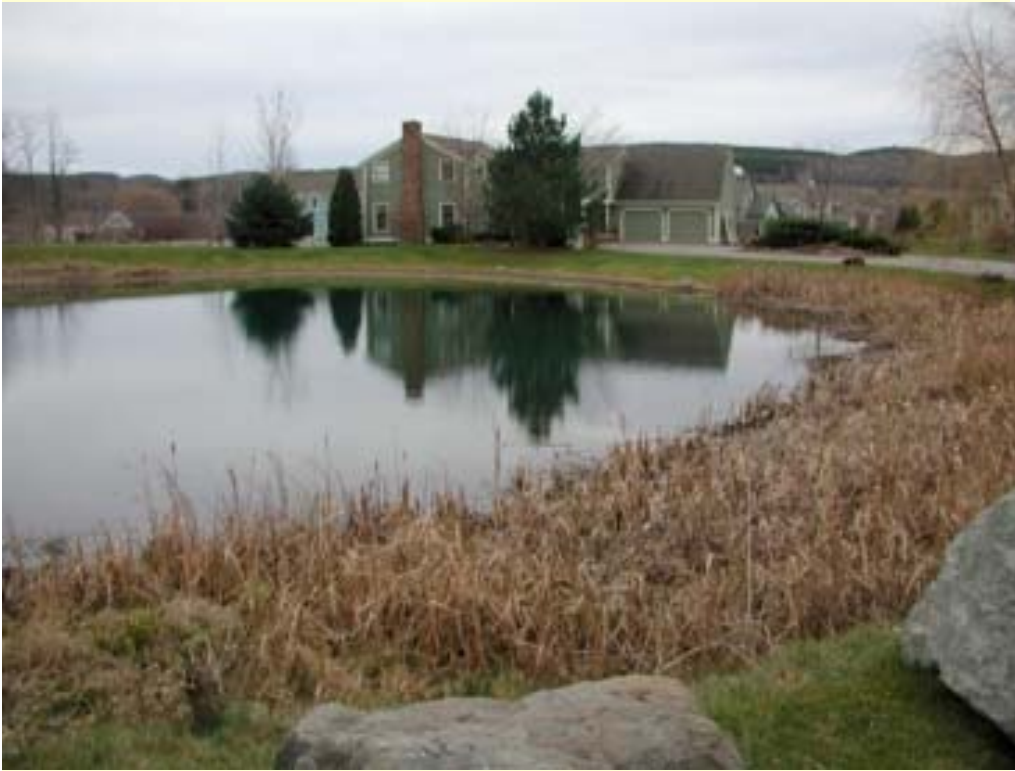
Turtle Pond. Example of good stormwater design that improves property values.
