Casco Bay Watershed Fish Barrier Priorities Atlas: North Yarmouth

Casco Bay Watershed Fish Barrier Priorities Atlas

North Yarmouth

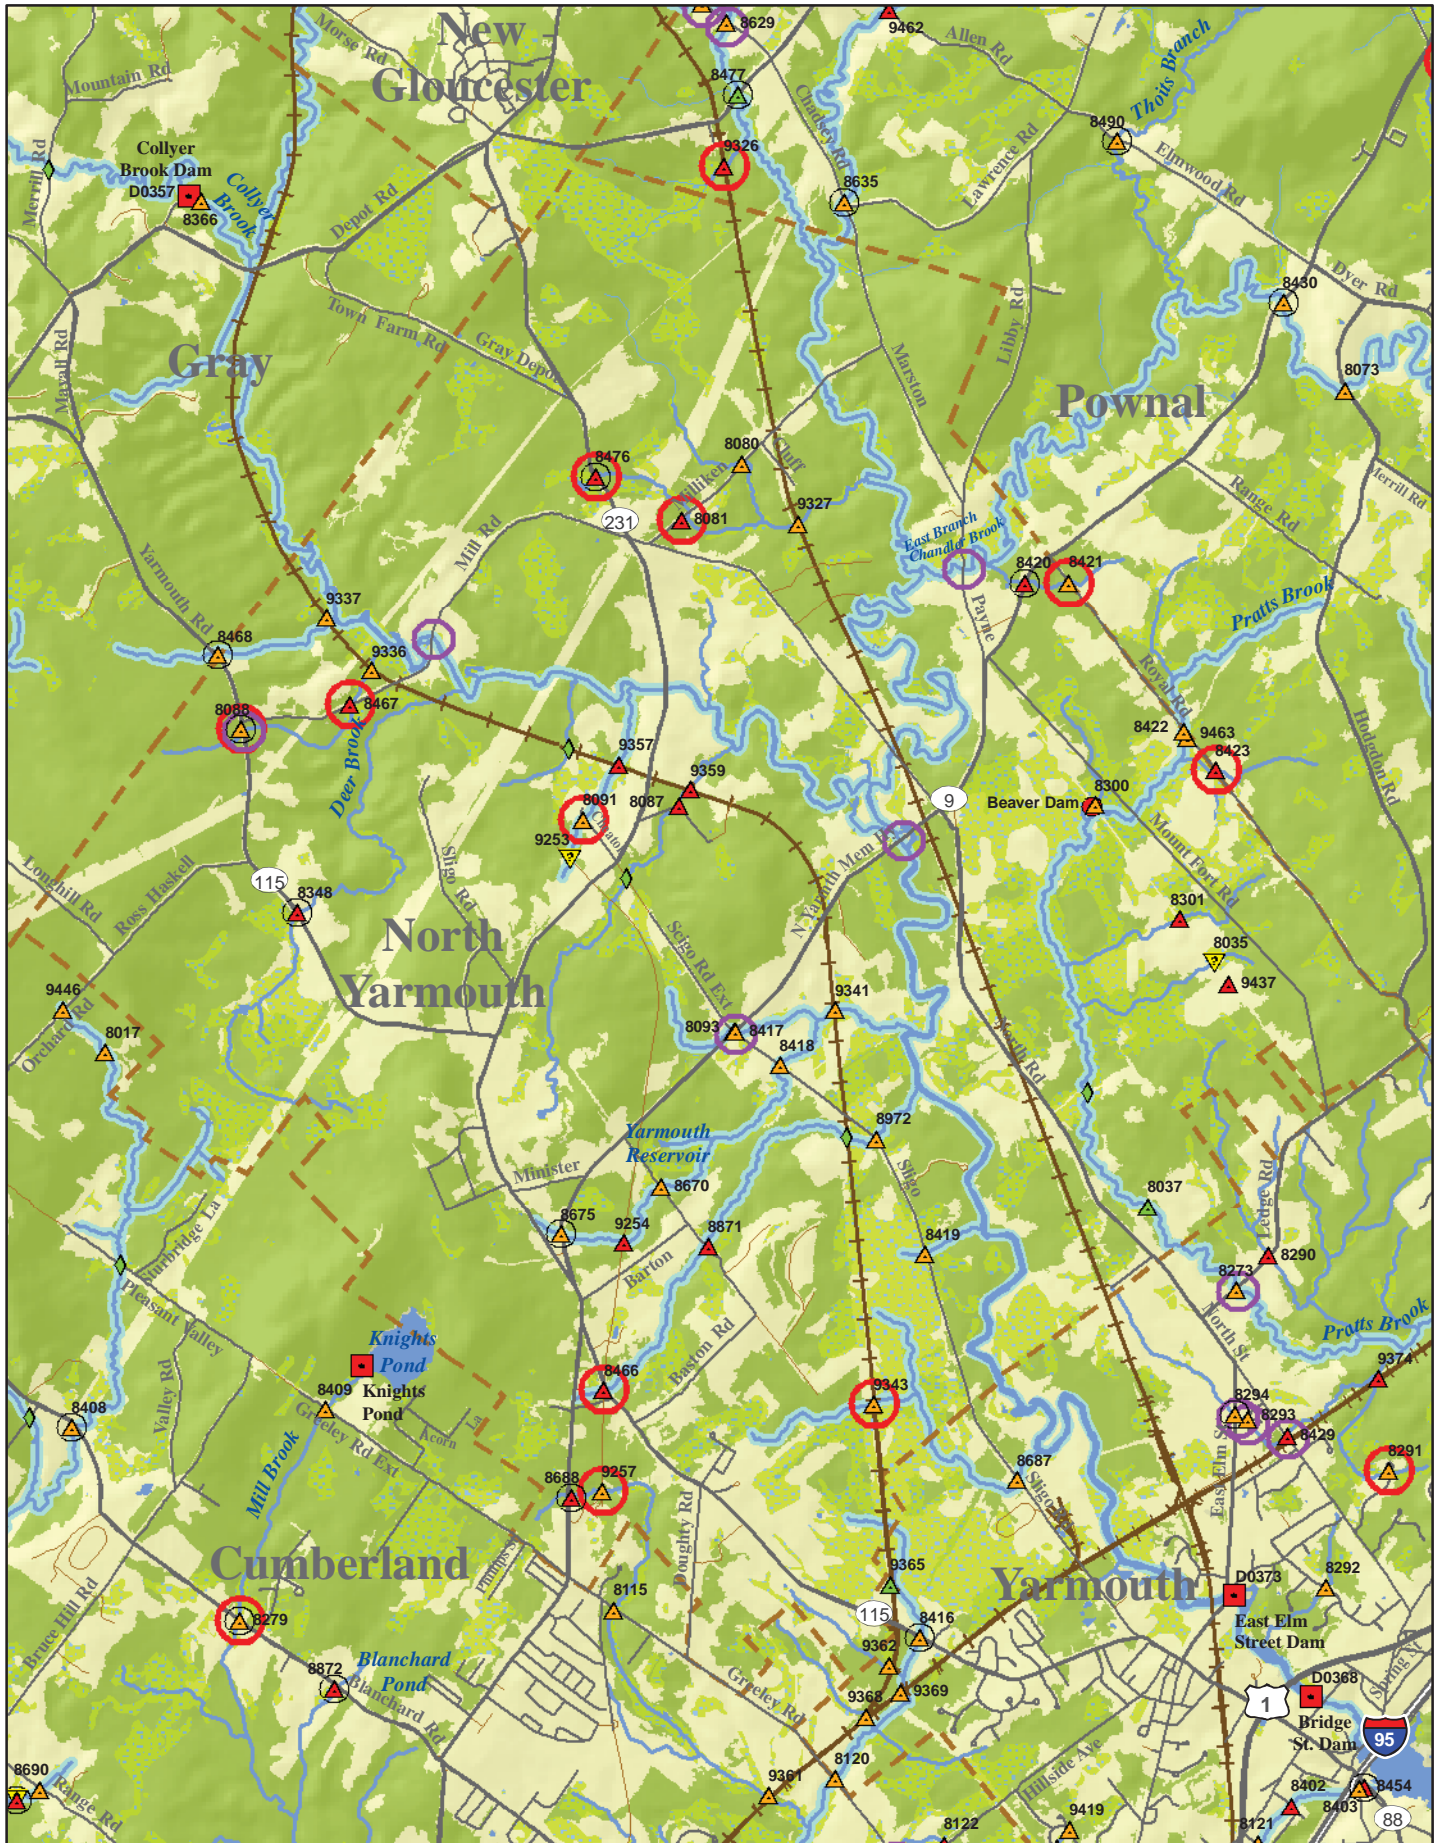
Casco Bay Barriers by Town

Road-stream crossings are shown with SiteID numbers to help identify them in the barrier database. Dams, in most cases, have labels both of SiteID and the dam's common name, if one is known. *Severe* barriers are defined as those road/stream crossings where fundamental physical barriers exist at either the inlet or outlet of the crossing, including inlets or outlets "perched" above the stream channel, and inlets blocked at least 50%, usually by debris. *Potential* barriers cover a wide spectrum of road-stream crossing situations where fish passage problems are likely to exist at some flows for some species or age groups of fish, and passage of other aquatic organisms such as amphibians and macroinvertebrates is likely also limited. Sites that were inaccessible to survey crews, and therefore not surveyed, are shown as unsurveyed, but are included in our analysis as *Potential* barriers. Dams are classified by whether or not they have effective facilities in place to provide upstream fish passage. Natural barriers, including waterfalls, debris jams (including woody debris or rock and fine sediments), and beaver dams were assessed when in close proximity to surveyed crossings and dams, and are mapped as well.

USFWS-GOMCP and CBEP staff consulted with state fisheries biologists to identify streams with important fish habitat, primarily for brook trout or Atlantic salmon, or both. These *priority streams* are highlighted on the maps. The scope of the road/stream crossing barrier assessment was limited to perennial streams, those with continuous flow year round. Although intermittent streams were not surveyed, fish using priority streams also rely on connectivity with intermittent tributaries at various times of year. There are likely to be additional barriers on important intermittent streams that have not been assessed.

The maps present data from Cumberland County Emergency Management Agency (CCEMA) and CBEP to show where flood hazards are likely to overlap with fish barriers. CCEMA, in cooperation with towns, has identified many road crossings as flood hazards based on past flood events. CCEMA sites are marked by purple circles, and do not always coincide with barrier survey sites because they may be located on intermittent streams or larger rivers crossed by bridges, which are generally passable for fish but may still entail flood hazards.
