Casco Bay Watershed Fish Barrier Priorities Atlas: Otisfield

Casco Bay Watershed Fish Barrier Priorities Atlas

March 2012

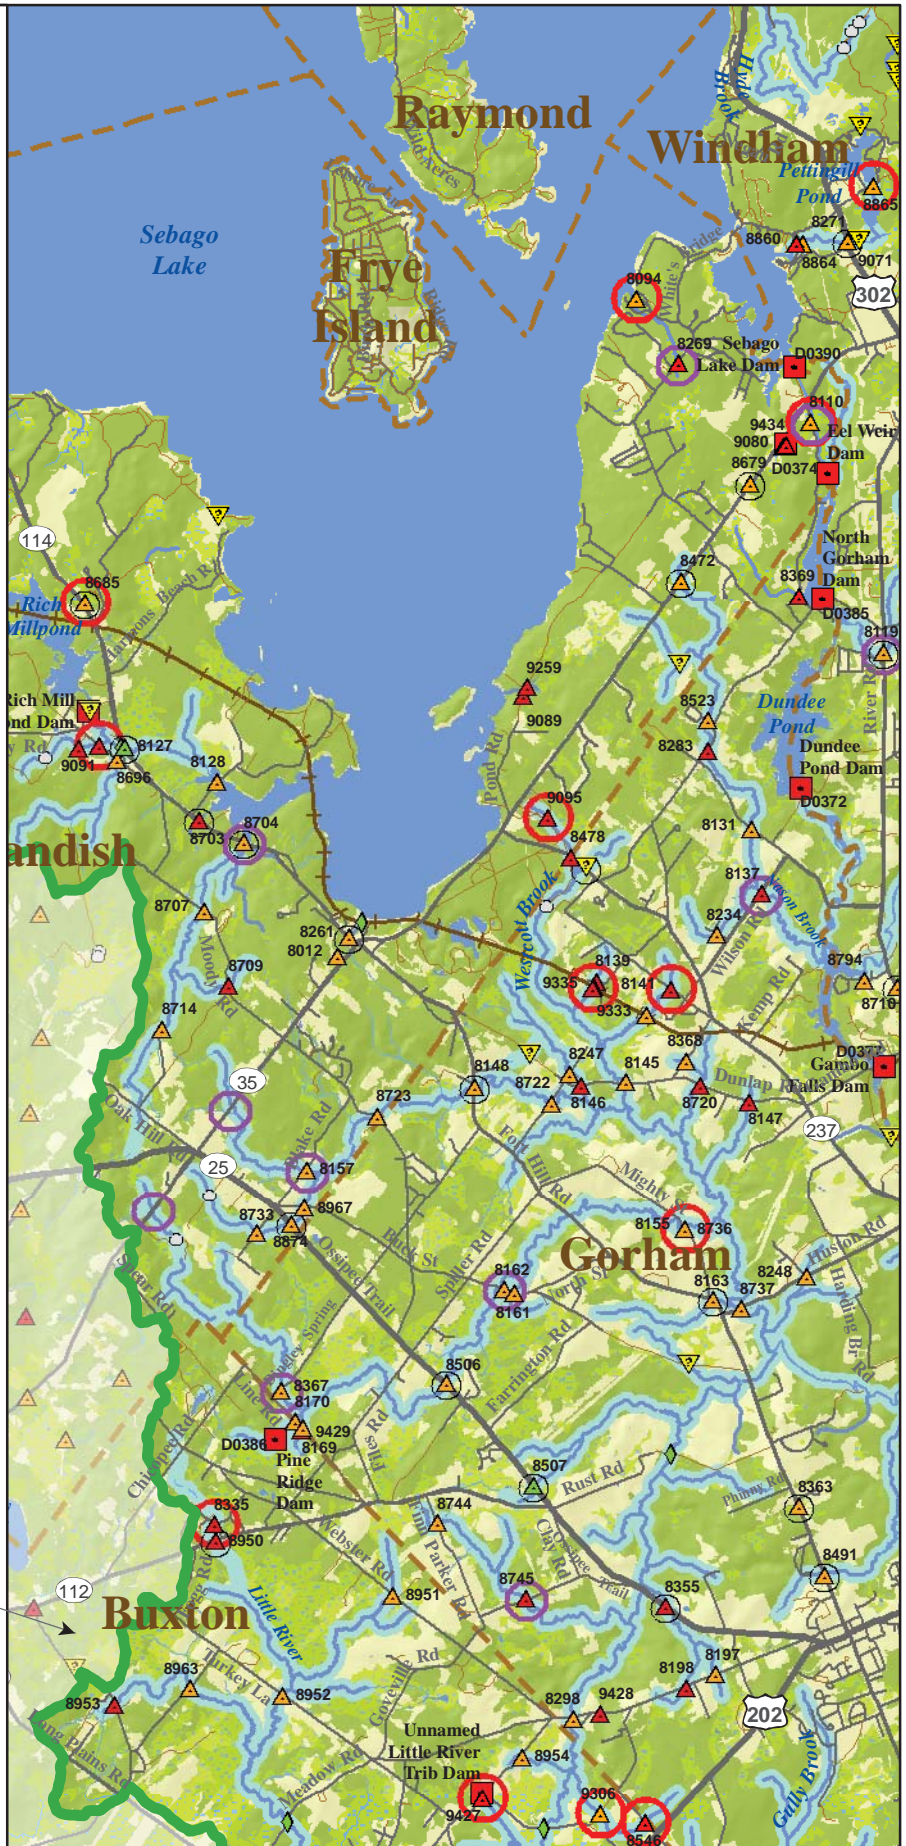
Casco Bay Barriers by Town

Road-stream crossings are shown with SiteID numbers to help identify them in the barrier database. Dams, in most cases, have labels both of SiteID and the dam's common name, if one is known. *Severe* barriers are defined as those road/stream crossings where fundamental physical barriers exist at either the inlet or outlet of the crossing, including inlets or outlets "perched" above the stream channel, and inlets blocked at least 50%, usually by debris. *Potential* barriers cover a wide spectrum of road-stream crossing situations where fish passage problems are likely to exist at some flows for some species or age groups of fish, and passage of other aquatic organisms such as amphibians and macroinvertebrates is likely also limited. Sites that were inaccessible to survey crews, and therefore not surveyed, are shown as unsurveyed, but are included in our analysis as *Potential* barriers. Dams are classified by whether or not they have effective facilities in place to provide upstream fish passage. Natural barriers, including waterfalls, debris jams (including woody debris or rock and fine sediments), and beaver dams were assessed when in close proximity to surveyed crossings and dams, and are mapped as well.

USFWS-GOMCP and CBEP staff consulted with state fisheries biologists to identify streams with important fish habitat, primarily for brook trout or Atlantic salmon, or both. These *priority streams* are highlighted on the maps. The scope of the road/stream crossing barrier assessment was limited to perennial streams, those with continuous flow year round. Although intermittent streams were not surveyed, fish using priority streams also rely on connectivity with intermittent tributaries at various times of year. There are likely to be additional barriers on important intermittent streams that have not been assessed.

The maps present data from Cumberland County Emergency Management Agency (CCEMA) and CBEP to show where flood hazards are likely to overlap with fish barriers. CCEMA, in cooperation with towns, has identified many road crossings as flood hazards based on past flood events. CCEMA sites are marked by purple circles, and do not always coincide with barrier survey sites because they may be located on intermittent streams or larger rivers crossed by bridges, which are generally passable for fish but may still entail flood hazards.

These maps are created primarily with 1:24,000 scale basemap data, with landcover data added to provide general distinctions between open and forested lands. Areas outside of the Casco Bay watershed are masked to obscure them.

Where these sites do coincide with barriers, the combination of flood hazard with fish passage problems should place them high on any town's priority list for replacement.
