Casco Bay Watershed Fish Barrier Priorities Atlas: Cape Elizabeth

Casco Bay Watershed

Fish Barrier Priorities Atlas

Cape Elizabeth

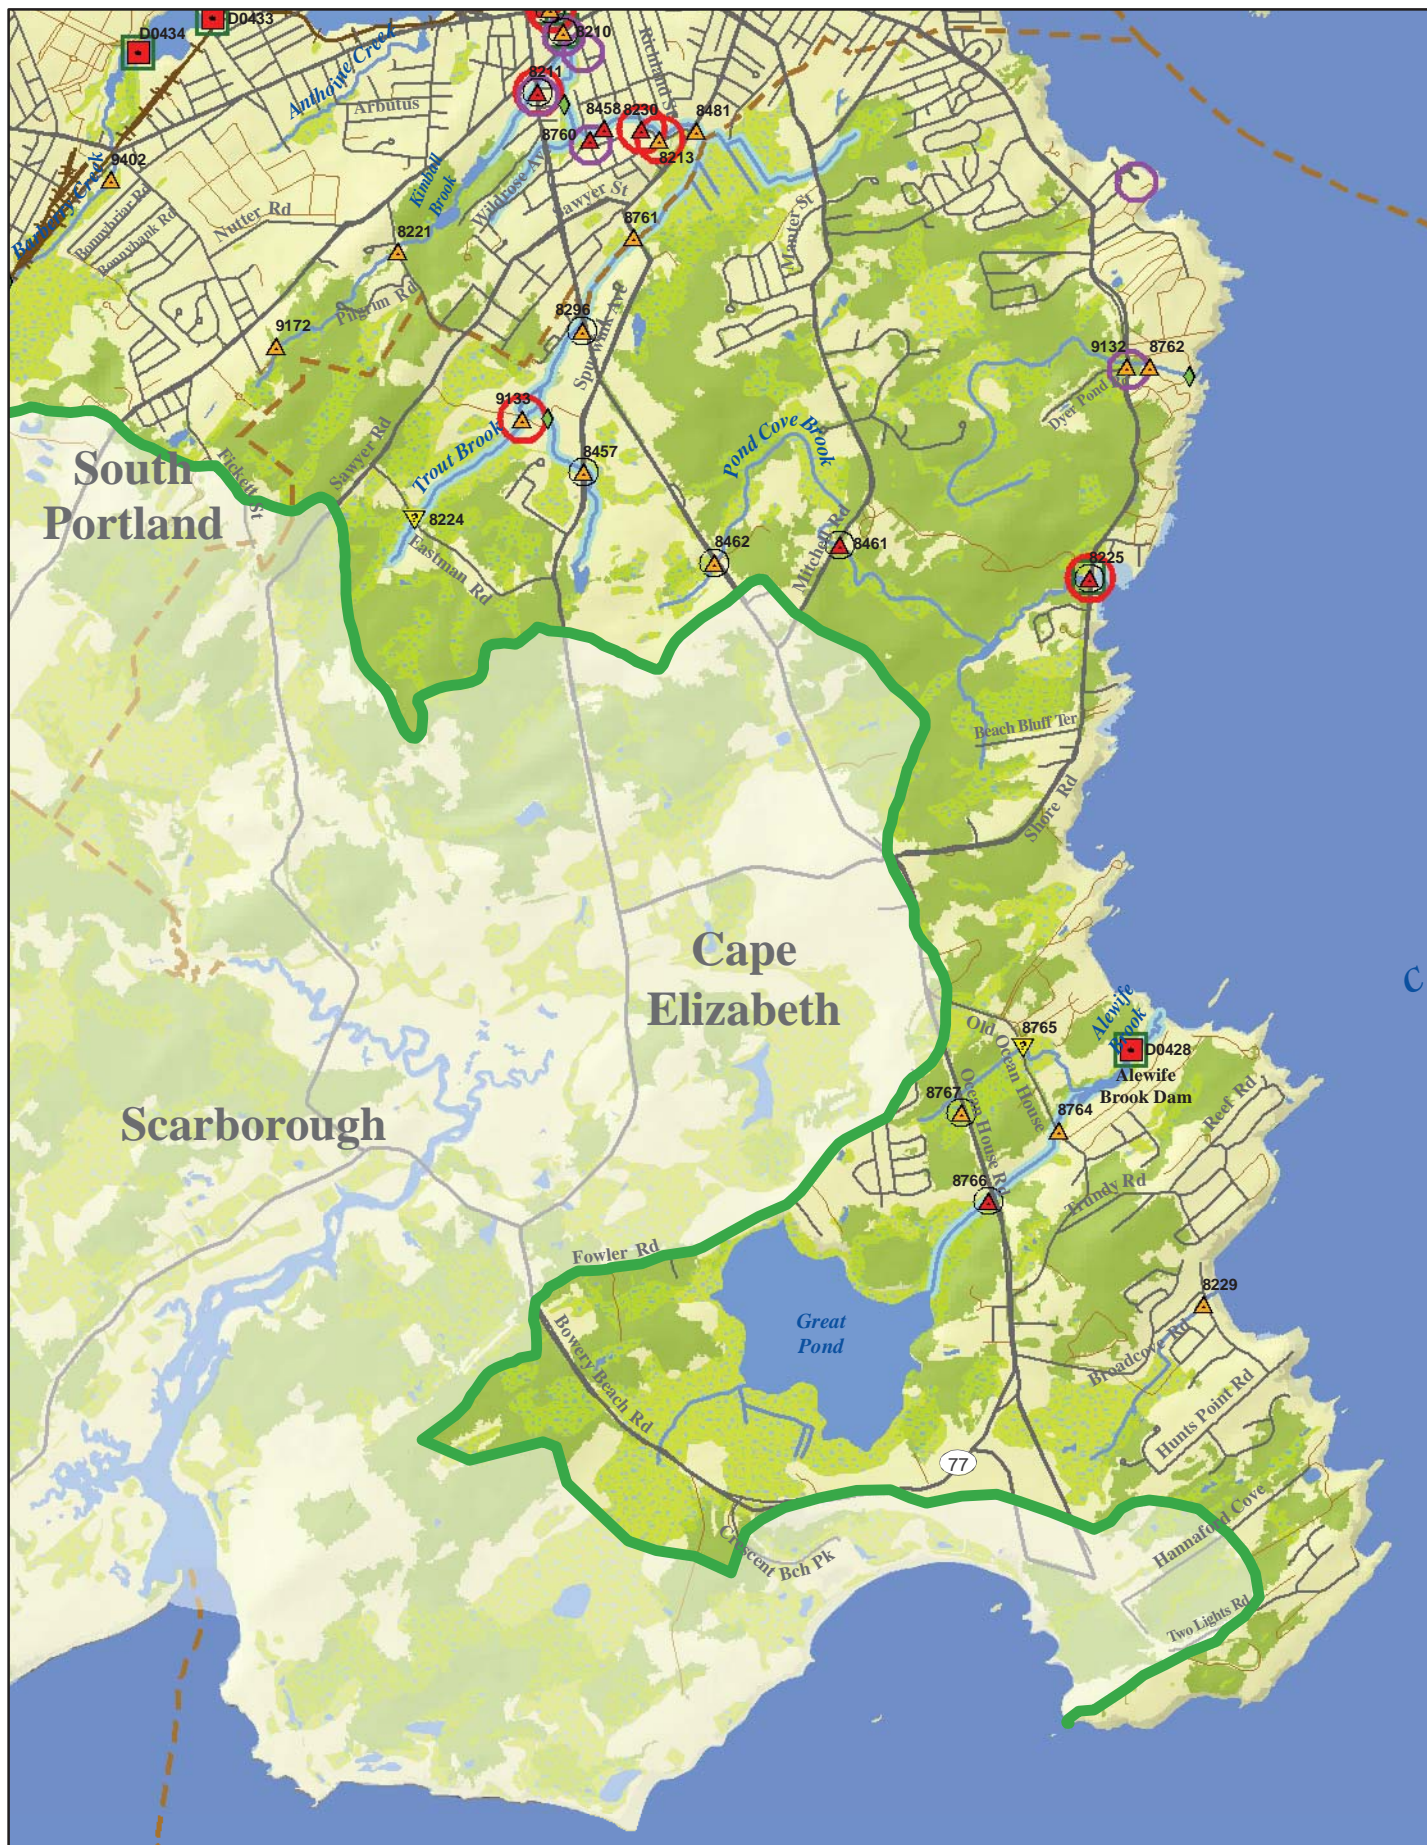
Road-stream crossings are shown with SiteID numbers to help identify them in the barrier database. Dams, in most cases, have labels both of SiteID and the dam's common name, if one is known. *Severe* barriers are defined as those road/stream crossings where fundamental physical barriers exist at either the inlet or outlet of the crossing, including inlets or outlets "perched" above the stream channel, and inlets blocked at least 50%, usually by debris. *Potential* barriers cover a wide spectrum of road-stream crossing situations where fish passage problems are likely to exist at some flows for some species or age groups of fish, and passage of other aquatic organisms such as amphibians and macroinvertebrates is likely also limited. Sites that were inaccessible to survey crews, and therefore not surveyed, are shown as unsurveyed, but are included in our analysis as *Potential* barriers. Dams are classified by whether or not they have effective facilities in place to provide upstream fish passage. Natural barriers, including waterfalls, debris jams (including woody debris or rock and fine sediments), and beaver dams were assessed when in close proximity to surveyed crossings and dams, and are mapped as well.

The maps present data from Cumberland County Emergency Management Agency (CCEMA) and CBEP to show where flood hazards are likely to overlap with fish barriers. CCEMA, in cooperation with towns, has identified many road crossings as flood hazards based on past flood events. CCEMA sites are marked by purple circles, and do not always coincide with barrier survey sites because they may be located on intermittent streams or larger rivers crossed by bridges, which are generally passable for fish but may still entail flood hazards.

Where these sites do coincide with barriers, the combination of flood hazard with fish passage problems should place them high on any town's priority list for replacement.
