Casco Bay Watershed Fish Barrier Priorities Atlas: Harrison

Casco Bay Watershed

Fish Barrier Priorities Atlas

Harrison

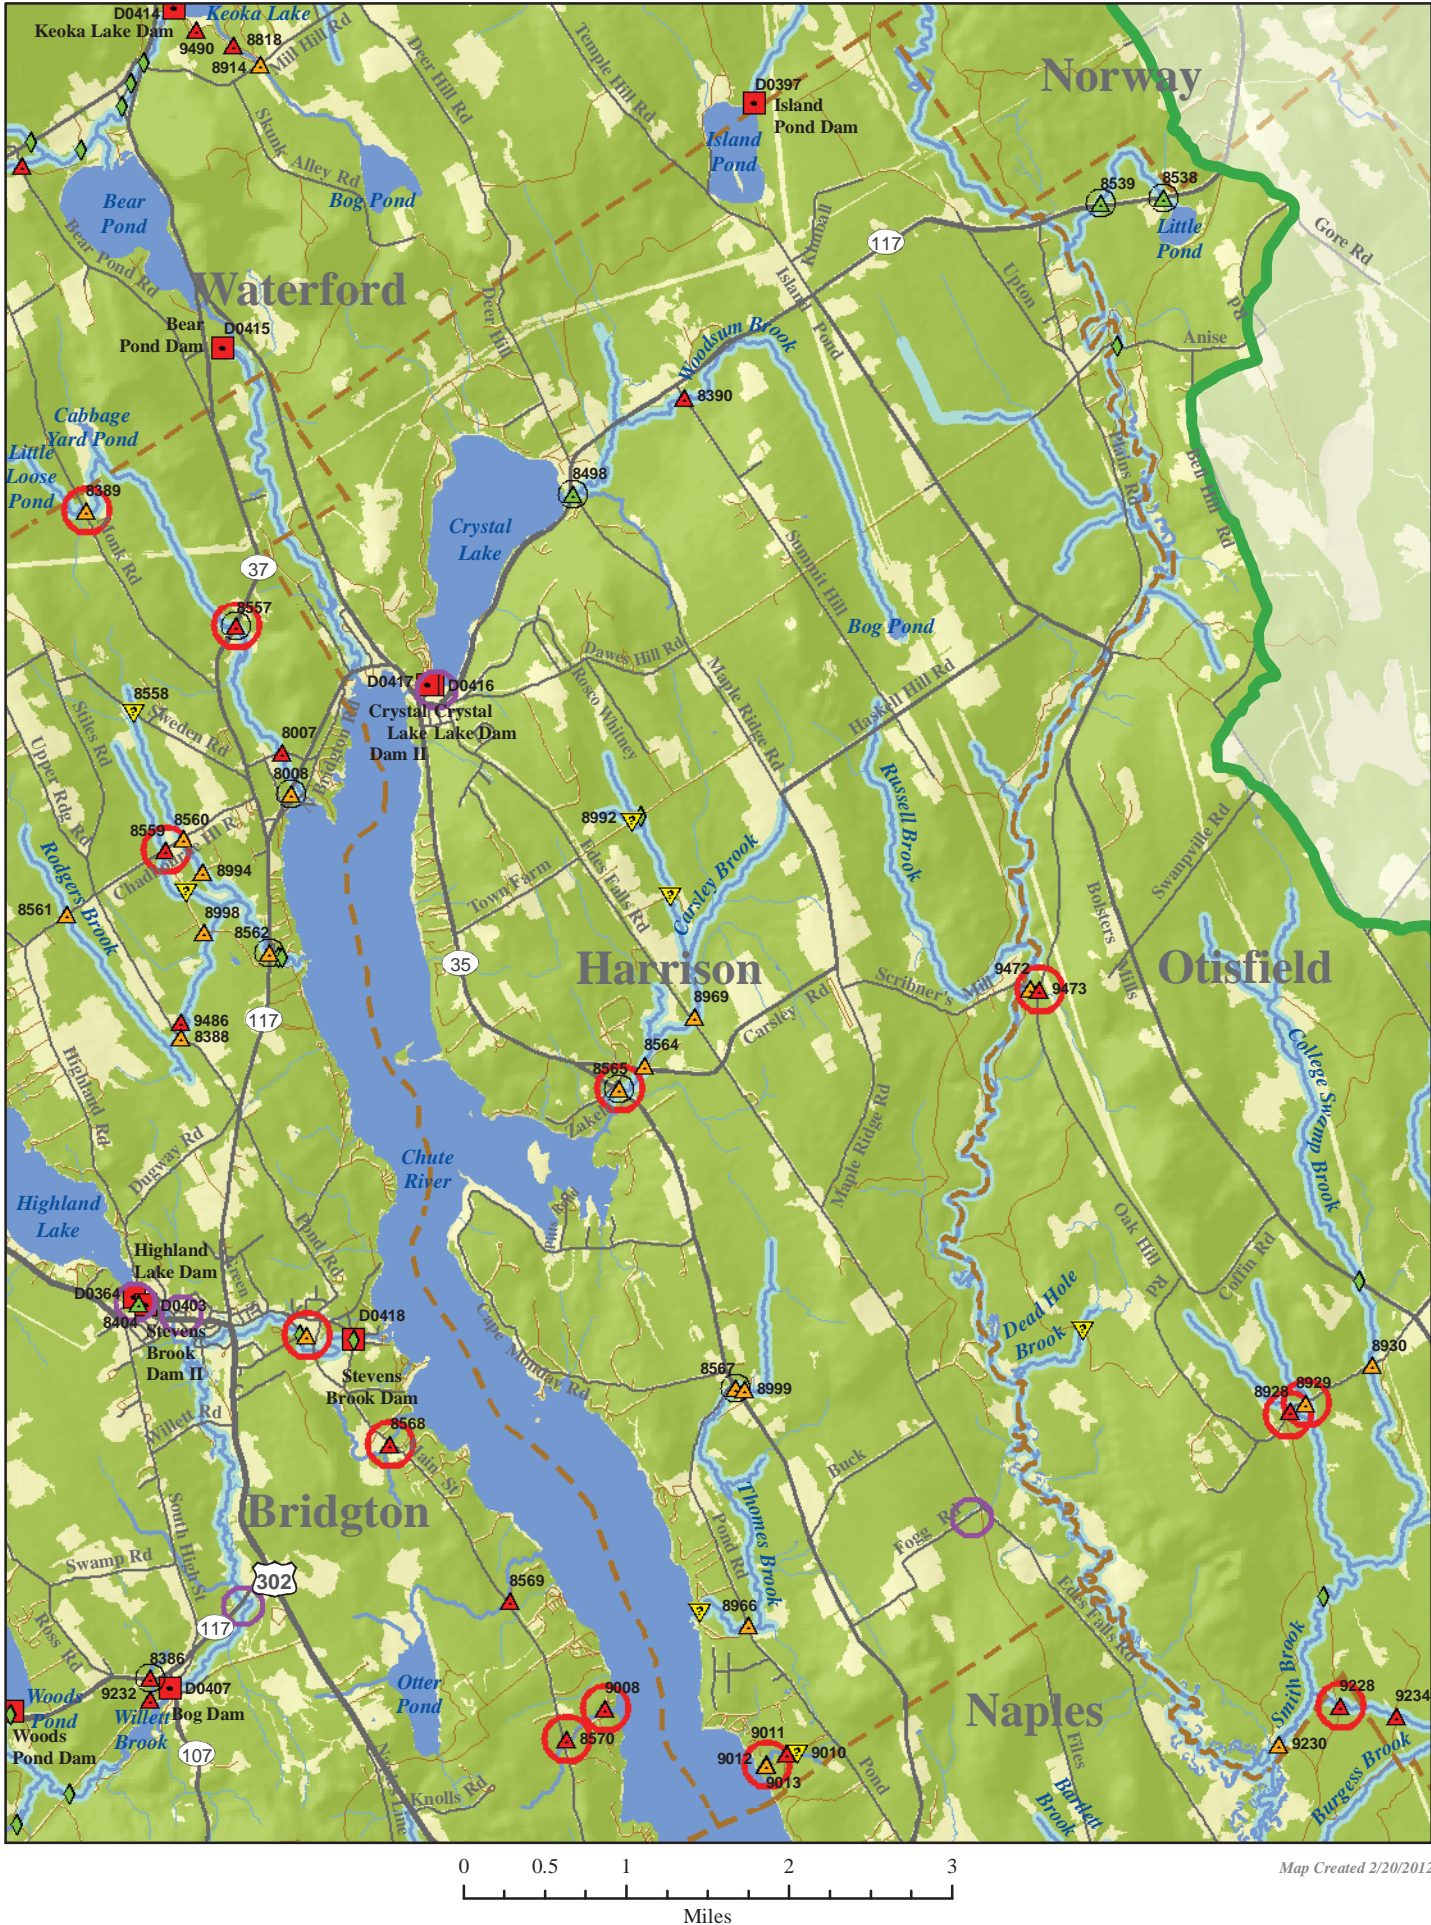
Casco Bay Barriers by Town

Site ID	Town	Habitat Priority	Basic Structure Type	Barrier Class	Survey Date	Road Name	Road Type & Class	Stream	UTM East	UTM North	Stream Type	Number Of Culverts	Material	Condition
8564	Harrison	High	Multiple Culverts	Potential	10/13/2010	Carsley Rd	Private / Paved	Carsley Brook	367778	4881858	Perennial	2	Metal	
8969	Harrison	High	Multiple Culverts	Potential	10/13/2010	Edes Falls Rd	Town / Paved	Carsley Brook	368270	4882340	Perennial	2	Metal	
8966	Harrison	High	Culvert	Potential	9/30/2010	Lewis Rd.	Town / Paved	Thomes Brook	368810	4876320	Perennial	1	Metal	
8567	Harrison	High	Culvert	Potential	10/5/2010	Pond Rd	State / Paved	Thomes Brook	368682	4878664	Perennial	1	Metal	
8565	Harrison	High	Multiple Culverts	Potential	10/12/2010	Rte 35	State / Paved	Carsley Brook	367531	4881629	Perennial	2	Plastic	
8999	Harrison	High	Multiple Culverts	Potential	10/12/2010	Rte. 35	Private / Unpaved	Thomes Brook	368762	4878655	Perennial	2	Plastic

8390	Harrison	High	Multiple Culverts	Severe	7/1/2010	Summit Hill	Town / Paved	Woodsum Brook	368172	4888462	Perennial	2	Metal	
9011	Harrison		Culvert	Severe	9/29/2010	Unknown	Private / Unpaved	Unknown	369179	4875058	Perennial	1	Metal	
8992	Harrison	High	Culvert	Potential	10/13/2010		Private	No Data	367656	4884250	Perennial			
8995	Harrison	High	Unknown	Potential	10/13/2010		Private	No Data	368036	4883505	Perennial			
9004	Harrison	High	Unknown	Potential	10/12/2010		Private	Thomes Brook	368323	4876443	Perennial			
NBCasco11	Harrison	High	Debris Jam	Potential	10/13/2010		NA	Unknown	367779	4884348	Perennial			
D0416	Harrison	High	Dam	Severe	8/3/2010		NA	unnamed	365700	4885604	Perennial			
D0417	Harrison	High	Dam	Severe	8/3/2010		NA	unnamed	365638	4885598	Perennial

Site ID	Specific Structure Type	Inlet Condition	Inlet Blocked	Primary Inlet Span FT	Crossing Structure Length FT	Outlet Condition	Outlet Drop FT	Crossing Substrate	Fill Height FT	Estimated Stream Width FT	Upstream Miles to Next Barriers	Up-Stream Barriers	Total Upstream Miles	Down-stream Barriers	Dam Name	Hydraulic Height FT
8564	Round Culvert	At Grade	No	5.9	27.9	At Grade		None		14.0	0.960	4	4.442	2		
8969	Round Culvert	At Grade	No	6.4	33.8	At Grade		None		6.0	2.166	3	3.482	3		
8966	Pipe Arch Culvert	At Grade	No	10.0	58.1	At Grade		Comparable		9.9	2.385	2	2.579	2		
8567	Round Culvert	At Grade	No	4.4	44.6	At Grade		Unknown		1.9	0.051	1	0.193	3		
8565	Round Culvert	At Grade	No	4.5	63.0	At Grade		None		2.9	0.268	5	4.710	1		
8999	Round Culvert	At Grade	No	3.0	21.3	At Grade		None		6.6	0.143	0	0.143	4		
8390	Pipe Arch Culvert	At Grade	No	8.7	41.3	Perched	3.3	None		3.1	2.885	0	2.885	3		
9011	Round Culvert	At Grade	No	3.0	36.1	Perched/Cascade	0.8	None		6.8	0.263	0	0.263	1

8992			No	< 1.5						2.7	0.227	0	0.227	5		
8995			No							3.3	0.653	2	1.317	4		
9004			No							3.6	0.520	3	3.099	1		
NBCasco11										12.4	0.437	0	0.437	5		
D0416										7.8	3.584	1	6.469	2	Crystal Lake Dam	6.6
D0417										4.0	0.044	2	6.513	1	Crystal Lake Dam II	9.8
