Casco Bay Watershed Fish Barrier Priorities Atlas: New Gloucester

Fish Barrier Priorities Atlas

March 2012

Index Map

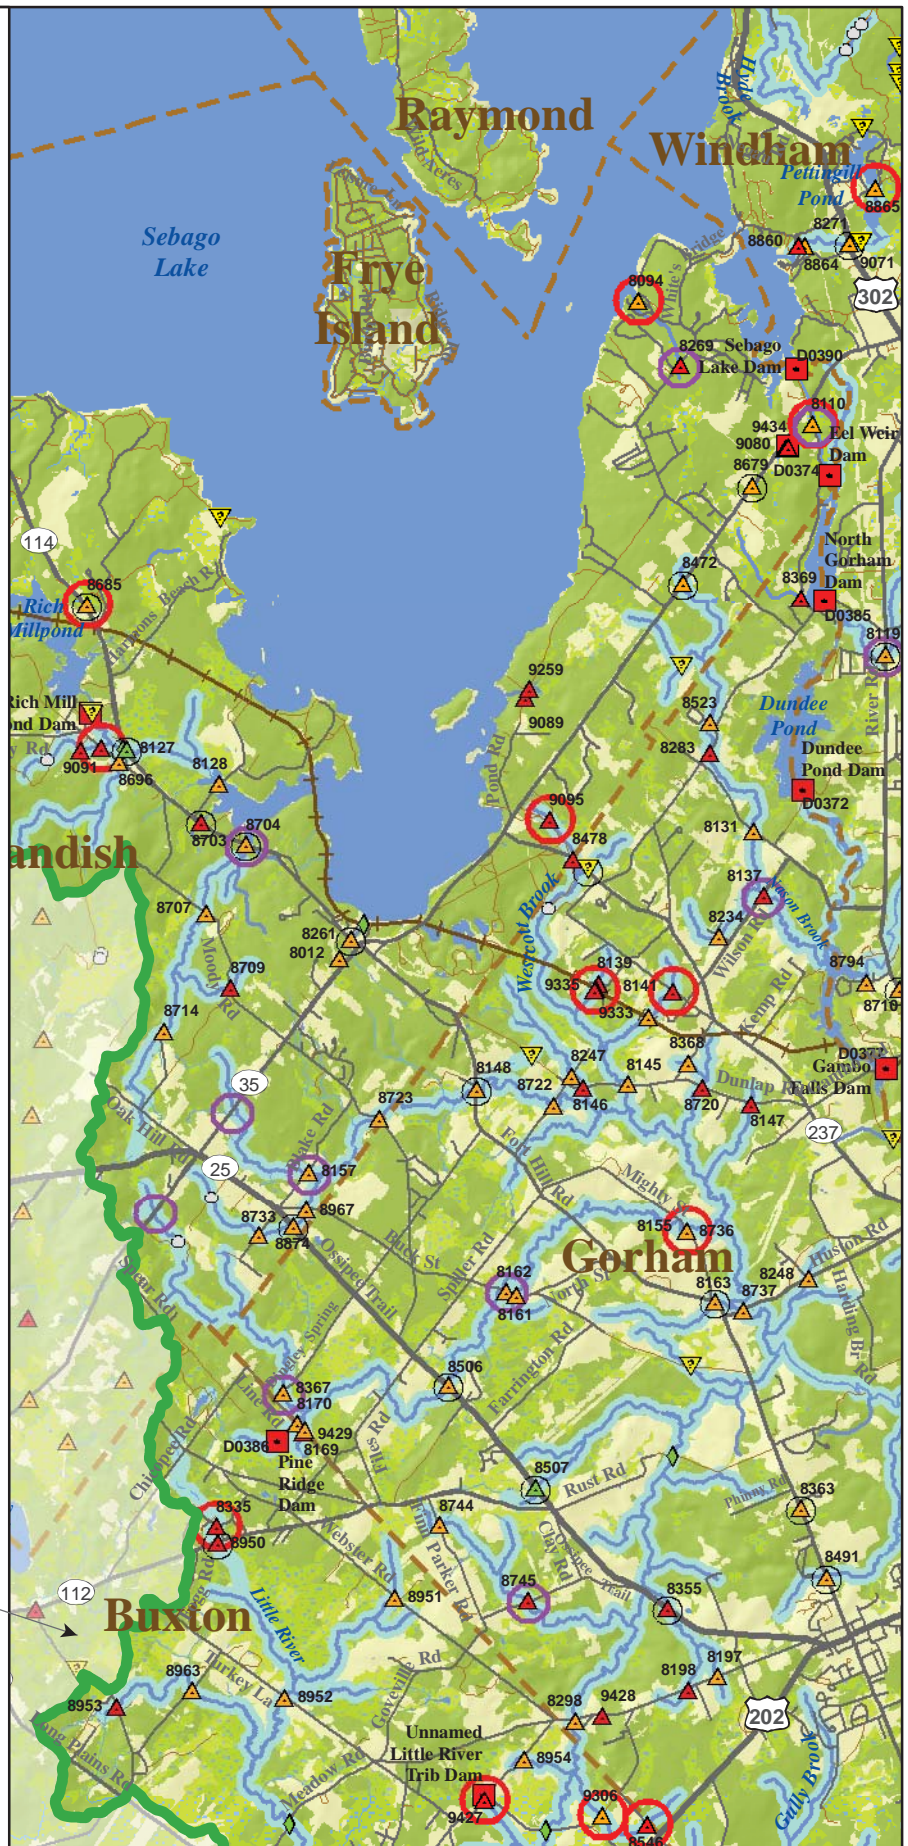
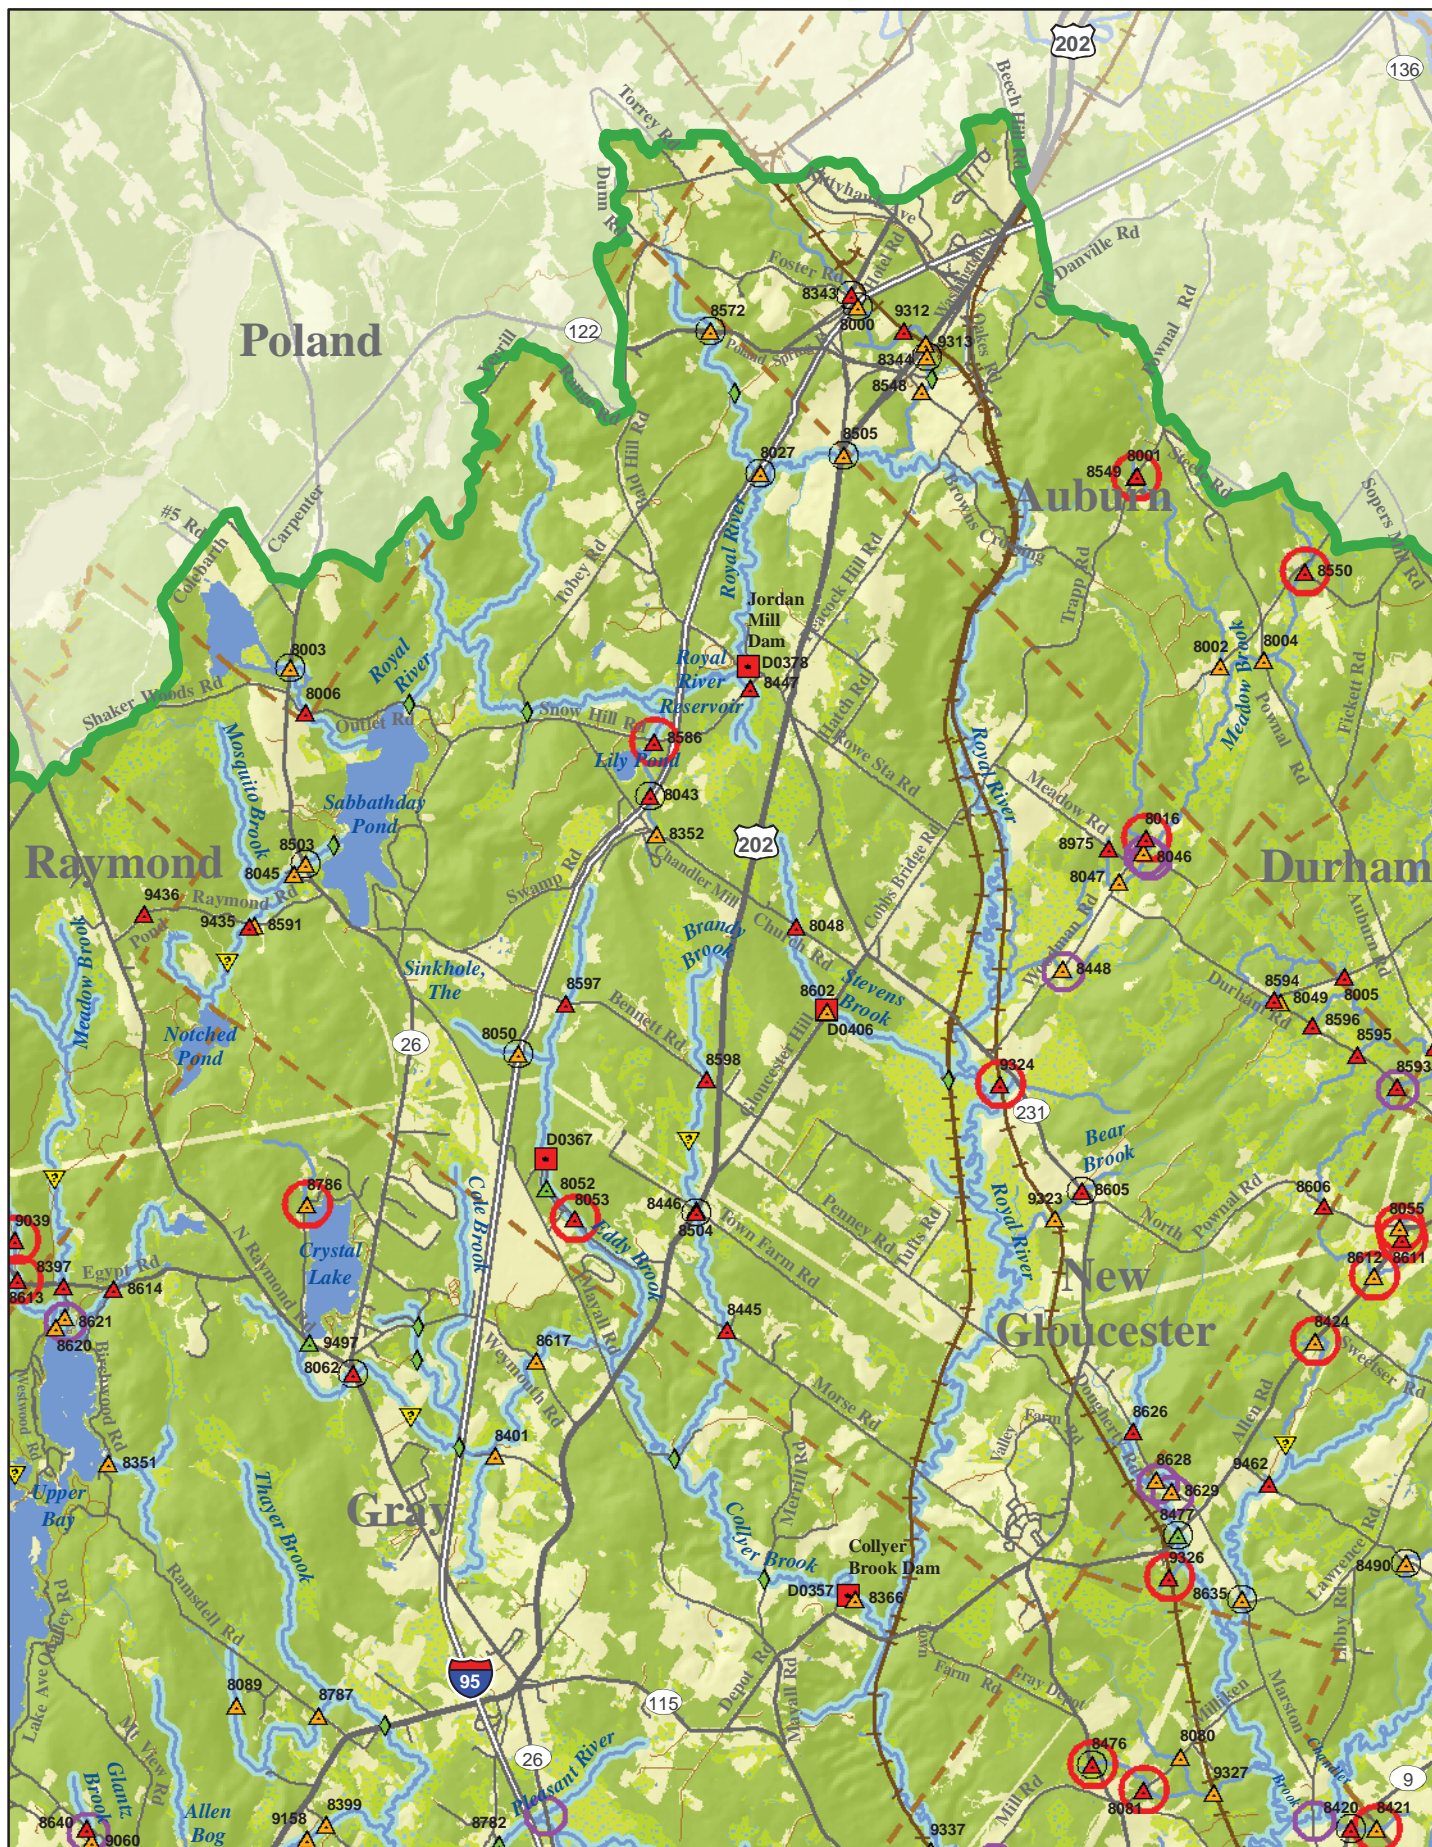
Casco Bay Barriers by Town

Road-stream crossings are shown with SiteID numbers to help identify them in the barrier database. Dams, in most cases, have labels both of SiteID and the dam's common name, if one is known. *Severe* barriers are defined as those road/stream crossings where fundamental physical barriers exist at either the inlet or outlet of the crossing, including inlets or outlets "perched" above the stream channel, and inlets blocked at least 50%, usually by debris. *Potential* barriers cover a wide spectrum of road-stream crossing situations where fish passage problems are likely to exist at some flows for some species or age groups of fish, and passage of other aquatic organisms such as amphibians and macroinvertebrates is likely also limited. Sites that were inaccessible to survey crews, and therefore not surveyed, are shown as unsurveyed, but are included in our analysis as *Potential* barriers. Dams are classified by whether or not they have effective facilities in place to provide upstream fish passage. Natural barriers, including waterfalls, debris jams (including woody debris or rock and fine sediments), and beaver dams were assessed when in close proximity to surveyed crossings and dams, and are mapped as well.

USFWS-GOMCP and CBEP staff consulted with state fisheries biologists to identify streams with important fish habitat, primarily for brook trout or Atlantic salmon, or both. These *priority streams* are highlighted on the maps. The scope of the road/stream crossing barrier assessment was limited to perennial streams, those with continuous flow year round. Although intermittent streams were not surveyed, fish using priority streams also rely on connectivity with intermittent tributaries at various times of year. There are likely to be additional barriers on important intermittent streams that have not been assessed.

The maps present data from Cumberland County Emergency Management Agency (CCEMA) and CBEP to show where flood hazards are likely to overlap with fish barriers. CCEMA, in cooperation with towns, has identified many road crossings as flood hazards based on past flood events. CCEMA sites are marked by purple circles, and do not always coincide with barrier survey sites because they may be located on intermittent streams or larger rivers crossed by bridges, which are generally passable for fish but may still entail flood hazards.

These maps are created primarily with 1:24,000 scale basemap data, with landcover data added to provide general distinctions between open and forested lands. Areas outside of the Casco Bay watershed are masked to obscure them.
