## Casco Bay Watershed Fish Barrier Priorities Atlas: Standish

## Fish Barrier Priorities Atlas

March 2012

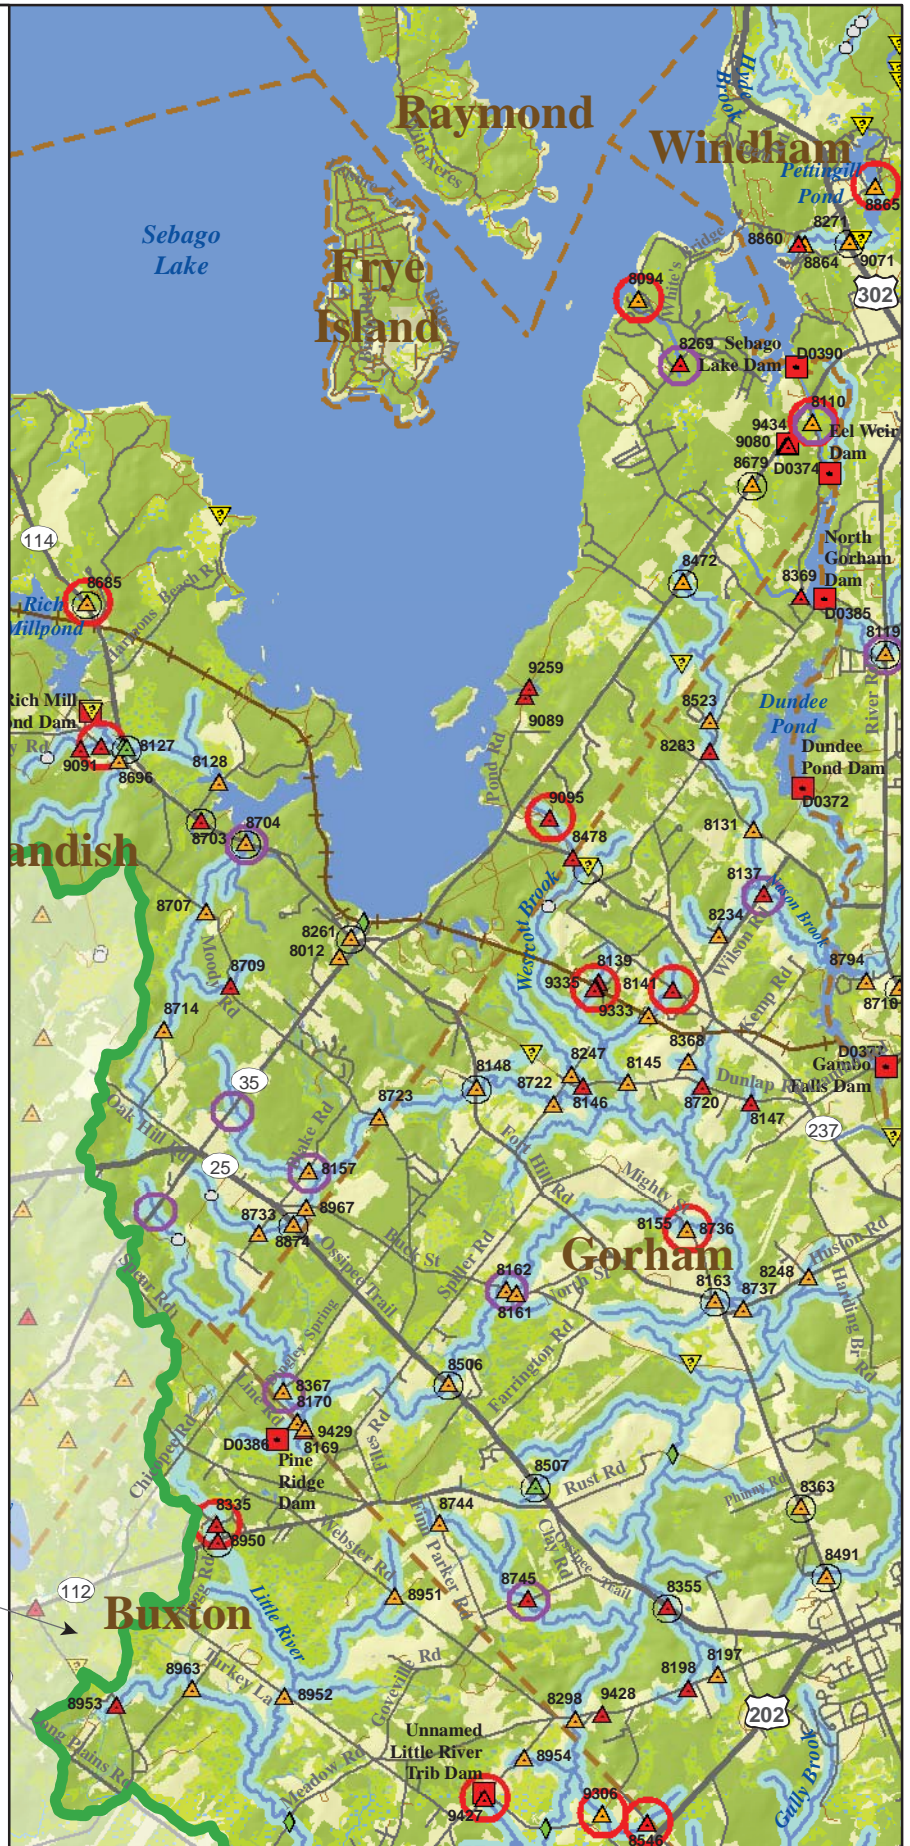
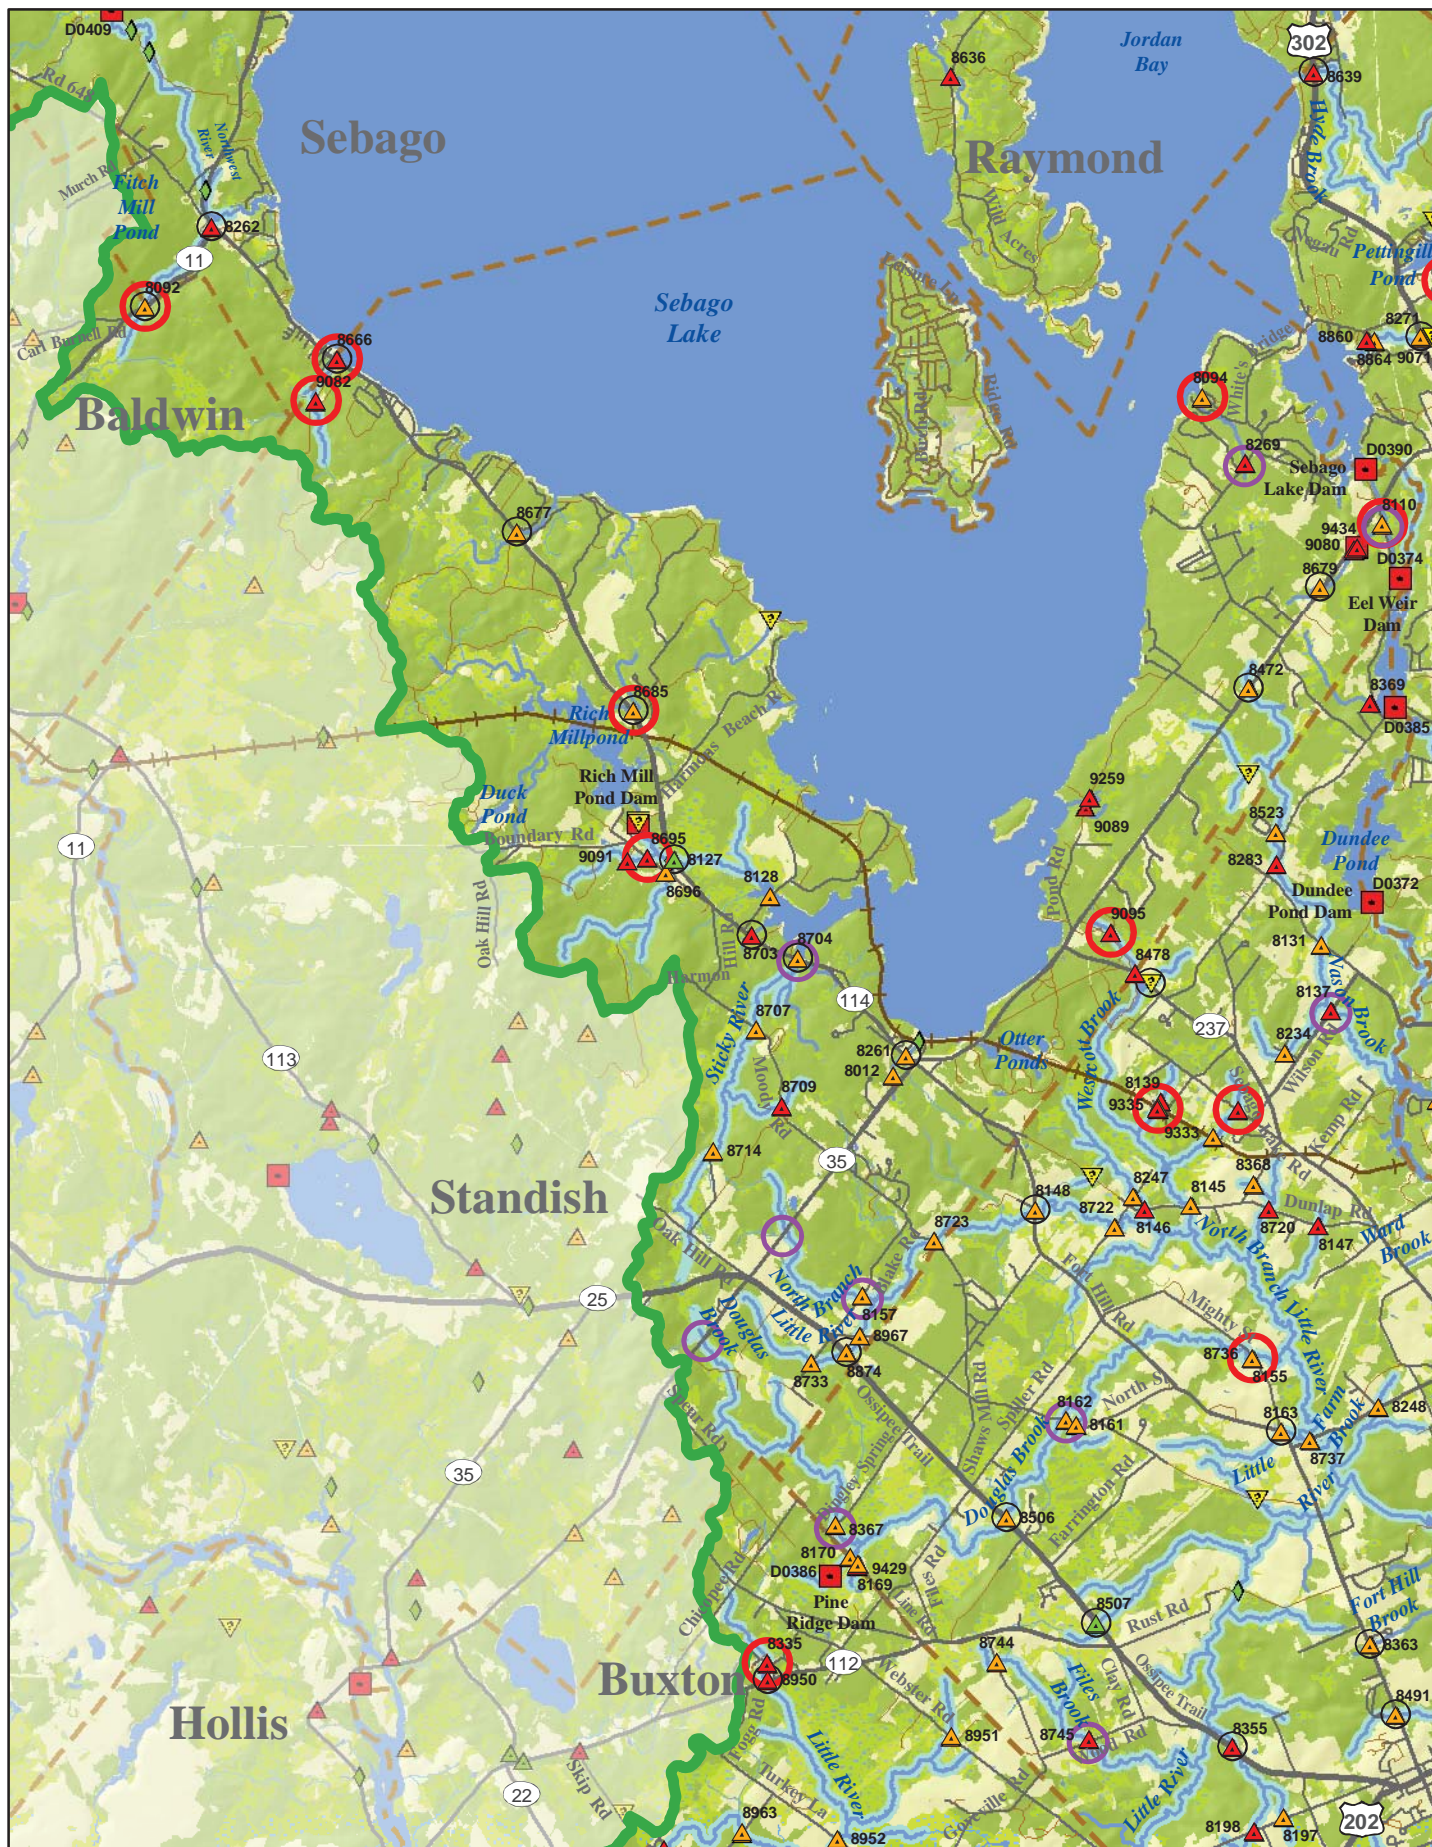
These maps are created primarily with 1:24,000 scale basemap data, with landcover data added to provide general distinctions between open and forested lands. Areas outside of the Casco Bay watershed are masked to obscure them.

Scale Varies by Town  
See scale bar at bottom of each map

Road-stream crossings are shown with SiteID numbers to help identify them in the barrier database. Dams, in most cases, have labels both of SiteID and the dam's common name, if one is known. *Severe* barriers are defined as those road/stream crossings where fundamental physical barriers exist at either the inlet or outlet of the crossing, including inlets or outlets "perched" above the stream channel, and inlets blocked at least 50%, usually by debris. *Potential* barriers cover a wide spectrum of road-stream crossing situations where fish passage problems are likely to exist at some flows for some species or age groups of fish, and passage of other aquatic organisms such as amphibians and macroinvertebrates is likely also limited. Sites that were inaccessible to survey crews, and therefore not surveyed, are shown as unsurveyed, but are included in our analysis as *Potential* barriers. Dams are classified by whether or not they have effective facilities in place to provide upstream fish passage. Natural barriers, including waterfalls, debris jams (including woody debris or rock and fine sediments), and beaver dams were assessed when in close proximity to surveyed crossings and dams, and are mapped as well.

USFWS-GOMCP and CBEP staff consulted with state fisheries biologists to identify streams with important fish habitat, primarily for brook trout or Atlantic salmon, or both. These *priority streams* are highlighted on the maps. The scope of the road/stream crossing barrier assessment was limited to perennial streams, those with continuous flow year round. Although intermittent streams were not surveyed, fish using priority streams also rely on connectivity with intermittent tributaries at various times of year. There are likely to be additional barriers on important intermittent streams that have not been assessed.

The maps present data from Cumberland County Emergency Management Agency (CCEMA) and CBEP to show where flood hazards are likely to overlap with fish barriers. CCEMA, in cooperation with towns, has identified many road crossings as flood hazards based on past flood events. CCEMA sites are marked by purple circles, and do not always coincide with barrier survey sites because they may be located on intermittent streams or larger rivers crossed by bridges, which are generally passable for fish but may still entail flood hazards.
