Wallace Shore Road in Harpswell, Tidal Restriction Restoration 2015 Monitoring Report, Year 1 of 5, Post-Construction

Tidal Restriction Restoration at Wallace Shore Road

2015 Monitoring Report: Year 1 of 5, Post-Construction

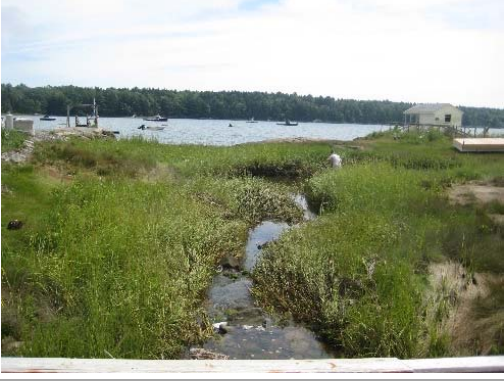
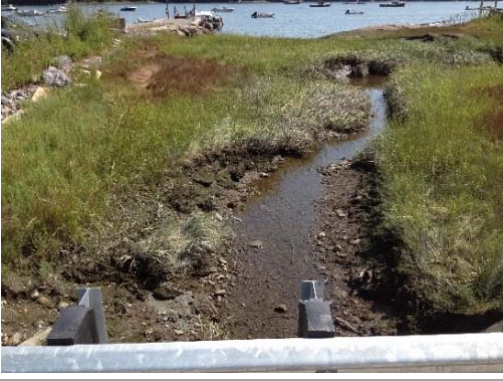
SITE 9079, PRE-PROJECT	SITE 9079, POST-PROJECT (YEAR 1)
View Downstream (Est). Dates (L to R): 7/31/2012; 8/18/2015.

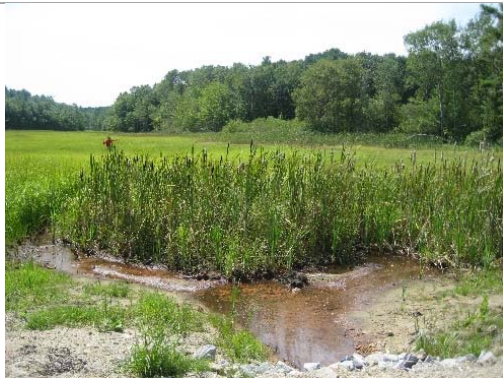
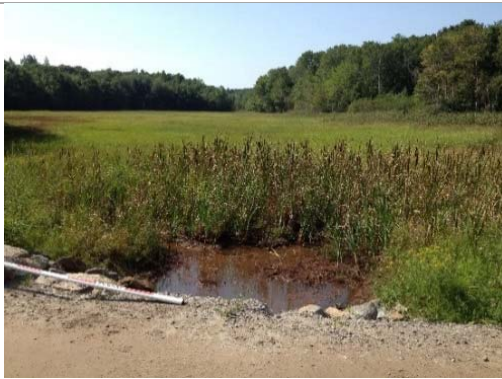
SITE 9078, PRE-PROJECT		SITE 9078, POST-PROJECT (YEAR 1)	
View Downstream (South). Dates (L to R): 7/23/2012; 8/18/2015

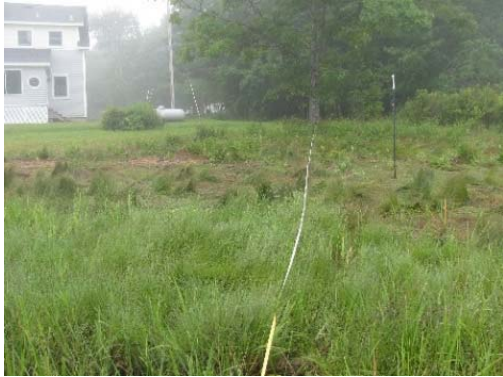
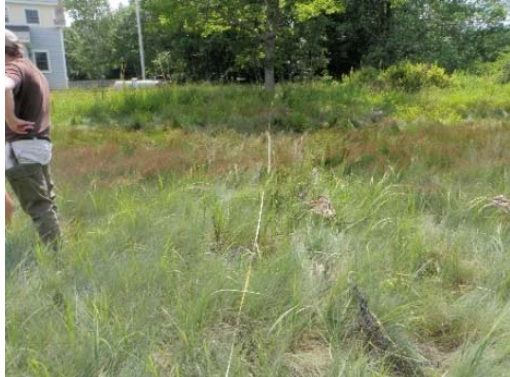
PRE-PROJECT		POST-PROJECT (YEAR 1)	
Transect 1a. (L – 7/15/2014; R - 7/14/2015); view S/SW from channel to upland.

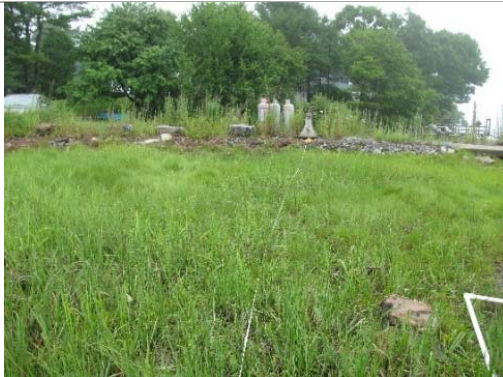
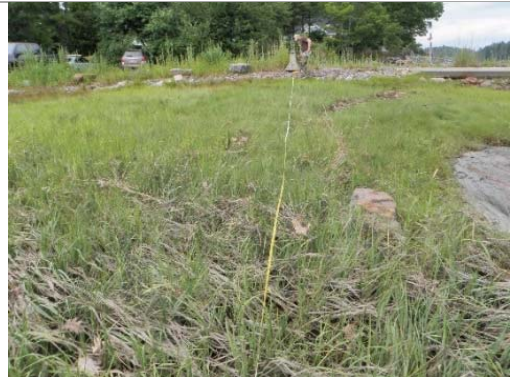
Station 1b. (L – 7/15/2014; R – 7/14/2015); view N from channel to upland/gravel parking lot.

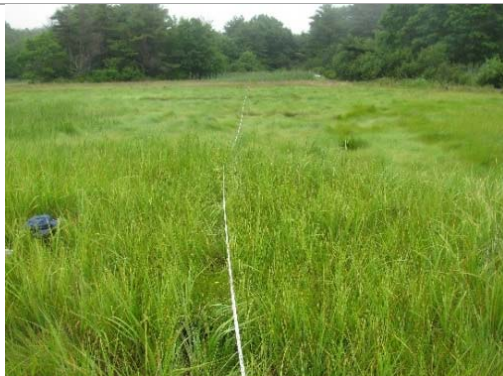
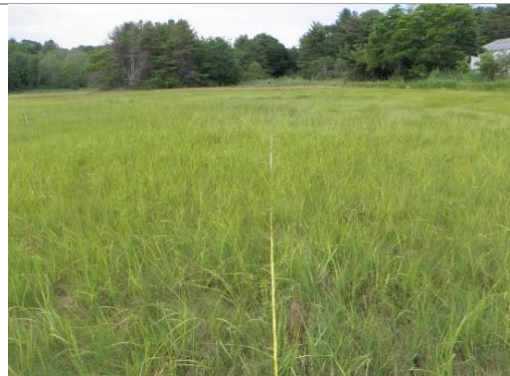
Station 2. (L – 7/15/2014; R – 7/14/2015); view N from channel toward upland.

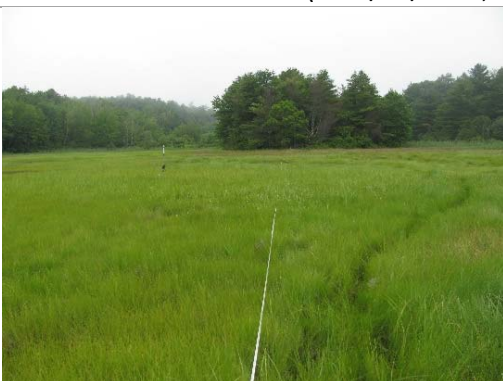
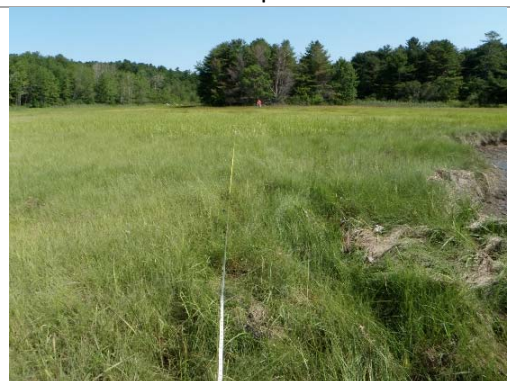
Station 3. (L – 7/15/2014; R – 7/16/2015); view N from channel to upland.

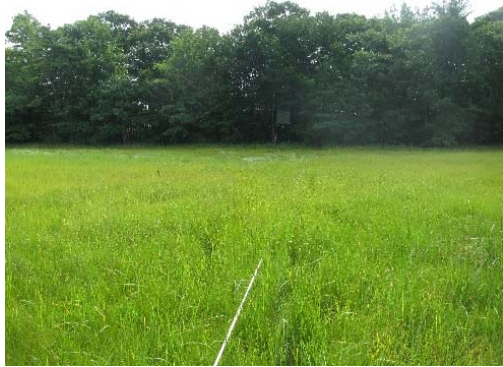
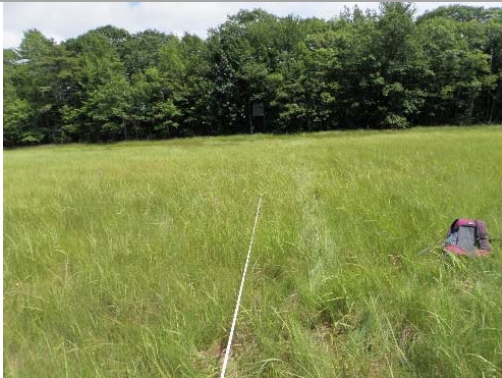
PRE-PROJECT		POST-PROJECT (YEAR 1)	
Transect 4. (L – 7/17/2014; 7/14/2015); view E from channel to upland.

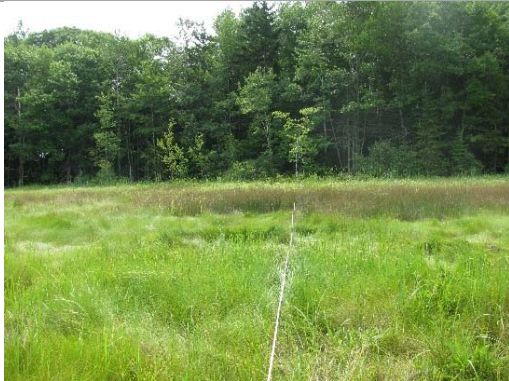
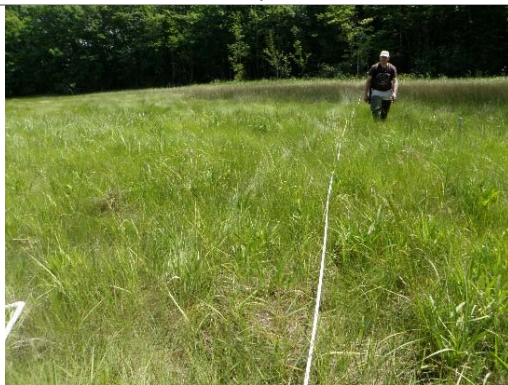
Station 5. (L – 7/17/2014; R – 7/14/2015); view E from channel to upland.

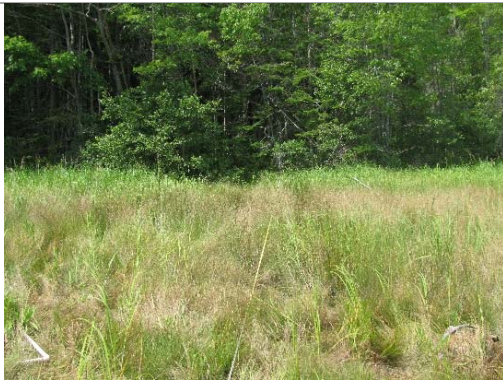
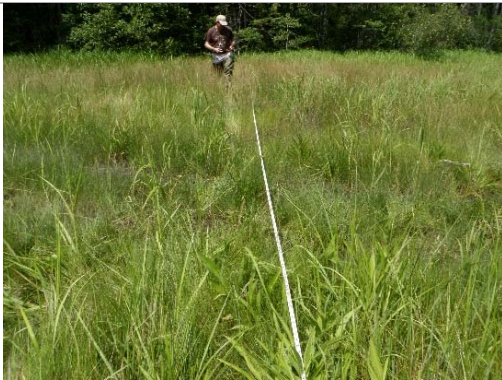
Station 6. (L – 7/17/2014; R – 7/14/2015); view E from channel to upland.

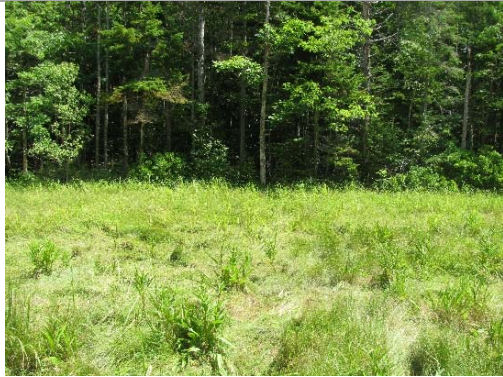
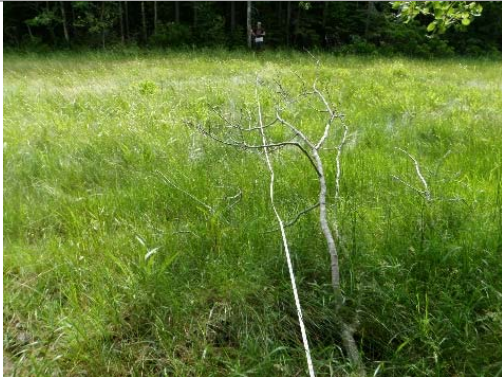
Station 7. (L – 7/17/2014; R – 7/14/2015); view E from W end of transect.

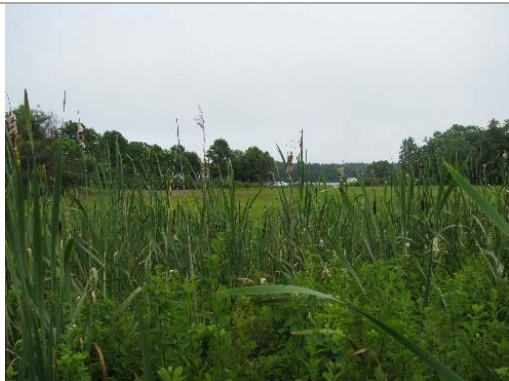
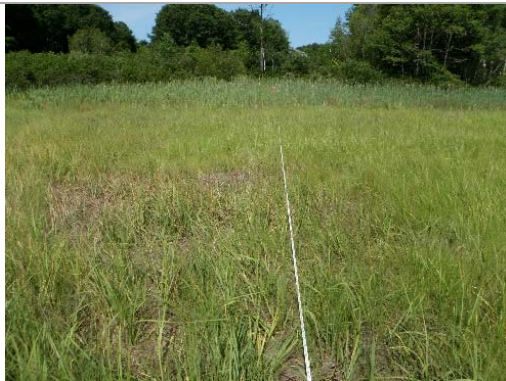
PRE-PROJECT		POST-PROJECT (YEAR 1)	
Transect 8. (L – 7/15/2014; 7/16/2015). L - view E from upland to channel; R - view W from channel to upland.

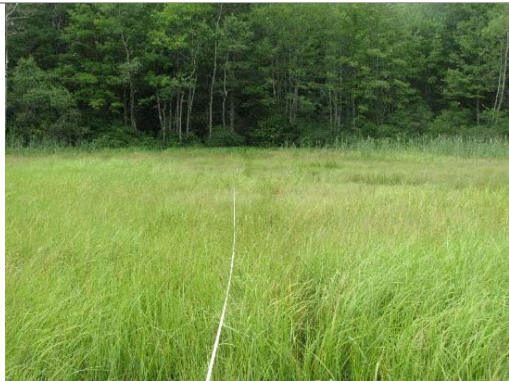
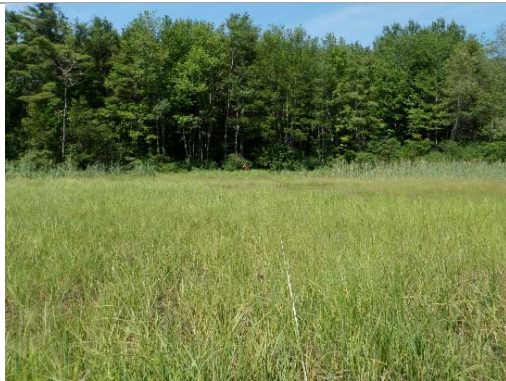
Station 9. (L – 7/15/2014; R – 7/16/2015). View W from channel to upland.

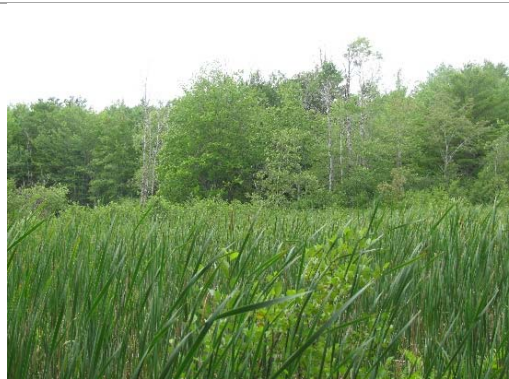
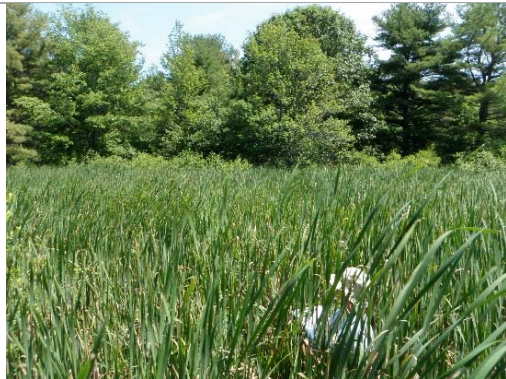
Station 10. (L – 7/15/2014; R – 7/16/2015). View E from W end of transect.
